March 13, 2019

PS 2019.014 - Suffield Town Hall Moisture Investigation Report

The following report covers Building Science Corporation's (BSC) evaluation of the moisture issues occurring at Suffield Town Hall, 83 Mountain Rd, Suffield, CT 06078, in preparation for a major renovation project at the building. The report is based on BSC's site investigation of March 7, 2019.

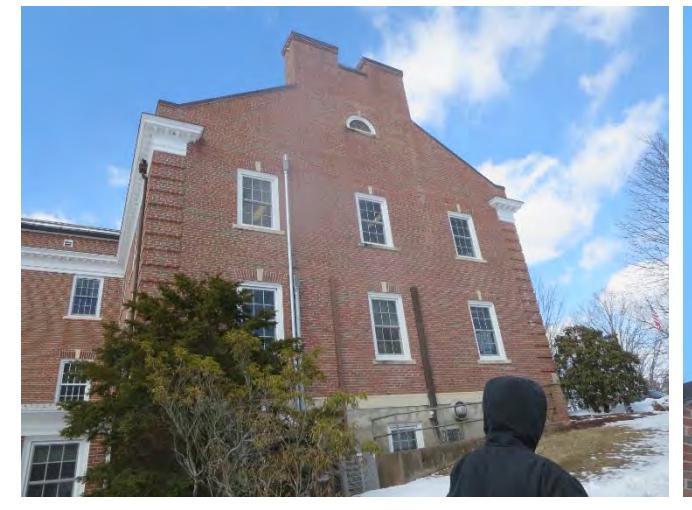
Figure 8: Gable end of attic showing false chimney

The attic gable end walls are CMU/brick solid mass masonry composite wall (i.e., no water resistive barrier, drainage plane, or system of flashings/weeps). The gable end is detailed with false chimneys on the east side (Figure 8), and one false/one real chimney on the west side. The chimneys appear to be capped with sheet metal covers (Figure 9).

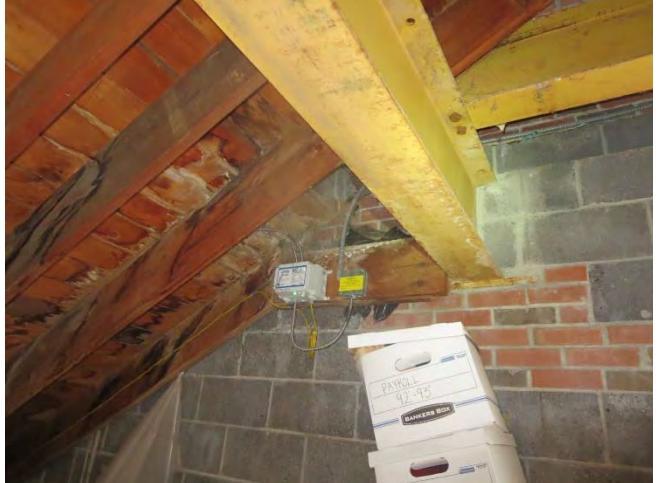
Another water control issue was signs of previous water leakage at the roof sheathing at the base of the chimney; images from the east end of the attic are shown in Figure 12 and Figure 13. There is no clear sign whether these water issues are still active, or solved with previous retrofits.

Figure 12: Water-stained roof sheathing, SE corner

These water control issues should be evaluated over time, to determine whether they are still active, via inspections after severe rain events. If they are active leaks, further investigation is required to determine appropriate retrofit detailing.

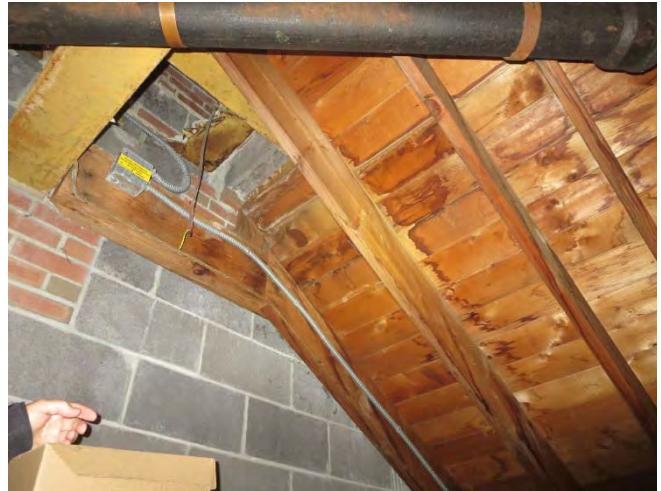
Figure 13: Water-stained roof sheathing, NE corner

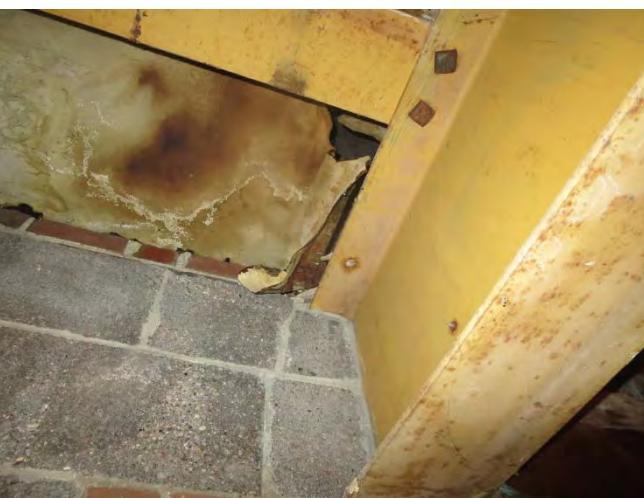
An unusual geometry occurs at the walls of the false chimney: a steel beam holds the inner wall of the false chimney as shown in Figure 14 and Figure 15 (reference exterior shots, Figure 8 and Figure 9). There is a copper/bitumen flexible

flashing spanning across the false chimney opening; this flashing is failing, with holes. The flashing is entirely removed at one false chimney on the east end of the building (Figure 16).

Figure 15: Failed flexible flashing at chimney

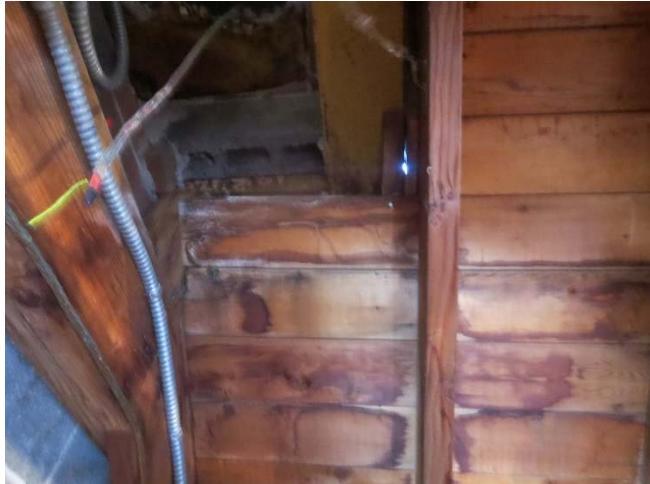
Figure 17: Sheathing staining and daylight

Looking upward at the east end of the building, daylight is visible at the flashing detail between the roof and the brickwork (Figure 17), at an area with water staining on the roof sheathing. This might indicate a current or inactive water leak. However, visible daylight does not automatically mean water leakage occurs: a properly shingle lapped flashing/ counterflashing might still have these gaps. However, it does make the detail more vulnerable to wind-blown water penetration.

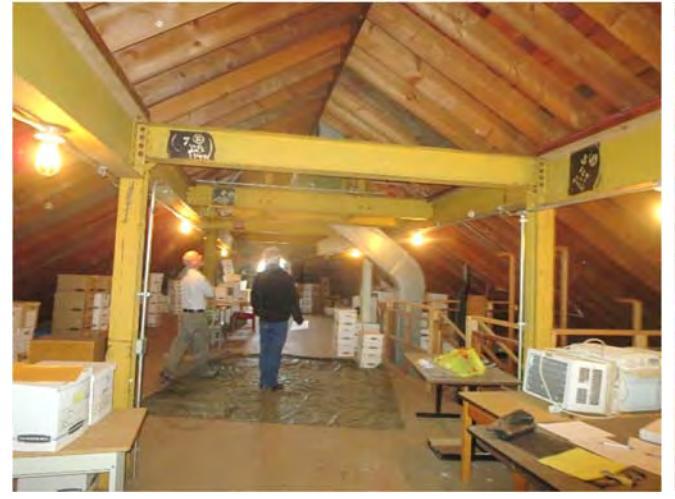
The roof has a decorative vented cupola; it functions as upper attic ventilation, via the open louvers. It also provides the exit point for the exhaust fan ductwork (Figure 20). However, the cupola also appears to be an ongoing water leakage issue: a tarp is spread on the attic floor (Figure 19), likely to catch rainfall blown through the open louvers.

Figure 19: Overview of floor below cupola

The cupola is the portion of the building most exposed to wind-blown rain. Water will continue to get blown in through the cupola louver openings. We recommend continuing to collect blown-in rain, via a catch pan on the floor of the attic, or suspended from the steel structure. If a conditioned attic (spray foam at roofline) approach is taken, alternate details will be required at the cupola.

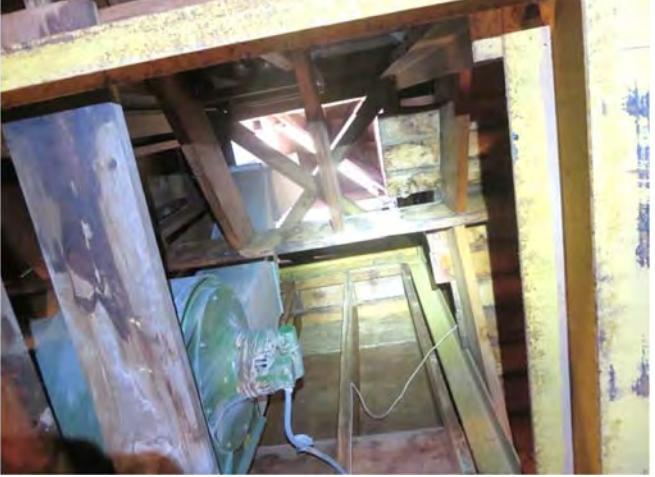
Figure 20: Looking up cupola; exhaust fan & ductwork

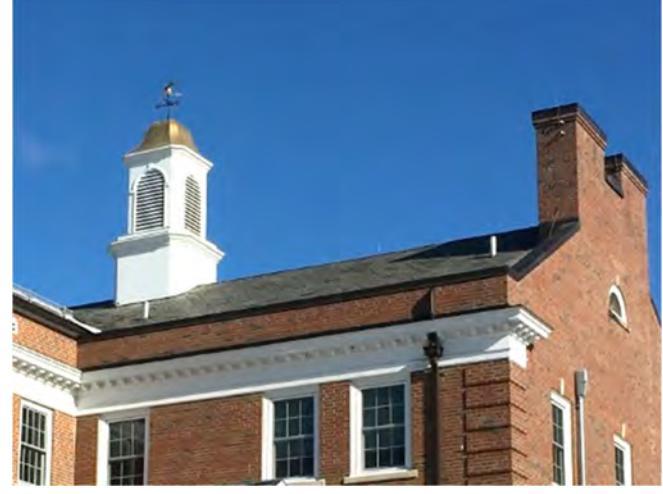
The cupola is completely exposed as the highest point of the building, per Figure 21 and Figure 22.

Figure 21: Cupola overview from rear (south)

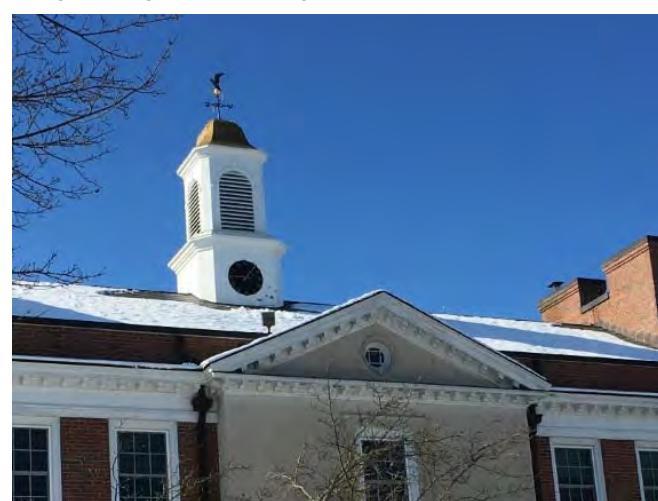
Figure 22: Cupola overview from front (north)

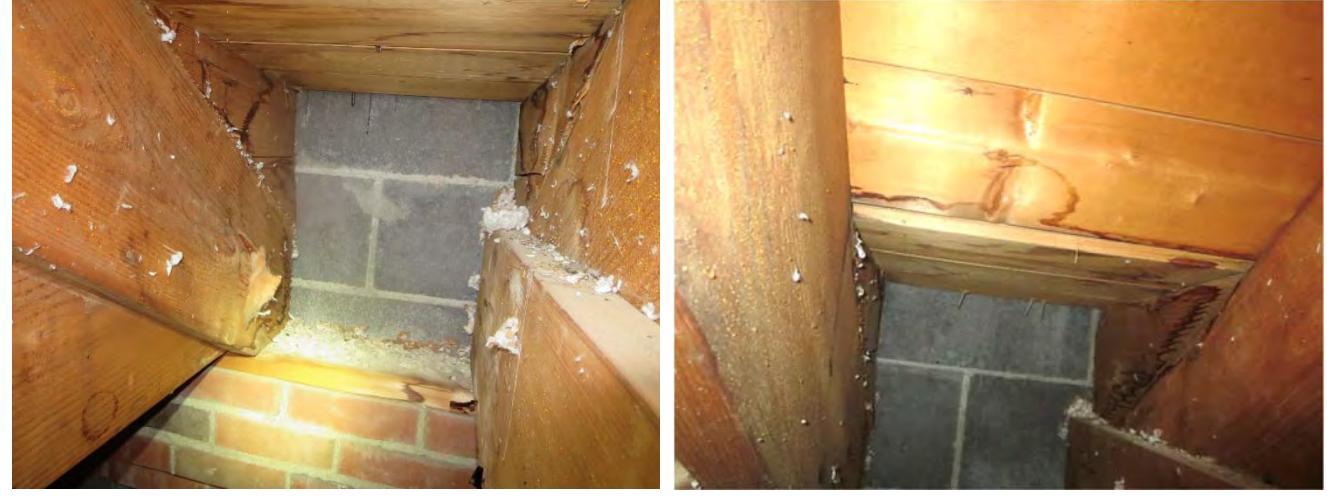
Attic ventilation normally functions by providing a pathway for outdoor air, from low to high. The cupola provides the "high" ventilation. However, examination of the lower edge of the roof (eave) showed no sign of openings for "low" ventilation (Figure 24 and Figure 25).

Figure 24: Close-up of rafter tail and eave condition

Figure 25: Roof sheathing slope-to-horizontal

Overall, retrofitting "low" attic ventilation is a low priority compared to other retrofit action items.

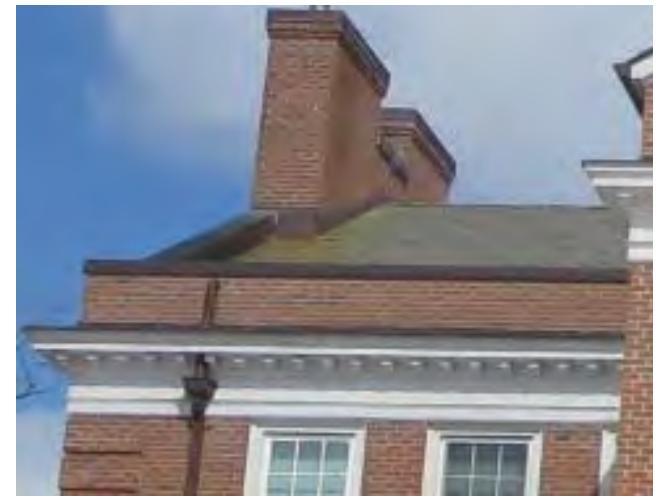
This is consistent with the exterior detailing (Figure 26) and the 1961 plans (Figure 27): a masonry "parapet" wall forms the base of the sloping roof, to prevent severe snow slide issues. The roof is drained from the horizontal "gutter" inboard of the brick parapet, and from there into exterior downspouts. Therefore, it is difficult to provide an outside air pathway into the bottom of the attic.

Figure 26: Exterior view of roof showing parapet

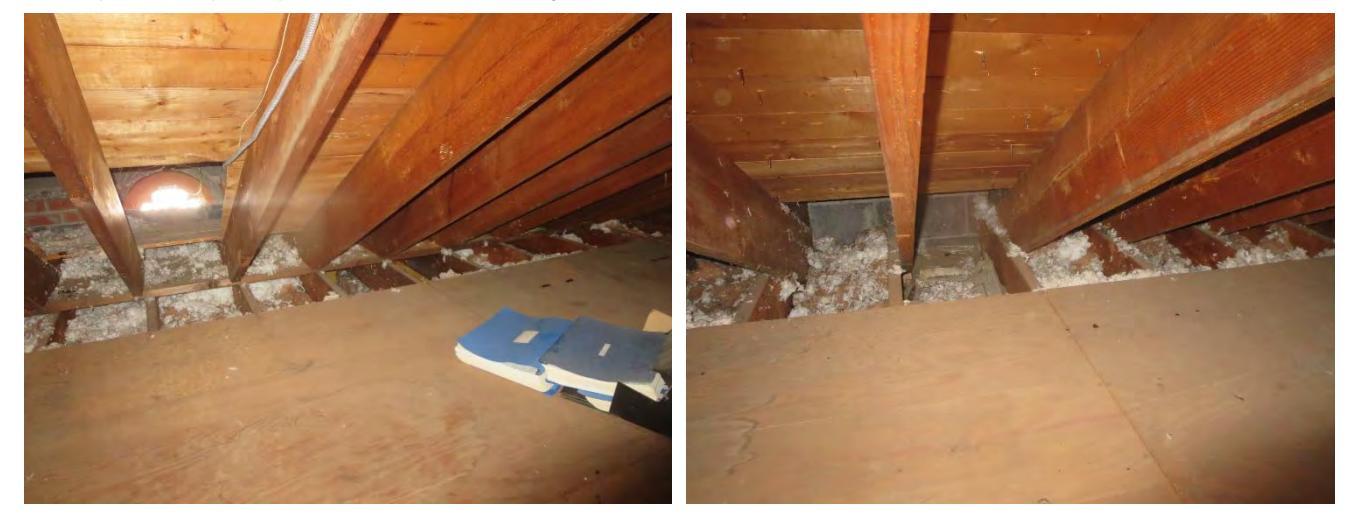
The floor of the attic is mostly a plywood deck, with exposed insulation at the perimeter eave conditions (Figure 28 and Figure 29). However, infrared camera observations (covered below) revealed warm thermal anomalies "streaming" up the rafter bays, which typically indicates outward leakage of warm interior air.

Figure 28: Attic floor sheathing, insulation, and eave

Figure 29: Attic floor sheathing, insulation, and eave

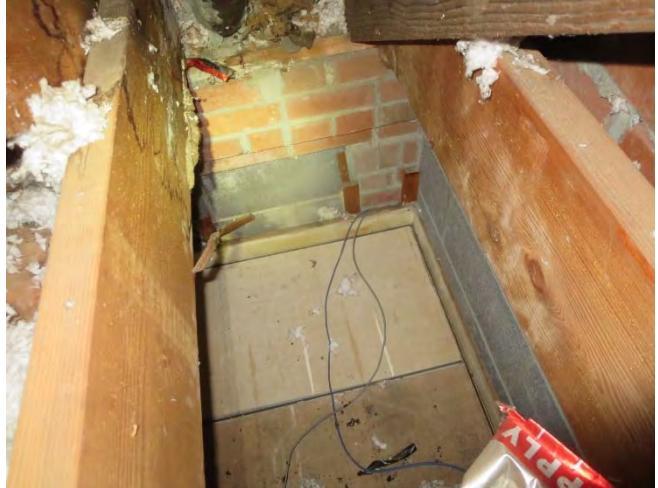
Closer examination of these areas revealed sections where the foil-faced fiberglass insulation had fallen or was missing. For instance, Figure 30 shows an area with the batt removed, and a polyethylene air/vapor barrier "patched in" with a large hole. Looking further downward reveals the upper side of the lay-in suspended ceiling tile grid (Figure 31). The 1961 plans (Figure 7) show this geometry: the batt insulation is in line with 2x10 ceiling joists, and the suspended ceiling tile lines up with the "hung ceiling" callout.

Figure 31: Suspended ceiling tile visible below

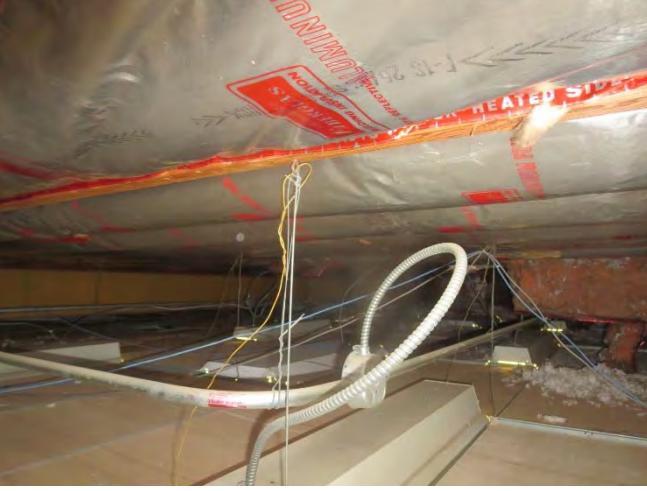
Conditions looking laterally at the cavity between the batt insulation and the ceiling tile are shown in Figure 32, Figure 33, Figure 34, and Figure 35. As shown in the latter two images, many of these batts are failing and have fallen from the ceiling joists. The fiberglass batts are "inset stapled" (stapled to the sides of the joists), with no attempt at air sealing the seams.

Figure 33: Conditions above suspended ceiling

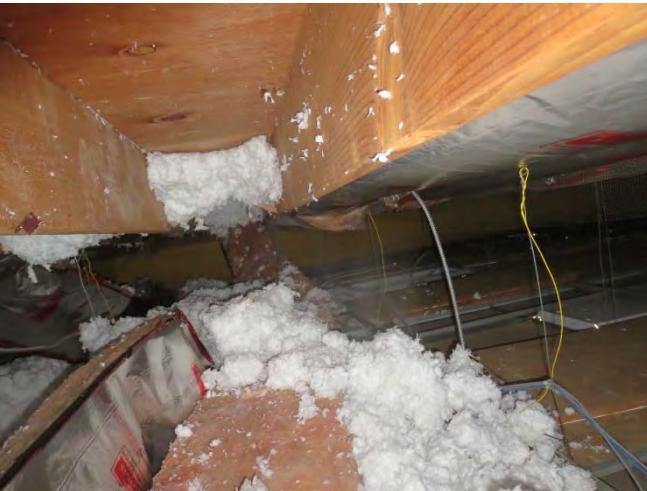
Figure 35: Failed insulation batts at ceiling

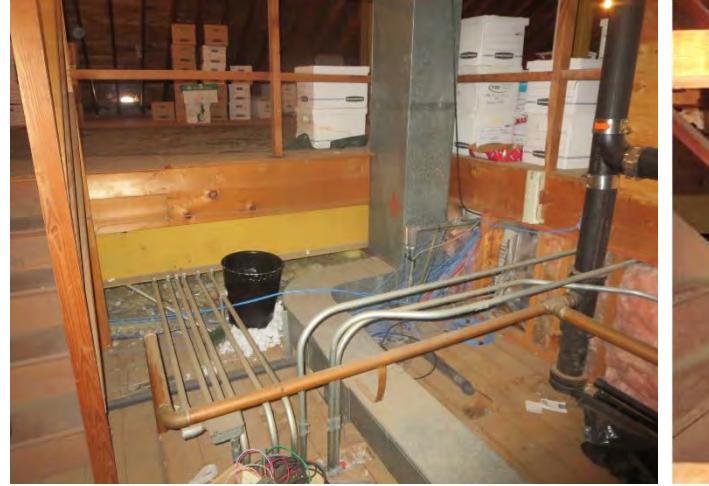
The stairwell to the attic is a variation from the main geometry of the attic; it is shown in the 1961 plans in Figure 7. The stairs from the second floor to the attic reach a landing platform lower than the main attic deck, resulting in vertical "kneewall" conditions between the lower platform and the main attic floor deck (Figure 36 and Figure 37).

Figure 36: Stairwell/landing area; exhaust ductwork

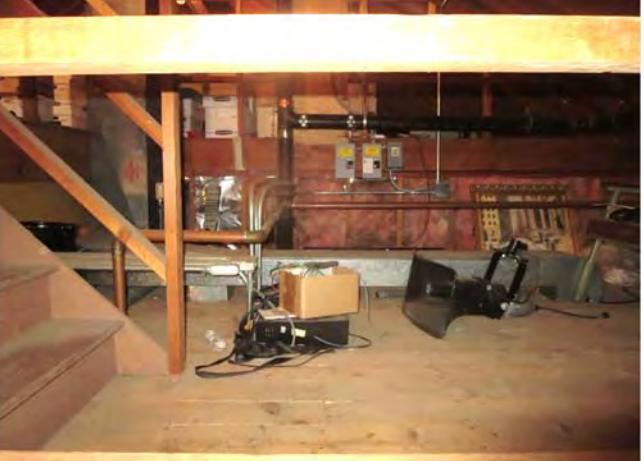
Figure 37: Kneewall at stairwell, ceiling height change

This resulting geometry also results in greater heat loss due to air leakage, as demonstrated with an infrared camera. The infrared camera (FLIR ONE Pro, -4°F to 752°F; \pm 3 °C (5.4 °F) or \pm 5%, typical percent of the difference between ambient and scene temperature accuracy) shows surface temperatures using a color scale: blue/purple are cooler temperatures, and yellow/orange warmer temperatures. Heat loss from the interior to the attic would appear as warm surfaces.

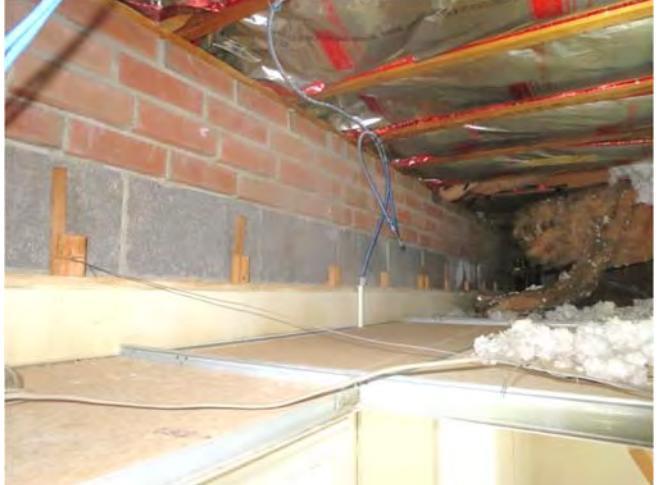
Again, the foil-faced batts are inset stapled to the side of the ceiling joists, and no attempts were made to detail it in an airtight manner (taping of seams, etc.). This is particularly evident at the eave condition (Figure 43).

There were multiple cases of the insulation failing and falling down from its installed position, leaving openings in the ceiling plane.

Figure 41: Conditions over suspended ceiling, IT room

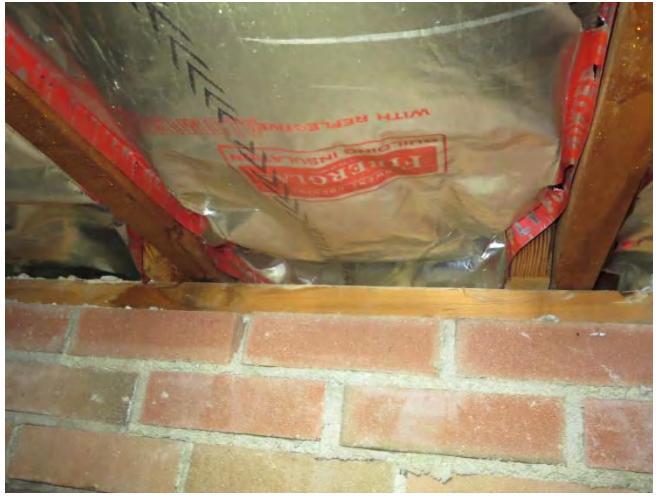
Figure 43: Typical stapled batt installation

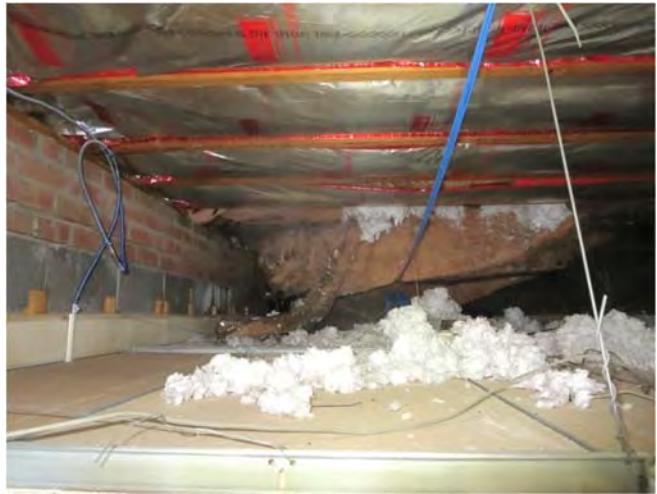
Figure 42: Conditions over suspended ceiling, IT room

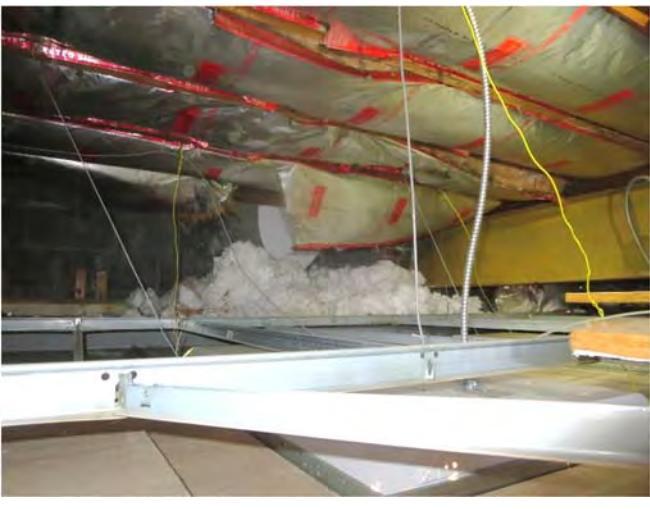
Figure 44: Failed insulation at conference room

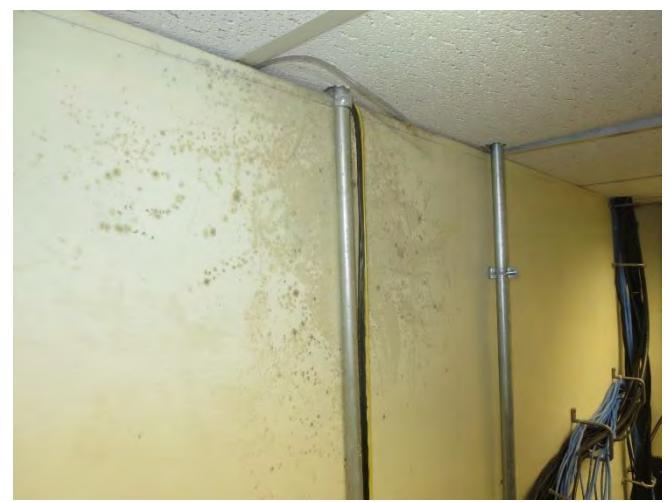
An overview of the server room is shown in Figure 46; it is a "landlocked" (no exterior wall) room on the second floor. An example of moisture issues seen here is apparent mold staining near the ceiling at the east wall (yellow circle in Figure 46 and Figure 47).

Figure 47: Apparent mold staining on wall at ceiling

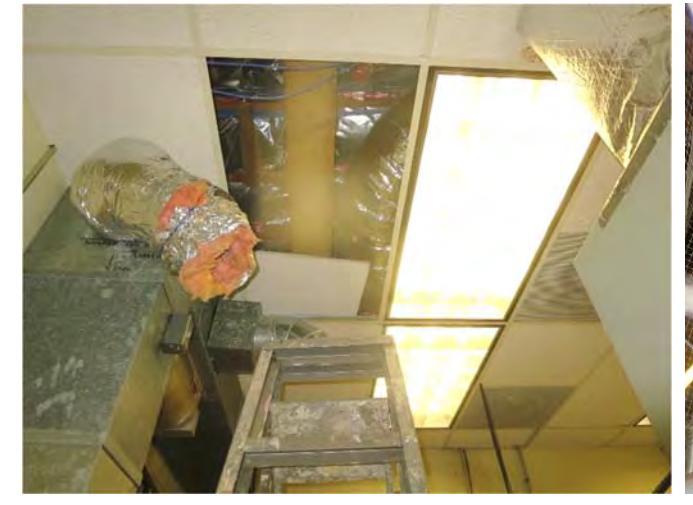
The ceiling space was examined (Figure 48), revealing similar conditions to the remainder of the second floor (Figure 49), with exposed foil-faced batts. Netting was installed to hold the batts in place. There is extensive cabling and electrical conduit throughout this ceiling space.

Figure 48: Suspended ceiling at server room

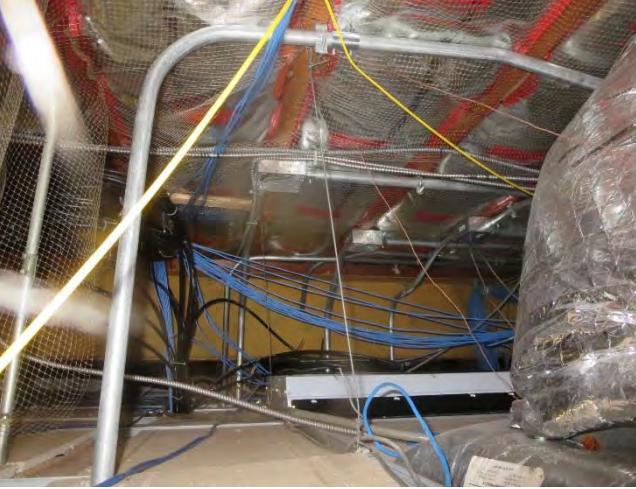
Figure 49: Server room suspended ceiling conditions

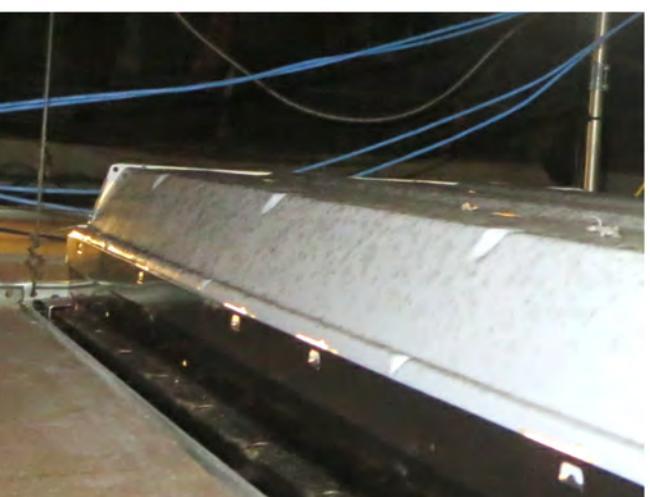
The metal T-bar suspended ceiling grilles have notable corrosion on their surface (Figure 50). There is apparent spotting/mold staining on the upper surface of the light fixture in the ceiling grid (Figure 51).

Figure 51: Apparent mold spotting on light fixture

The moisture problems occurring at the server room are a manifestation of this lack of an air barrier between the attic and the conditioned space. In the summer, the attic (and ceiling space) will be filled with warm, humid outdoor air. Based on pressure measurements, this attic air will tend to be "sucked in" at the server room when the door is closed. When this warm, humid air hits cold surfaces, it can condense, drip, and cause mold growth. This inward airflow occurs at the opening around the electrical conduit (Figure 47, with resulting mold growth), and ceiling T-bar grilles (Figure 50). The lack of an air barrier means the space above the suspended ceiling operates near outdoor conditions, resulting in condensation on cold exposed surfaces, such as light fixtures (Figure 51) and ductwork (Figure 52 and Figure 53).

The most robust solution is to provide a "hard ceiling" (gypsum board) at the underside of the ceiling joists, as shown in Figure 56, which requires the following steps:

- Remove ceiling tile and grid for construction work
- Repair/replace fiberglass batts as required (from below)
- Install gypsum board as air barrier; fire tape and seal all penetrations/joints. Select gypsum board as required by fire rating needs. Details must be developed at perimeter, structural beam penetrations, interior walls, etc.
- OPTIONAL: install closed cell spray foam at exposed brick/CMU wall above ceiling

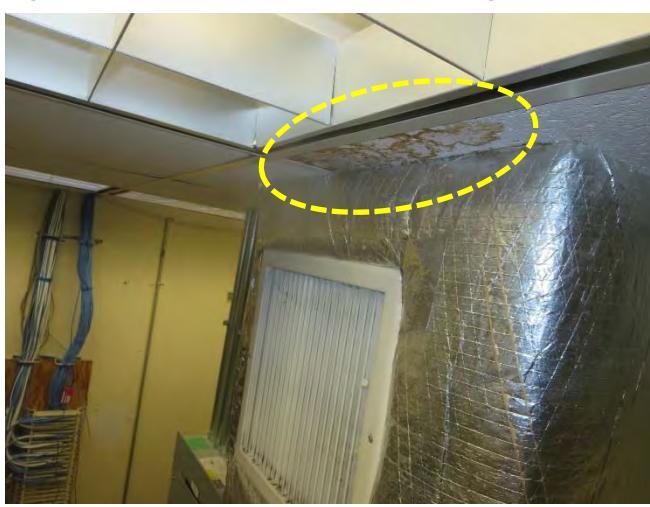
Another moisture issue is ceiling tile staining at the cooling unit's supply duct plenum (Figure 52); there is also some rust spotting on the connection band (Figure 53), all consistent with previous condensation and dripping.

Figure 52: Stained ceiling tile at supply plenum

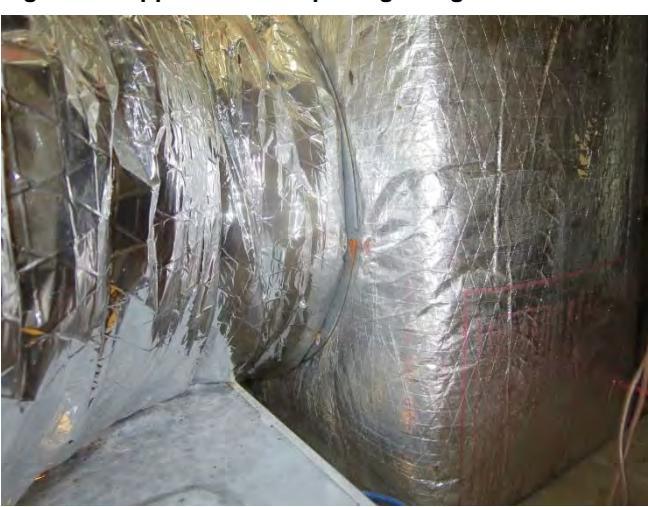
Figure 53: Air handler supply plenum, corrosion

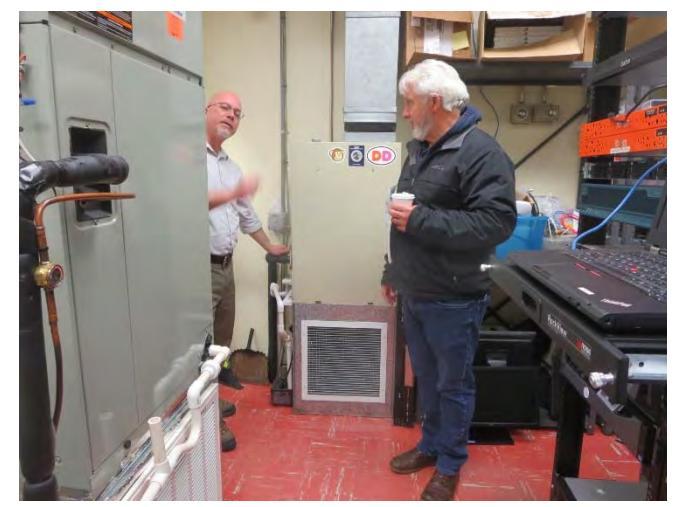
Cooling is provided in the server room with two ducted HVAC systems: a larger 5-ton unit, and a smaller 1.5 ton unit (Figure 54 and Figure 55).

Figure 54: Large (foreground) and small (rear) AHUs

The cooling units are a Trane 5-ton air handler, connected to an American Standard 5 ton outdoor unit, and a smaller Carrier 1-½ ton air handler. The team reported that cooling does not function well in extremely cold weather. Based on Trane literature (e.g., https://www.trane.com/download/equipmentpdfs/ssprc002en_r2.pdf), there are limits on outdoor temperatures for running cooling equipment.

Lastly, if the server room will be gut renovated, it is worth considering replacing the existing HVAC systems with a specialized computer room air conditioner (CRAC) designed to operate at low ambient temperatures. In addition, the new system should be sized to match the actual server heat load. The current equipment size (5 tons) is equivalent to 18 kW (18,000 W, or 180 100-W light bulbs) continuous electrical draw, which sounds high for a server room of this size. Of course, the cooling load of the server room will decrease once an effective air barrier is in place at the ceiling. This will eliminate the inadvertent conditioning of attic air, as is currently occurring.

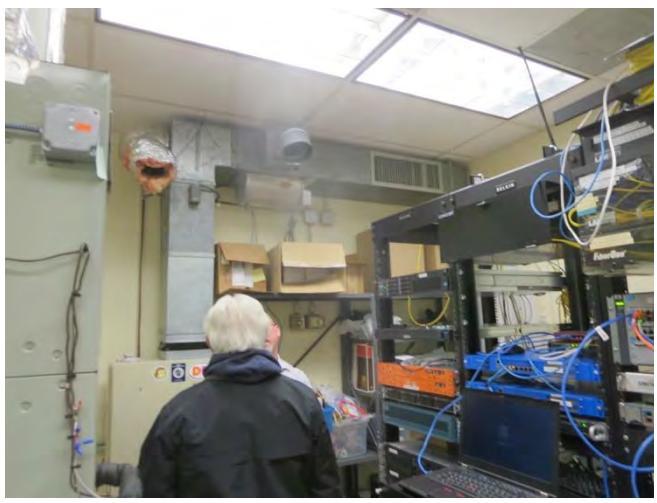
Figure 55: Ductwork from small AHU

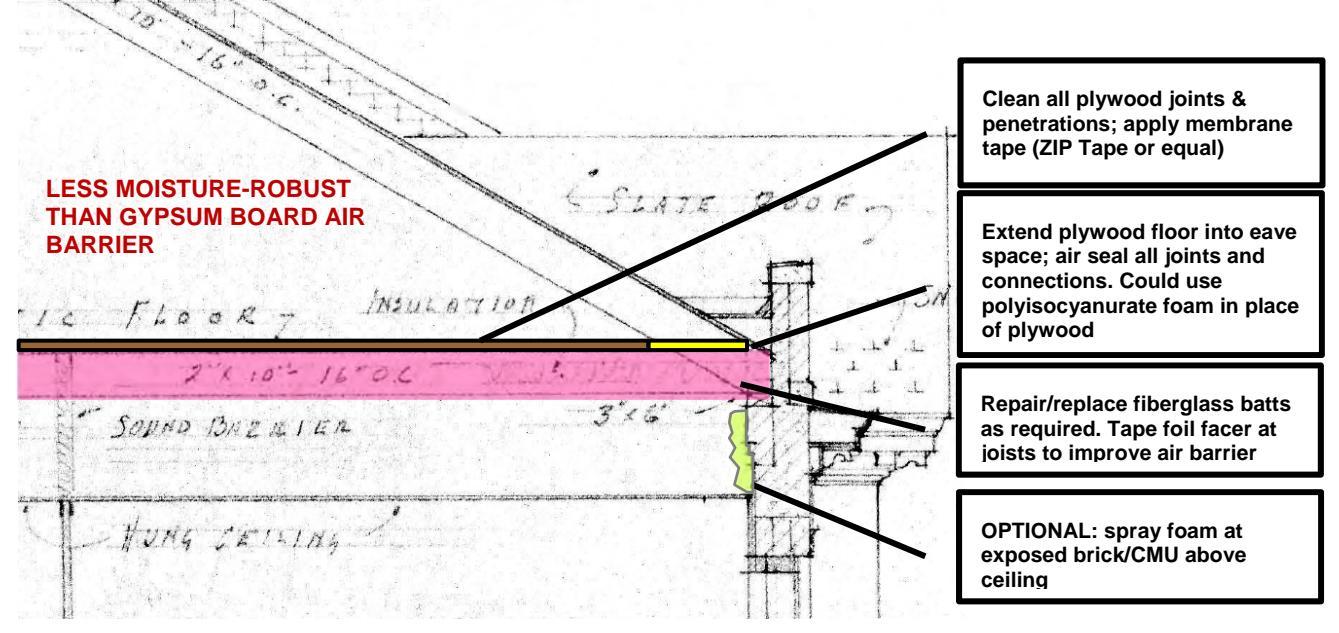
Figure 57: Conceptual design of retrofit with plywood floor ceiling air barrier (vented attic space)

However, this plywood floor approach (Figure 57) is a less moisture-robust assembly than the gypsum board (Figure 56) approach. Making the exterior side of the insulated cavity airtight (rather than the interior side) means that moisture could potentially condense on the underside of the plywood sheathing in winter. In contrast, with the gypsum board approach lets this moisture escape into the attic via air leakage. The plywood floor approach should only be done if the airtightness of the foil facers is improved by taping joints on the interior.

An alternate approach is shown in Figure 57: given that the plywood floor covers most of the attic, it could be leveraged to create an effective air barrier, with some detailing.

It has the advantage of shifting most of the work to the top side (attic side) of the assembly, minimizing interior disruption (assuming the second floor does not require a gut renovation).

- Repair/replace fiberglass batts as required (from below); requires opening ceiling tile grid on a "spot" basis
- Use housewrap tape or similar to seal joints of fiberglass batt foil facers
- Extend the plywood floor into the eave space; air seal all joints and connections. See perimeter conditions of the attic in Figure 58: the board must be "notched" around the rafters. The team could use polyisocyanurate foam in place of plywood; it will function as an effective air barrier
- Clean all plywood joints & penetrations; apply membrane tape (ZIP Tape or equal) and seal all penetrations. For instance, the joint between the CMU gable end wall and plywood (Figure 10) requires an air sealing detail.

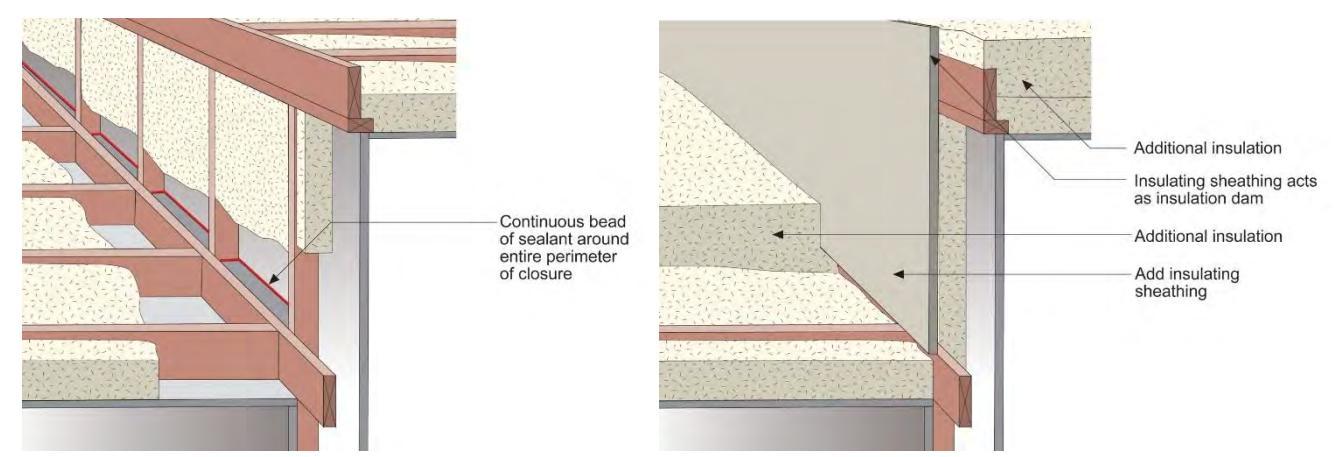
The stairwell platform and associated kneewalls will also need air barrier detailing. At the kneewalls, the recommended solution is to provide a solid airtight sheathing (e.g., rigid foam insulation board) on the attic side of the wall cavity, keeping the batt insulation inside a "six-sided box."

Figure 59: Air sealing and insulation details for two-story kneewall geometry

Details for retrofitting this condition are shown in Figure 59, taken from BSC's *Attic Air Sealing Guide and Details*. Further guidance can be found in the Building America Solution Center: Attic Knee Walls (https://basc.pnnl.gov/resource-guides/attic-knee-walls#quicktabs-guides=0)

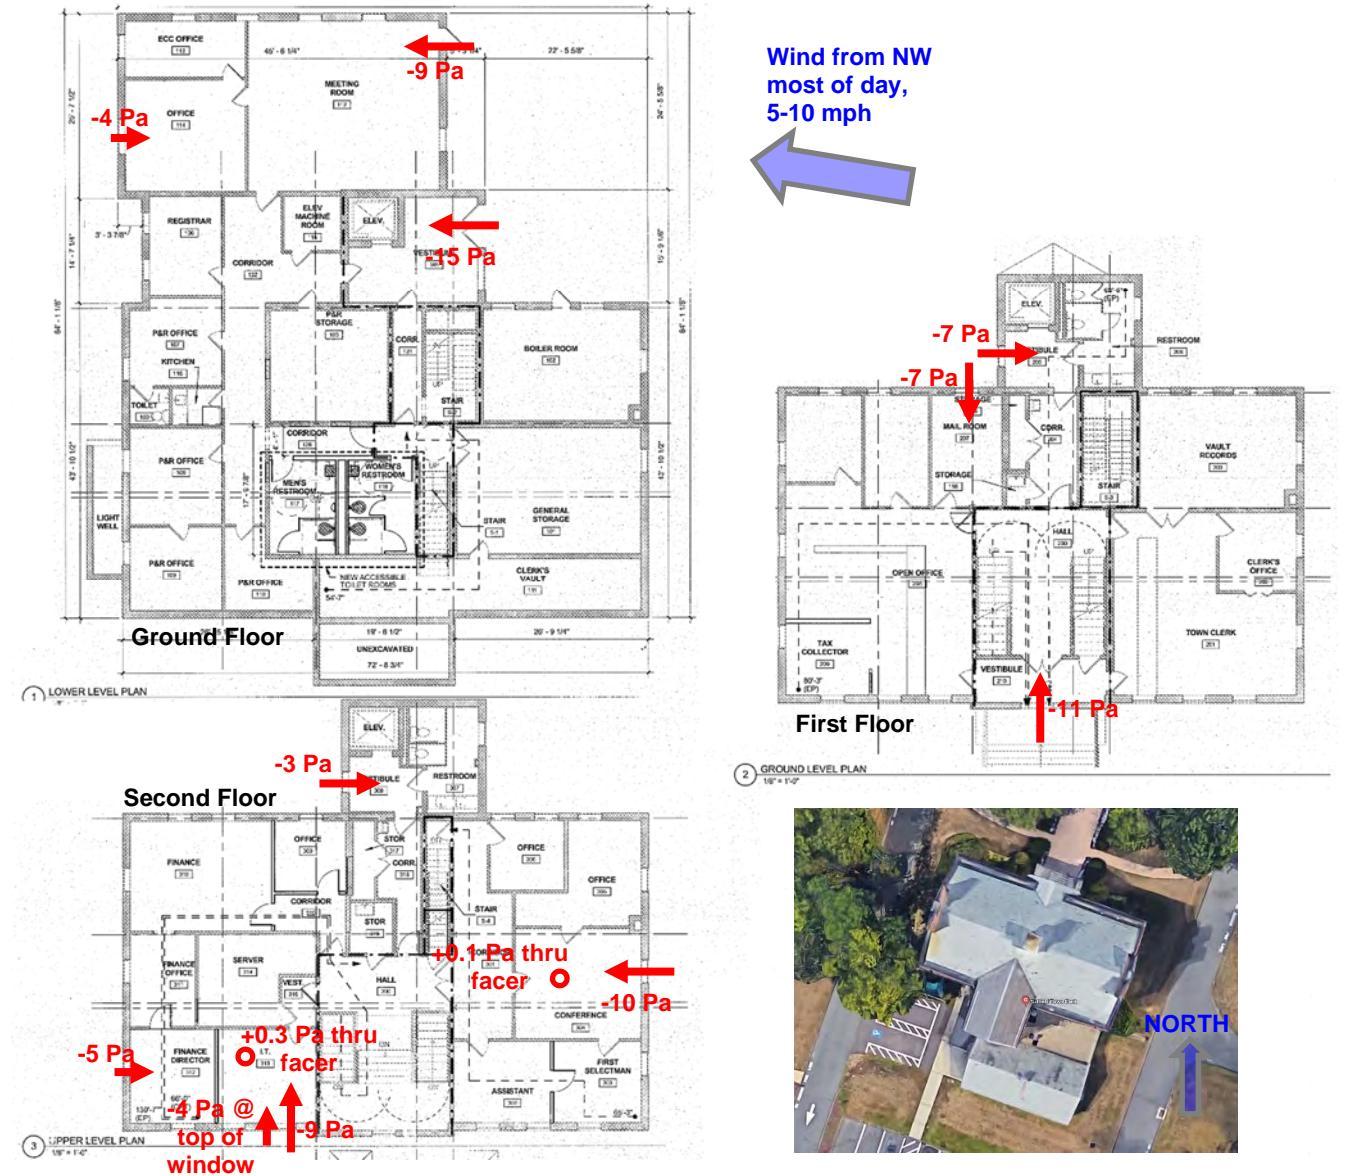
The pressure measurements are shown in a floor plan in Figure 67, and in Table 1. *Almost all pressure measurements were "negative" with respect to exterior (i.e., air flowing from outdoors to indoors), as shown by the arrows. As discussed below, this is unexpected behavior for normal building operation.* The exceptions were pressure measurements through the foil-faced batt facer (slightly outward/positive; +0.1 to +0.3 Pa).

Figure 67 includes an arrow showing rough wind direction during the day (predominantly from the NW, 5-10 mph). This explains the variation in pressure measurements based on orientation: the wind hitting the west- and north-facing sides of the building resulted in greater inward pressures on those orientations.

Figure 67: Building plan and pressure measurements, with wind direction noted; overhead view for reference

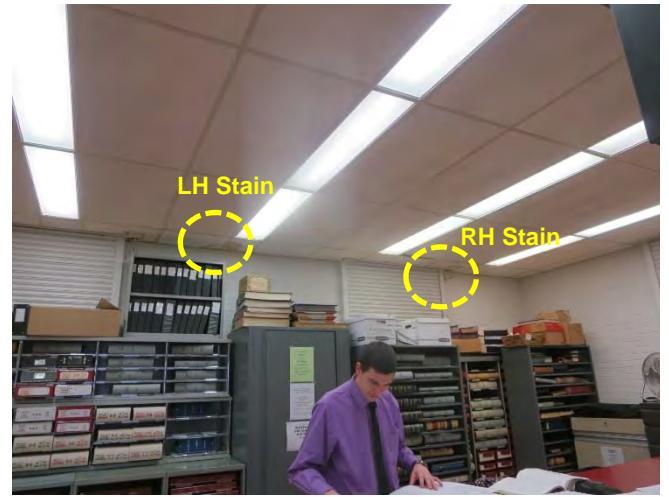
One issue reported by the team was ceiling tile staining throughout the building; examples in the vault/records room are shown in Figure 71. The left hand stain was examined more closely (Figure 72); there is a cluster of hot/chilled water piping joints at the exterior wall, directly above the stain. Looking more closely at the valve and joint (Figure 73), there is extensive patching (including expanding foam and duct tape) at this joint; this previous repair is consistent with the leakage problem. The repair materials were left in the suspended ceiling near the repair (Figure 74).

Figure 71: Ceiling tile stains, vault/records room

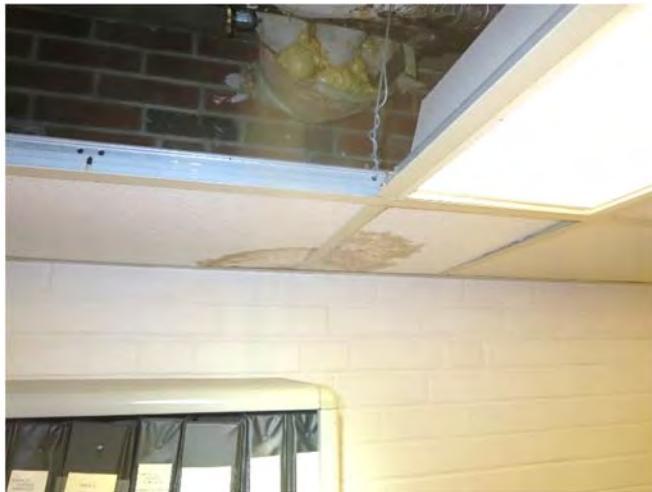
Figure 72: Left-hand stain, vault/records room

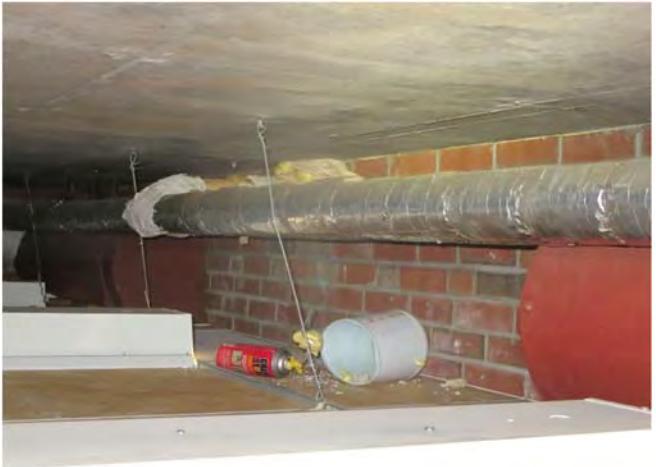
Figure 74: Repair materials remaining at left-hand stain

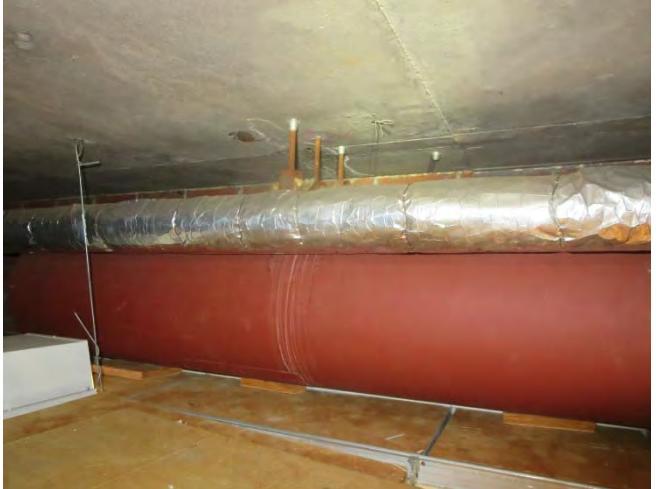
At the right hand stain, there are water stains running down the metal housing for the roll-up window shutter (Figure 75). These drips originate from the concrete slab ceiling, which may be related to the perimeter heating system.

Figure 75: Drip marks on shutter, right-hand stain

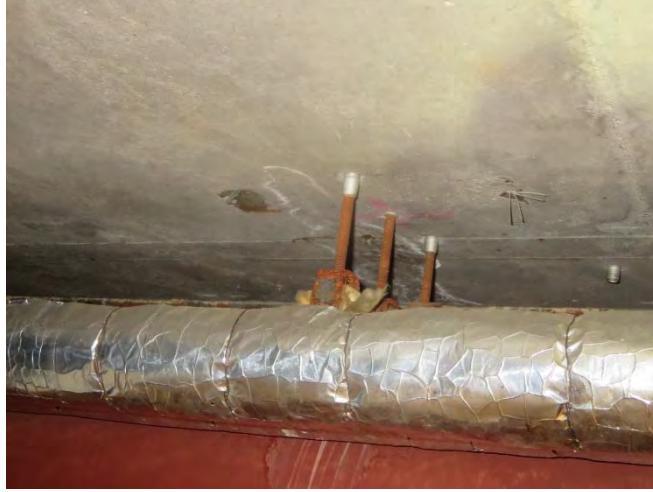
Figure 76: Drip marks at ceiling over shutter

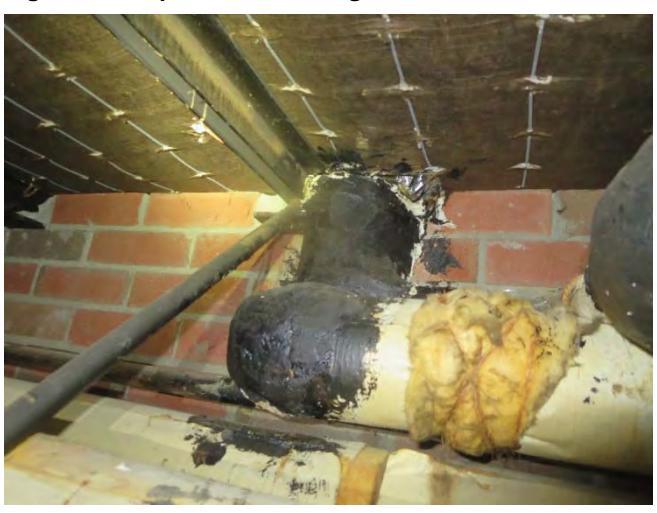
A similar examination was done at the Tax Collector's office (Figure 77); again, drip marks aligned with various insulated piping joints (Figure 78). These drip marks were also visible at the exterior wall finishes, above the suspended ceiling (Figure 79 and Figure 80).

Figure 78: Mechanical piping at Tax Collector office

Overall, it appears that the ceiling tile staining is due to leakage or condensation at the heating/chilled water piping. This does not preclude the possibility of through-wall water leaks, but evidence for wall leakage is not strong.

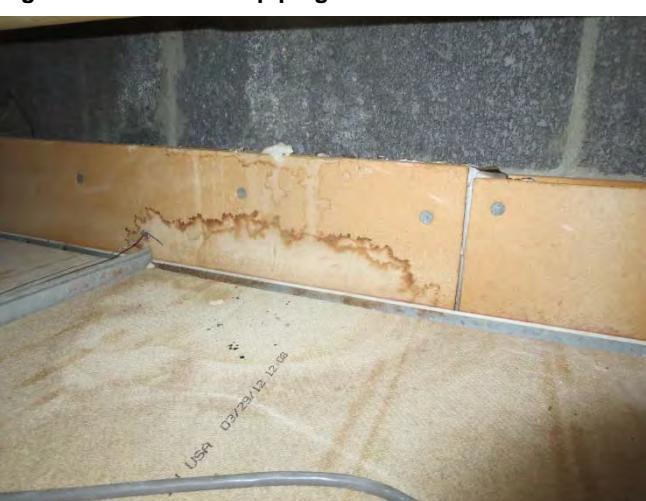
Figure 80: Stains on wall finishes, Tax Collector office

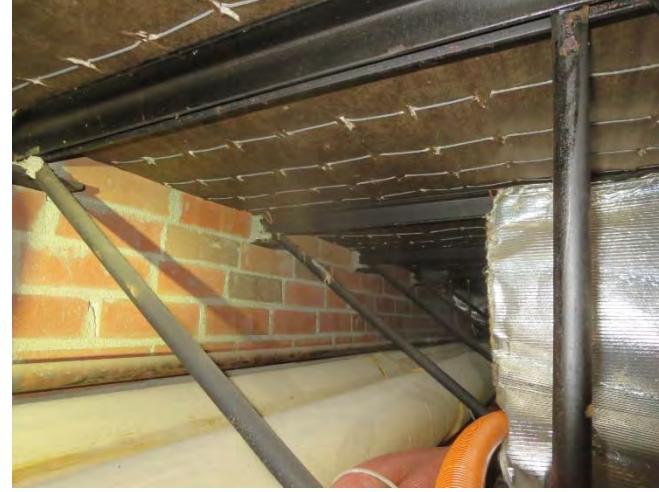
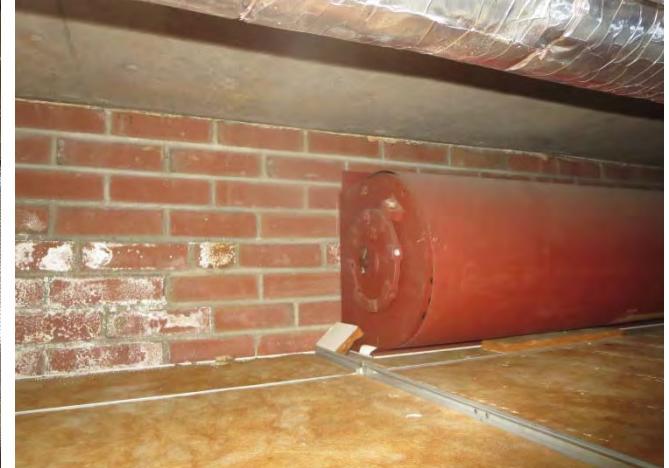
The exterior wall condition above the suspended ceiling is exposed brick or concrete block (Figure 81 and Figure 82); the second floor is supported on top-bearing bar joists.

Figure 81: Ceiling space, Tax Collector office

Figure 82: Ceiling space, vault/records room

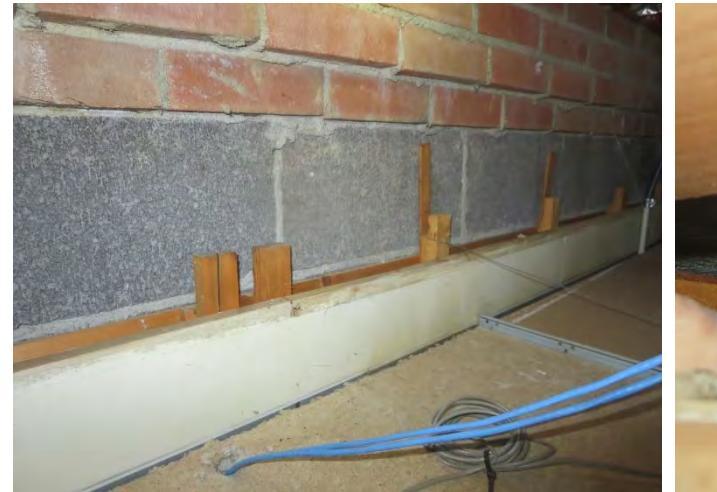
The walls below the suspended ceiling are finished with an interior board and a strapped cavity (Figure 83); a foil facer is used to provide some minimal insulating value at this cavity (Figure 84).

Figure 83: Exterior wall furring & board, Tax Collector

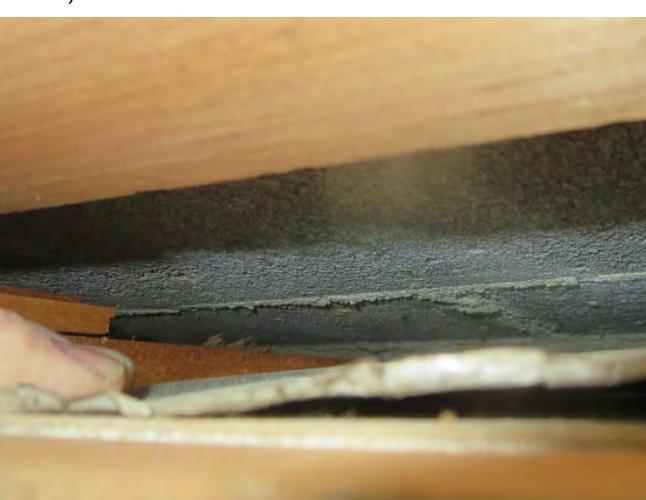
Figure 84: Foil facer in strapped cavity

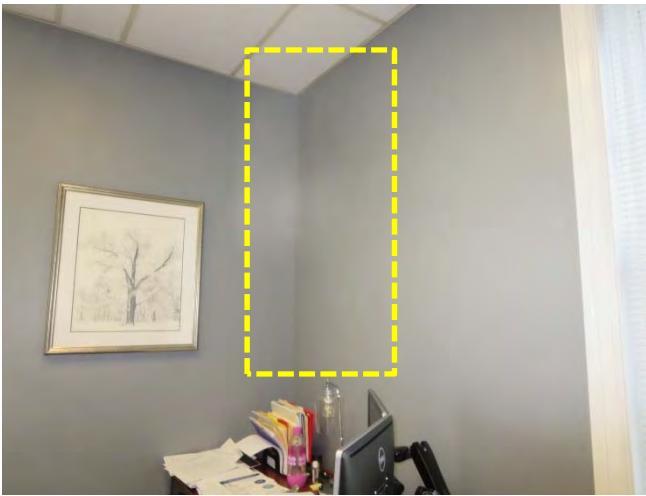
A similar issue of bubbling paint and plaster was seen at the northwest corner of the building, in the First Selectman's office (Figure 91). Again, Tramex measurements read 0, indicating that whatever moisture issues (likely roof leakage) caused this problem, they are not currently active. This was corroborated by infrared observations (Figure 93): the only visible pattern was thermal bridging through the wood strapping between cavities, rather than latent moisture issues.

Figure 91: First Selectman office NW corner damage

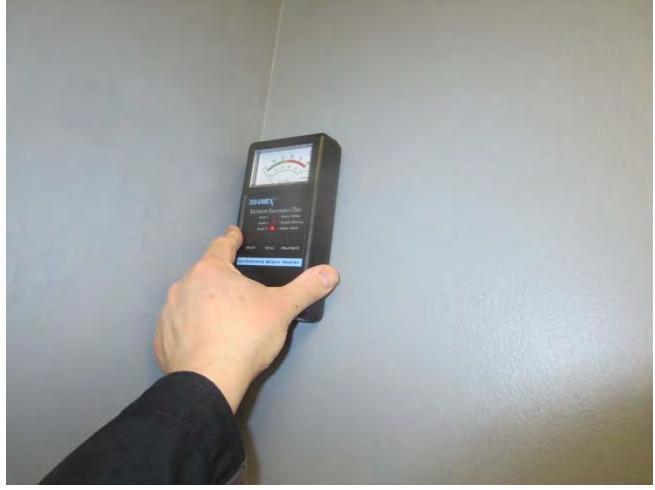
Figure 92: Moisture measurement at plaster

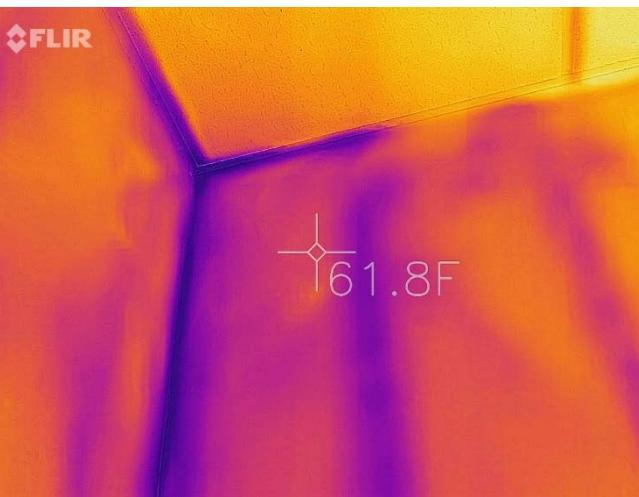
Figure 93: Visual and infrared image of First Selectman office NW corner damage
