March 13, 2019

PS 2019.014 - Suffield Town Hall Moisture Investigation Report

The following report covers Building Science Corporation's (BSC) evaluation of the moisture issues occurring at Suffield Town Hall, 83 Mountain Rd, Suffield, CT 06078, in preparation for a major renovation project at the building. The report is based on BSC's site investigation of March 7, 2019.

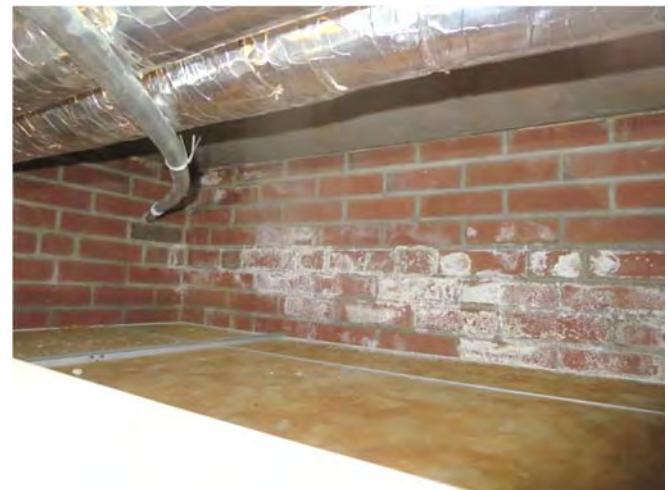
Lastly, at the west side of the vault/records room, the wall above the suspended ceiling had significant efflorescence staining, consistent with previous water leakage (Figure 94); the location is shown on the exterior in Figure 95.

Figure 94: Efflorescence on brick, vault/records room

This water issue was not currently active, so no further investigation was conducted. The water leakage pattern is consistent with failed water control features at the corner of the building (e.g., clogged/overflowing gutters).

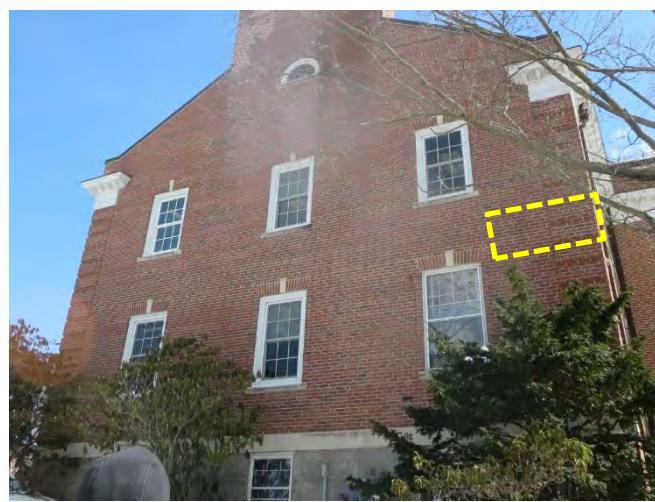
Figure 95: Location of efflorescence on west exterior

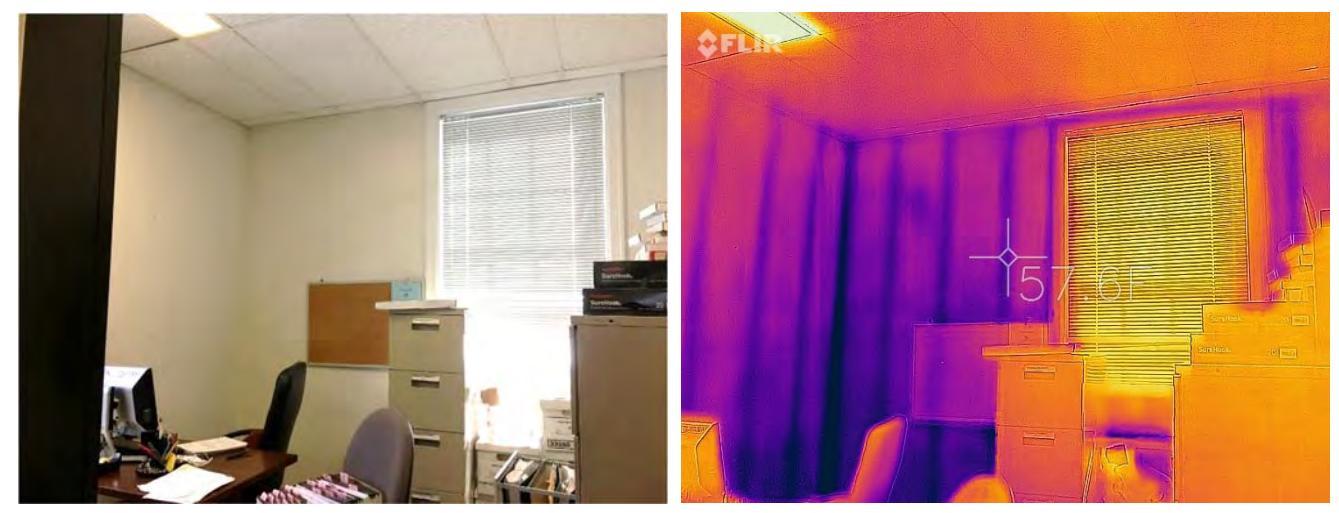
As discussed previously, the wall cavity (with a foil facer) has a higher R-value than the solid wood vertical strapping. This is demonstrated by infrared images of the walls (Figure 96 and Figure 97), showing the thermal bridging through the wood members (cooler surface temperatures).

Figure 96: Visual and infrared image of tax collector rear (south and east) office walls, showing thermal bridging

Addressing this is a much lower priority than other retrofits. Changing this condition would require a gut retrofit of the interior, and detailing similar to the basement walls (Figure 108 and Figure 109).

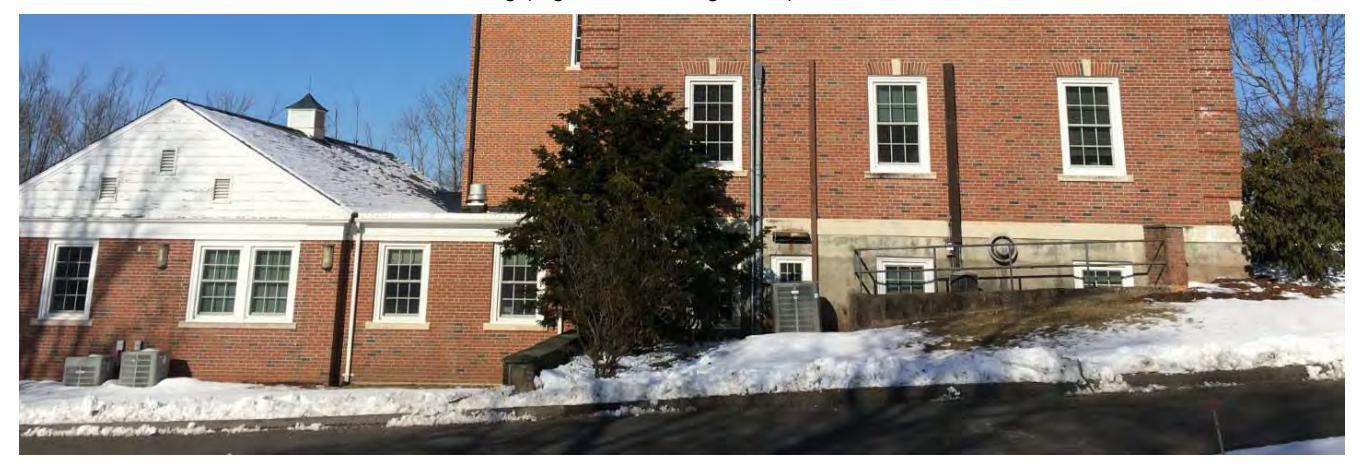
Exterior grade changes around the building perimeter; the one-story wing (former garage) is at slab on grade conditions, but grade rises towards the front of the building. This results in partially-buried walls at the sides of the main building, and full basement conditions at the front of the building (Figure 98 and Figure 99).

Figure 98: Exterior of east side, showing sloping grade (buried basement at front/sides)

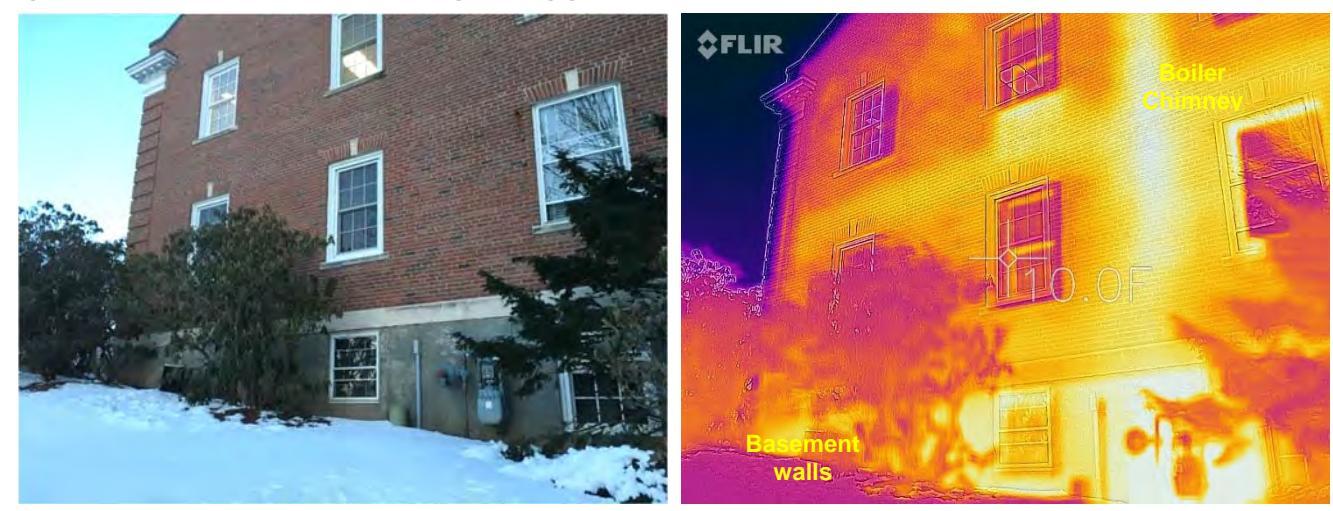
Figure 99: Visual and infrared image of west wall, showing boiler chimney and heat loss at basement

The exterior infrared image shows heat loss at the boiler chimney, the uninsulated wall between the first and second floors, and at the solid concrete basement wall.

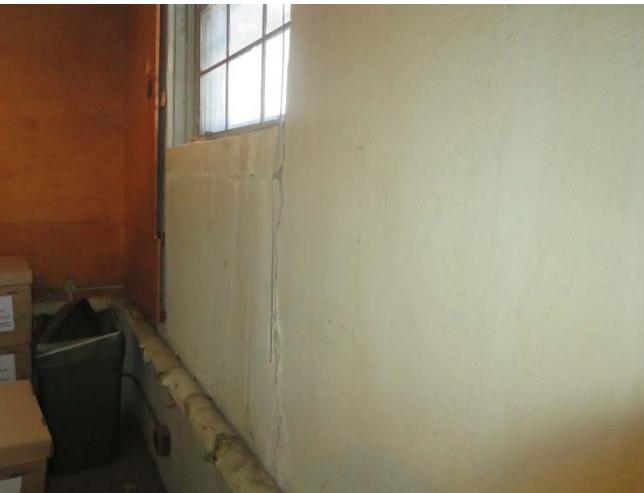
Most of the basement perimeter has unfinished walls (painted solid concrete), as shown in the general storage room (Figure 100). Few issues were noted; one issue was a foundation crack (Figure 101), but it did not appear to be an active source of water leakage.

Figure 101: Concrete crack at window, general storage

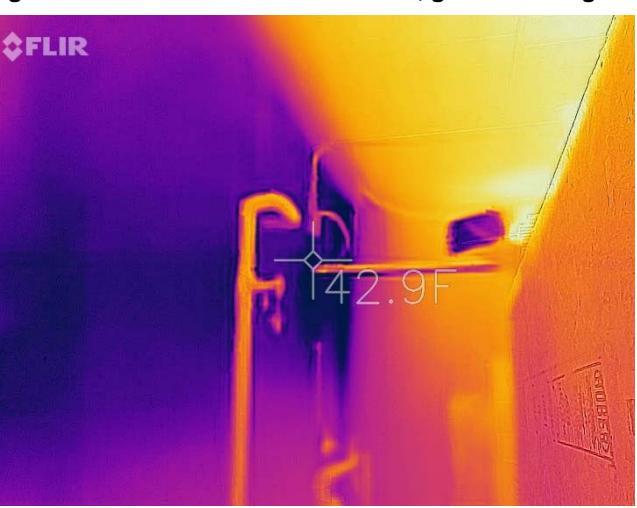
Infrared images of the general storage room (Figure 102) and the clerk's vault (Figure 103) show cooler temperatures at the above-grade portions of the basement walls, showing greater heat loss where the wall is exposed above the ground. No other problematic thermal anomalies were noted.

Figure 102: Visual and infrared image of general storage room west wall; heat loss at above-grade exposed portion

Lastly, at the unfinished storage spaces, heat loss could be reduced by applying insulation to the exposed concrete walls. A lower cost insulation detail is to use Dow THERMAX insulation on the foundation wall, which can be left exposed (Figure 110 and Figure 111).

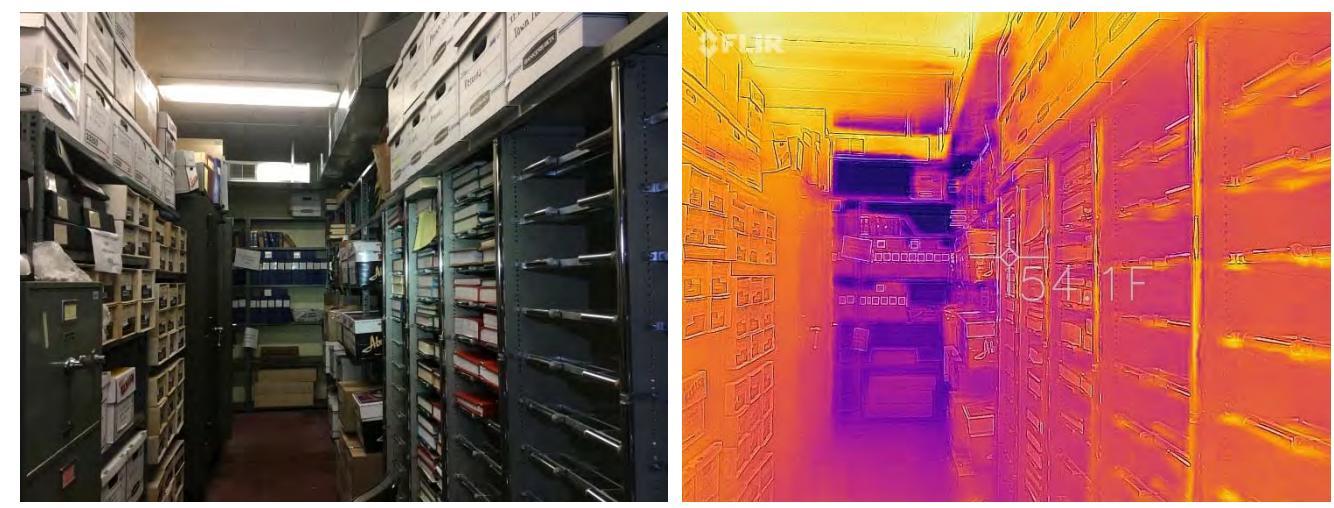
Figure 103: Visual and infrared image of clerk's vault west wall; heat loss at above-grade exposed portion

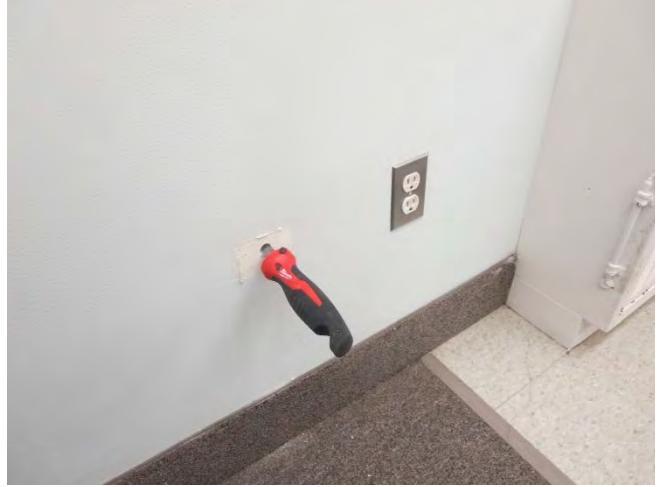
Wall build-out was examined more closely: based on probing with a saw (Figure 106), the framing cavity is empty (no insulation), with a \sim 4-½ inch airspace. The interior finish appears to be a cementitious plaster, which is a far more moisture-resistant and durable finish for a below-grade space than paper-faced gypsum board.

Figure 106: Measuring depth of cavity behind finish

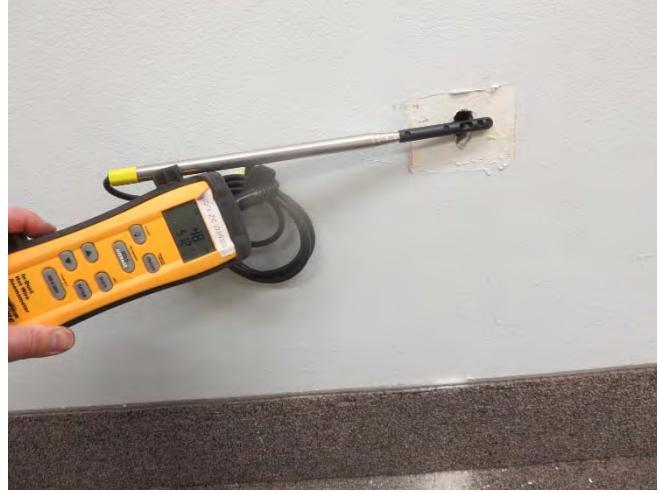
The presence of airflow at the openings in the interior plaster was confirmed with air velocity measurements, using a Fieldpiece STA2 In Duct Hot-wire Anemometer (Figure 107). Measurements are shown in feet per minute (FPM) velocity; conditions at the opening were 50-140 FPM of ~50°F inward airflow. *This airflow is consistent with the negative pressure of the building pulling in cold outdoor air from the basement wall cavity, and has the potential to bring in moisture, musty odors, and contaminants.*

Figure 107: Air velocity measurement at opening

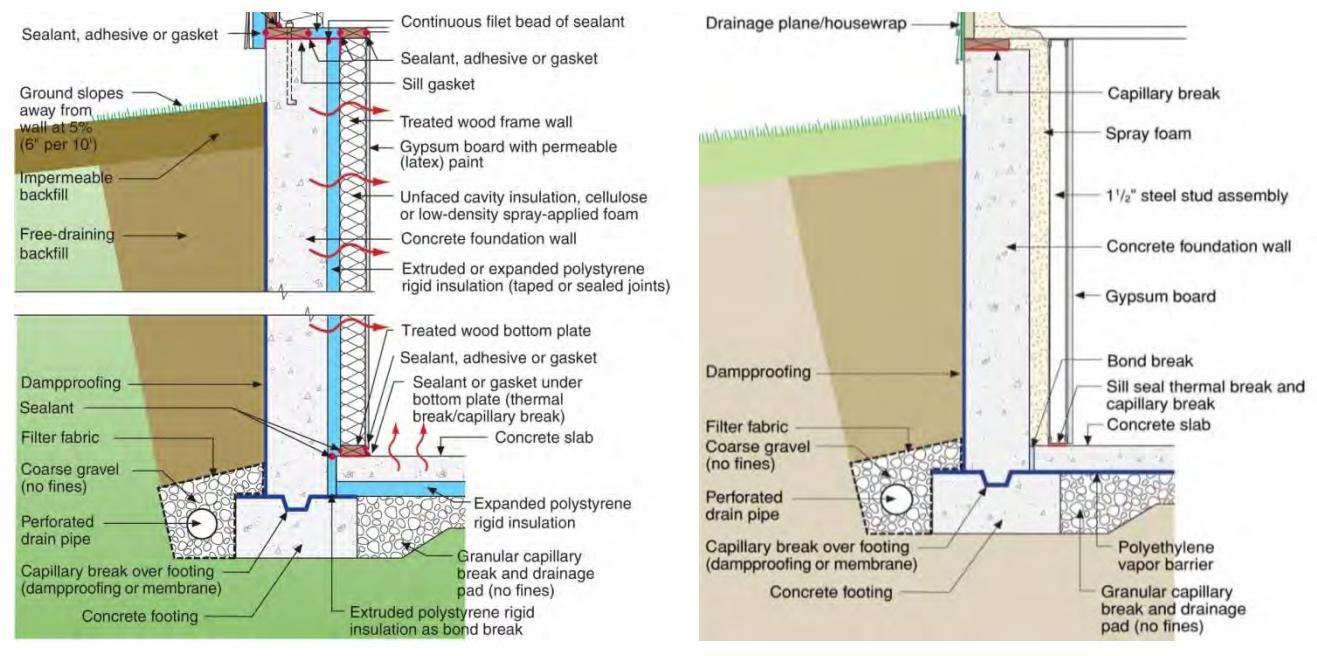
Figure 108: Interior basement insulation with insulated wood frame wall and gypsum board

Figure 108 shows the use of rigid foam board insulation (e.g., XPS) on the interior, attached either with adhesive or mechanical fasteners. Note that the rigid foam must be detailed as an air barrier (taped seams, caulk details at top, bottom, and window penetrations), to prevent interior air leaking into the air space behind the foam, and condensing on the hidden surface. A stud frame wall can be built inboard of the XPS foam, and filled with insulation (e.g., fiberglass), if additional R value is required. However, if only R-10 is required (e.g., typical code value), a 2" layer of XPS foam would be sufficient insulation.

Foundation insulation details that have greater moisture safety are covered in Building Science Digest 103: Understanding Basements. Some recommended assembly options are shown in Figure 108 and Figure 109. They show the options of rigid foam (extruded polystyrene/XPS) or closed cell (2 pounds/cubic foot) polyurethane spray foam, applied to the interior side of the foundation wall. All these materials have the advantage of being air impermeable (unlike fiberglass insulation), keeping interior air away from cold surfaces (avoiding condensation risks). The materials are also somewhat tolerant of moisture intrusion: they can take incidental, periodic wetting without damage.

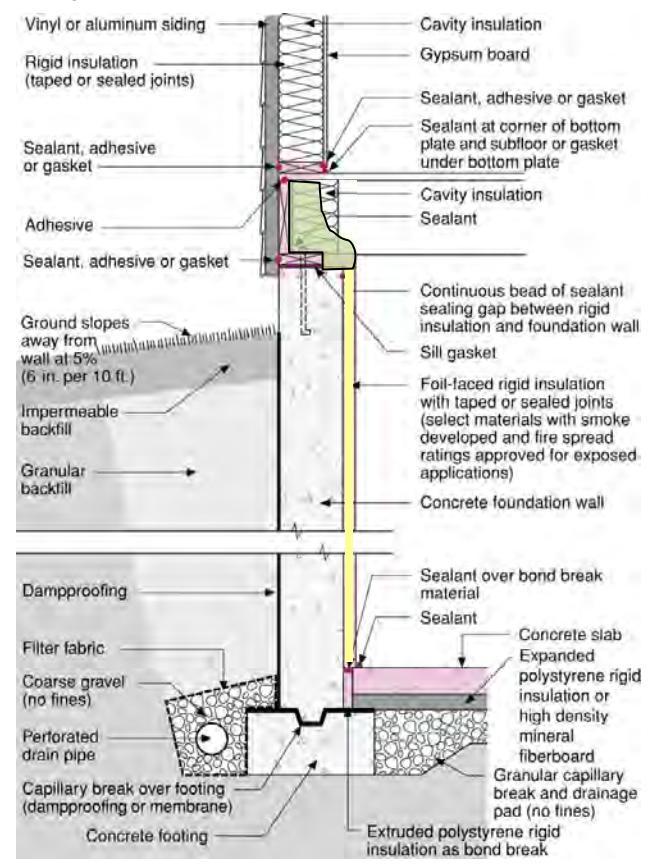
Figure 110: Interior basement insulation with rigid polyisocyanurate foam (THERMAX) left exposed

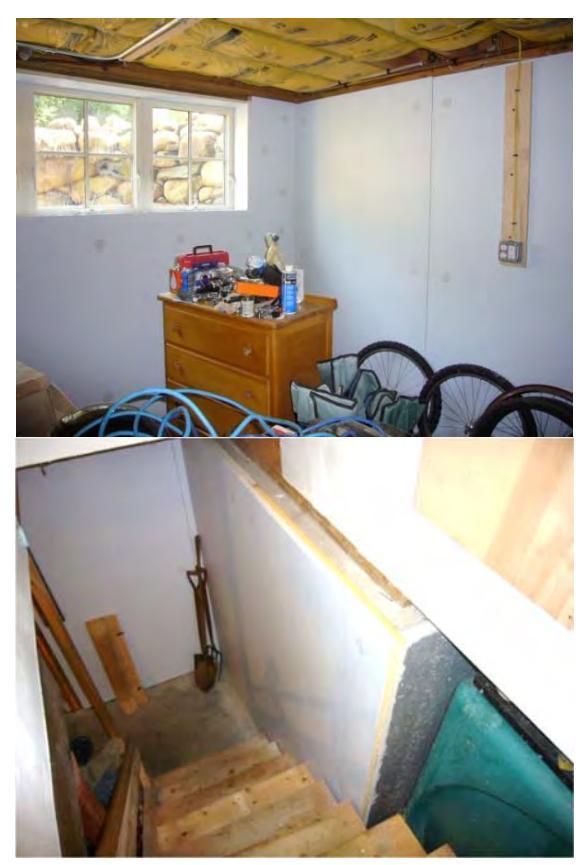
Figure 111: Basement interior with rigid polyisocyanurate foam (Rosenbaum 2011)

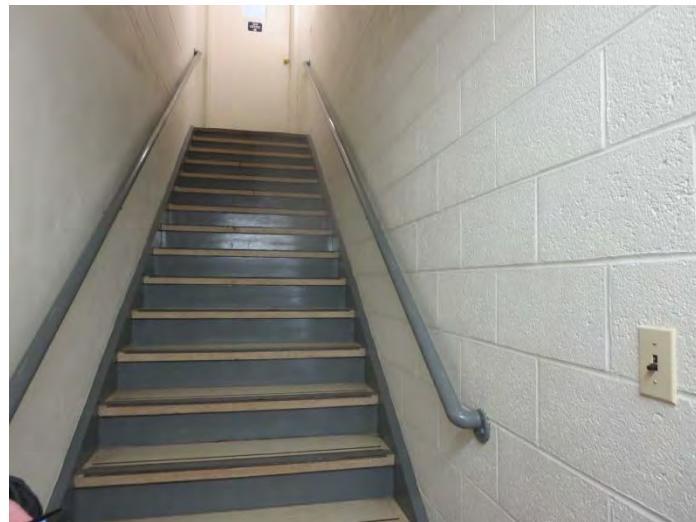
Figure 112: Ground-to-first floor stairway

The team reported that in the summer of 2018, condensation occurred at several locations in the building. They included condensation at the front lobby/foyer floor, and at portions of the stairwell from the ground floor to the first floor (Figure 112 and Figure 113).

The recommended retrofit measure is to improve building airtightness (roof/ceiling air barrier). If the problems persist after this retrofit, the addition of dehumidifiers is recommended. However, this is a lower priority project, assuming that this condensation issue was a "one-summer" event.

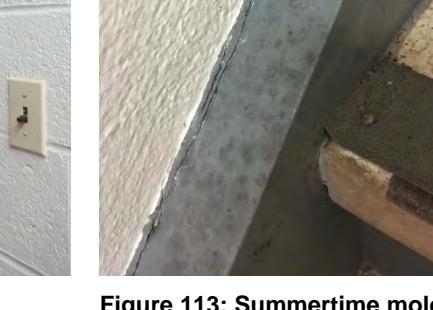
Figure 113: Summertime mold on stair edge

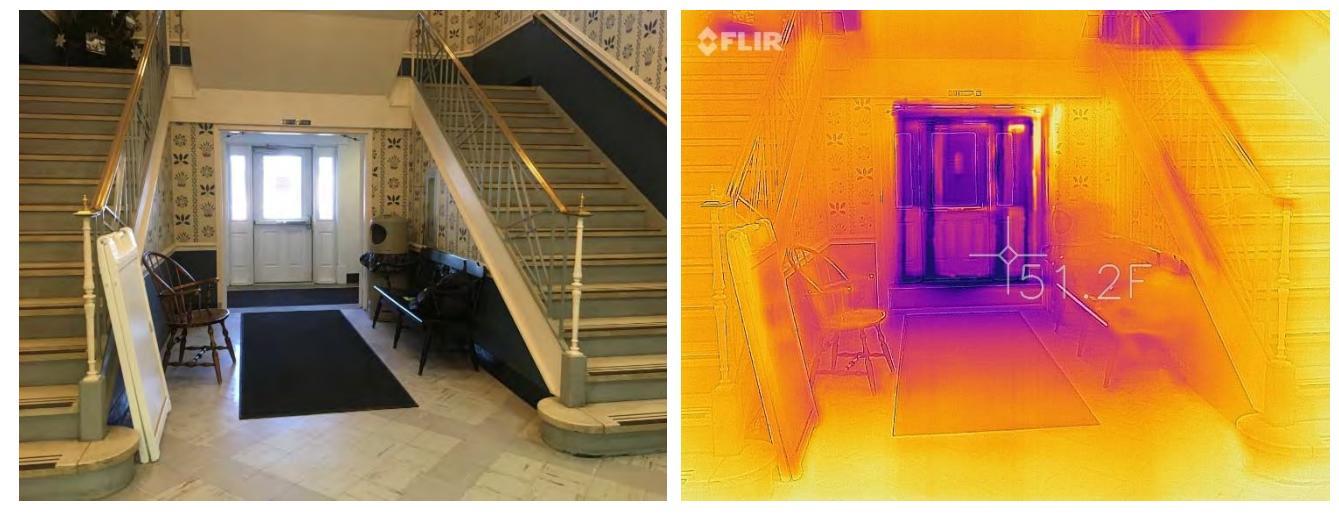
The first floor lobby (Figure 114) shows suspected air leakage around the door, and warm interior conditions (past the exterior foyer). No notable thermal anomalies are seen.

Figure 114: Visual and infrared image of front entryway and front door (first floor)

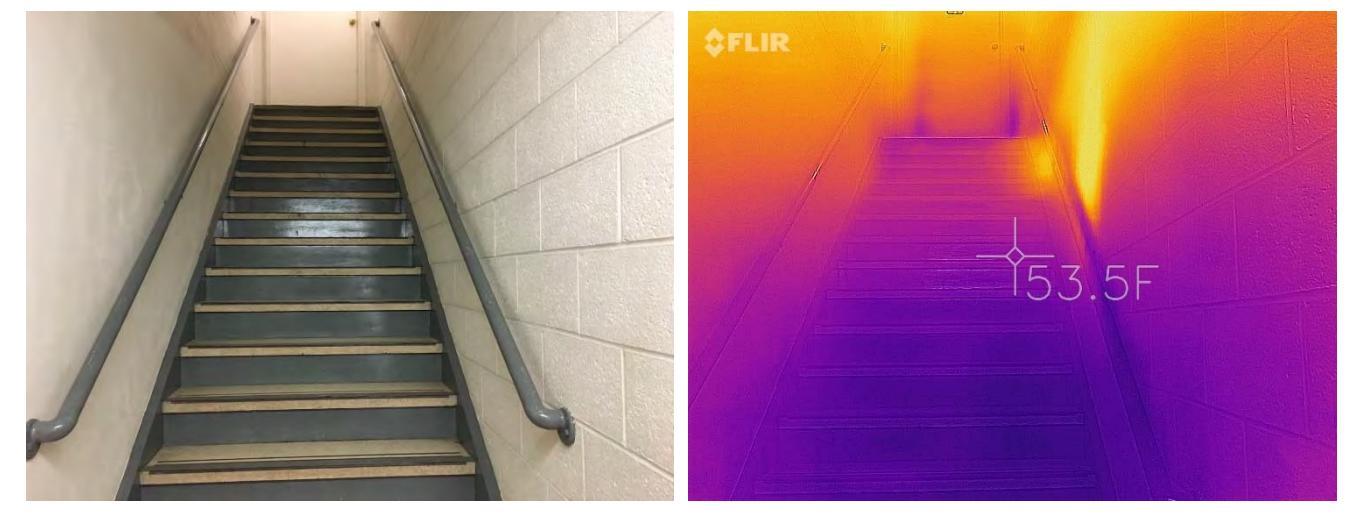
The stairwell from the first floor to the basement was also examined (Figure 115 and Figure 116); the only notable thermal anomaly is warm areas behind the stairwell wall. The thermal anomalies are consistent with the wall mounted fancoil and piping in the Ground Floor Women's Room. The thermal anomaly does not match pattern of condensation and mold growth. Therefore, again, the condensation/mold problems are likely a thermal mass/outdoor air problem.

Figure 115: Visual and infrared image of ground-to-first floor stairway; thermal anomaly at wall

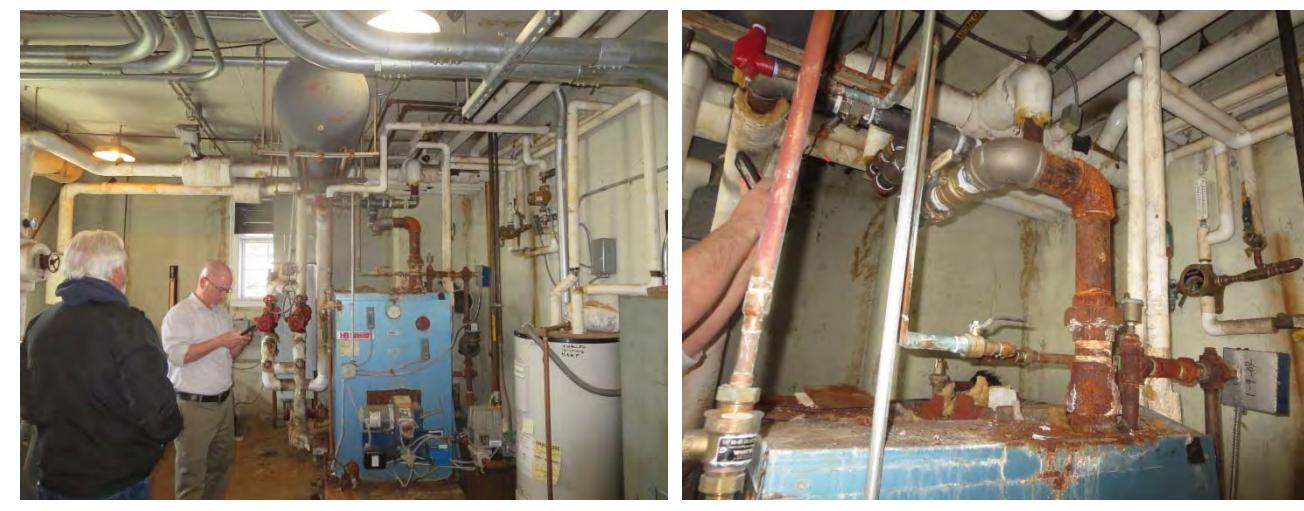
These fancoil units are fed in turn by a boiler and screw chiller on the ground floor level (Figure 118). There are current issues with near-boiler piping leakage (Figure 119).

Figure 119: Boiler piping (leakage issues)

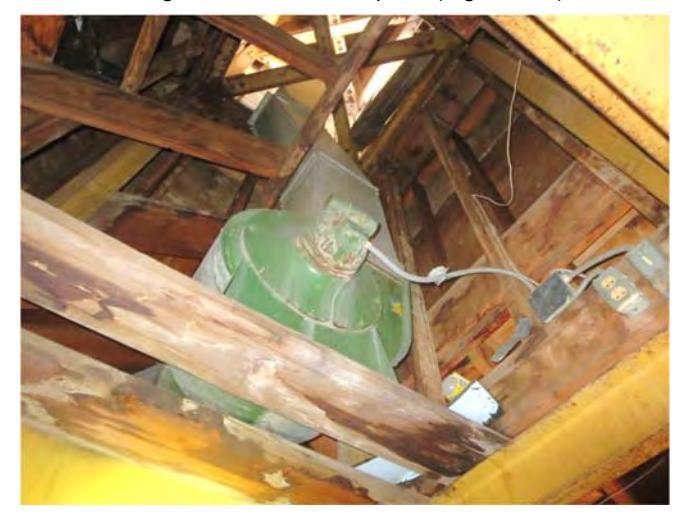
There is an exhaust fan installed in the attic, venting out of the cupola (Figure 122); it is connected to sheet metal ductwork that runs through the conditioned space (Figure 123).

Figure 122: Exhaust fan in attic, routed thru cupola

Given that most of these ventilated rooms are out of service, the existing exhaust system is ejecting ~880 CFM of air in order to ventilate two ground floor bathrooms (~100 CFM required), unless previous work turned down the fan speed. The fan in the attic does not provide exhausts for the new ADA bathrooms; they are ventilated via a system in the ceiling of the elevator vestibule on the second floor (~300 CFM). Of course, massive overventilation is a waste of energy, and hurts humidity control and interior temperature control.

Assuming the ground floor bathrooms are being renovated, BSC would recommend either (a) installing a new exhaust system sized for that smaller flow, out through a sidewall, or (b) completely revamping the old existing exhaust system, including capping off all unused duct openings, sealing the system airtight, installing new fan set to the correct flow for 2 bathrooms.

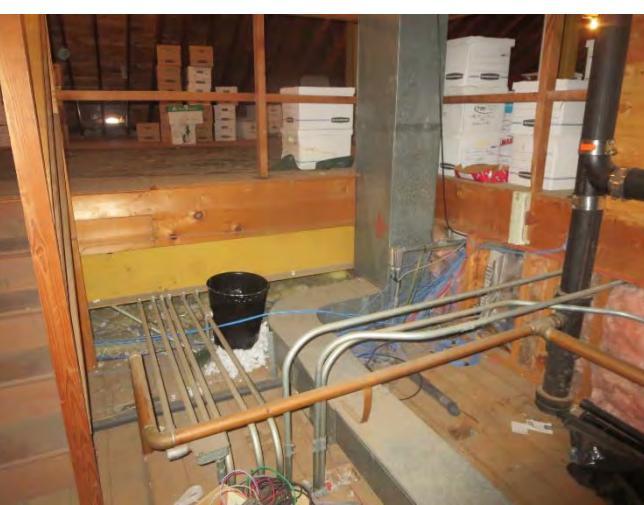
Figure 123: Attic exhaust fan ductwork

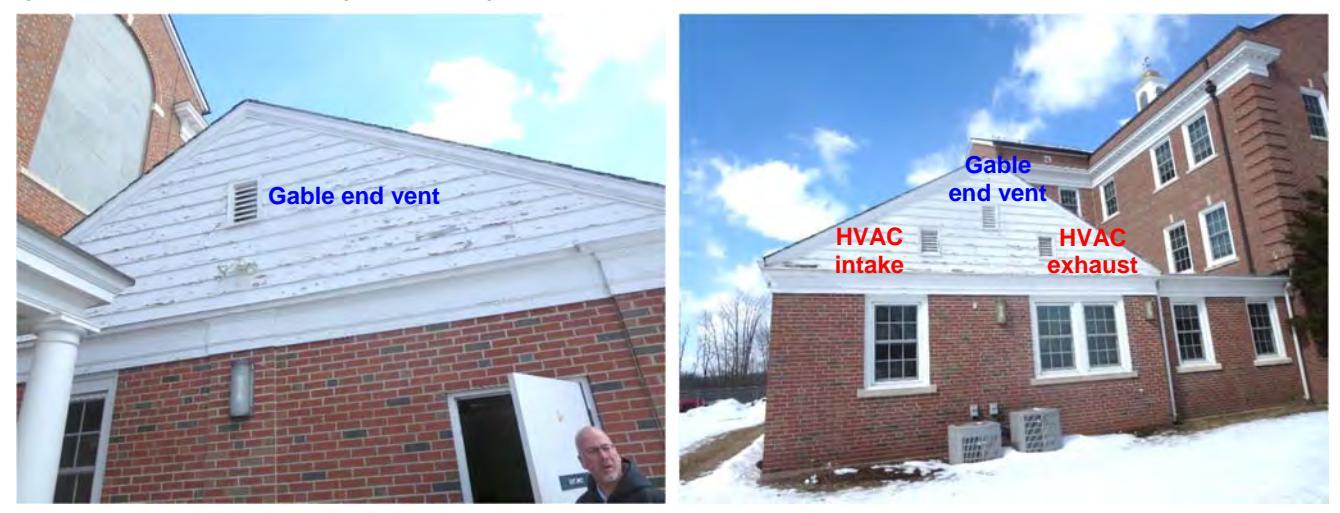
The most notable exterior observation is the poor condition of the paint on clapboard at the gable ends (Figure 127 and Figure 128). The paint is peeling and "blowing off" of the wood clapboard.

Figure 127: West gable end of rear one-story wing

Figure 128: East gable end of rear one-story wing

There are many possible causes for these paint issues, including (a) paint reaching end of service life, (b) repeated applications of oil paint, resulting in low vapor permeance and inhibited outward drying, and/or (c) possible moisture issues in the attic. The recommended solution is to strip the paint down to bare wood, and repaint with a "breathable" (vapor permeable) latex exterior primer and paint. Alternately, replacement with a non-moisture sensitive cladding (e.g., fiber cement clapboard) is a good long-term solution. The attic might be investigated for moisture issues (as discussed below).

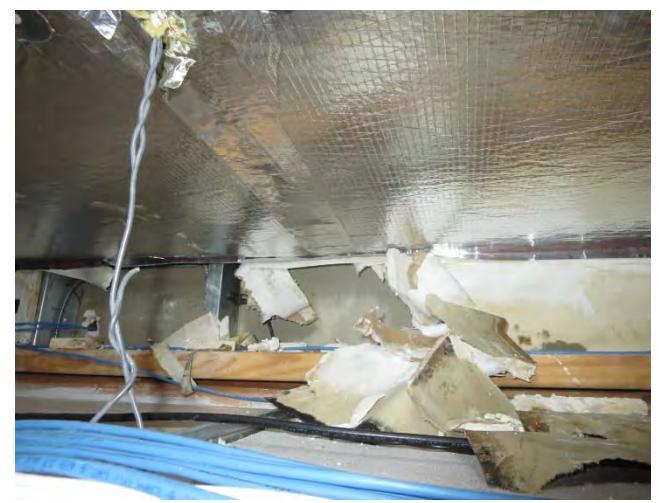
Examination of this interior partition wall above the suspended ceiling revealed water staining of the gypsum board, demolished gypsum board, and suspected mold (Figure 131 and Figure 132). The location of this water issue was

Figure 131: Damaged sheetrock, interior wall

- Examine the attic for indications of the source of the water issues seen at the interior partition wall
- Consider a retrofit of HVAC-1, to reduce outside airflow in proportion to occupancy. Options include a CO₂ sensor (occupancy-based) or a CFIS controller and motorized damper (timer-based).
- Replace the ceiling diffusers at the meeting room, switching from horizontal "throw" to vertical "throw" units, in order to break up stratification.

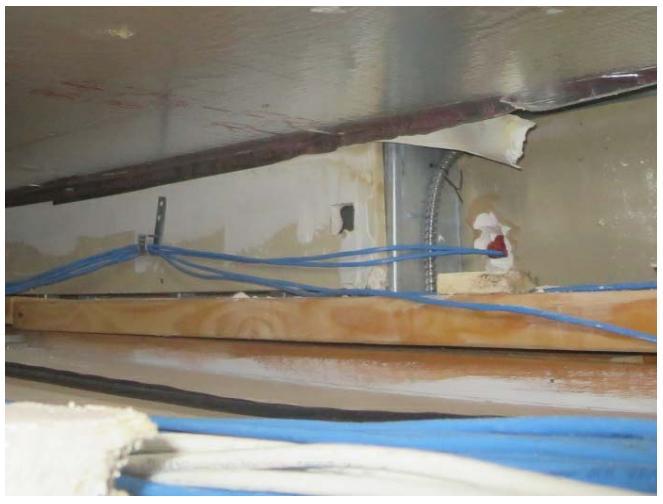
Figure 132: Damaged sheetrock, interior wall

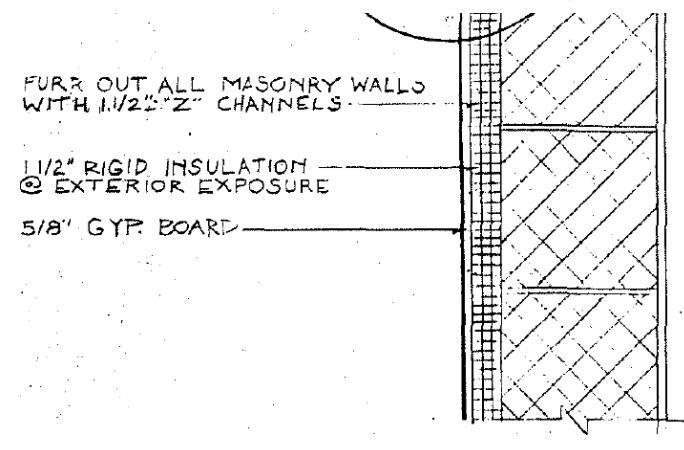
The reason for this thermal bridging is shown in the 1997 renovation plans (Figure 148): the 1-1/2 inch rigid insulation is interrupted with 1-1/2 inch metal Z channels, which bypasses the insulation, creating the "cold lines."

Figure 148: 1997 Meeting room renovation plans, showing interior wall insulation

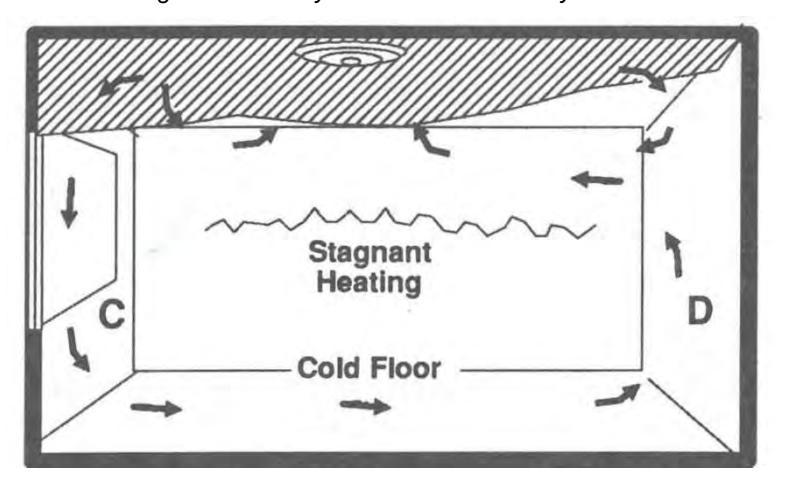
As a result, *Manual T* shows that if a space is heated with ceiling ductwork with a horizontal (parallel to ceiling) flow, there will be stratification of warm air near the ceiling (Figure 149). This is exactly the pattern seen at the meeting room.

Figure 149: Horizontal ceiling discharge effect on heating pattern and stratification (ACCA Manual T)

Takeaway: switching the ceiling registers from horizontal to vertical throw units will help break up thermal stratification. Downsides include some risk of comfort issues (if the "jet" of air lands on occupants), and impaired cooling performance. Improving thermal performance (e.g., reducing air leakage) will reduce stratification.

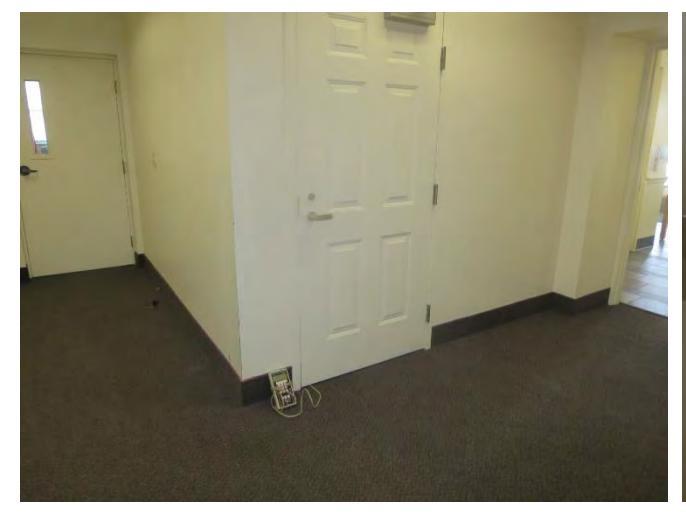
Figure 151: Elevator machine room from hallway

A consistent complaint at the elevator machine room (Figure 151) is cold temperatures in wintertime; a small electric space heater is located in this room, despite the heat generated by elevator machinery.

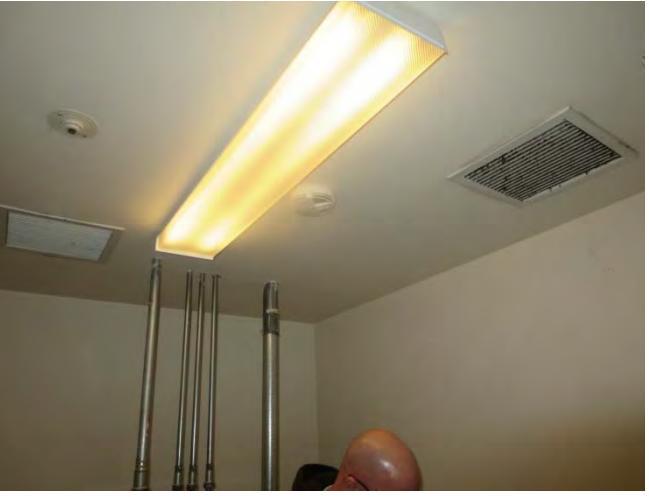
Figure 152: Elevator machine room ceiling registers

The ceiling of the elevator machine room has two ceiling registers (Figure 152). Based on the 2001 mechanical plans (Figure 154), the elevator machine room is ventilated by a rooftop exhaust fan and a relief duct with a motorized damper (Figure 153). The exhaust fan is controlled by a wall-mounted thermostat: when the elevator machine room exceeds a certain temperature, the fan runs to cool the space with outdoor/ambient air.

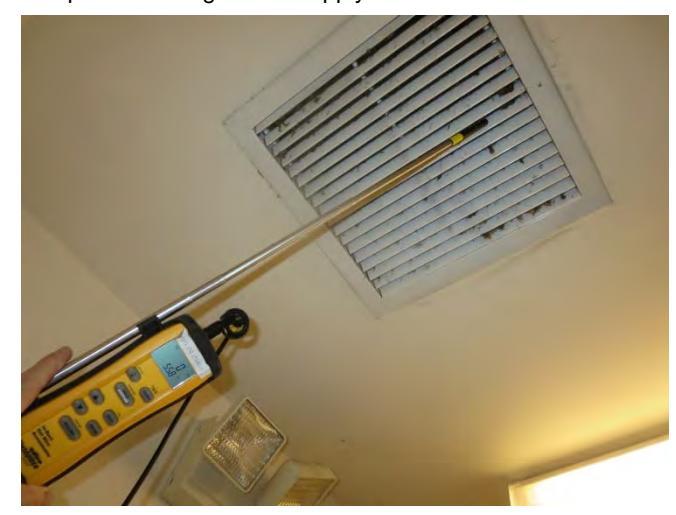
Figure 156: Air velocity measurement at ceiling grille

Conditions at these registers were examined more closely with the hot-wire anemometer (Figure 156). Airflow was below the meter's detection limit (40 FPM), but cool air was distinctly felt "falling" from these ceiling registers, at 50°F or colder. This is consistent with outside air being pulled into the machine room, due to building negative pressures. It also suggests that the motorized dampers are ineffective at sealing against outdoor air.

As an alternate system, the elevator machine room could be conditioned with a mini-split heat pump (MSHP) head, which would eliminate this cold air leakage problem. The ductwork would ideally be sealed off in an airtight manner and abandoned in place.

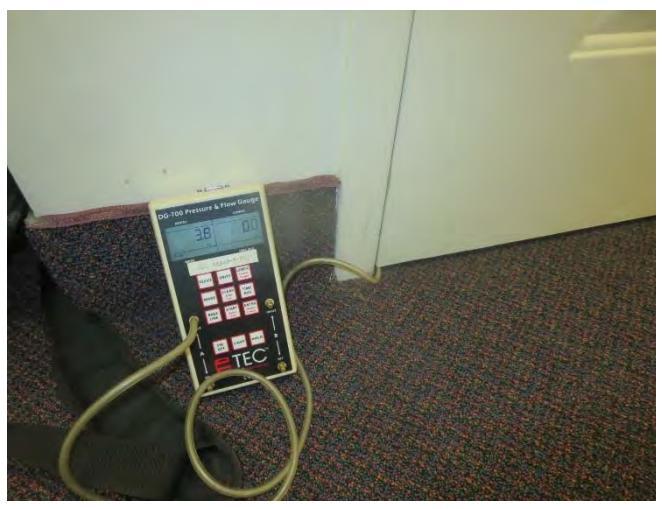
Figure 157: Pressure measurement. elevator mach. rm

The pressure of the elevator machine room relative to the hallway was measured with the fan on and off (Figure 157). Surprisingly, the room was positively pressurized (+4 Pa) with the fan on, compared to +2 Pa fan off. This suggests that the rooftop fan is configured to supply air rather than exhaust air.
