BEAVERTON SCHOOL DISTRICT COOPER MOUNTAIN ELEMENTARY SCHOOL

SEISMIC EVALUATION AND CONCEPTUAL SEISMIC STRENGTHENING SCHEME

NOVEMBER 14, 2018

KPFF PROJECT No. 10021800754

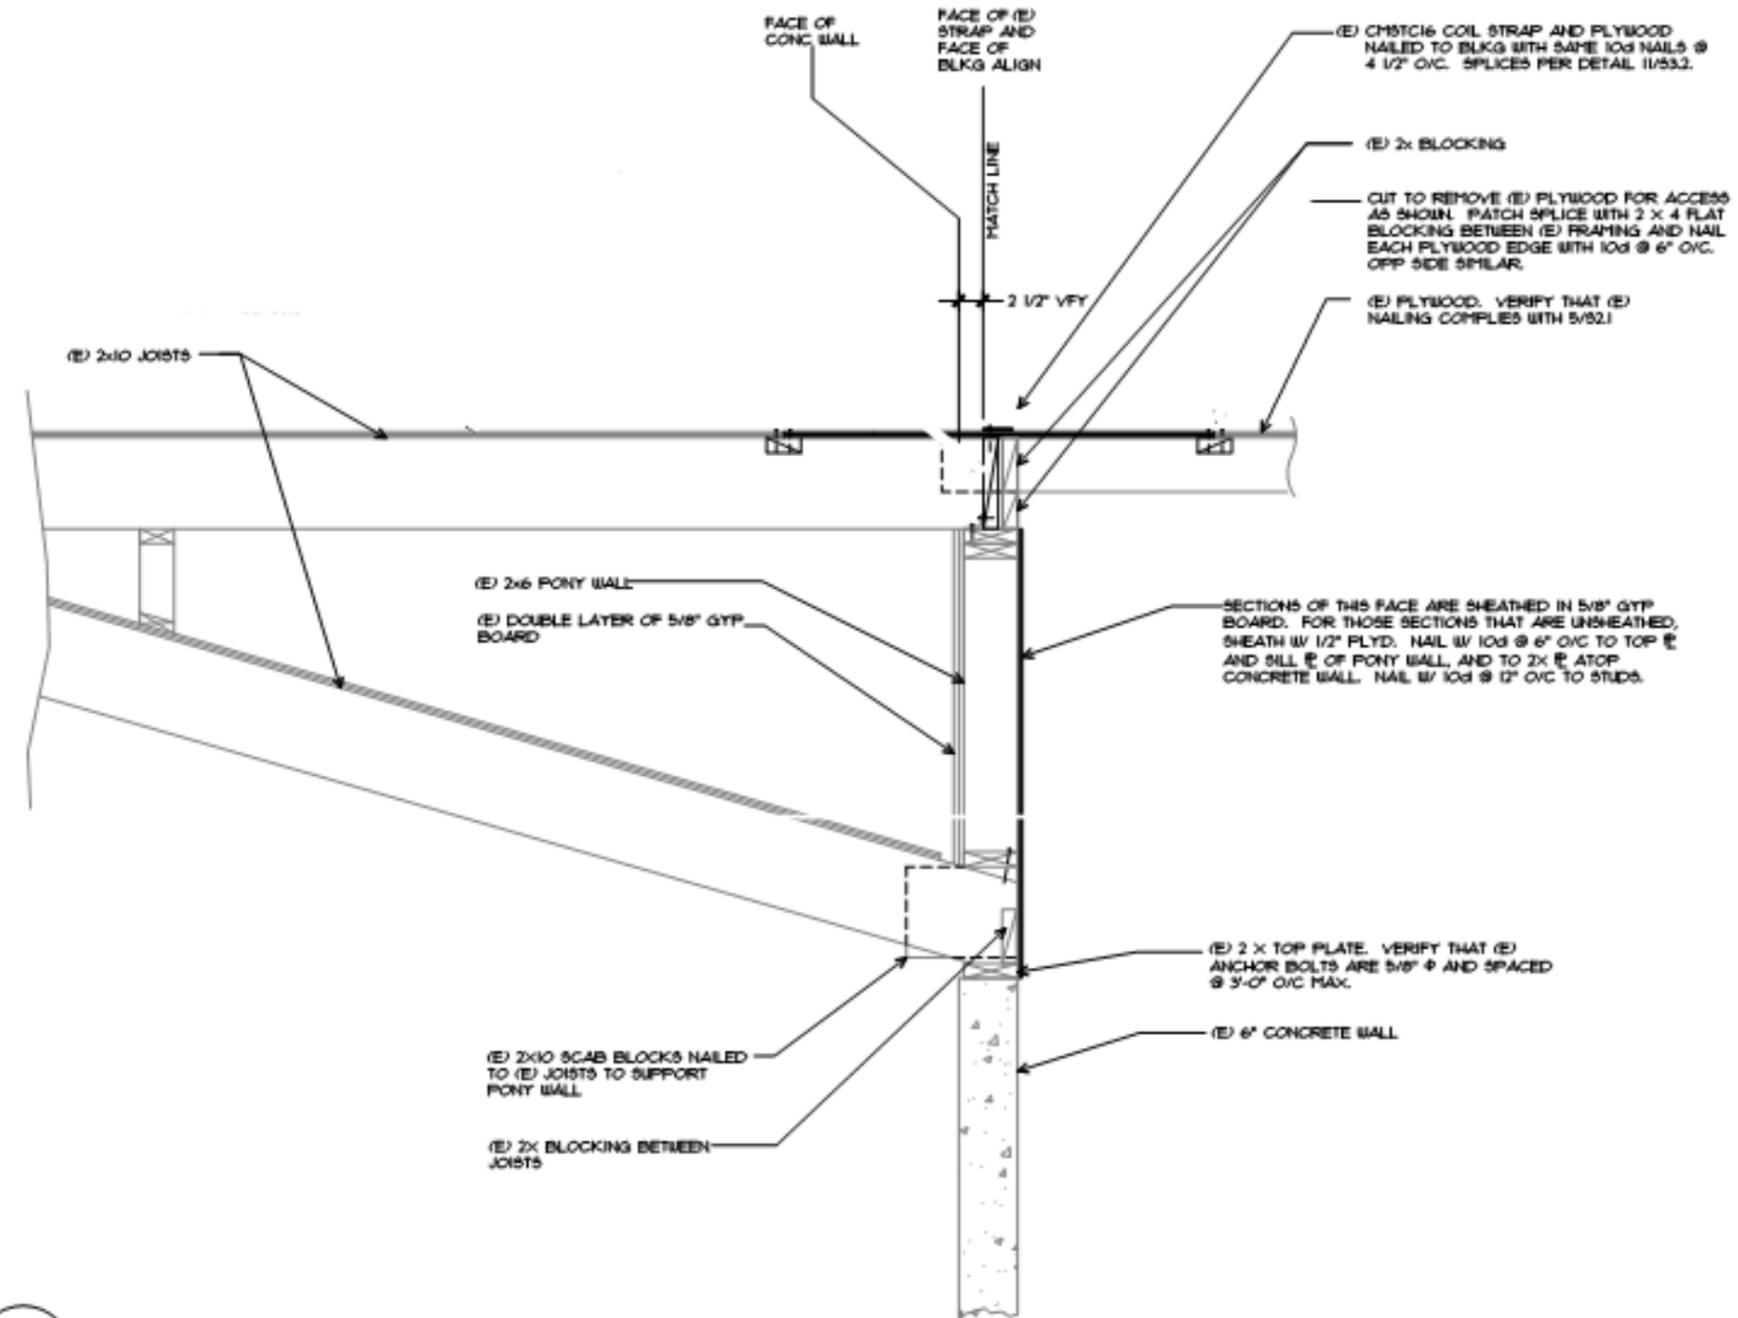
SK1

LATERAL UPGRADE: DIA, DIA. CONN., OUT OF PLANE WALL CONN.

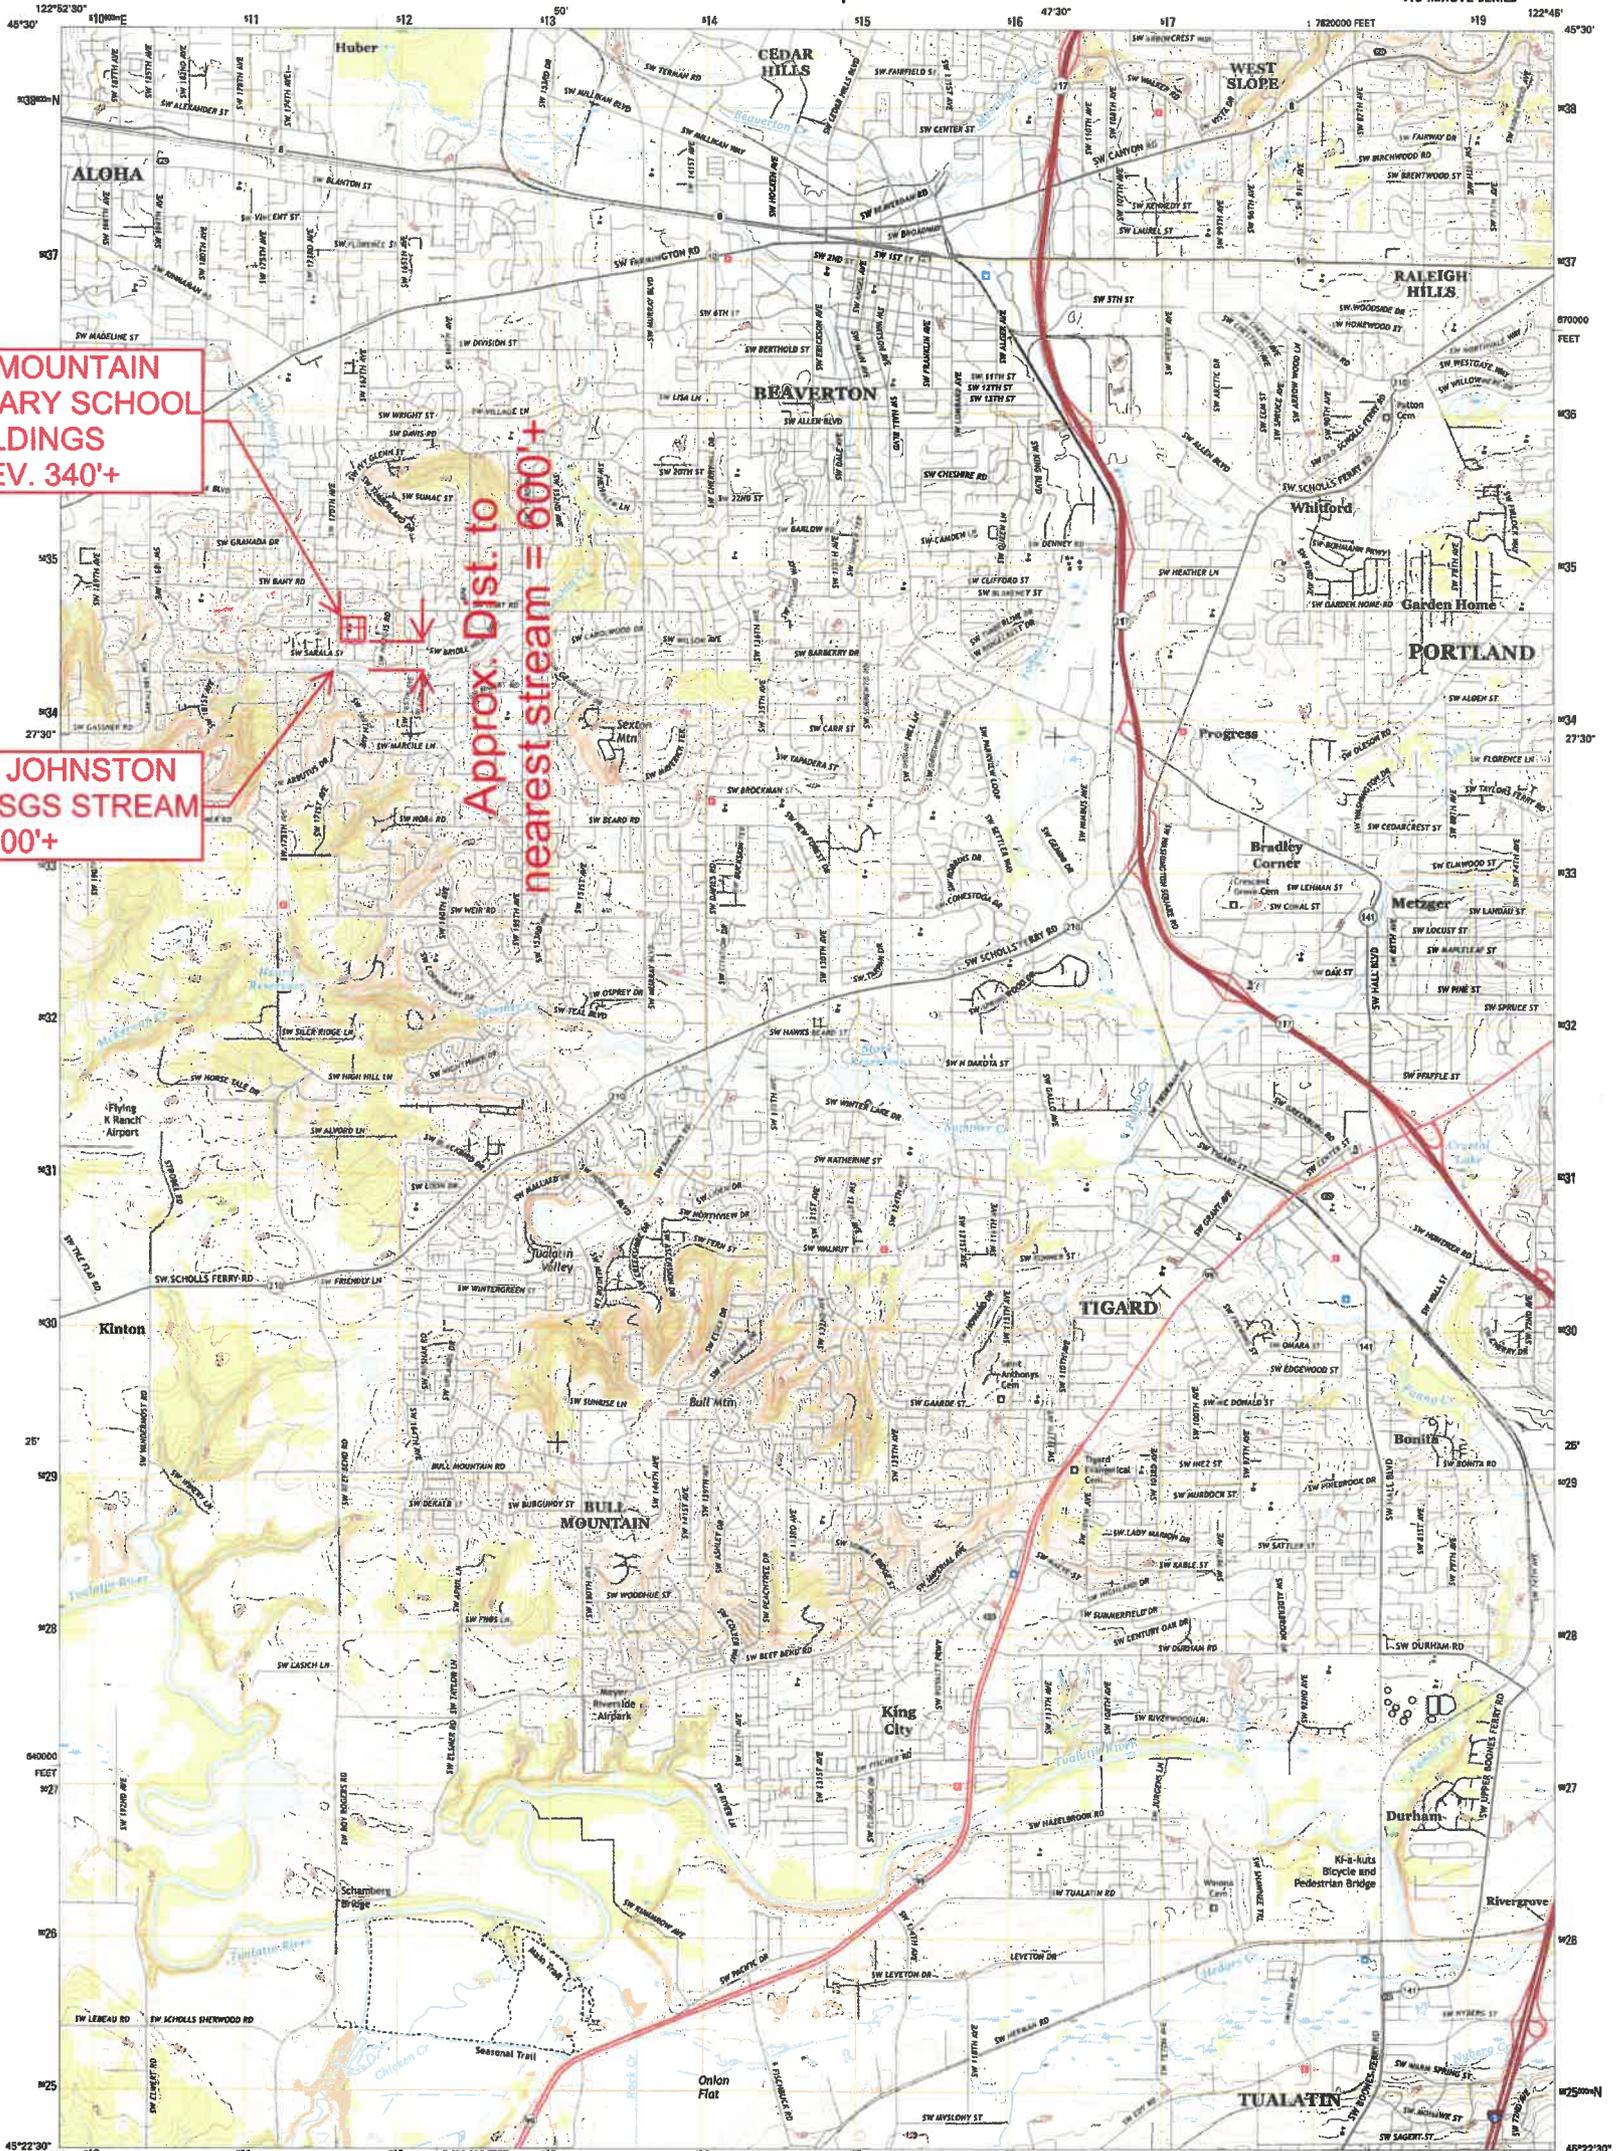
Because the subject school is located within Zone X, located at a high point and 600 feet distance from the nearest stream, it is our opinion that no further information is necessary to determine that the school is located outside of the 100-year flood zone.

COOPER MOUNTAIN
ELEMENTARY SCHOOL
MAIN BUILDINGS
USGS ELEV. 340'+

APPROX. JOHNSTON
CREEK USGS STREAM
ELEV. = 300'+
