Graceland

2803 East 51st Street

REUSE ASSESSMENT

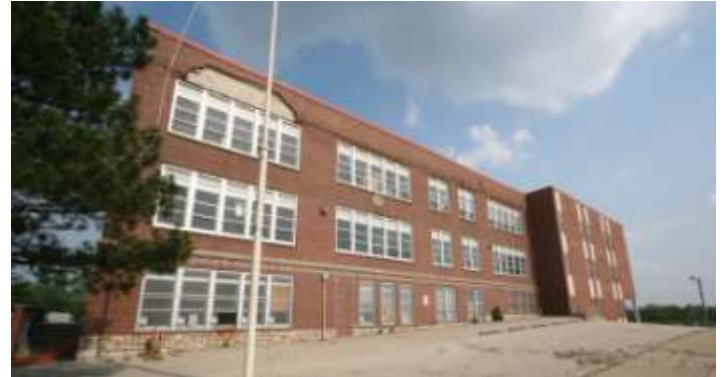
BUILDING/SITE ASSESSMENT:

Building is in fair condition, requiring repair/replacement of deteriorated lintels and associated failing brick veneer. The location of stairs and exits makes it difficult to divide the building for multiple tenants. Its size and layout are adaptable for multi-family housing (25 +/- units), although the institutional finishes make this somewhat less desirable. The building's exterior and interior design limit the visibility required for good retail use but could work as an office occupancy or business incubator with classrooms converted into single or multi-person office space. The amount of circulation space relative to office space is inefficient, although typical for a building of this type. Uses other than office or education will typically require installation of a fire sprinkler system (a community center may not require this depending on overall square footage and location of exits). The large paved playground offers opportunities for community use of the grounds (garden, farmer's market, open space, playground, etc.)
