Meservey

4210 East 45th

REUSE ASSESSMENT

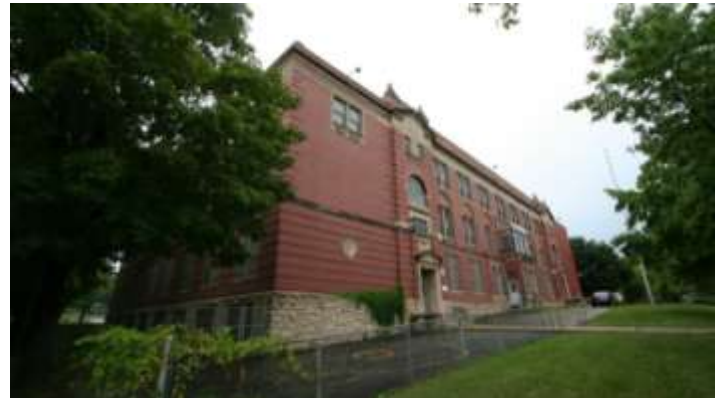
BUILDING/SITE ASSESSMENT: Building is in good condition. Its size and layout are readily adaptable for multi-family housing (33 +/- units), or a combination of housing + community services/office use. Classroom size converts well into a single bedroom apartment or combines well into two bedroom apartments. Classrooms could also be converted into multi-person office space, although there is a large amount of circulation space relative to office space. The building's exterior and interior design will typically require installation of a fire sprinkler system (a community center may not require this depending on overall square footage and location of exits). The large paved playground on the north side of the building offers opportunities for community use of the grounds (garden, farmer's market, open space, playground, etc.)

HISTORIC ASSESSMENT: Excellent example of a Progressive Era elementary school with a Modern Movement addition. The original plan and much of the original fabric remain intact. Windows have been replaced in the historic openings and finishes have been updated. The placement, design and materials of the addition complement the original construction. The building appears eligible for listing in the National Register of Historic Places.
