March 15, 2010

**PHASE I TARGETED BROWNFIELDS ASSESSMENT
HAZARDOUS MATERIALS SURVEY
REVISION 01**

**RECOVERY-WEST HIGH COMPLEX
1810 AND 1829 MADISON AVENUE, KANSAS CITY, MISSOURI**

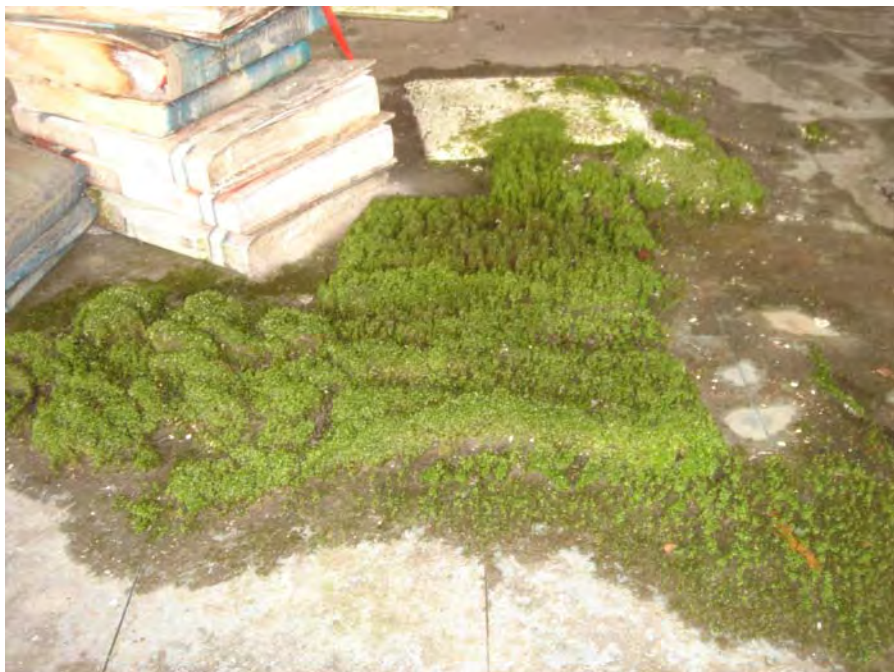
Photo 1: Suspected mold growth in the Cafeteria, third floor of Building A.

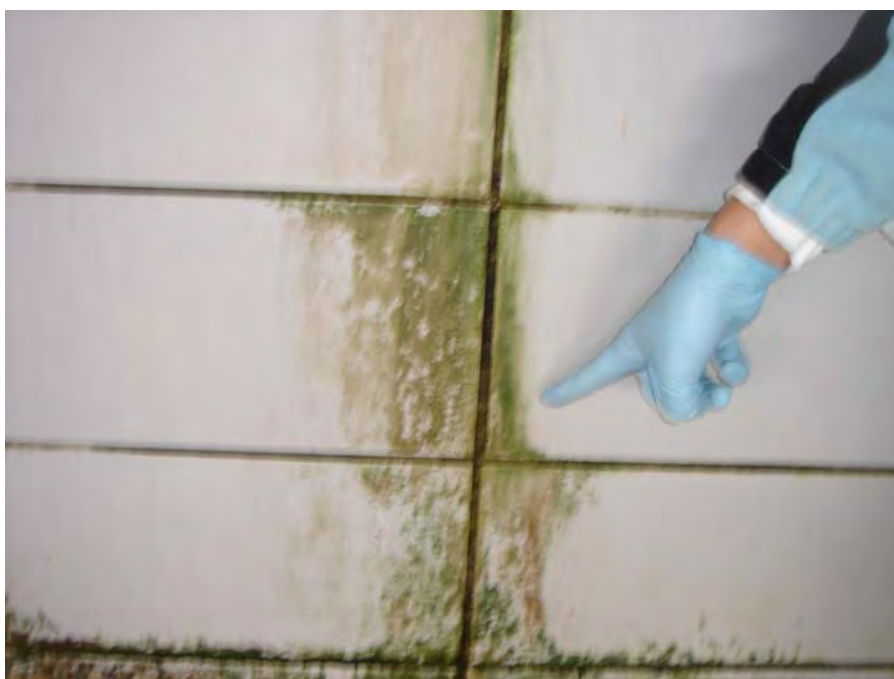
Photo 2: Suspected mold growth in Cafeteria, third floor of Building A, where sample No. MD-A-3-CAF-1 was taken.

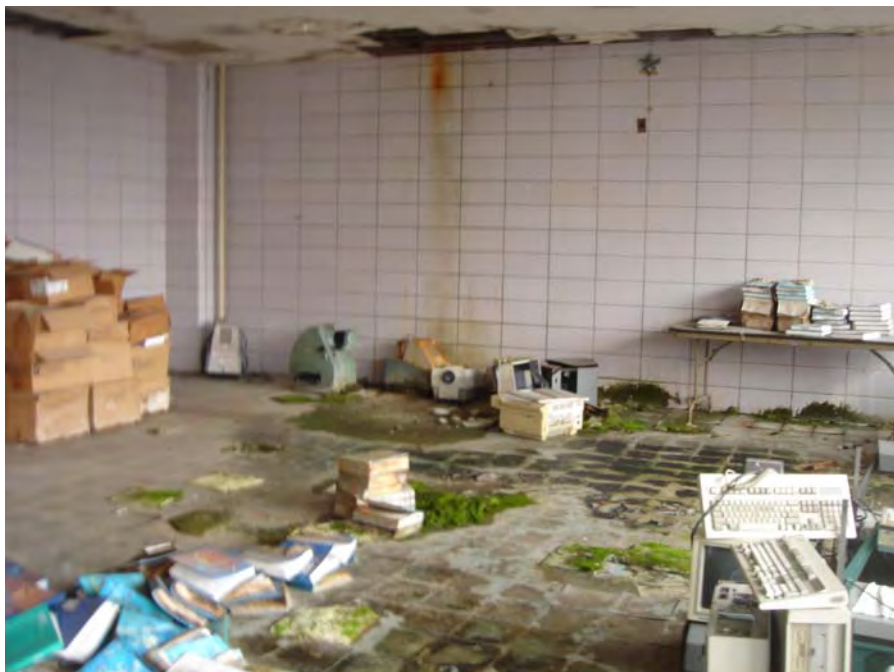
Photo 3: Suspected mold growth in Cafeteria of Building A on the third floor.

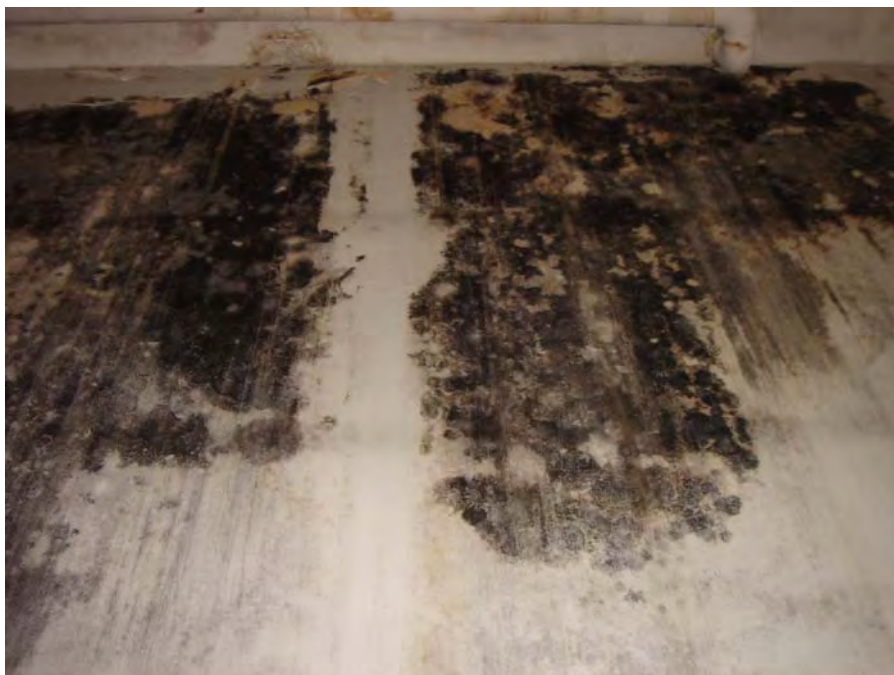
Photo 6: Suspected heavy black mold growth on the south wall of the south classroom on the second floor in Building A.

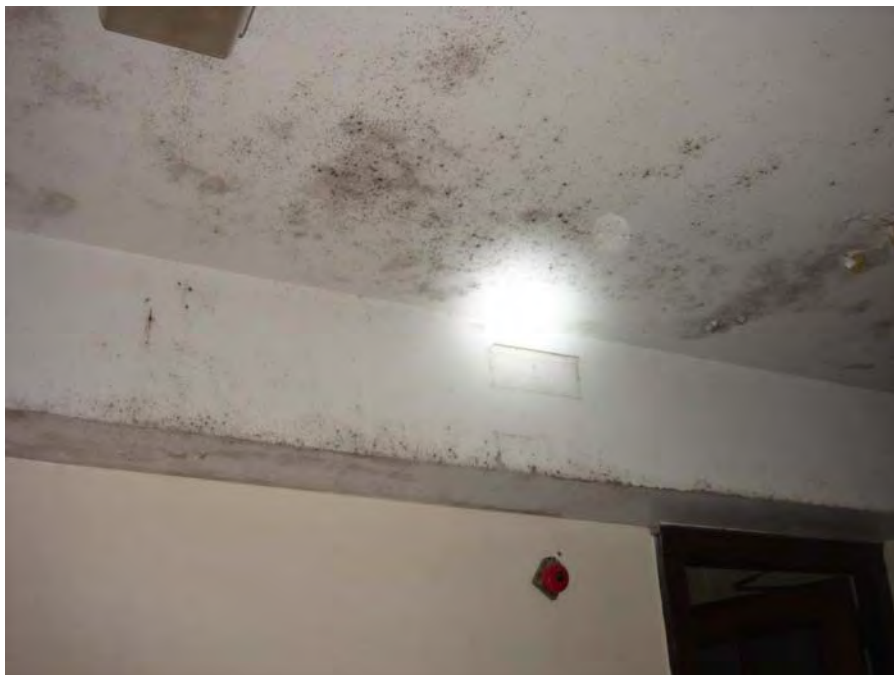
Photo 9: Suspected mold growth on the ceiling and walls of the pool locker room in Building B on the basement floor. Sample MD-B-LR-1 was taken here.

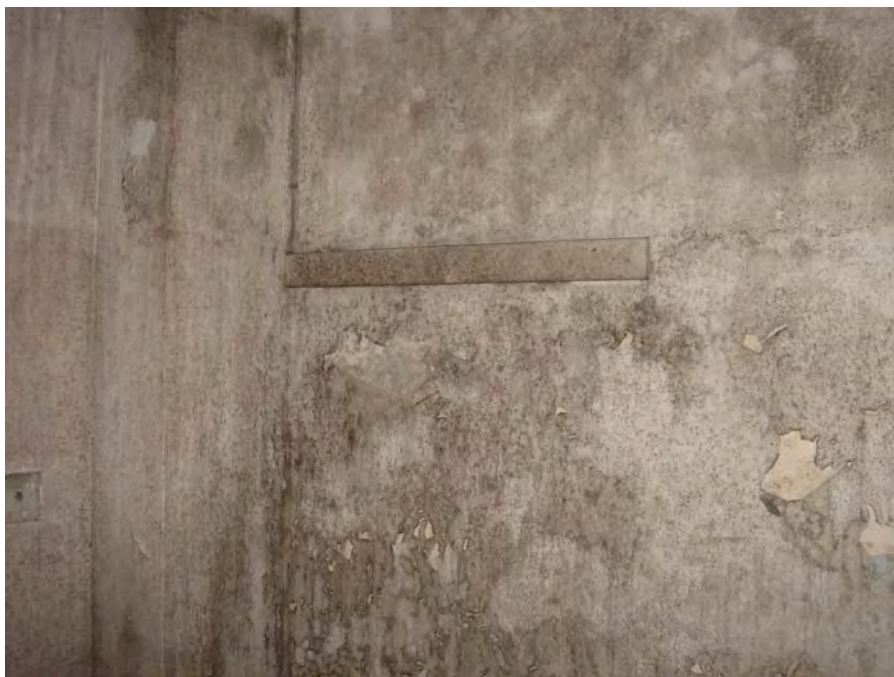
Photo 10: Suspected mold growth on the ceiling and walls of the pool locker room in Building B on the basement floor.

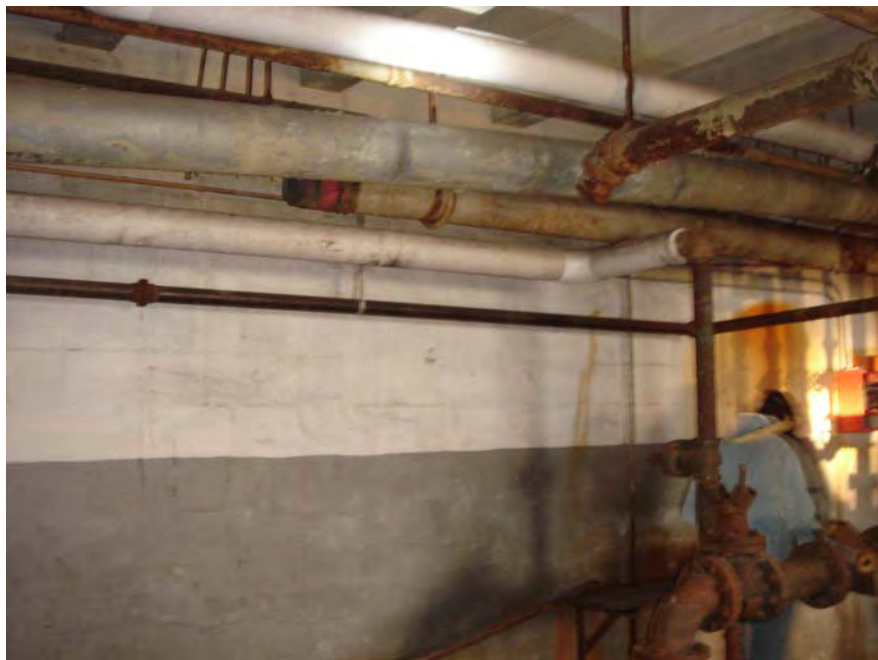
Photo 11: Suspected mold growth on pipes and walls in the lower boiler room in the basement of Building B. Sample MD-B-G-BR-1 was taken here.

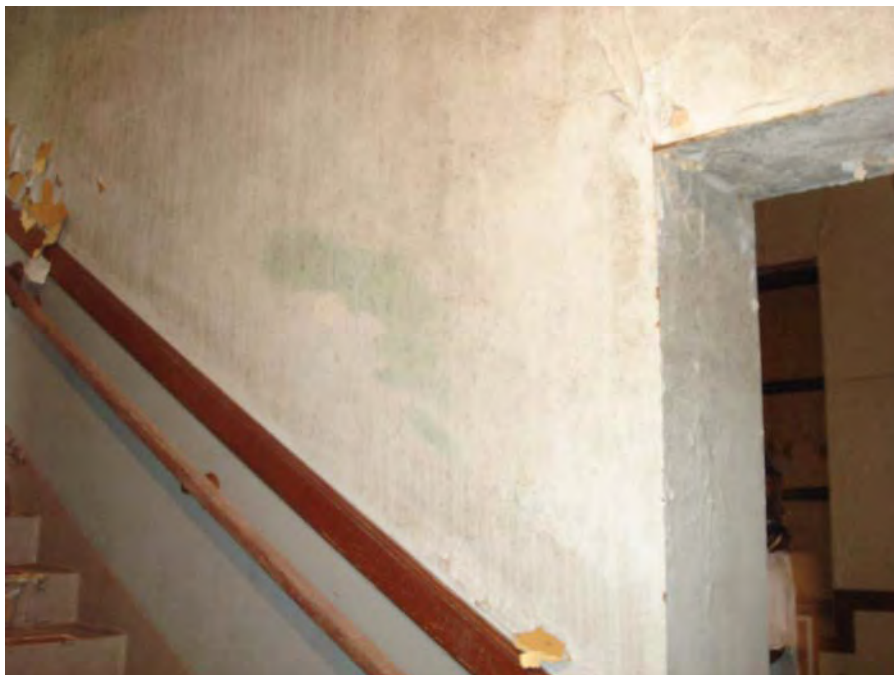
Photo 15: Suspected mold growth on the walls of a stairwell of Building C on the first floor where sample No. MD-C-1-SW-1 was taken.

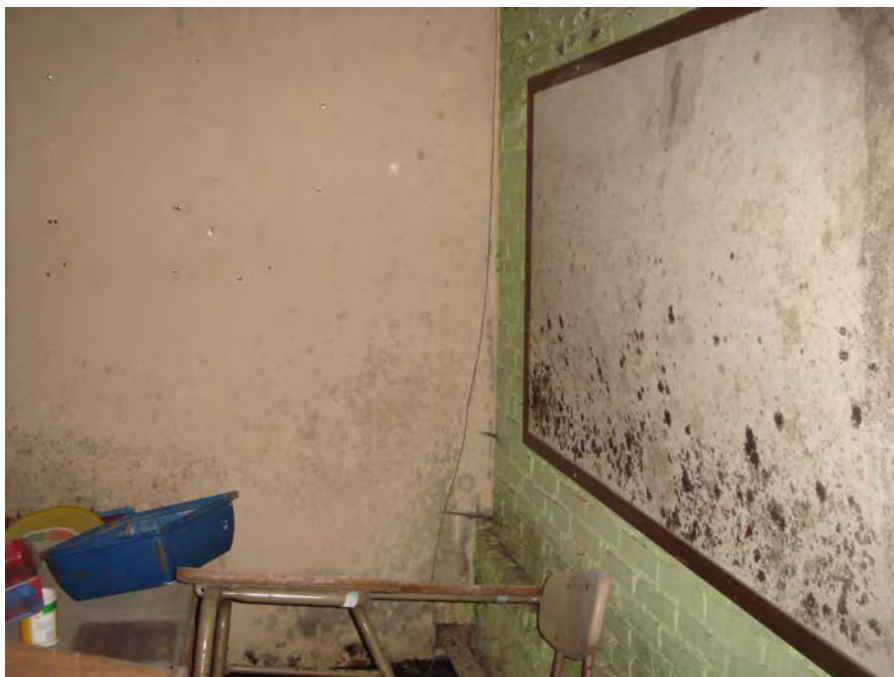
Photo 16: Suspected mold growth on the walls of Room 19 in Building C on the ground floor where sample No. MD-C-G-19-1 was taken.

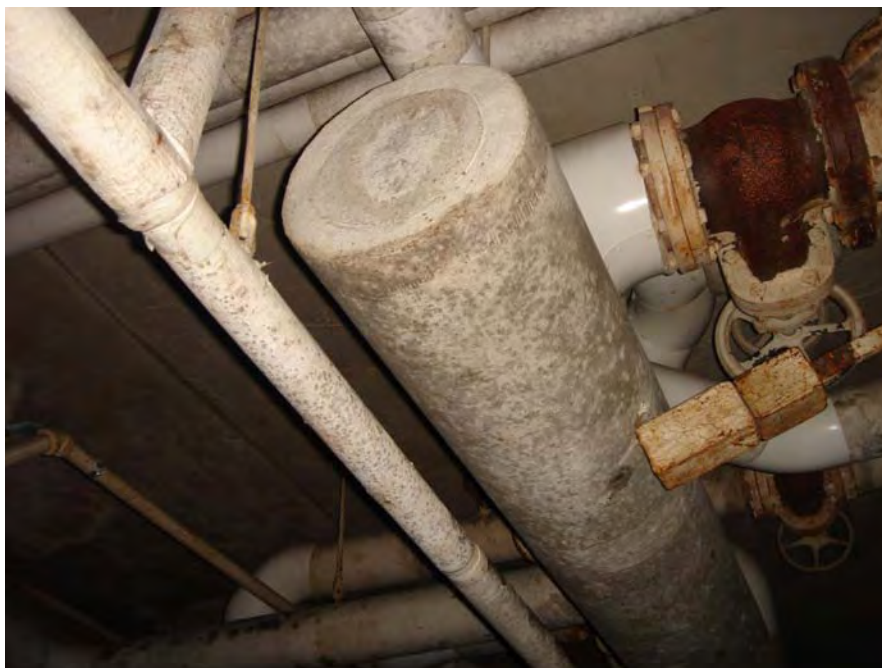
Photo 17: Suspected mold growth on the ceiling and pipes on the ground level of Building C, where sample No. MD-C-G-Mech-1 was taken.

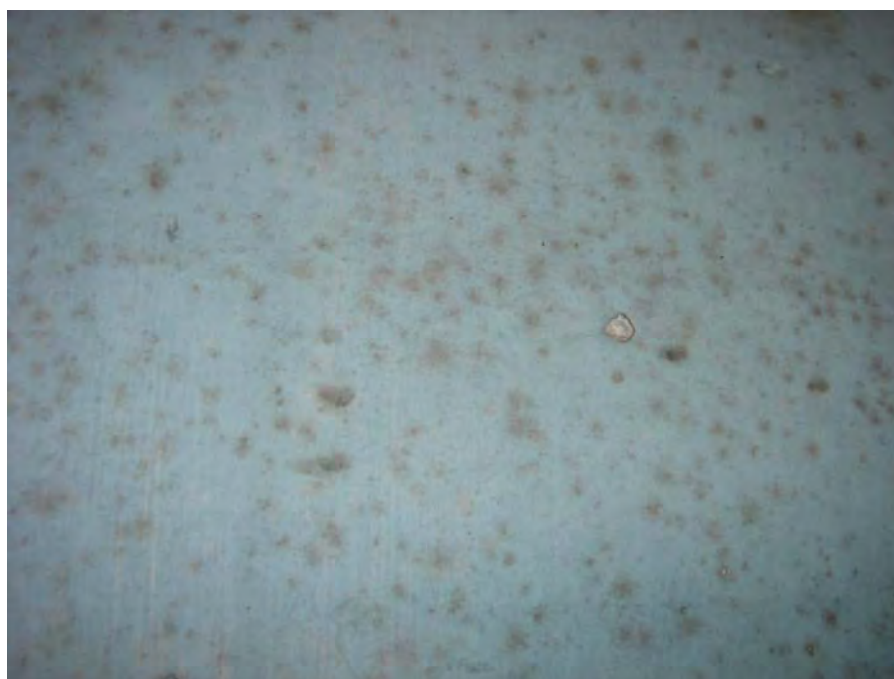
Photo 18: Suspected mold growth on the walls of the Transition Center in Building D on the ground floor where samples MD-D-G-TR-1 and MD-D-G-TR-1DUP were taken.

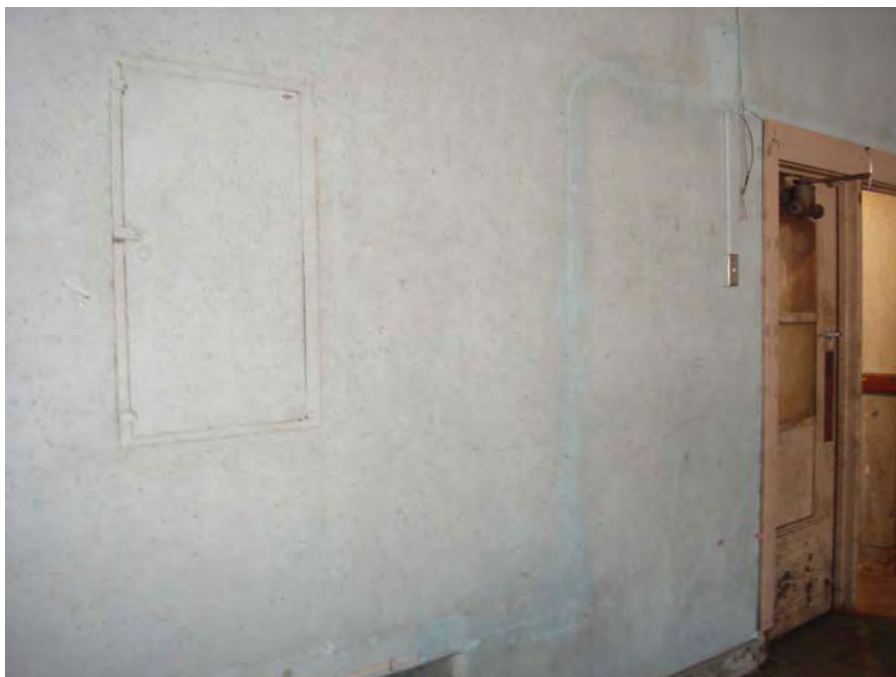
Photo 19: Suspected mold growth on the walls of the Transition Center in Building D on the ground floor where samples MD-D-G-TR-1 and MD-D-G-TR-1DUP were taken.

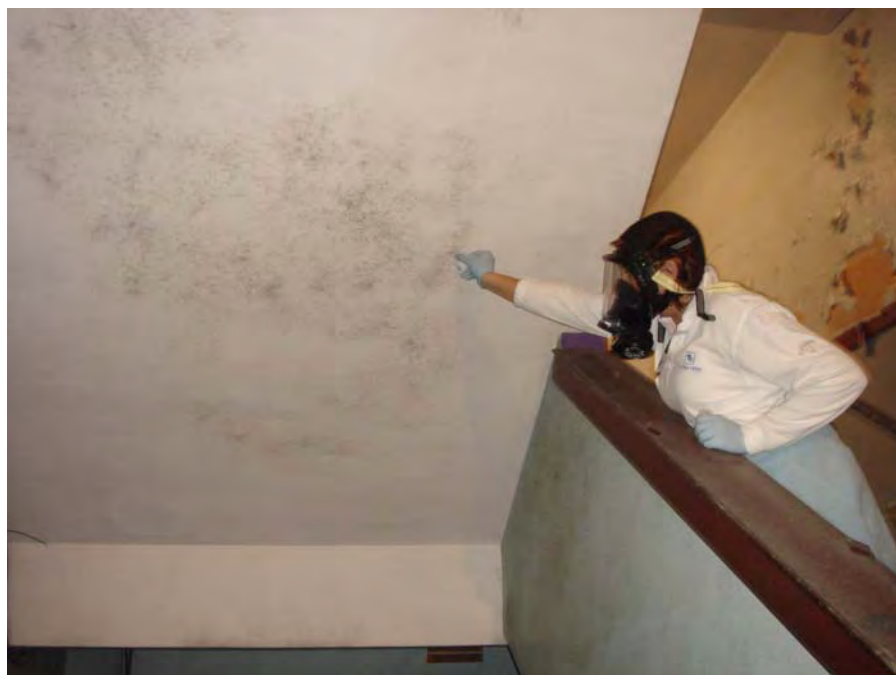
Photo 20: Suspected mold growth on the walls of a stairwell of Building D on the first floor where sample No. MD-D-1-SW-1 was taken.

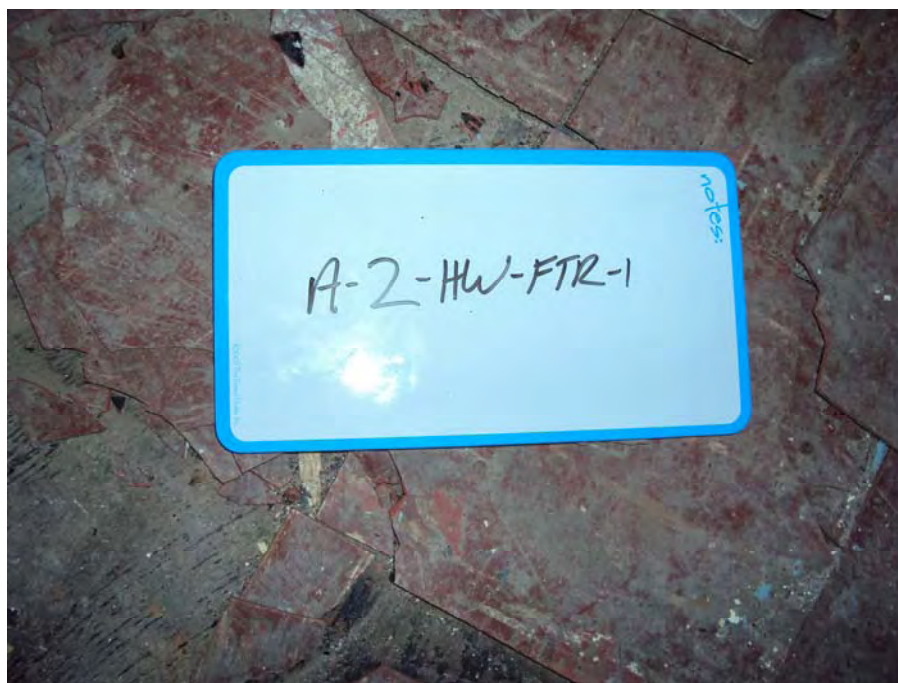
Red 9x9 floor tile and associated mastic represented by sample number A-2-HW-FTR-1 located on the 3rd floor hallway of Building A.

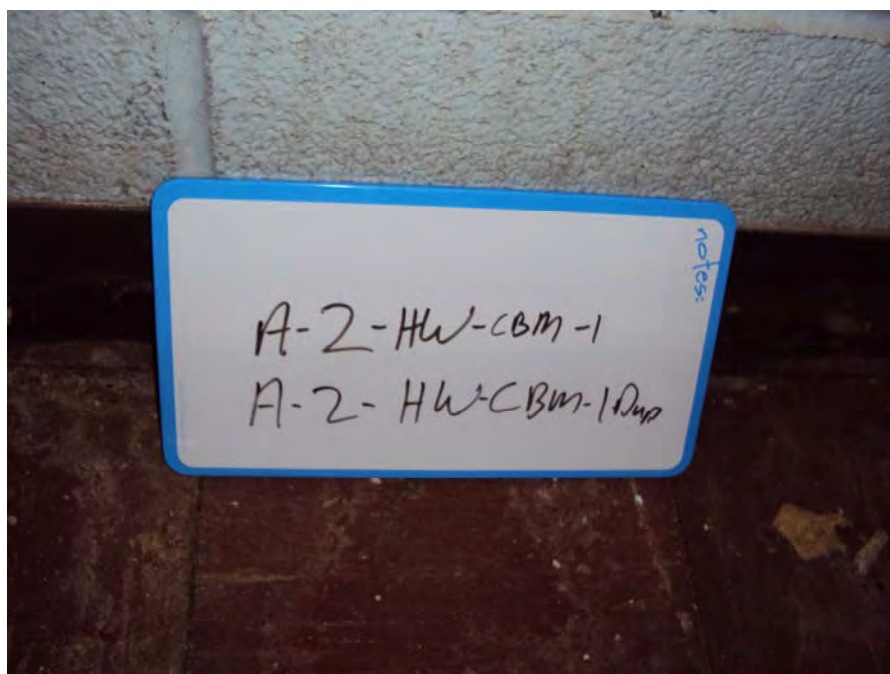
Black cove base mastic represented by sample number A-2-HW-CBM-1 located on the 3rd floor hallway of Building A.

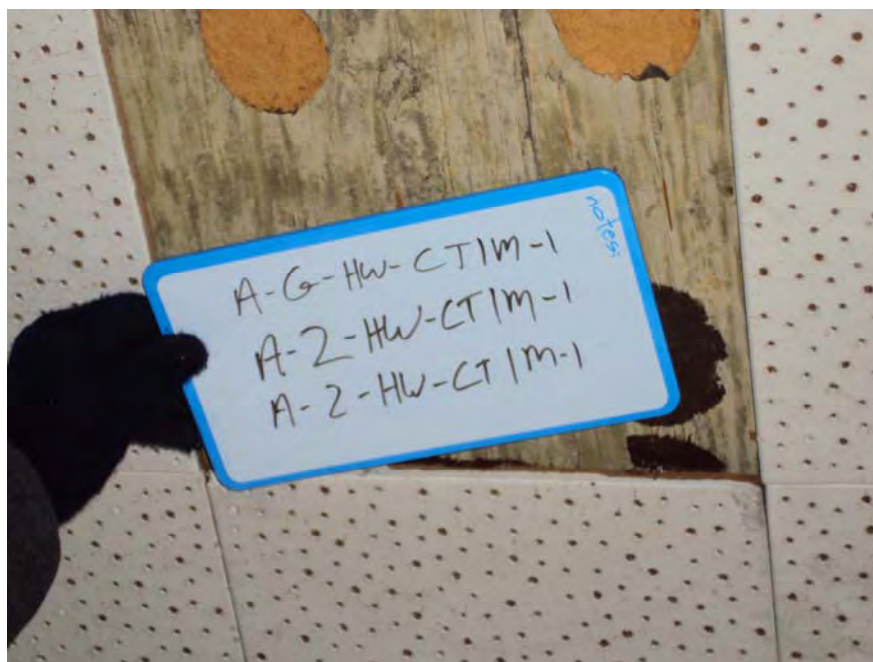
White 12x12 ceiling tile represented by sample number A-G-HW-CT1-1, A-2-HW-CT1-1 and A-1-WCR-CT1-1 located on the 1st, 2nd and 3rd floor of Building A.

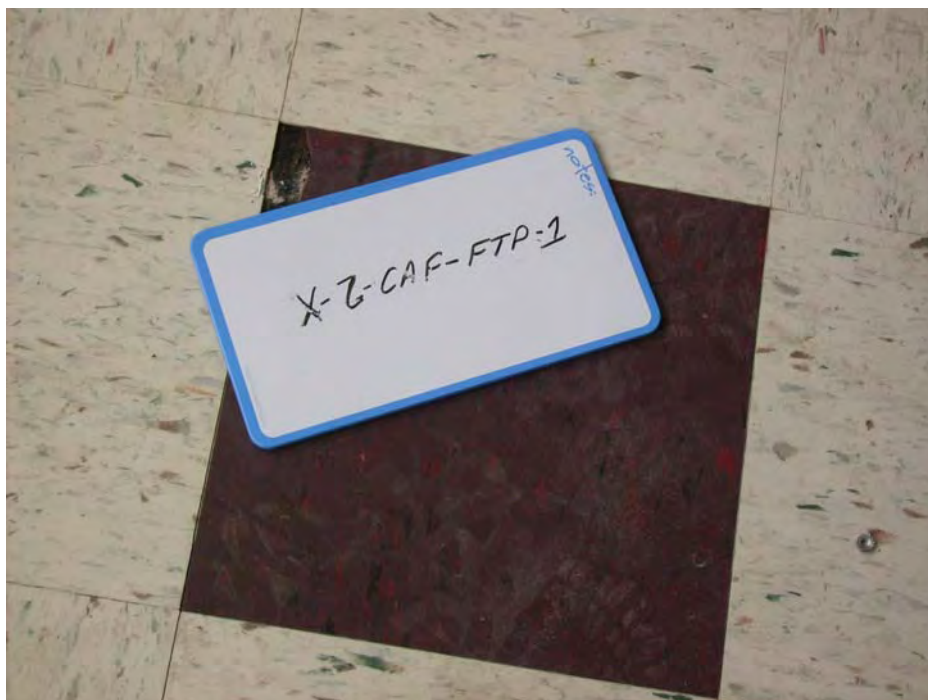
12x12 red floor tile and associated mastic represented by sample number X-2-CAF-FTR-1 located in the cafeteria of the Annex Building.
