# REUSE STRATEGY AND ACTION PLAN

## WILLARD SCHOOL SITE

5015 Garfield Avenue, Kansas City, Missouri 64130

## PHYSICAL BUILDING ASSESSMENT

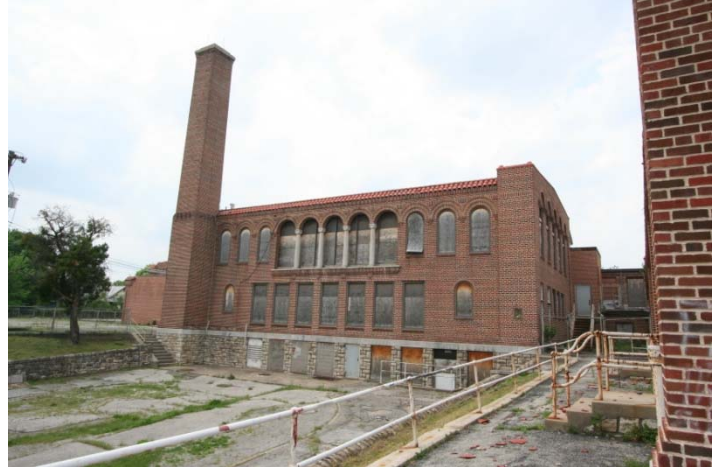
- Exterior Wall Construction: Red brick with cut and cast stone, stucco and tile accents. Masonry is generally in fair condition with multiple areas requiring repointing and brick replacement.

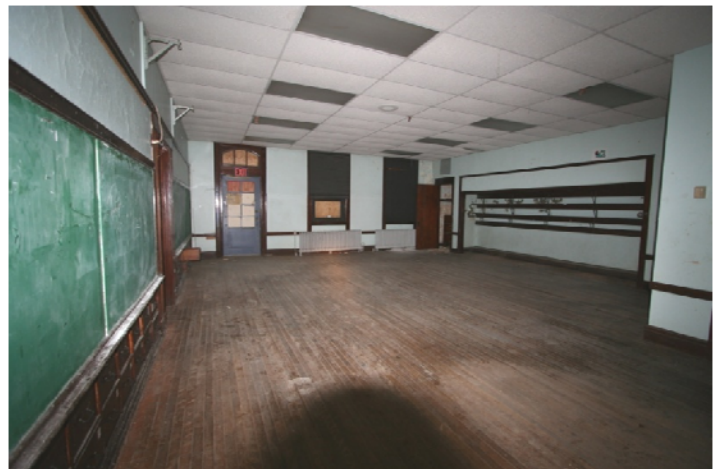
- Classroom Entries: Multi-light wood doors in deep frames with paneled wood jambs. Materials are generally in fair condition.
- Classrooms: Plaster walls, wood floors, wood base, and wood chair rail. Dropped acoustical tile ceiling grid obscures wood skylights. Classrooms have multiple built-in features including recessed coat areas, some with pivot doors, and framed chalk boards. Area under some chalkboards has rows of drawers. Single-user restrooms are built out in some classrooms. Classrooms in 1930 block have concrete floors and no sky lights – this area may have been an open air classroom at one time. Materials are generally in fair condition.
