Fairfield Ludlowe High School Ventilation Study Issues Resolution

for
Fairfield Public Schools
Fairfield, CT

March 2, 2021

van Zelm Project #: 2020073.01

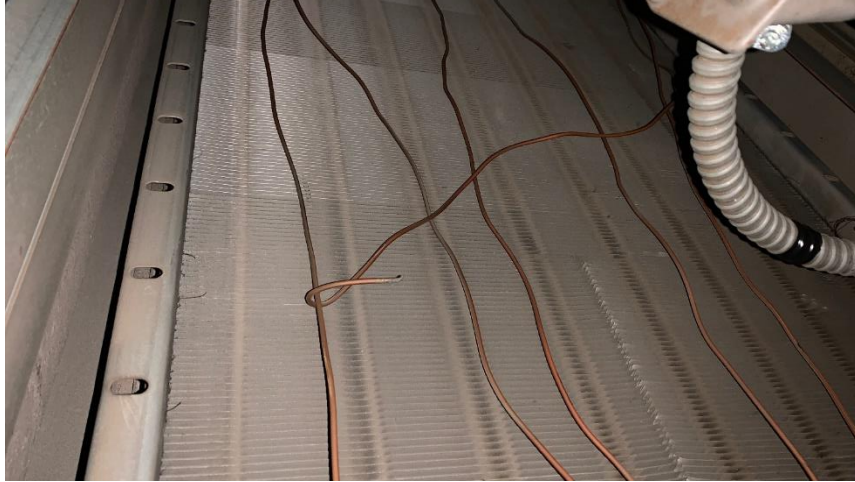
13	AHU-17	2	Coil was cleaned?	IAQ	Yes, the coil was cleaned.

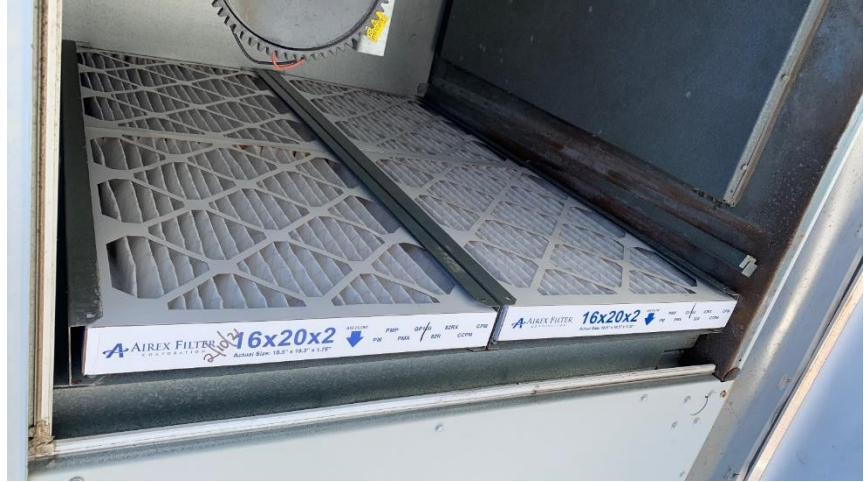
40	MUA-2	2	Was/were any new filter(s) installed? If so, when and what type? If not, why not?	IAQ	2" MERV 13 filters were installed on 2/10/21.

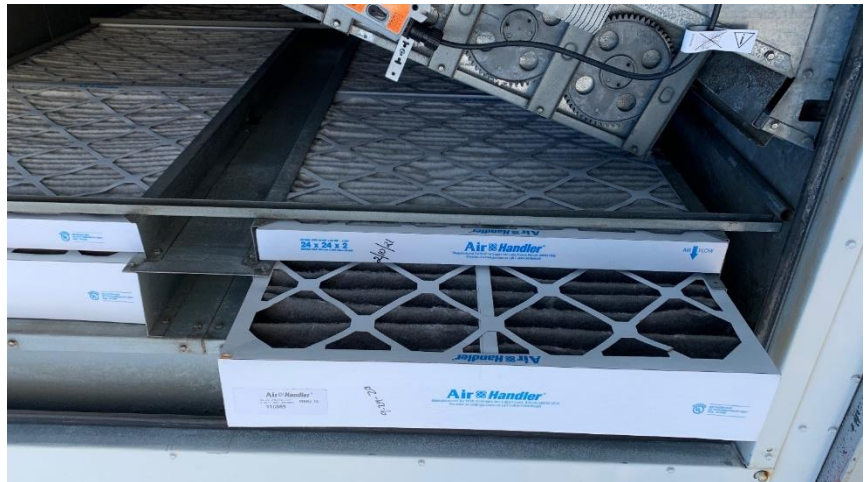
46	RTU-1	3	What about filter(s) changed? If so, when & what type? If not, why not?	IAQ	4" MERV 13 filters were installed on 9/29/20 and 2" MERV 13 filters were installed on 2/10/21.

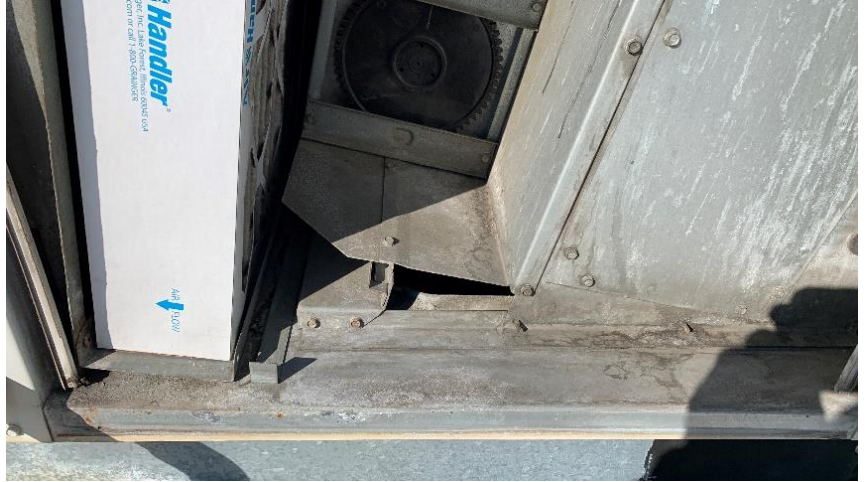
Item ID	Unit	#	Comment	IAQ or Maint.?	vZ Response	Picture
49	RTU-2	3	Has the return air duct been resealed?	Maint.	This has been added to the maintenance punch list but does not affect IAQ since the air is still filtered.

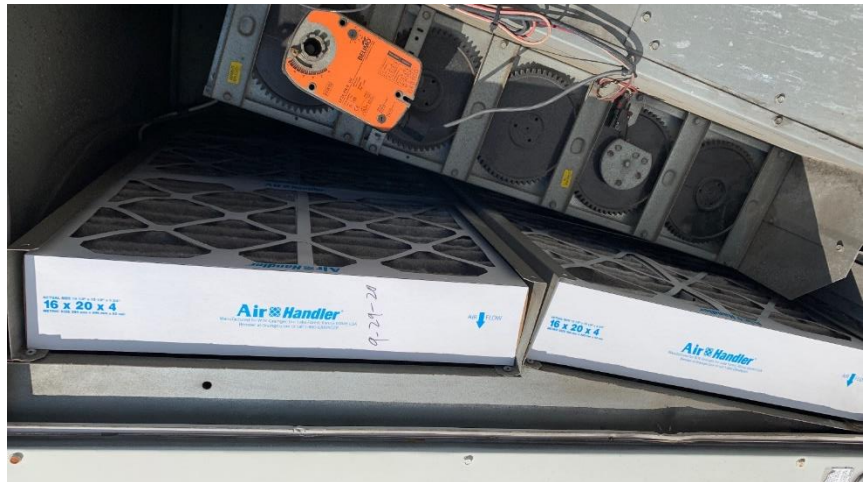
50	RTU-2	4	van Zelm references "filters." Your note referenced "filter" changed on 9/14/20. How many filter(s) are there? Have they all been changed? What type installed?	IAQ	Non-plural was a typo. The unit has 6-16x20x4. All of these were changed on 9/29/20 to 4" MERV 13 filters.

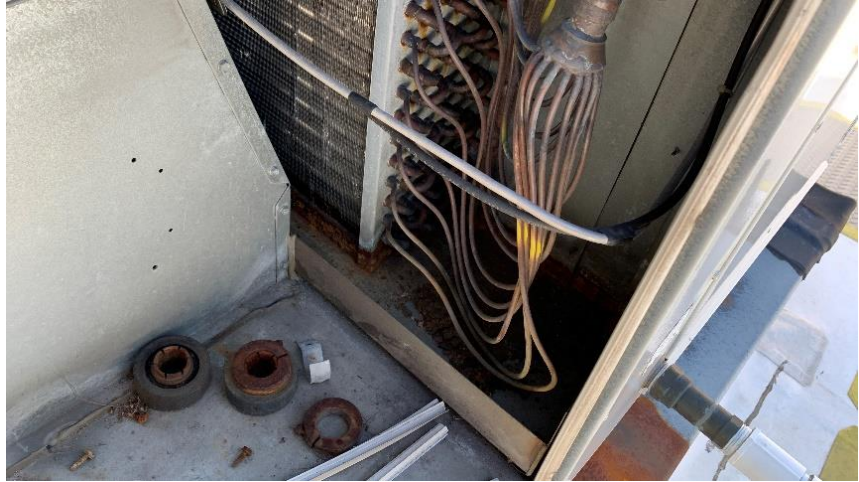
Item ID	Unit	#	Comment	IAQ or Maint.?	vZ Response	Picture
55	RTU-4	2	Does the condensate pan still have standing water?	Maint.	No. Facilities will review during the summer to confirm it does not refill.

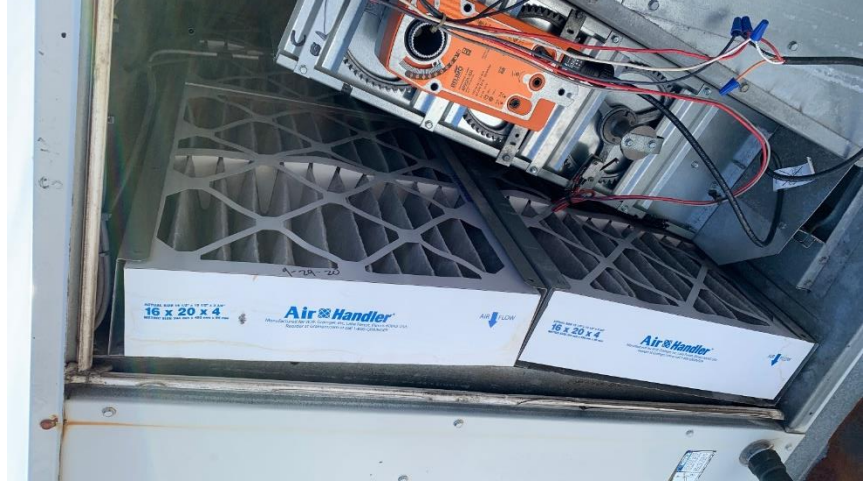
Item ID	Unit	#	Comment	IAQ or Maint.?	vZ Response	Picture
59	RTU-4	6	What about filter(s) changed? If so, when & what type? If not, why not?	IAQ	4" MERV 13 filters were installed 9/29/20.

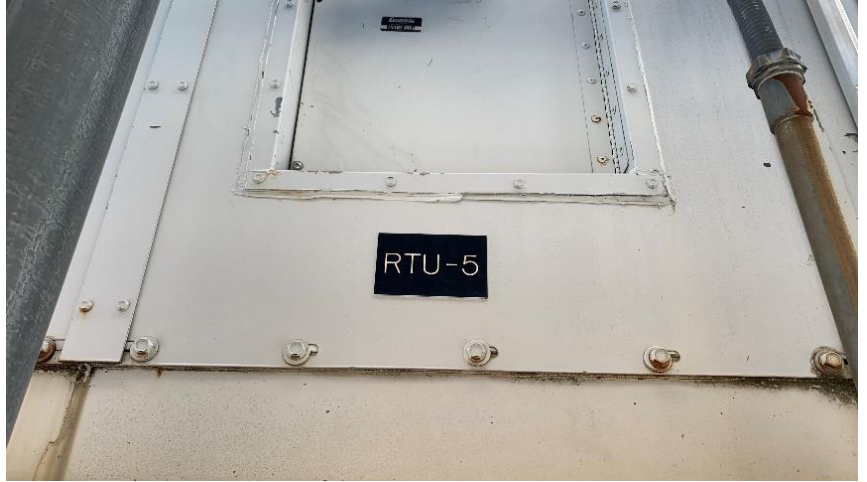
60	RTU-5	1	Has the nametag changed to reflect the proper unit?	Maint.	The unit was mislabeled from the factory, but RTU-6 and RTU-5 are different sizes. Facilities knows this and has them labeled correctly through the control system. The tags on the exterior of these units indicate the correct numbering, not the manufacturer tag with the motor data.

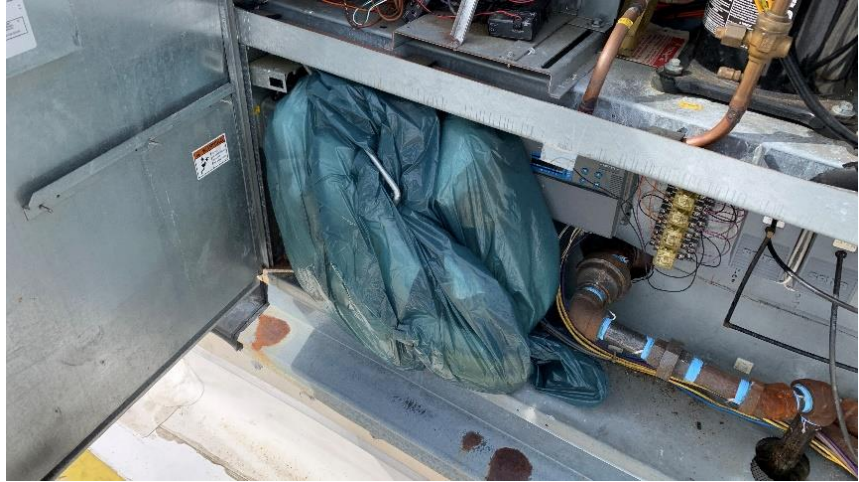
68	RTU-7	2	Was the plastic bag removed containing the piping insulation?	IAQ	The plastic bag was removed from the fan section and put into the control section, which does not block or affect the air. This will be used to insulate the coil and has been added to the maintenance punchlist (see the above item).

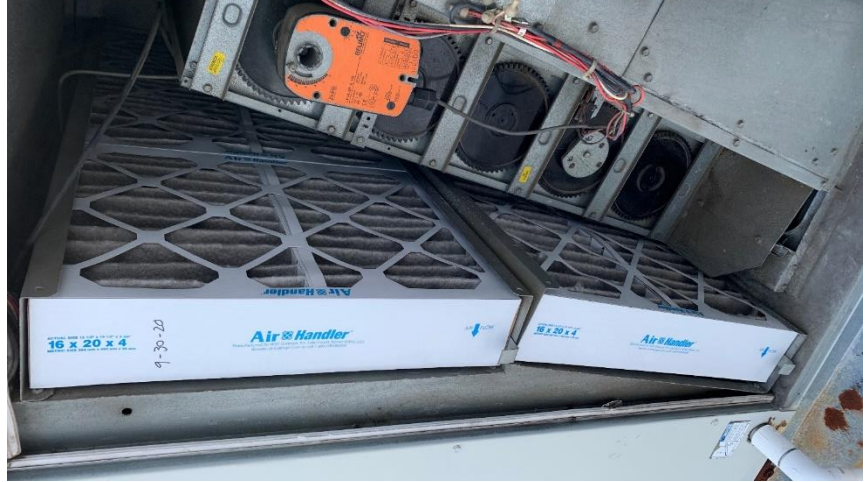
Item ID	Unit	#	Comment	IAQ or Maint.?	vZ Response	Picture
69	RTU-7	3	Is this unit operable? If so, what about the filters? If so, how many, when and what type filters were installed? If not, why not?	IAQ	The unit is now operating. 6-16x24x4" MERV 13 filters were installed 9/30/20.

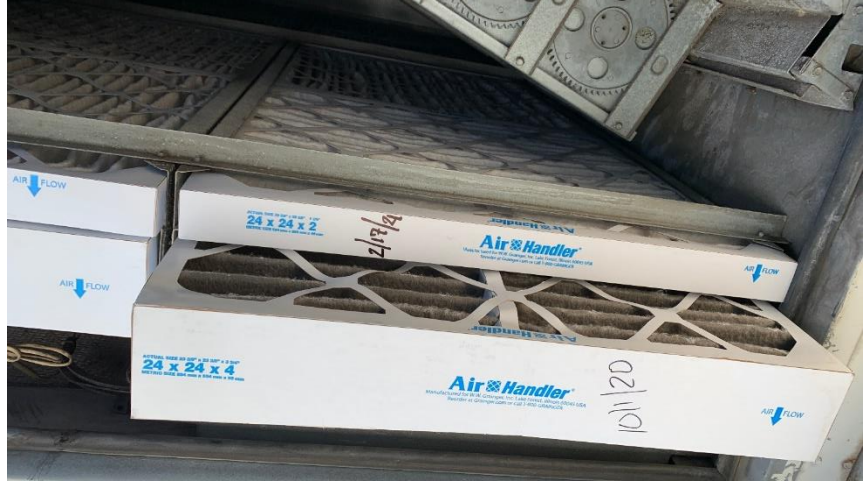
70	RTU-8	1	When were the filters on this unit last changed? If so, how many, when and what type filters were installed? If not, why not?	IAQ	4" MERV 13 filters were installed on 10/1/20 and 2" MERV 13 filters were installed on 2/17/21.

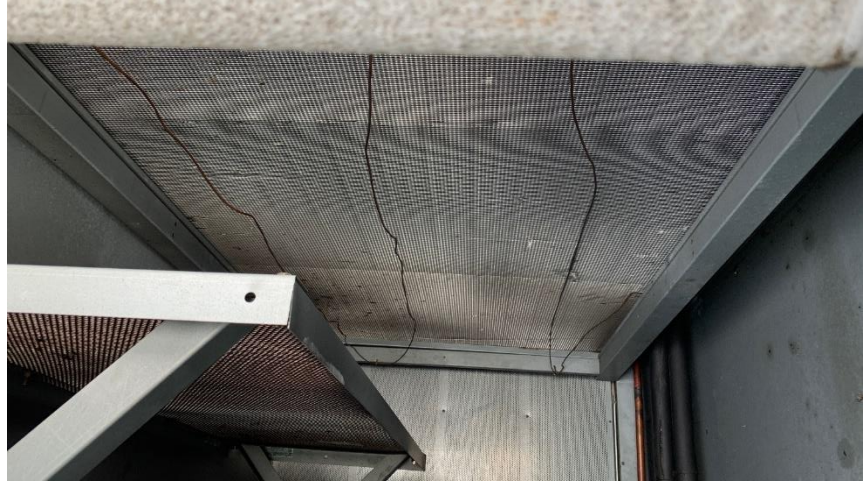
Item ID	Unit	#	Comment	IAQ or Maint.?	vZ Response	Picture
73	RTU-9	3	Has the coil been cleaned?	IAQ	The coil has been fully cleaned and combed.

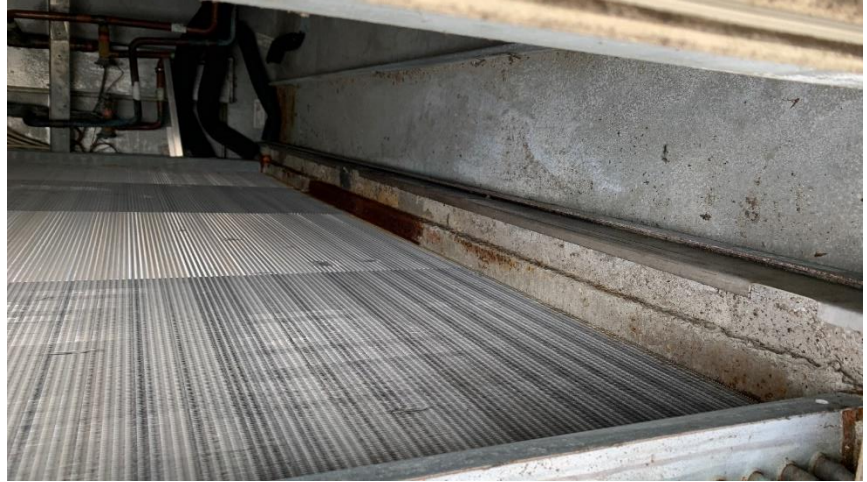
74	RTU-9	4	Have you verified that the drain pan was cleaned?	IAQ	The drain pan was cleaned.

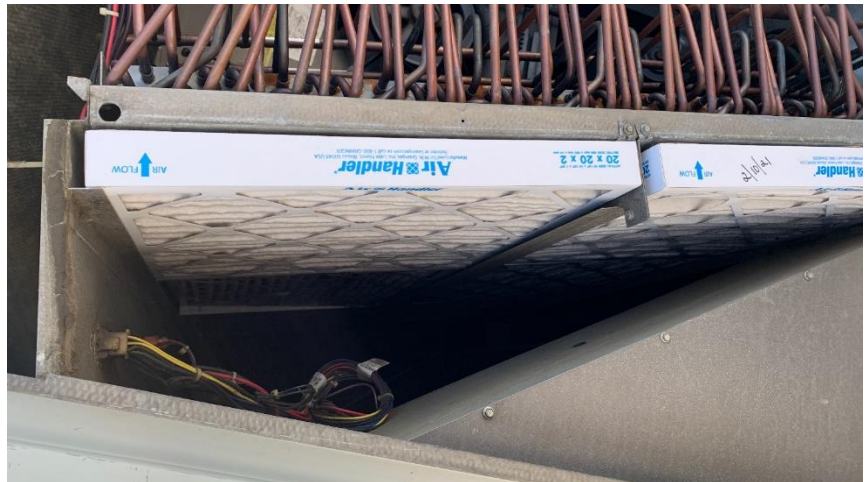
84	RTU-12	4	van Zelm report mentions "filters"; your note states "filter" changed on 9/14/20? How many filter(s) are there? Have they all been changed? When& what type?	IAQ	Non-plural was a typo. 6-20x20x2" MERV 13 filters were installed 2/10/21.
