INSPECTION REPORT: N. MIANUS SCHOOL, OLD GREENWICH SCHOOL, RIVERSIDE ELEMENTARY SCHOOL, AND JULIAN CURTISS SCHOOL

February 24, 2021

Job No. 21211.00

RE: Ceiling collapse at N. Mianus School (309 Palmer Hill Rd.) and subsequent inspections of the ceiling systems at N. Mianus, Old Greenwich School (285 Sound Beach Ave.), Riverside Elementary School (90 Hendrie Ave.), and Julian Curtiss School (180 E Elm St.).

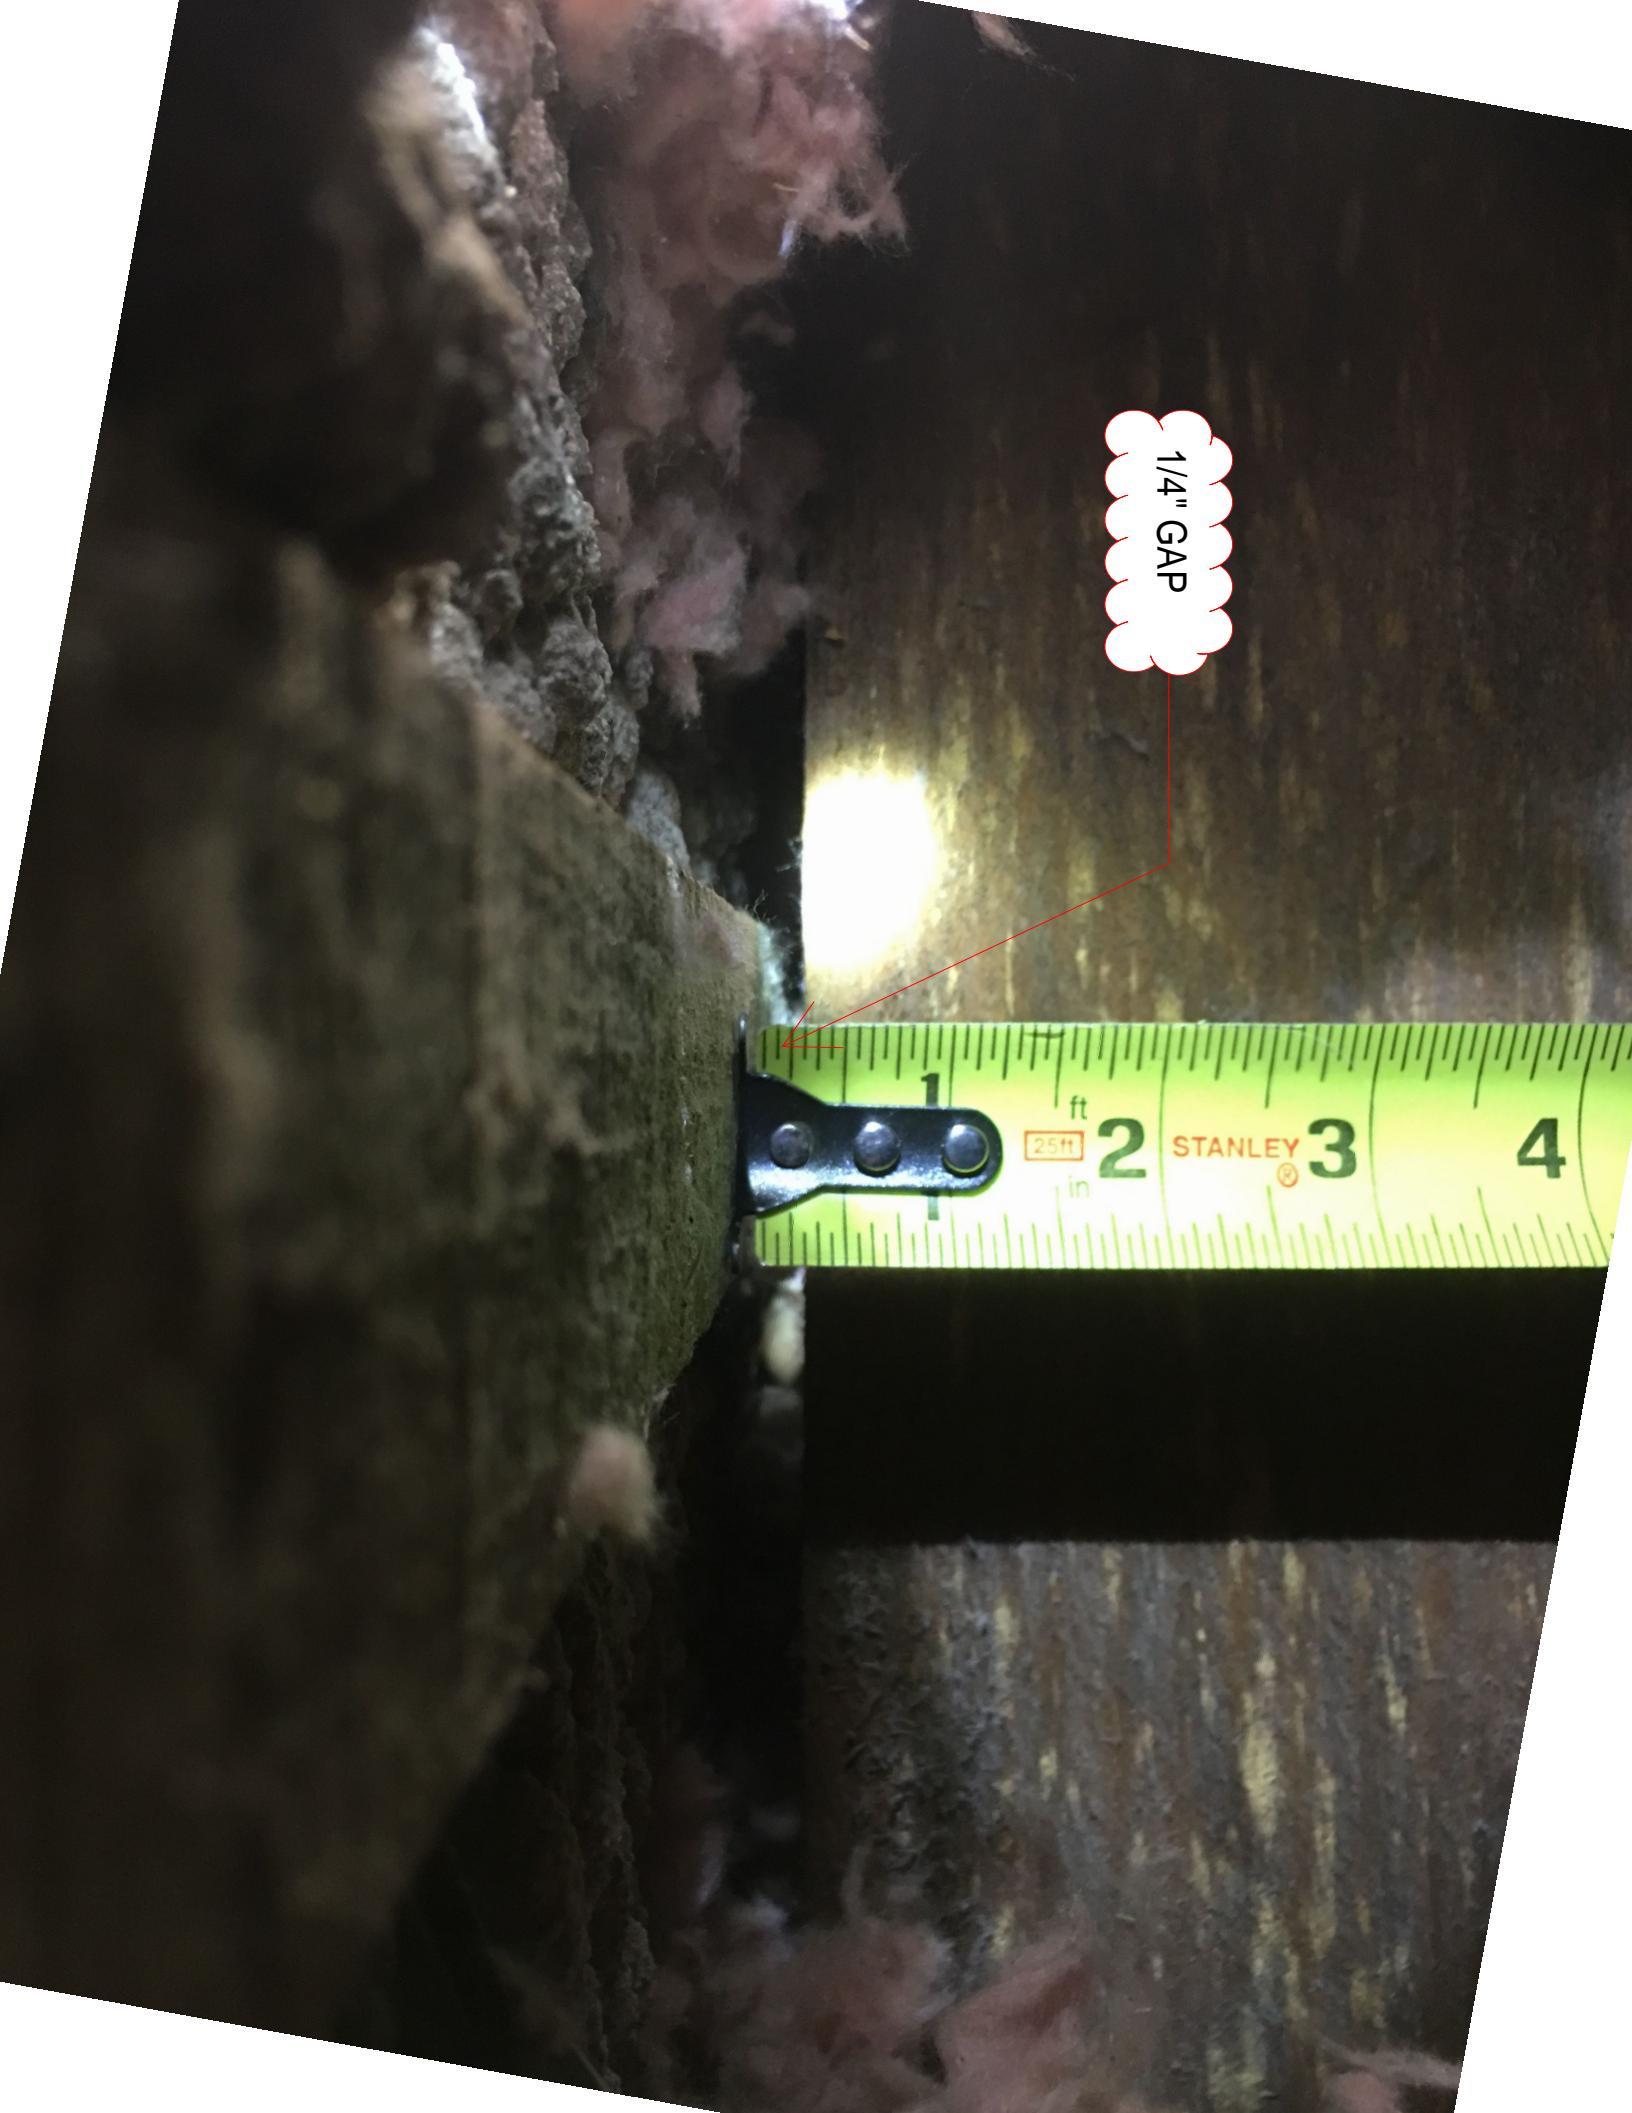
FURRING STRIP

2" GAP, ONLY 1/2" OF NAIL REMAINS EMBEDDED. 5

TOGGLE BOLTS SUPPORTING SUSPENDED CEILING AND SPRINKLER SYSTEM INSTALLED ATTACHED TO PLASTER ONLY.

The extent of this ceiling assembly is shown shaded in red on the attached floorplan. These areas are currently not safe, the plaster ceiling assembly should be removed and replaced with a properly installed drywall ceiling (thickness and assembly type TBD by current architectural, fire and building codes), and all hanging loads should be re-installed and secured to the ceiling structure.
