Existing Conditions Assessment -

Executive Summary

February 23, 2018

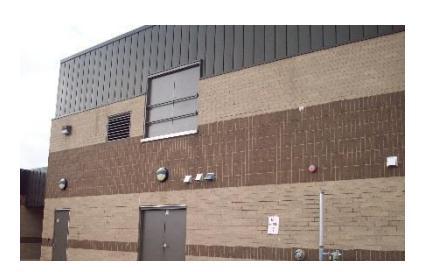
Note: I surveyed this building on November 6th. The night before Erie experienced a major rain/wind event. While walking around the outside, I noticed many areas of the brick mortar that appeared to be very wet. I discussed this issue with Brad Dunn and will do a follow up on a future visit.

WET MORTAR

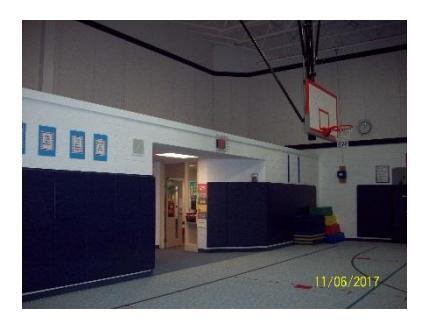
Gymnasium. The gym has one full size basketball court and two smaller side courts with the related court lines in the carpet. There is a climbing wall. The finishes and equipment are in excellent condition. However, there is second story open unusable space above the group toilets and the storage areas. These areas may want to be partitioned to prevent faculty and/or students from accessing these areas.

GYM - OPEN AREA ABOVE TOILETS

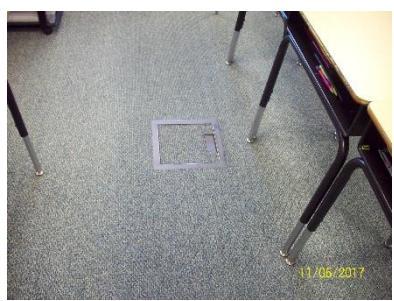
COMPUTER ACCESS PANEL

Classrooms. The finishes, casework, and whiteboards are in excellent condition. However, there are computer access panels in the floor which create an uneven surface.

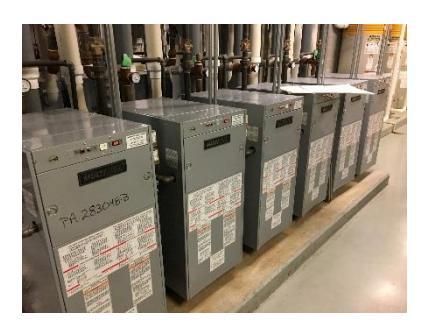
HEATING BOILERS

The school is heated by a water source heat pump system and the heat pump loop is heated by 12 "Hydrotherm" high efficiency gas fired heating boilers. The boilers mainly appear to be in good condition. Combustion air is provided directly to the boilers. The boiler room is ventilated by a roof mounted exhaust fan and wall mounted intake louvers, all appear to be in good condition.

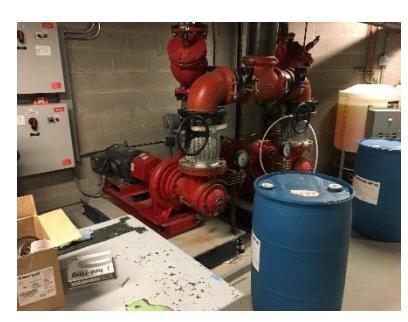
CONDENSER WATER PUMPS

Condenser water is distributed through the building by two primary pumps that appear to be in good condition. The piping is original to the building, no reported issues with this system. The pumps are controlled by variable frequency drives.

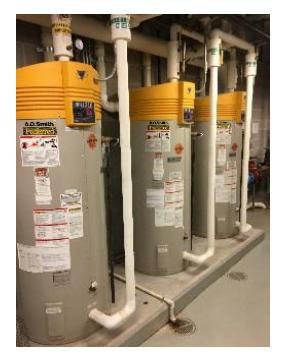
WATER HEATERS

Two power vented tank-type gas fired water heaters, located in the mechanical room, serve the building. (State model SDV 80140NE), these units appear to be in good condition.

One power vented tank-type gas fired water heater, located in the mechanical room, serves the kitchen. (State model SDV 100199NE), this unit appears to be in good condition.

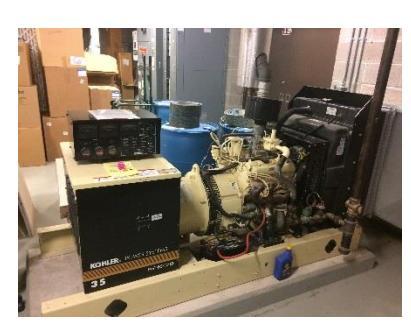
KOHLER 35KW EMERGENCY BACK-UP POWER GENERATOR

There is one emergency generator located in the main equipment room that provides back-up power to the facility. The generator is 35kw, 277/480 volt, 3 phase, natural gas fired, was manufactured by Kohler and is original to the building construction. The generator is located in the upper level of the building in the boiler room and is ducted directly to the exterior for venting. The generator is tested weekly and serviced once a year and appears to be in good operating condition. The generator should continue to be maintained yearly and tested regularly to verify proper operation.

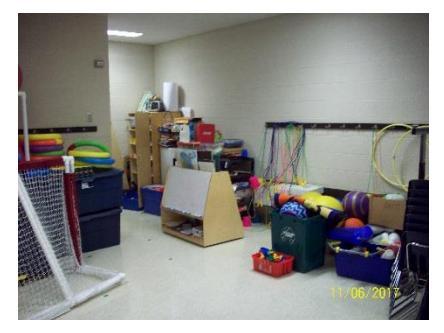
LOCKER ROOMS USED FOR STORAGE

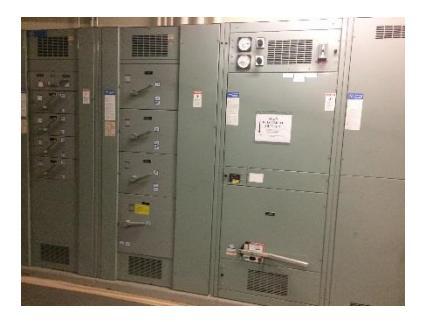
2000A MAIN SWITCHBOARD

The pad mounted transformer serves a 2000 amp, 277/480 volt switchboard located in a main equipment room on the second level. The switchboard feeds two interior step down transformers to supply 120/208 volt, 3 phase power to the building, one for general power equipment loads and one dedicated to computer and electronic equipment loads. The main switchboard was manufactured by Westinghouse, and is original to the building construction and is in good condition. It was observed to have approximately 150 amps of load per phase which indicates it has plenty of capacity to serve future loads needed in the building. There are several spaces available in the switchboard and distribution panelboards for ease of connection to future loads.

Branch panelboards throughout the facility were all manufactured by Westinghouse which is no longer in business; however, the equipment is still in good condition and parts are still available.

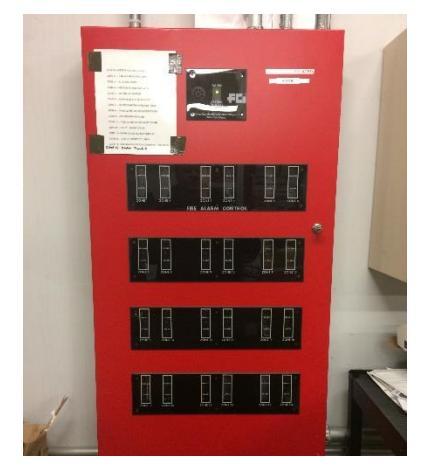
FCI FIRE ALARM CONTROL PANEL

An FCI fire alarm system presently provides fire alarm protection to the building with the main panel being located on the first floor of the school. The system is an older zoned system (16 active zones of indication); however, it is operational and should be tested regularly for proper operation. Initiating devices (pull stations, smoke detectors, sprinkler system tamper and flow switches, and duct detectors) are located throughout the building. Fire alarm notification appliances (horns and strobes) are also located throughout the building; however, some areas do not meet the proper coverage.

The fire alarm system was installed in 1990 during the original construction and meets the current needs of the facility; however, consideration should be given to upgrading to new addressable technology with devices located to meet

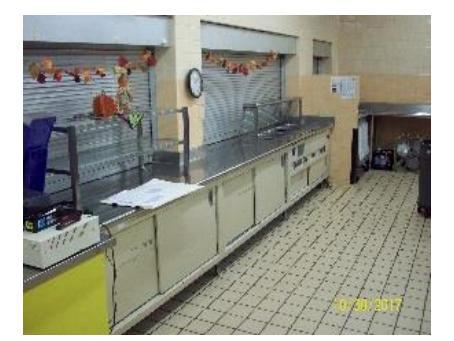
KITCHEN SERVING LINE

Kitchen. The full prep kitchen has some dated equipment, a walk-in cooler that needs to be replaced, an original natural

gas heated serving line and a new walk in freezer. The ceramic tile finishes are in good condition.

Walk in cooler in Kitchen	Existing cooler is in poor condition			Replace - already on District's maintenance/replacement list			Х

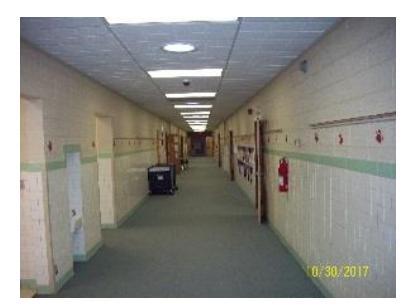
TYPICAL CORRIDOR

Corridors. The corridors are carpet, the walls have a ceramic tile wainscot with painted block above and a suspended tile ceiling. These finishes are in good condition.

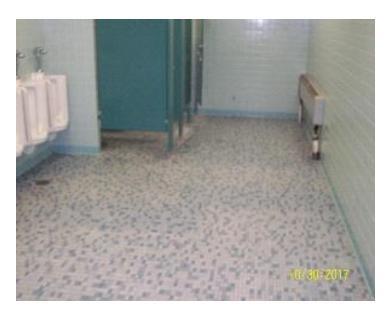
GROUP TOILET

Toilet Rooms. Group toilets - The ceramic tile floors, ceramic tile walls, gypsum board ceilings, fixtures and metal partitions are in good condition. The ADA stall does not meet clearance standards.

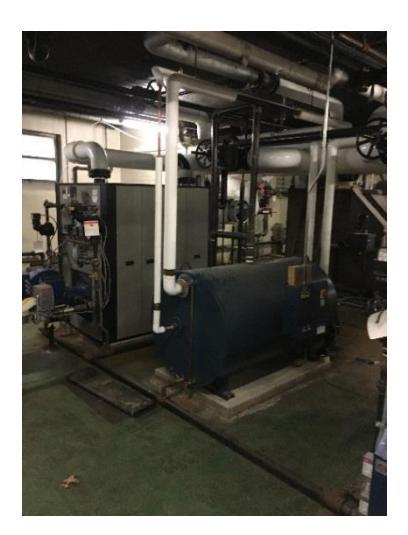
STEAM BOILER

The building is served by a Weil-McLain model 88 cast iron gas fired steam boiler installed in 2011 and is in good condition. The boiler room combustion air is provided untreated to the boiler room through louvers in the outside wall and the exit door from the boiler room. Boiler emergency shut down switches were not installed. Relief vents from boilers not piped to the outdoors. Relief vents from boiler gas regulator not pied to the outdoors.

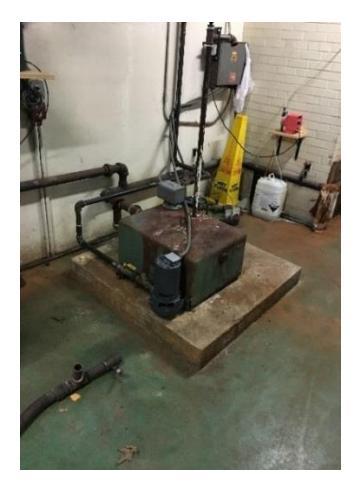
CONDENSATE RECEIVER

Duplex steam condensate return pump in boiler room appears to be in poor condition. Relief vent from condensate receiver is not piped to the outdoors.

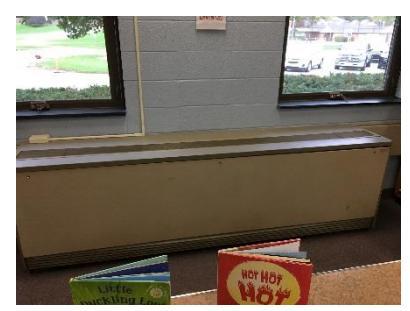
CLASSROOM UNIT VENTILATOR

Classrooms. The classrooms are heated and ventilated by floor mounted vertical unit ventilators with steam coils for heating and fin tube radiation/draft-stop steam fin tube under windows. The unit ventilators are original and appear to be in poor condition.

Unit Ventilators		28 years old	The unit ventilaors are at the end of their expected useful lives and should be replaced. The cost to replace is without adding air conditioning.	\$	150,000		
Option 1 - Add air conditioning to existing classrooms	existing unit ventilators are in various condition states and are overal in fair condition.	28 years old	Replace the existing unit ventilators with new DX thru wall unit ventilators with steam heating coil.			\$ 300,000	
Option - 2 Add air conditioning to existing classrooms	existing unit ventilators are in various condition states and are overal in fair condition.	I 44 years old	New four pipe unit ventilators with hot water heating coil and chilled water cooling coil, add new water chiller, convert existing steam boiler to hot water heating boilers.			\$ 1,200,000	
Multi-purpose room	The existing air handler is located on a platform above the storage room at the Multi-purpose room.	44 years old	The air handler is at the end of its useful service life and shouold be replaced.	\$	120,000

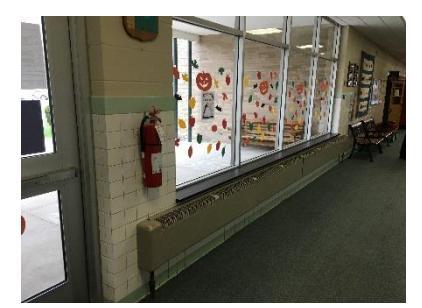
FIN-TUBE RADIATION

Corridors. Steam convectors and fin-tube radiation heat the corridors. These units appear to be in poor condition.

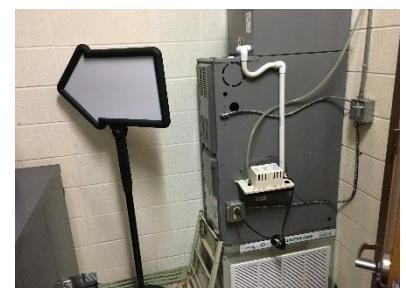
OFFICE SPLIT SYSTEM AIR CONDITIONER

Offices. Steam convectors along the perimeter for heating and a residential style split system was installed in 2010 to provide air conditioning to the offices.

-			Expectancy		3		2	1			0
Administration/office are	There are steam convectors along the perimeter and a residential style split system for air conditioning.	conv. 54 yrs old split sytem 7 yrs old		The heating and air conditioning system for this area should be replaced with a system the will provide both heating,air conditioning and proper ventilation of the office areas.			\$ 50,000				
Building temperature co	The existing building distribution control system is pneumatic and is original to the building, no reported issues with the air lines at this time.	54 yrs old		The existing temperature controls system shall be replaced when building renovations take place, the system should be changed to all electronic control system.					\$ 230	0,000	
Electrical											
Emergency Generator	The existing emergency generator is a 38kw natural gas generator manufactured by Kohler connected to the distrbution system via one automatic transfer switch which provides back-up power to egress lighting and select equipment. The generator was recently replaced	Approx 5 years		Maintenance existing generator, change all fluids yearly and provide regular testing to ensure proper operation.							\$ 2,500

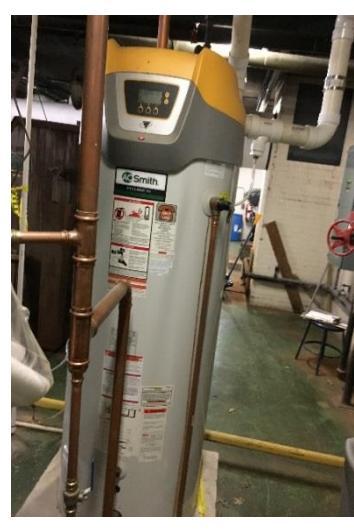
GAS FIRED WATER HEATER

Gas-fired water heater with separate, horizontal, storage tank in boiler room. The water heater is a newer high efficiency water heater and appears to be in good condition, the storage tank is original. Existing mixing valve and circulation pump.

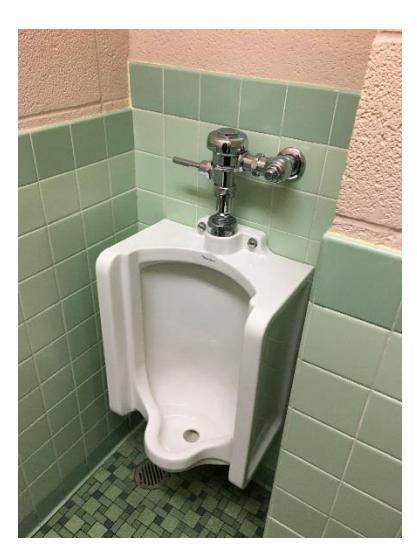
TYPICAL FLUSH VALVE WALL HUNG URINAL

Wall mounted flush valve water closets and urinals appear to be in good condition. Wall hung sinks in the Gang toilets are vitreous china and appear to be in good condition.

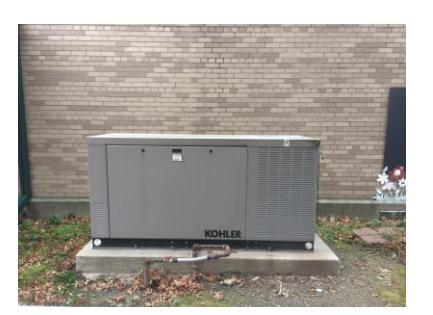
38KW GENERATOR IN EXTERIOR ENCLOSURE

There is one emergency generator located in the main equipment room that provides back-up power to the facility. The generator is 38kw, 120/208 volt, 3 phase, natural gas fired, was manufactured by Kohler and was recently replaced. The generator is located in courtyard in an exterior weather proof enclosure. The generator is tested weekly and serviced once a year and appears to be in good operating condition. The generator should continue to be maintained yearly and tested regularly to verify proper operation.

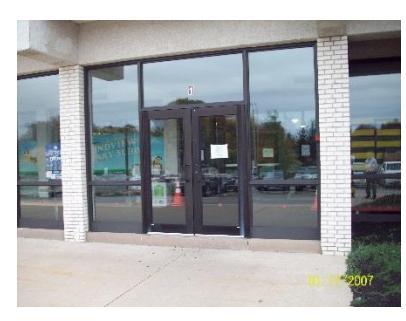
ENTRANCE – WITH STEP TO GRADE

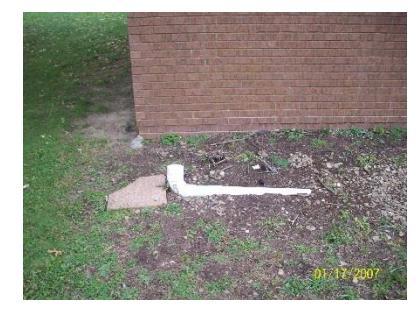
EXPOSED AND DAMAGED PIPE

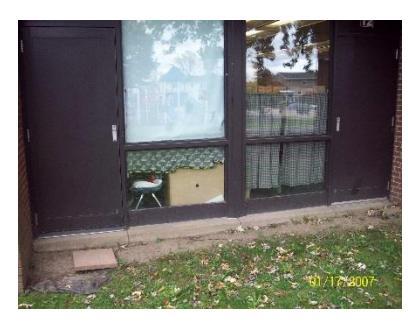
STEP AT EXTERIOR DOOR

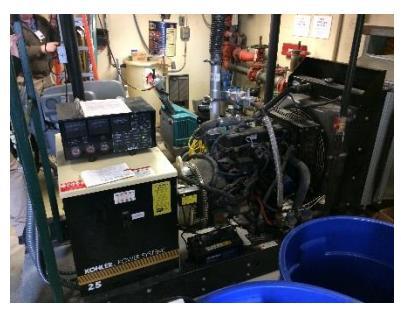
KOHLER NATURAL GAS EMERGENCY GENERATOR

There is one emergency generator located in the main equipment room that provides back-up power to the facility. The generator is 35kw, 277/480 volt, 3 phase, natural gas fired, was manufactured by Kohler and was recently relocated from another building. The generator is located in the boiler room below the main electric room and is ducted directly to the exterior for venting. The generator is tested weekly and serviced once a year and appears to be in good operating condition. The generator should continue to be maintained yearly and tested regularly to verify proper operation.

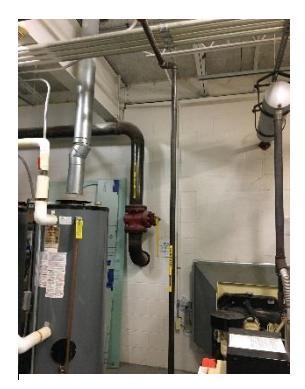
DOMESTIC WATER SERVICE

The building is serviced by a 4" domestic water service main. The piping for water distribution in the building is primarily copper piping and is in good condition.

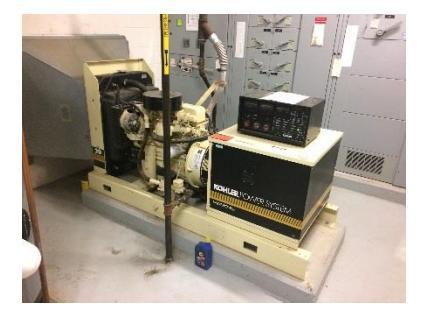
There is one emergency generator located in the main equipment room that provides back-up power to the facility. The generator is 20kw, 277/480 volt, 3 phase, natural gas fired, was manufactured by Kohler and is original to the building construction. The generator is located in the first floor of the building in the boiler room and is ducted directly to the exterior for venting. The generator is tested weekly and serviced once a year and appears to be in good operating condition. The generator should continue to be maintained yearly and tested regularly to verify proper operation.

KOHLER 20KW EMERGENCY BACK-UP POWER GENERATOR

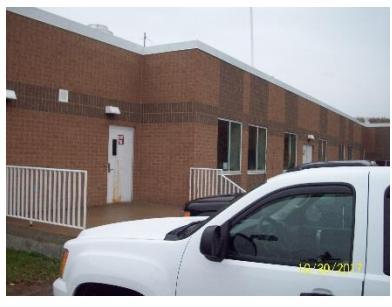
LOADING DOCK DOOR

The exterior is brick with aluminum doors and windows. There was noticeable rust on the man door at the loading area. There is also rusting and/or staining on the white fascia above several of the exterior doors at the ends of the classroom wings. This could be a possible roofing issue.

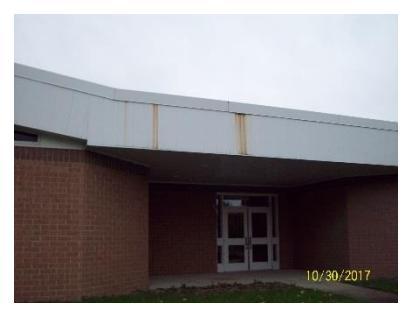
STAINED FACIA

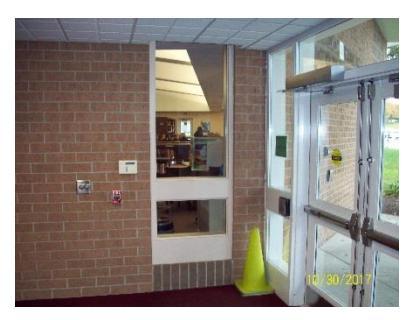
POSSIBLE SECURITY WINDOW

Vestibule/Lobby. The walk off carpet and brick walls of the vestibule are in excellent condition. The ceramic tile and painted walls of the lobby are in excellent condition as well. However, there is a security issue as the administration office is a considerable distance from the front door where several corridors connect.

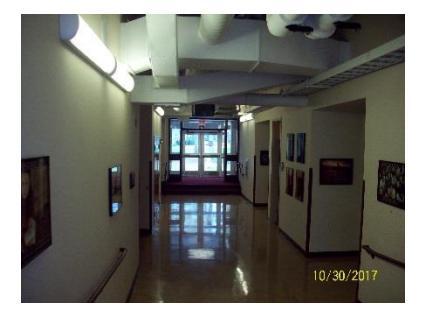
NON-ADA ACCESSIBLE EXIT

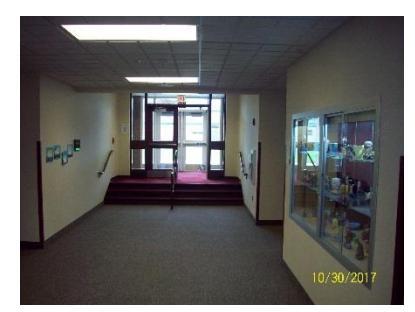
NON-ADA ACCESSIBLE EXIT

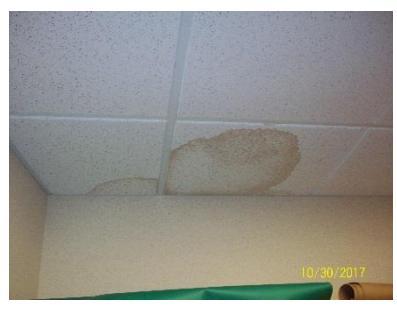
It is also noted that throughout the school, several ceiling tile are sagging or stained due to the condensation drips from the A/C lines.

CEILING - WATER STAIN

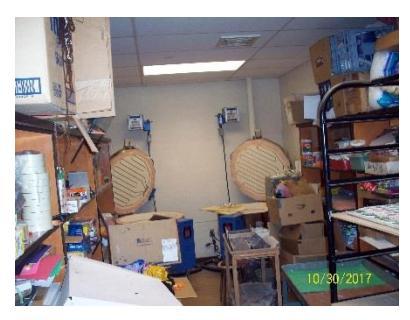
TWO KILNS – POSSIBLE ADDITIONAL VENTILATION ?

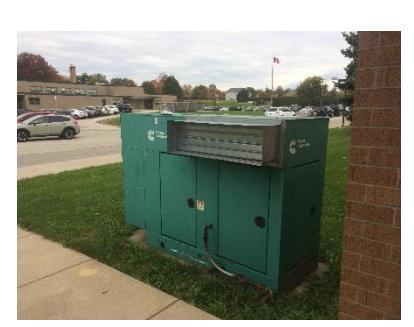
There is one emergency generator located outdoors in a weather proof enclosure that provides back-up power to the facility. The generator is natural gas fired, was manufactured by Cummins, and was installed in 2008. The generator size was unable to be determined by observation. The generator is tested weekly and serviced once a year and appears to be in good operating condition. The generator should continue to be maintained yearly and tested regularly to verify proper operation.

GENERATOR

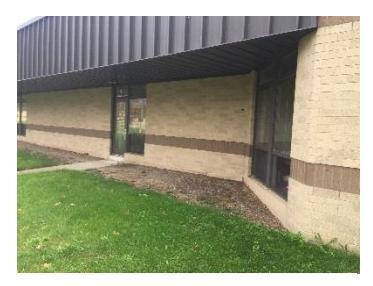
UNFINISHED YARD AREA UNDER OVERHANG

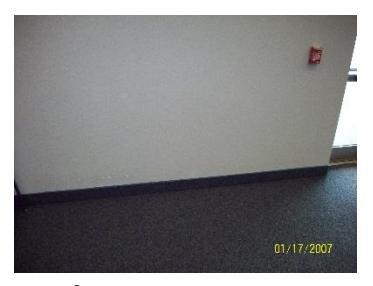
CAFÉ – DAMAGED WALLPAPER

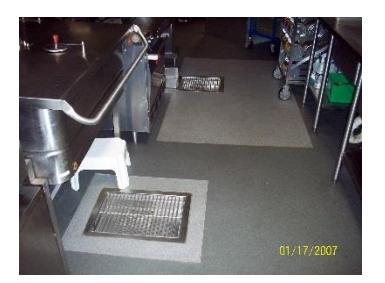
PATCHED KITCHEN FLOORING

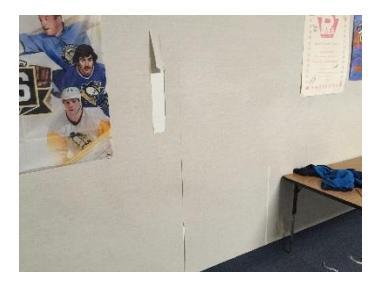
MUSIC ROOM DAMAGED WALL PAPER

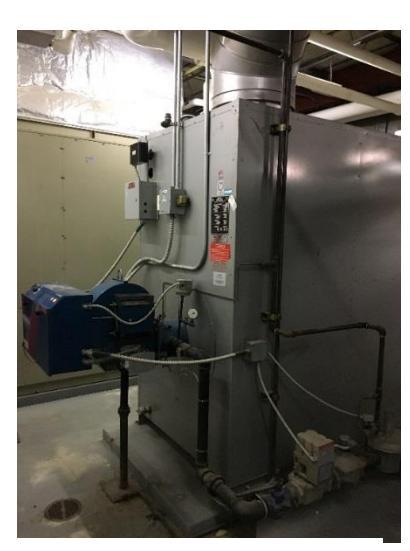
BOILERS

Two Bryan Flex-Tube boilers provide hot water to the heating equipment and are in good condition.

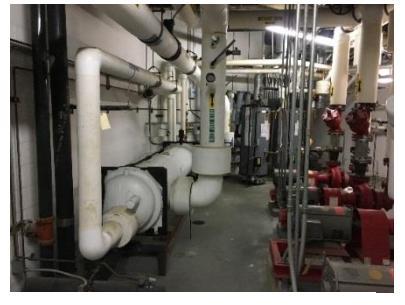
CHILLER

Chilled water system. A split air-cooled chiller provides 350 tons of cooling, utilizing R-22, to the chilled water piping loop and is in good condition.

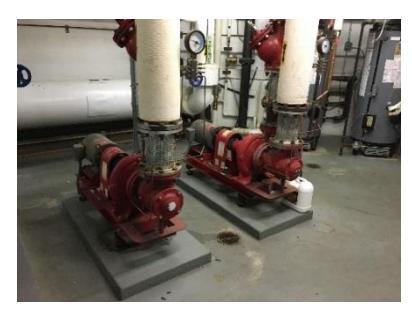
HOT WATER CIRCULATION PUMPS

Pumps P-3, P-4 alternate to provide to provide 512 GPM of 180 degree hot water to the heating loop and are in good condition.

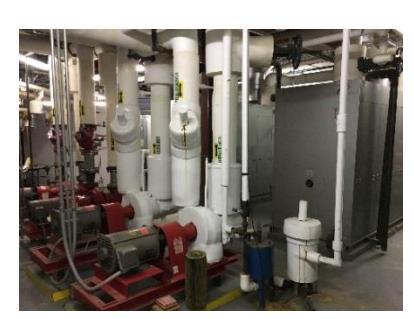
CHILLED WATER CIRCULATION PUMPS

Pumps P-1, P-2 alternate to provide to provide 760 GPM of chilled water to the cooling loop and are in good condition.

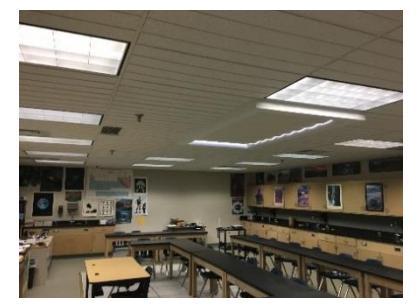
CLASSROOM

Classrooms. "Nesbitt" horizontal four-pipe unit ventilators, typically mounted concealed above classroom ceilings, with ducted supply air, outside air and return air. Units each have integral economizer function. Units are in good condition; however, replacement parts are hard to find.

Unit Ventilators	Horizontal ceiling mounted "Nesbitt" unit ventilators with ducted air distribution.	25 years	5 years	The unit ventilaors are approaching the end of their expected useful lives and should be replaced. Replacement parts are hard to procure.		\$250,000.00		
Hot Water Boilers	Gas fired hot water boilers are in good condition for their age.	25 years	5 years	maintain the boilers and they should continue to operate for several years.				\$5,000
Air cooled chiller	Split air cooled chiller with condenser mounted on the roof.	25 years	0 years	maintainance the chiller, keep tubes clean and ensure proper operation.				\$6,000
Temperature Controls	Existing distribution controls are pnuematic controls with the head end being DDC.	25 years	0 years	When project upgrades are done the controls system should be converted to an electronic DDC system.			\$750,000	
All systems	Existing mechanical systems in the building.	25 years	0 years	The existing mechanical systems are at the end of their service life and should be condiered for replacement.			\$ 4,900,000

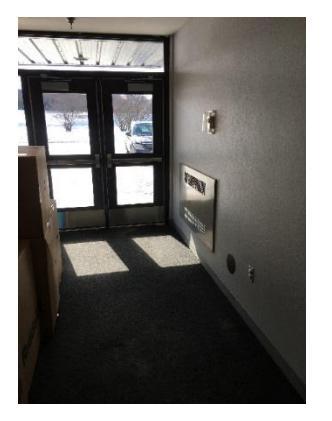
VESTIBULE HEATER

Corridors. Same as classrooms with supplemental hot water cabinet unit heaters in vestibules. All are in good condition.

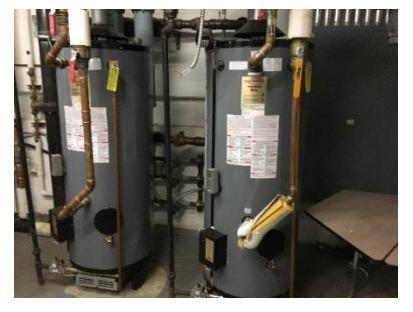
WATER HEATERS

Plumbing	Existing water heaters are aged and in good condition.	25 years	0 years	The water heaters should be considered for replacement due to their age.	\$12,000

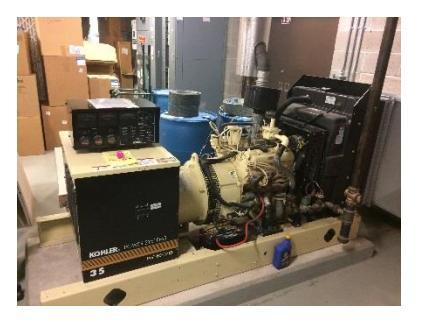
KOHLER DIESEL EMERGENCY GENERATOR

There is one emergency generator located in the main equipment room that provides back-up power to the facility. The generator is 250kW, 277/480 volt, 3 phase, diesel, was manufactured by Kohler and is original to the building construction. The generator is located in the upper level of the building in the boiler room and is ducted directly to the exterior for venting. The generator is tested weekly and serviced once a year and appears to be in great operating condition. The generator should continue to be maintained yearly and tested regularly to verify proper operation.

There is one automatic transfer switch located next to the generator that transfers loads to emergency power upon loss of normal service. The transfer switch appears to be in good condition and should be maintained and tested

regularly. Although the one transfer switch was acceptable at the time of installation, current codes require the facility to have two automatic transfer switches, one designated to serve life safety type loads and one to serve optional standby equipment. If the transfer switch is ever replaced, it should be replaced with two units to meet the current codes.

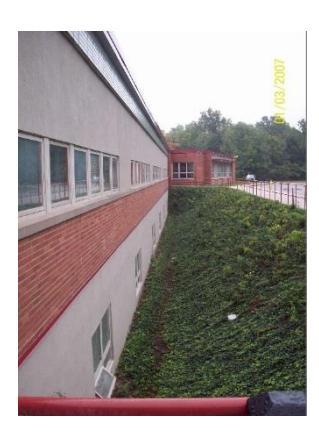
Areaway at 203 - 207

Storm Water and Drainage. There is an areaway at the front of the building that provides daylight to rooms 203 to 207. This appears to be well drained. There was no evidence of water infiltration in these rooms.

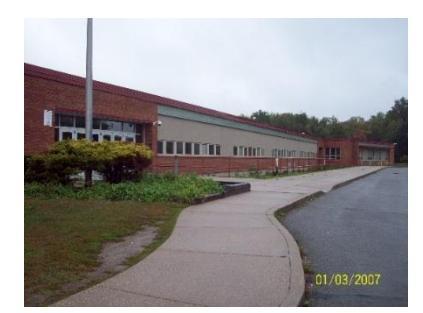
Main Building Elevation

The exterior is primarily standard orange face brick. There are areas of an aqua colored glazed brick. There are areas above the windows where there is EIFS. This is typical for buildings of this era where larger windows have been replaced. There are also EIFS areas where windows have been removed.

Generally, the EIFS system appears to be in good conditions. Yearly inspection and repair of failing sealant joints is recommended. Special attention should be taken where the EIFS meets grade.

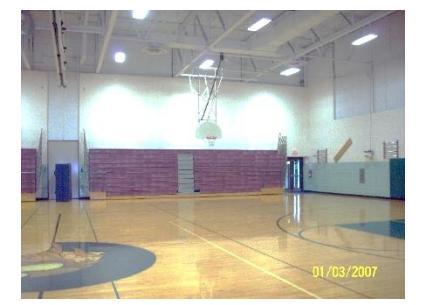
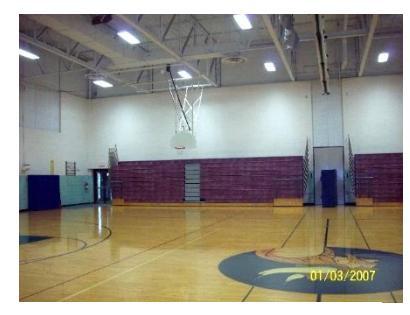
Gymnasium

Gymnasium. The gym is an adequate size for a facility of this size. It is located, due to layout and topography, somewhat away from the classrooms which separates the noise and disruption from the classroom areas. The gym seems adequately equipped; the main hoops are newer (assume the 1996 renovation) the side hoops appear older, there is a drop down curtain (replaced a full panel operable partition in a previous renovation), wall pads, and a matt hoist. The bleachers appear have been replaced in the 1996 renovation.

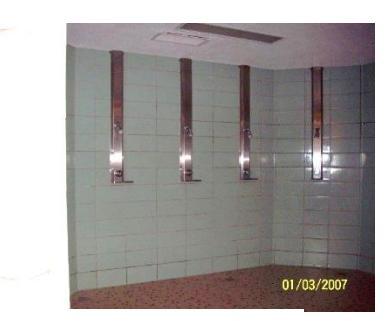
Gang Showers

The showers are a gang shower arrangement; typical middle school arrangements provide for more privacy.

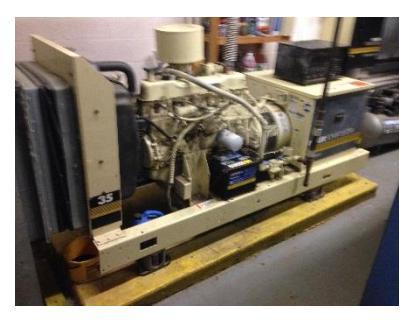
35KVA KOHLER EMERGENCY GENERATOR

There is one emergency generator located in the main equipment room that provides back-up power to the facility. The generator is 35kw, 277/480 volt, 3 phase, natural gas fired, was manufactured by Kohler was installed in 1996. The generator is located in the lower level of the building in the boiler room and is ducted directly to the exterior for venting. The generator is tested weekly and serviced once a year and appears to be in good operating condition. The generator should continue to be maintained yearly and tested regularly to verify proper operation.

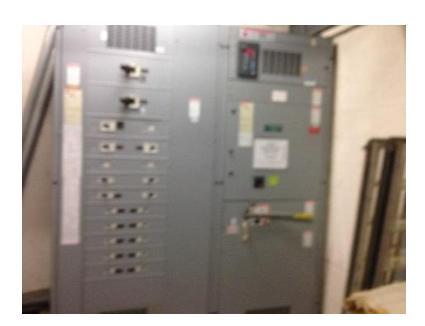
2000A WESTINGHOUSE MAIN SWITCHBOARD

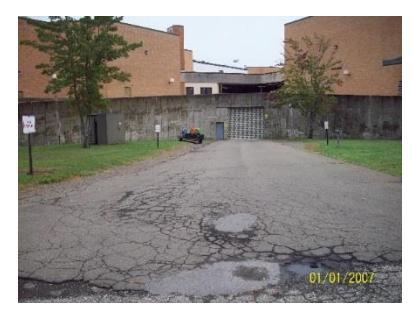
DAMAGED PAVING

The asphalt paving varies in condition. Some areas show enough deterioration to indicate subgrade failure. Monies should be budgeted for limited replacement.

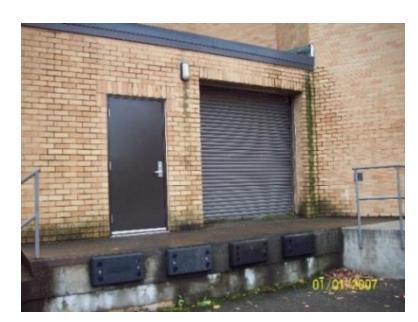
ROOF DRAINAGE ISSUES

The exterior is primarily brick and in good condition. There are areas of staining on the brick, some are simply cosmetic, but others indicate roof drainage issues that will eventually lead to water infiltration.

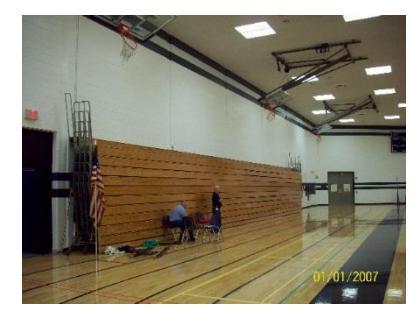
WOODEN BLEACHERS

The gym floor area is large and in good condition, but the bleachers are original and likely do not meet current code requirements for aisles. Side guards have been added to the bleachers. The floor is wood and likely original. It appears to have been recently refinished. At nearly 50 years old, the floor will likely not survive another sanding.

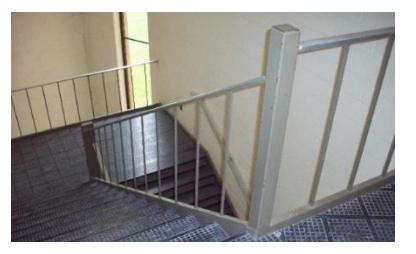
NON-COMPLIANT STAIR RAILING

Replace guardrails and handrails at stairs	The guardrails and the handrails in the stairs do not meet current building codes		Modify or replace the guardrails and handrails	\$100.00 LF
Improve Wayfinding	This large school has no variation of color to help establish awareness as to your location in the building		Add different color (paint) to areas of the building	\$1.00 SF
Roofing issues	The roofing is out of warranty and leaking issues.	1996	The district is considering having the roof sealed or a cap sheet to gain a 10 year warranty. The leaks will need to be investigated.	X

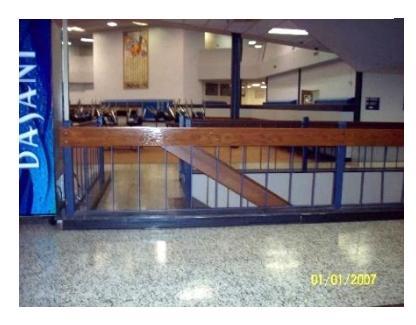
NON-COMPLIANT RAILING

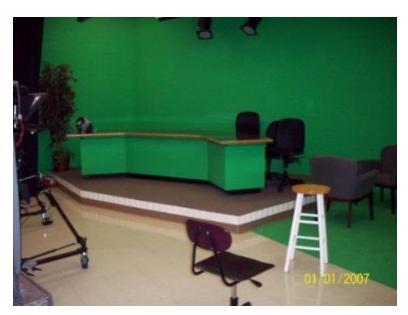
TV Studio. The TV studio in the lower level is a makeshift space used for the program. It is in a relatively isolated part of the building. It seems functional, but it is not in an appropriate space.

TV STUDIO

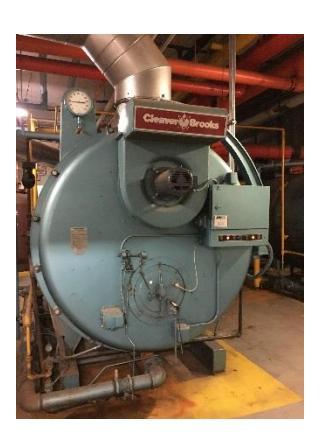
HEATING BOILER

The school is heated by 2 "Cleaver Brooks" packaged fire tube gas fired hot water boilers. The boilers are approximately 29 years old and appear to be in fair condition. These boilers are also used for domestic hot water heating but in the summer time there is one small boiler for domestic water heating. Replacement of the existing boilers is recommended due to age and efficiency.

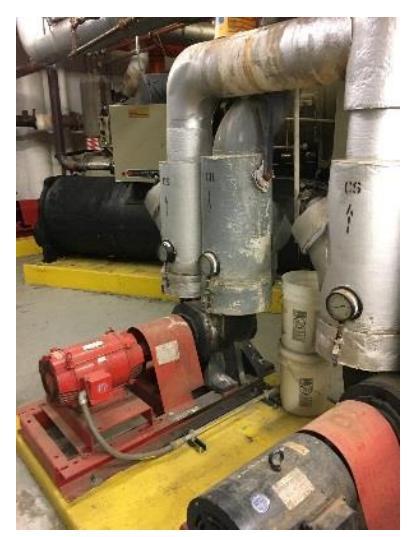
PUMPS

Chilled water is distributed through the building by two pumps that appear to be in fair condition. The piping is original to the building, no reported issues with this system.

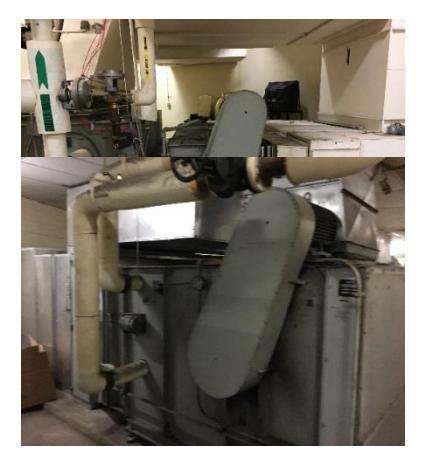
NATATORIUM AIR HANDLER

Natatorium. The Natatorium is served by central station air handling units located on the mechanical mezzanine alongside the pool. The air handlers and ductwork are approximately 30 years old and should be high on the priority list for being replaced. These return air grilles are in a position stationed over the top of the pool that makes them very difficult to clean and they are plugged with dirt which is causing the pool area to be under positive pressure. The pool should be under a slightly negative pressure to control humidity, condensation, and exfiltration of chloramines from pool water treatment. Tag air handler room has lay-in ceiling which is in poor condition from the moisture and humidity.

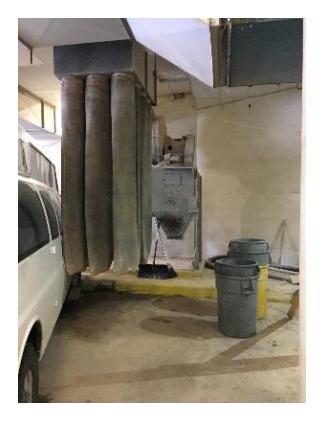
DUST COLLECTION SYSTEM

Wood Shop. The dust collection system appears to be in poor condition

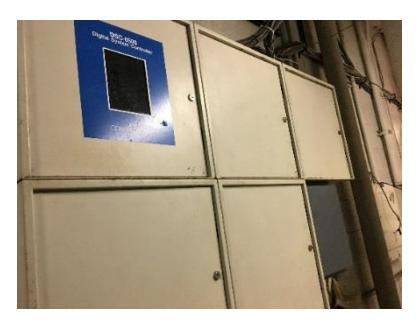
TEMPERATURE CONTROLS

The District standard control system is Johnson Controls/Metasys. The control system is pneumatic and is original to the building, installed in 1972. The head end of the control system is DDC so some of the central equipment can be monitored at the main computer system. The control system should be considered to be replaced with all DDC controls when the building systems undergo a renovation to new.

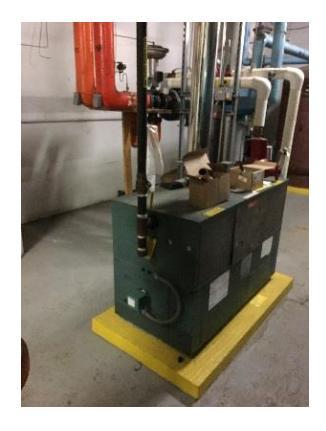
DOMESTIC WATER HEATER

Two domestic water heaters and storage tank for summer time hot water and in the winter-time the main heating boilers are used to generate domestic hot water for the facility. The water heaters are aged and should be considered for replacement. The pool water heater is in poor condition and should be replaced.

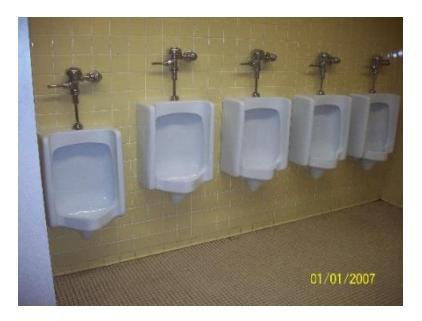
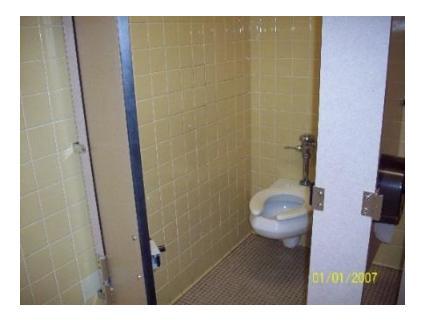
Wall mounted flush valve water closets and urinals appear to be in good condition. Wall hung sinks in the Gang toilets are vitreous china and appear to be in good condition.

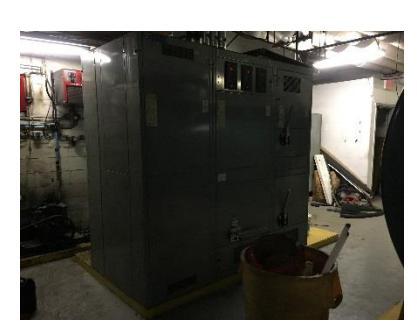
MAIN SERVICE SWITCHBOARD

The pad mounted transformer serves a 4000 amp, 277/480 volt switchboard located in a main equipment room on the lower level. The switchboard has three main switches. Two 800 amp switches that feed the chillers and a 2000 amp switch that feeds the building main service panel. The switches are fusible Pringle switches and the board was installed in 1989 when the facility was converted from on-site cogeneration to utility power. The switchboard was manufactured by Westinghouse and is in good condition. The load on the 2000 amp building switch was observed to be 815 amps which indicates the service has adequate capacity to serve the facility.

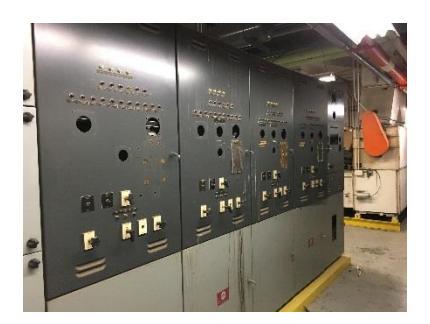
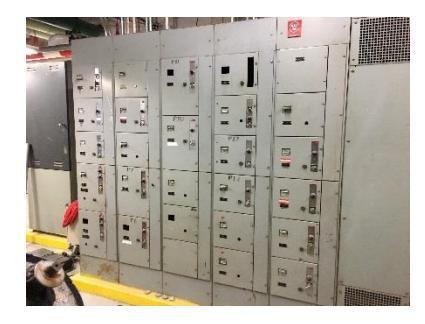
ORIGINAL SERVICE SWITCHBOARD WITH ABANDONED EQUIPMENT

The original building main service switchboard is located in the main equipment room and is still in operation as a distribution switchboard for service to the building power. The facility previously had on-site cogeneration generators that tied into the main switchboard via paralleling equipment and main generator switches that have been abandoned in place. The distribution section is still active for power distribution to distribution equipment within the facility. Recommendation should be considered to remove the original equipment that is abandoned or being used for distribution and replaced with a new 20004 switchboard for reliability, ease of maintenance and a clearer installation of the operation of the equipment.

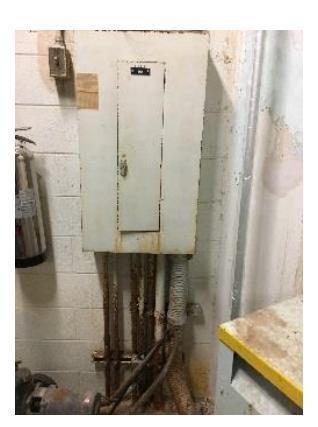
POOL EQUIPMENT ROOM PANELBOARD

Distribution and branch panelboard throughout the facility are mostly original to the building construction and are in fair to poor condition, lack capacity for any upgrades and replacement parts will become harder to obtain. The branch panelboard in the pool equipment room has deteriorated due to environmental conditions in the space.

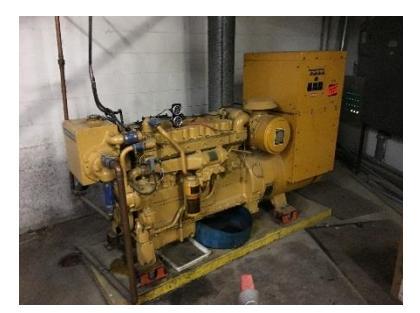
CATERPILLAR DIESEL EMERGENCY GENERATOR

There is one emergency generator located in a basement equipment room that provides back-up power to the facility. The generator is 125kw, 277/480 volt, 3 phase, diesel, was manufactured by Caterpillar and was installed in 1984 when cogeneration was eliminated. A diesel fuel tank is located next to the generator with a pump to fill a daytank that supplies fuel to the engine. The generator is tested weekly and serviced once a year and appears to be in fair operating condition. The generator should continue to be maintained yearly and tested regularly to verify proper operation.

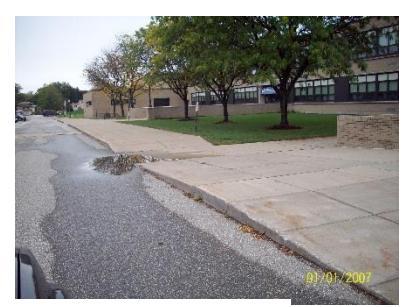
WATER PONDING

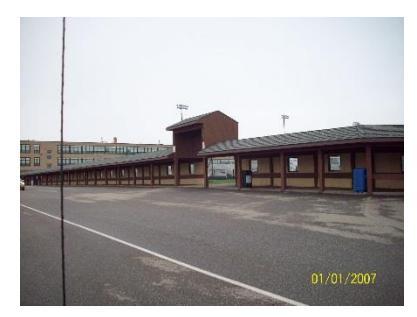
OPEN, UNSECURE CONNECTOR

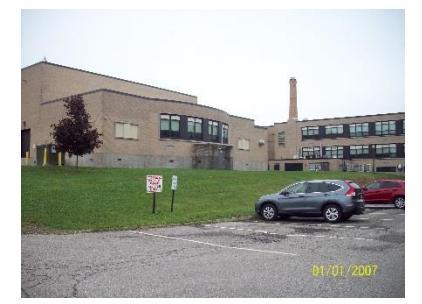
STAINING ON BRICK AT ONE STORY

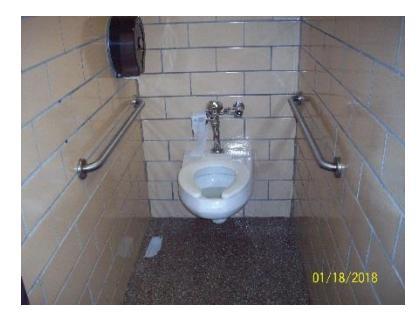
TOILET STALL – NON ADA ACCESSUIBLE

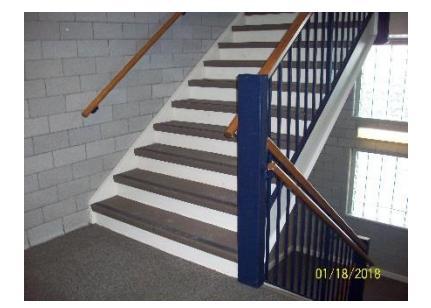
NON-CONTINOUS HANDRAIL

Stairs. Stairs are in good condition except there are ADA issues with the handrails. The handrails need to be continuous and have the proper clearances.

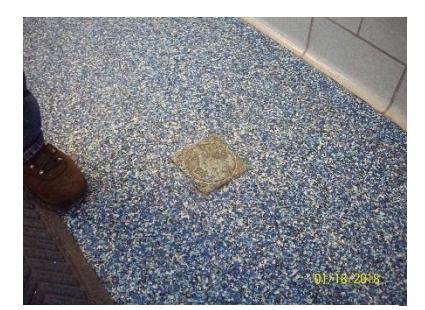
RAISED DRAIN COVER – LOWER LEVEL – TRIP HAZARD

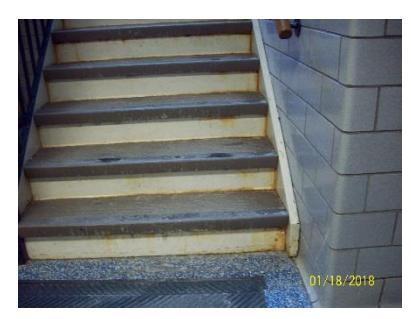
RUSTING STAIRS – NEAR CONNECTOR ENTRY

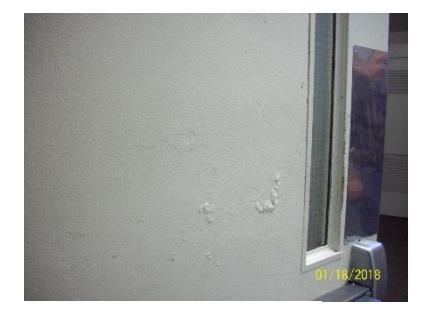
INTERIOR DOOR WITH PAINTED DEBRIS

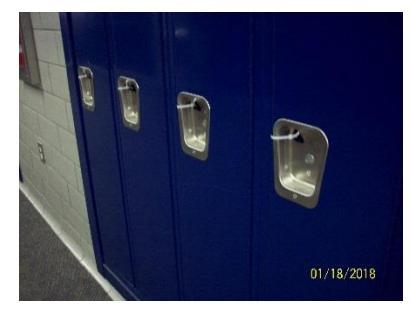
MANY BANKS OF LOCKERS ARE CORDONED OFF

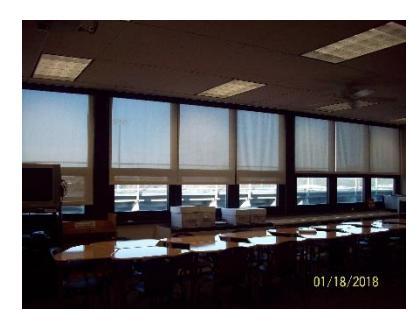
ROLLER SHADES THAT ALLOW IN TOO MUCH LIGHT

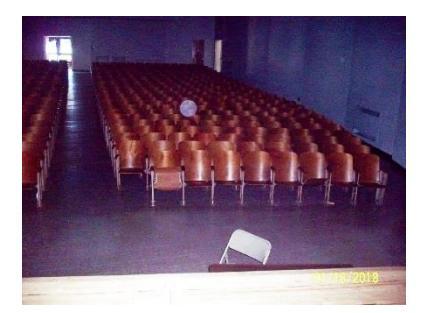
ORIGINAL SEATING IN THE SELDOM USED AUDITORIUM

Auditorium. The auditorium is served by four air handlers. The units heat and ventilate only. The space does not get used regularly because of a musty smell and uncomfortable conditions.

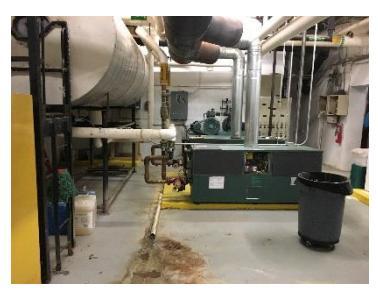
DOMESTIC WATER HEATERS AND STORAGE TANK

The domestic hot water plant consists of a large storage tank and two hot water boilers. The boilers are standardefficiency, gas-fired, atmospheric type and are in good condition. Much of the piping system was replaced in 1988. The piping is predominantly copper.

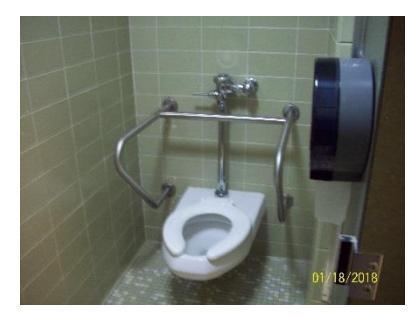
NON-ADA TOILET STALL

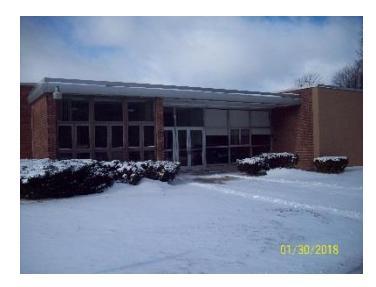
UNUSED MAIN ENTRANCE

Vestibule/Lobby. The existing vestibule and lobby on the East side of the building is not currently being used. The finishes are in very good condition. However, the entrance doors and adjacent window system are the original aluminum frames with single pane windows.

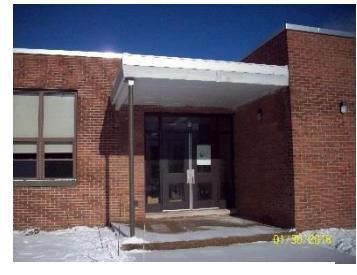
SOUTH EXIT – NON ADA

Corridors. The corridors are carpeted with a glazed tile or ceramic tile wainscot, painted walls and 2 x 4 lay-in ceiling. The finishes are in good condition with some small areas of ceiling water damage. The south entrance, southwest entrance and northwest entrance do not have ADA accessible entrances.

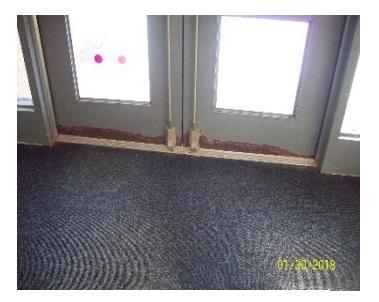
The brick aluminum windows and metal siding are in good condition. There is a mixture of aluminum exterior doors and painted steel exterior doors. The painted steel doors have extensive surface rust.

RUSTED ENTRY DOORS

- Replace damaged doors
- Replace casework
- Replace chalkboards with whiteboards
- Security entrance
- New Ceilings to replace areas of existing

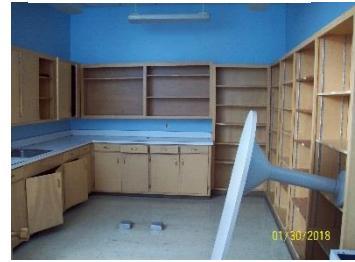
Library. The existing library on the Northeast corner of the building was previously repurposed. It was divided up into smaller rooms. It is currently unused. The finishes are in good condition. There is some wooden shelving in the library and adjoining work room that is in good condition.

LIBRARY SHELVING

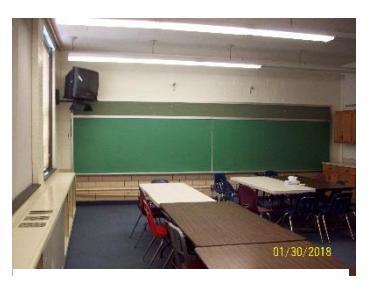
EXISTING CLASSROOM

The classroom finishes were in fair condition. There are some rooms with carpet and others with V.C.T. It appeared that many rooms have the original 1' x 2' ceiling tile. The casework is old, and the rooms have chalkboards.

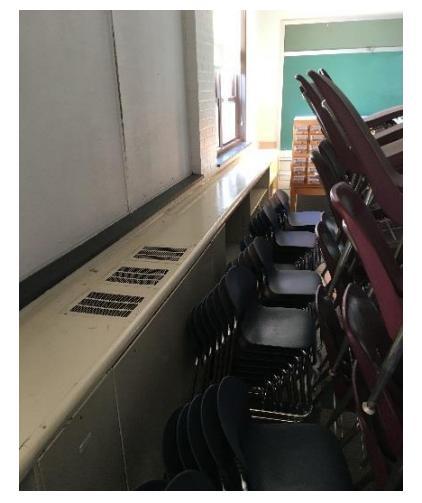
UNIT VENTILATOR

Classrooms, Gym/ Cafe. Unit ventilators provide heating and ventilation to the classrooms and the gym/ cafe. The units appear to be original to the building and are in poor condition.

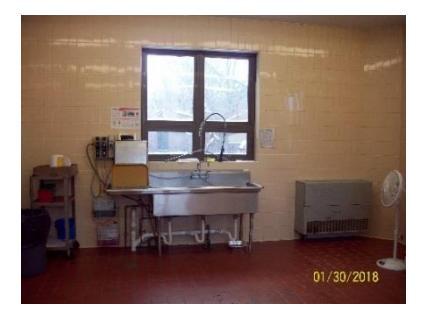
KITCHEN HEATER

Admin area, Kitchen, Faculty rooms, Corridors. Heated with cabinet unit heaters. The units appear to be original to the building and are in poor condition. A window AC unit is present in the admin area for use as-needed.

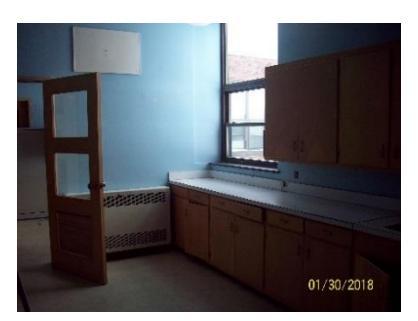
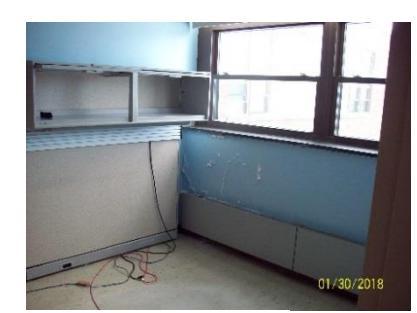
LIBRARY

Library. Heated with cabinet unit heaters and fin-tube. The units appear to be original to the building and are in poor condition.

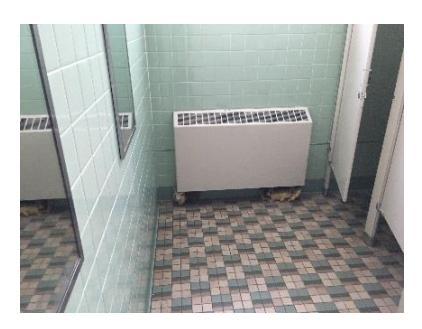
TOILET ROOM HEATER

Toilet rooms. Heated with cabinet unit heaters. The units appear to be original to the building and are in poor condition. Toilet exhaust fan for the Boy's room is not functioning and requires repair or replacement immediately.

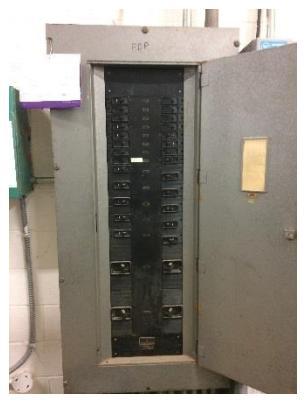
ORIGINAL LEONARD ELECTRIC SERVICE PANEL

Next to the main switchboard is the original main service panel that was installed in 1956 when the building was constructed. The panel was manufactured by Leonard Electric which is no longer in business. Five branch circuit panels were observed throughout the facility that were original to the building construction and also manufactured by Leonard Electric. These panels are in poor condition and maintenance is difficult and costly. Consideration should be given to replacing the panels.

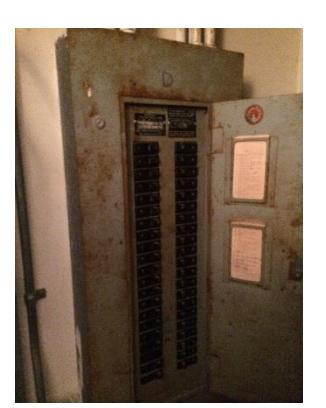
ORIGINAL LEONARD ELECTRIC BRANCH PANEL

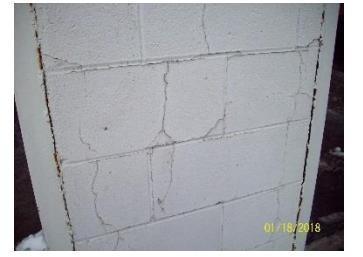
CRACKED CMU AT GARAGE PEIRS

is to install rebar in the cores and fill them to create ductility. In the absence of rebar, it is common to see the type of cracking that is evidenced at Millcreek.

We understand that the structure has adequately performed its function since 1969, however it is prudent to begin evaluations to provide a code compliant structure.

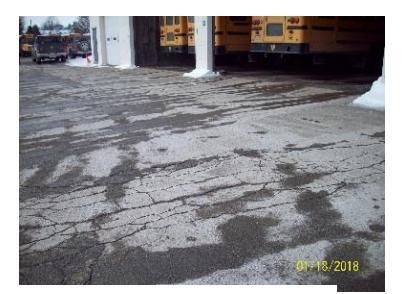
Paving. The asphalt paving in front of the door openings is cracked and failing.

CRACKED PAVING AT GARAGE DOORS

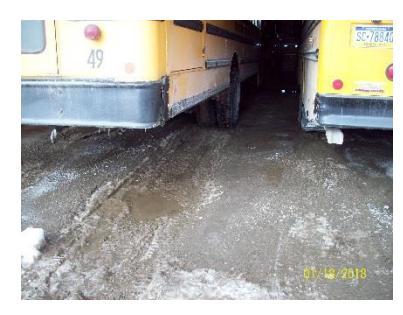
UNPAVED GARAGE FLOOR

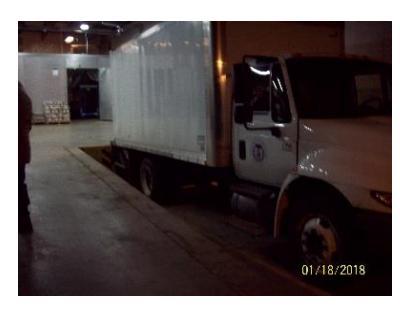
FOOD WAREHOUSE – GUARDRAIL NEEDED AROUND TRUCK RAMP

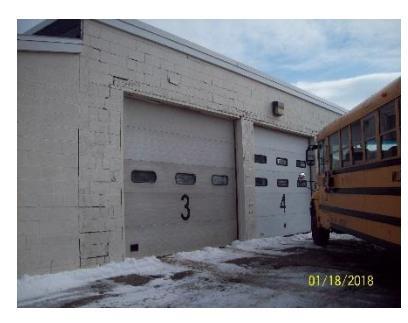
WEST WALL - UNDERSIZED GARAGE DOORS AND CRACKED MASONRY

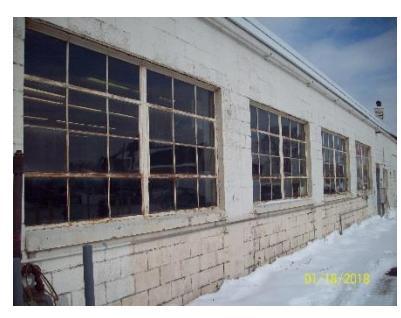
SINGLE PANE WINDOWS WITH RUSTING FRAMES

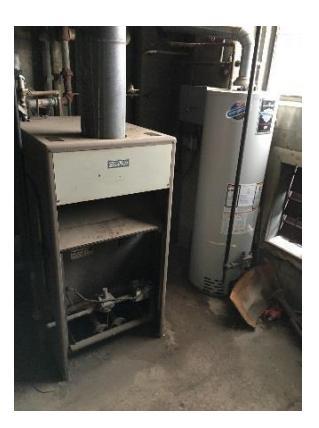
BOILER AND WATER HEATER

There is a gas fired hot water boiler that serves the offices in the service garage, this boiler is in the process of being replaced.

Gas fired water heater in the mechanical room provides hot water for the facility. This unit appears to be in fair condition.
