Existing Conditions Assessment -

Executive Summary

February 23, 2018

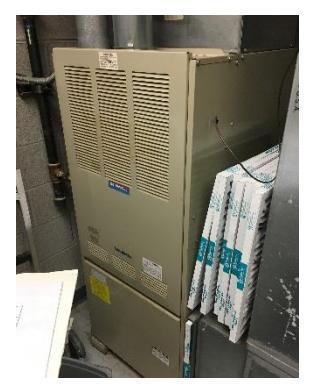
GAS FIRED FURNACE

Heating and cooling of the offices	Residential syle gas furnace with cooling capability and no outside air connection for ventilation		Replace the furnace with a commercial unit with outside air capability when renovations take place.		\$15,000

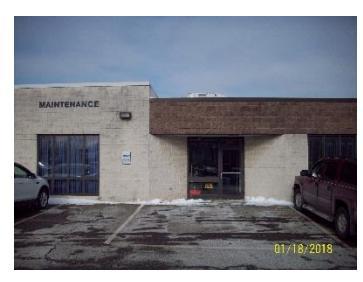
MAIN ENTRY – STAINING EVIDENT ON BLOCK

The splitface CMU metal trim and aluminum windows are in good condition. There is some surface dirt and/or staining on the splitface block that maybe able to be removed. There is also some rusting occurring on the door and sidelights and the garage doors.

- Clean the exterior
- Paint and repair entry doors
- Replace interior handrail
- Add railing at loading dock steps

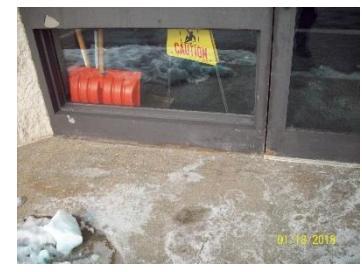
RUSTED ENTRY DOOR AND FRAME

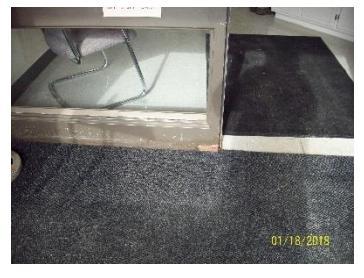
RUSTED INTERIOR ENTRY DOOR AND FRAME

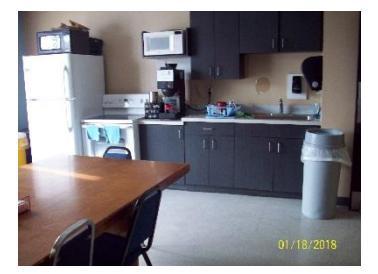
NON-ACCESSIBLE KITCHENETTE

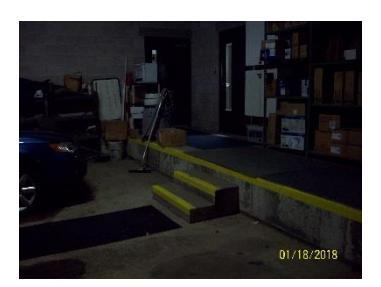
HANDRAIL NEEDED AT LOADING DOCK STEPS

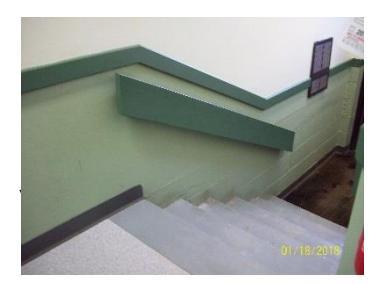
The finishes are in good condition. There is an ADA accessible toilet and shower. The interior stair railing is not ADA.

HANDRAIL DOES NOT MEET ADA REQUIREMENTS

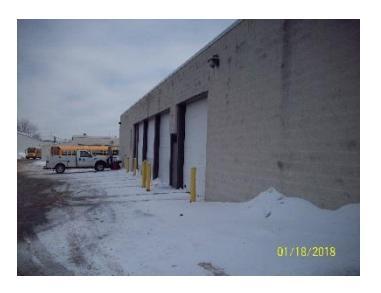
STAINING ON BLOCK

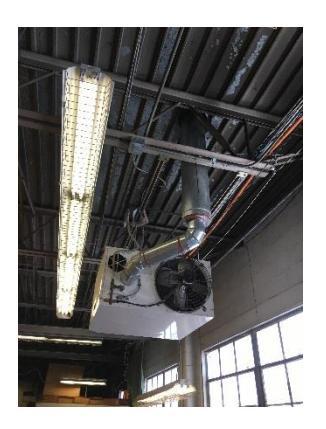
TRUCK BAY HEATER

The truck bays are heated by gas fired horizontal unit heaters which appear to be in fair condition.

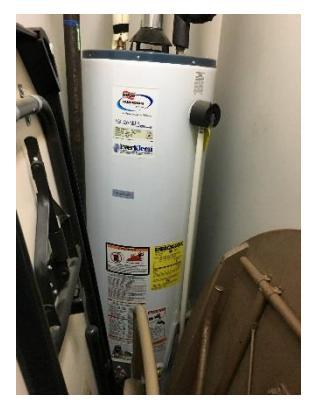
GAS FIRED WATER HEATER

The building water is heated by a RUUD gas fired water heater, this heater appears to be in good condition.

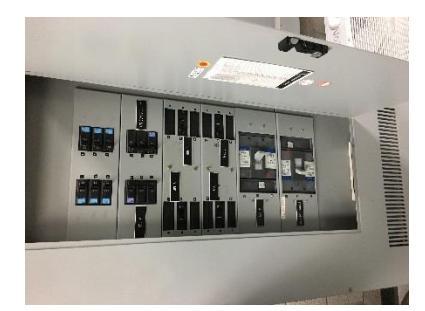
GE MAIN SERVICE PANEL

The feeder serves a 600 amp, 120/208 volt main panel located in an electrical closet. The panel was manufactured by GE, is in good condition, and appears to have adequate capacity to serve the building loads. There are five branch panelboards, all manufactured by GE, in good condition, which provide power to branch circuits needed in the building.

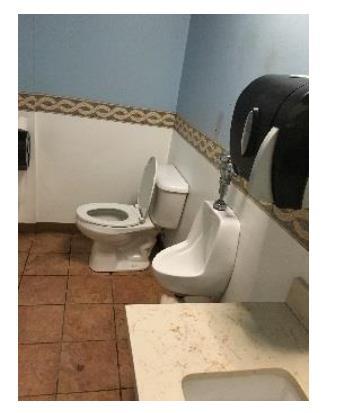
NON-ADA TOILET

- New siding and front entry.
- ADA upgrades.
- Replace the building

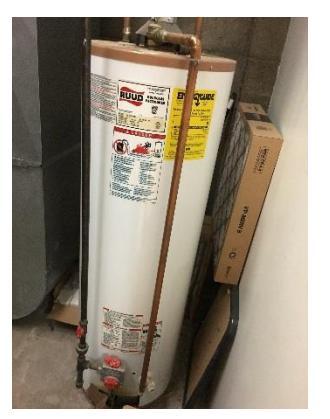
Gas fired "RUUD" water heater that appears to be in good condition.

GAS FIRED WATER HEATER
