SUFFIELD FACILITIES MASTER PLAN

PBC UPDATE PRESENTATION

SUFFIELD, CT

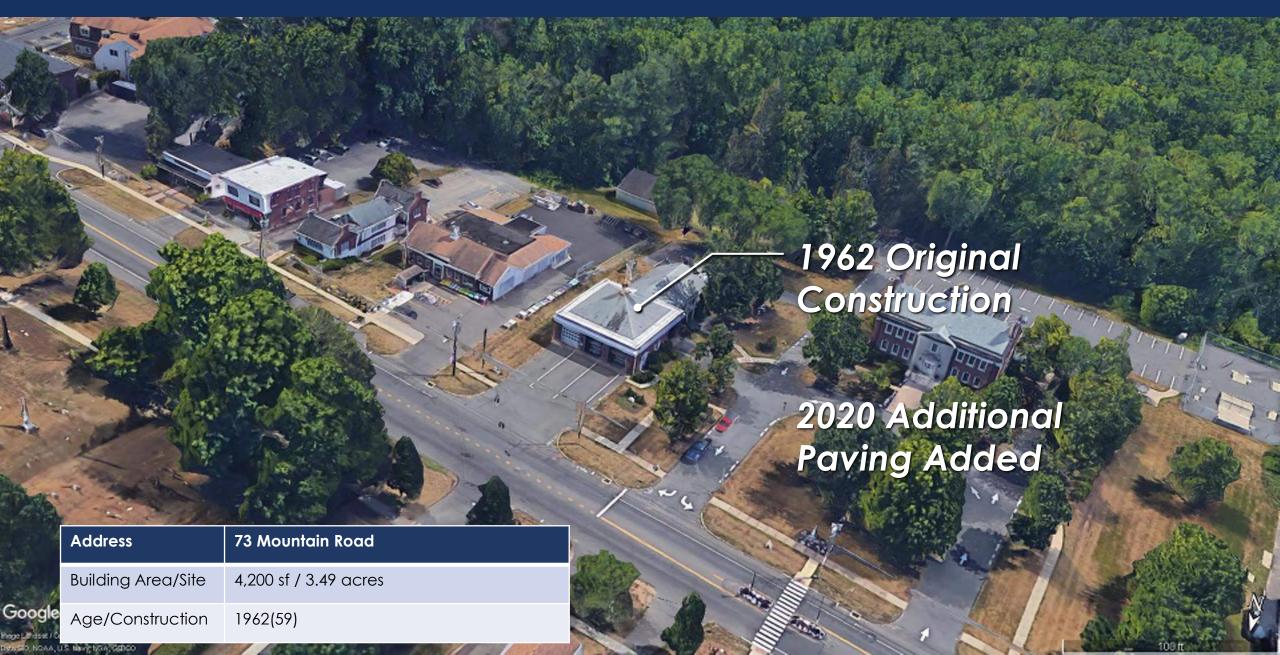
- 1. Recent expansion to paved site area
- 2. Differential settlement and cracking in existing concrete sidewalks
- 3. Apparatus Bay apron is in good condition

- 1. Masonry restoration required at chimney
- 2. Minor rot repair and repainting at wood trim work, railings, and louvers
- 3. Minor downspout repairs/replacement of downspout clips

- 1. All MEP Systems are old and past their useful life.
- 2. Needs full replacement of all systems

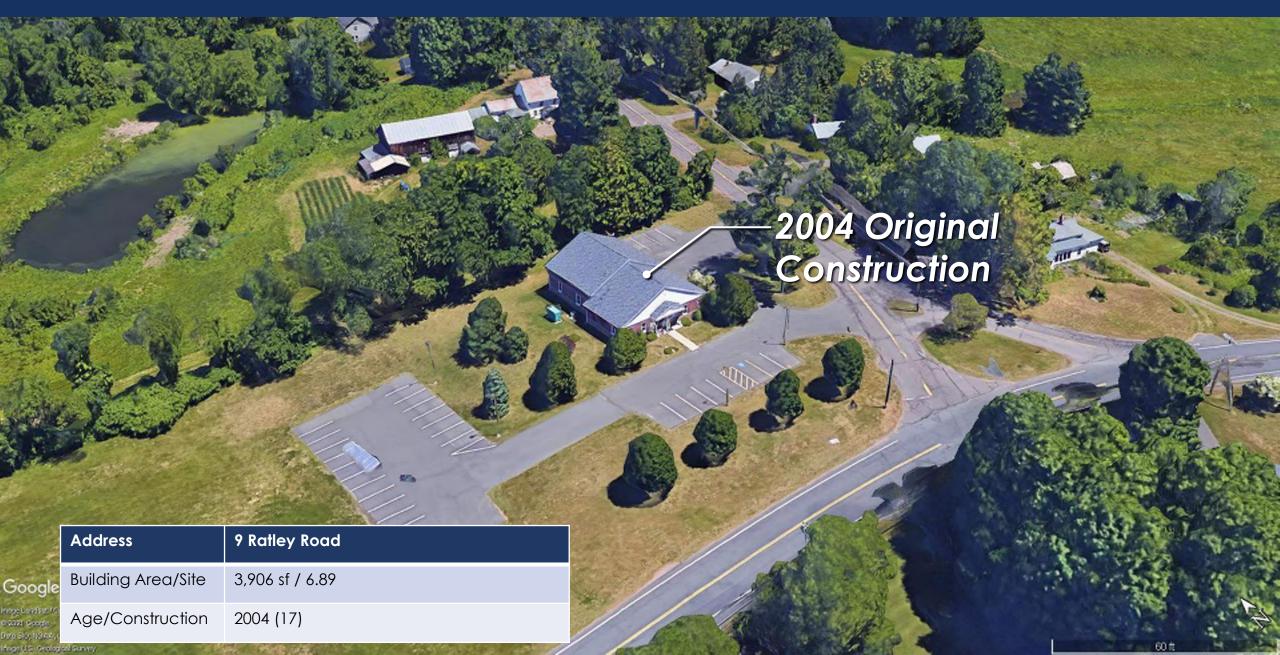
- 1. Newer station, well built, good apparatus space, in relatively good condition
- 2. Some ponding at transition between sidewalk and drive
- 3. Minor rusting at bottom of bollards

- Ice dams present at time of walkthrough, persistent issue for some time. May cause damage elsewhere if not properly addressed.
- 2. Exterior materials are in good condition.

- 1. Signs of moisture infiltration, possibly from ice dam
- 2. Ceiling tiles sagging throughout, possibly due to humidity issue
- 3. Currently used for department training

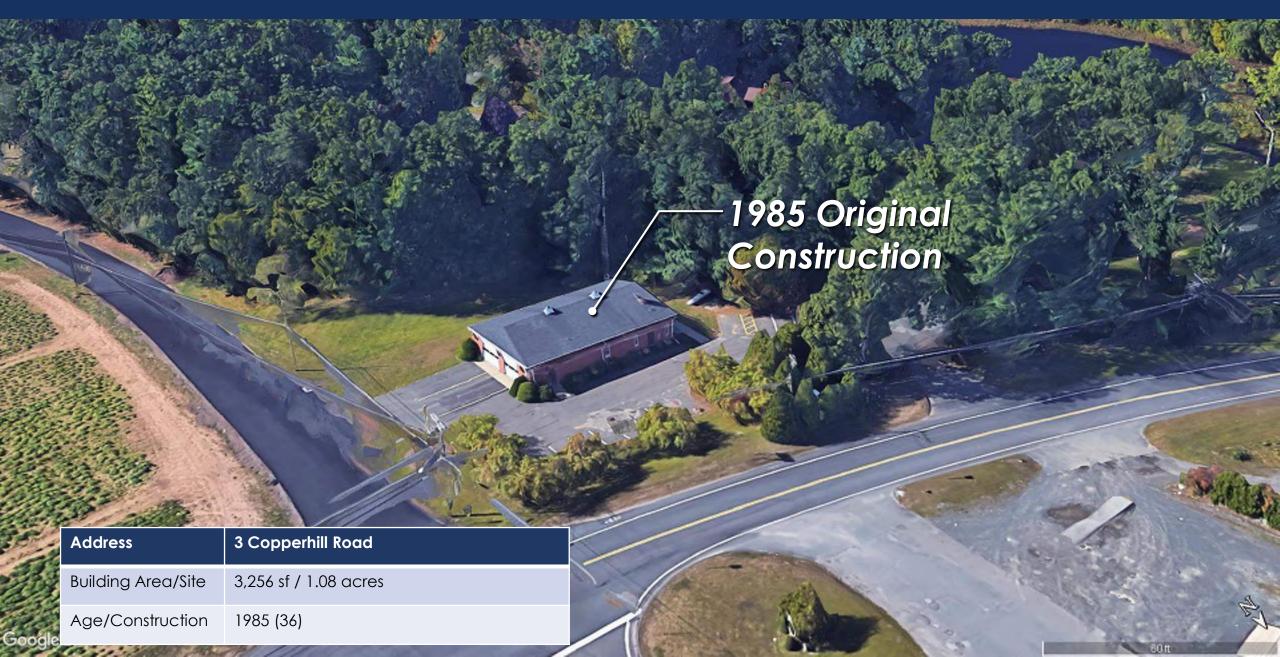
- 1. Poor site drainage causing hazardous conditions with ice, grading revisions
- 2. Minor cracking at apparatus bay apron
- 3. Anecdotal reference to storm water infiltrating tight tank

- 1. Older building but in relatively good condition for its age
- 2. Some signs of ice damming present
- 3. Minor staining on brick from water shed
- 4. Recommend preventative maintenance to extend useful life (caulking, sealants, etc.)

- Suspected mold on apparatus bay ceiling, possible condensation buildup
- 2. Possible accumulation of exhaust from vehicles settling on radiant heater resulting in wall staining, lack of hot/cold transition zone

- 1. Step at transition between apparatus bay and other program areas
- 2. Lack of pipe insulation below lavatory
- 3. Non-compliant grab bar at toilet
- 4. Non-accessible shower
- 5. Non-accessible sink at kitchenette

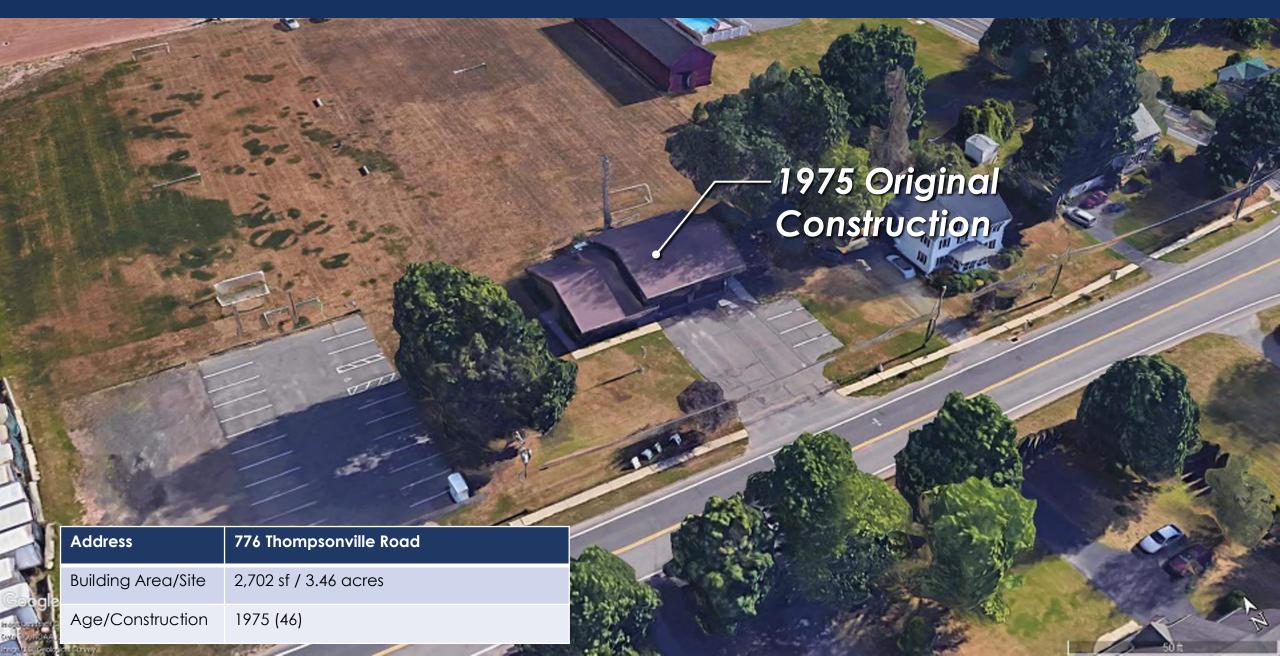
- 1. Minor cracking in asphalt
- 2. Lack of tie-in or splash block at downspout causing soil erosion

- 1. In good condition relative to its age.
- 2. Minor cracking at foundation/sidewalk
- 3. Improper fit of window air conditioning unit and staining of adjacent brick wall.

- 1. Finishes in fair condition considering age of building
- 2. Angle beginning to rust at apparatus bay doors

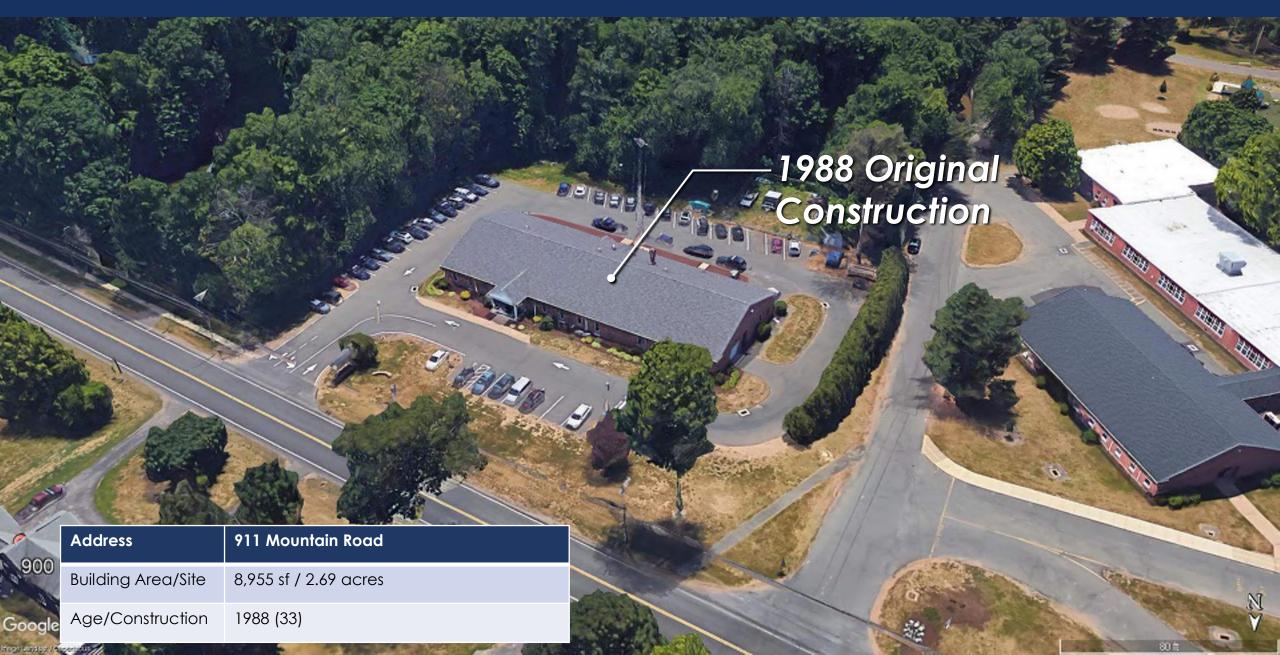
- 1. Minor cracking at sidewalk control joints
- 2. Rust present at downspout boots
- 3. New paving and fence
- Recommend preventative maintenance program to extend useful life.

- 1. In good condition relative to its age well maintained and built.
- 2. Minor snow build up and possible damming at roof valleys
- 3. Exterior materials have been well maintained
- 4. Snow melt on roof uneven due to super heating of garage spaces

- 1. Drywall cracking present at window lintels
- 2. Discoloration of ceiling tiles due to age.
- 3. Relatively minor cracking at multiple interior CMU walls, non structural issue.

- 1. Non-accessible sink at kitchenette
- 2. Non-accessible toilet facilities throughout
- 3. Step down into showers
- 4. Step down into Sally Port

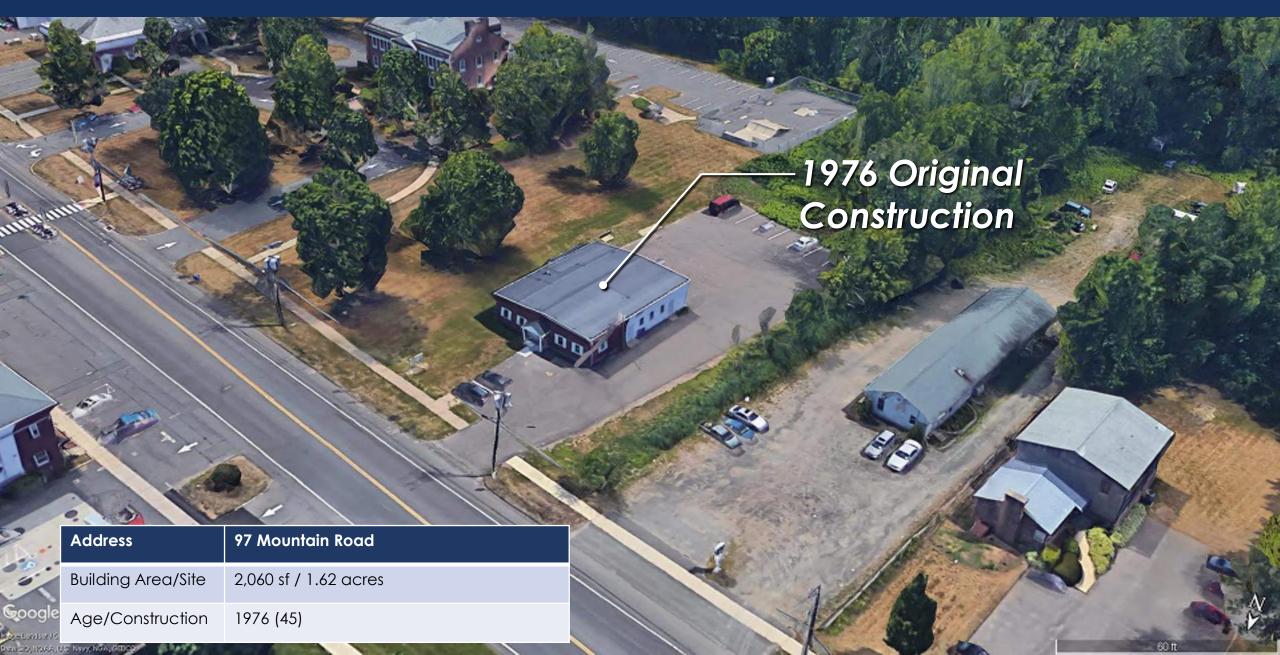
- 1. Pavement cracking throughout parking lot
- 2. Cracking and deterioration at garage door aprons
- 3. Storm water ponding at exterior wall

- 1. Appears to be pre-engineered structure with conventional wall framing
- 2. General cleaning of exterior masonry and foundation walls needed
- 3. Missing trim at joint between brick and siding
- 4. Corrosion of exterior hollow metal door
- Damage to corner trim, trim between garage doors, and siding near grade
- 6. Re-caulk windows and clean up excess sealant

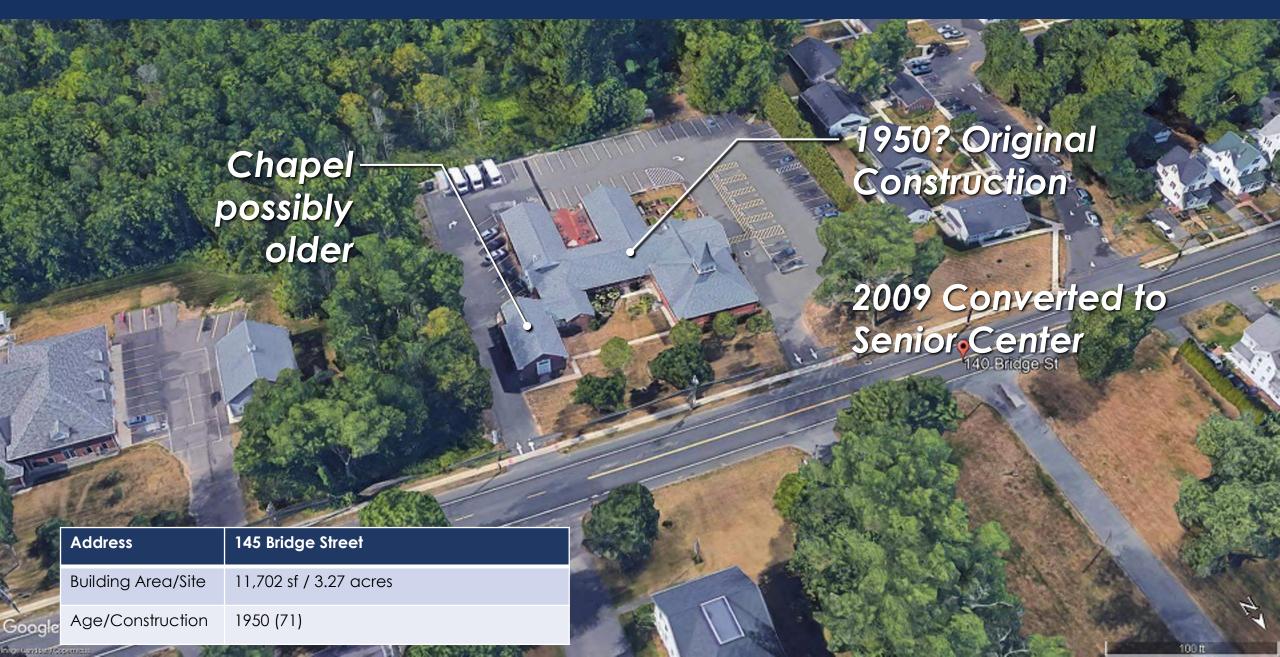
- 1. Cracking in pavement throughout
- 2. Uneven brick patio in courtyard

- 1. Recent renovations (2009) in good condition.
- 2. Lack of gutters at large hip roof and main entrance
- 3. Brick staining at windows
- Exterior wood windows may need replacement within 5-10 years
- 5. General brick cleaning needed
- 6. Lack of gutter causing ice building up at exterior wall

- 1. Hollow metal doors rubbing on frames, causing paint damage
- 2. Movement of VCT flooring near exterior door threshold causing separation
- 3. Lack of weatherstripping at chapel exterior door causing air infiltration

- 1. Youth Services and Parks & Rec do not have accessible entrances from exterior
- 2. Non-accessible sink at Youth Services
- 3. Damaged VCT at Youth Services

- 1. No Automatic Sprinkler System.
- 2. Renovated recently.
- 3. Most MEP in good condition.
- 4. Will start to need more maintenance in the next 5 10 years.
- 5. Perimeter radiant heating units leaking, causing damage to flooring

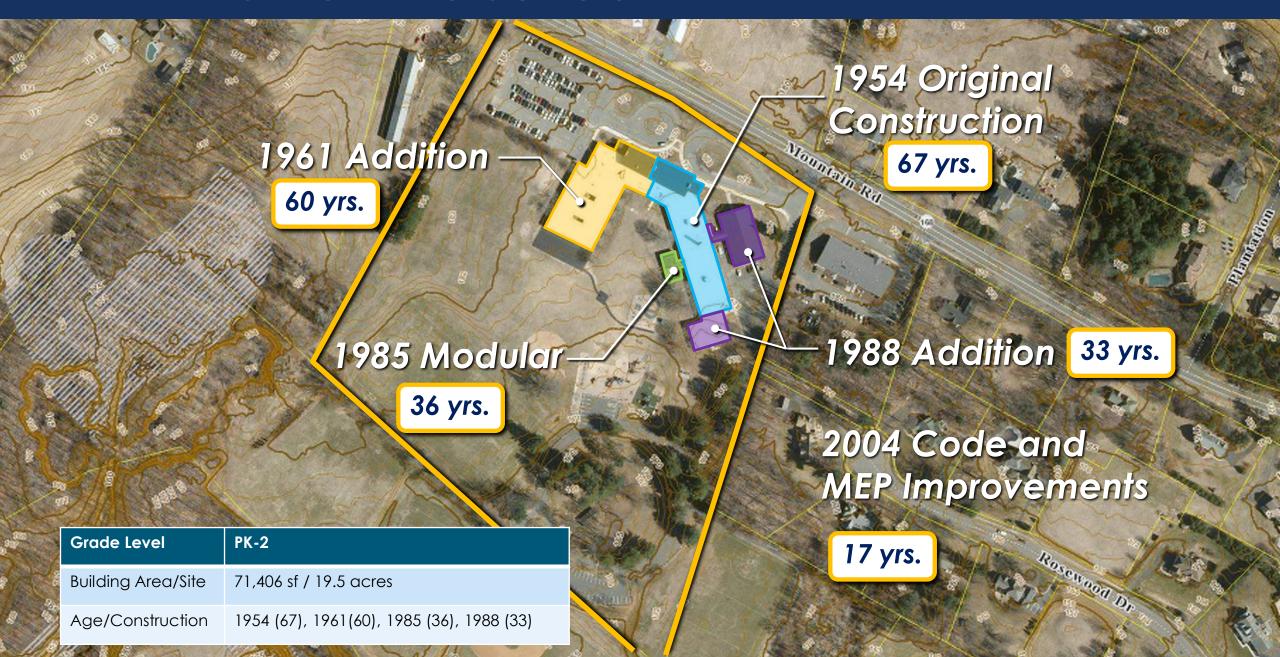
Site ~ Insufficient parking for events, parking immediately adjacent to building a safety concern, over 50% of paved areas and sidewalk in need of replacement, poor definition of school boundary, remote/unprotected playground and playscapes

Architectural Exterior ~ Masonry in need of repointing/repair, efflorescence on portions of building, windows approach 20 years, modular addition in poor condition

Architectural Interior ~ Overall well built, some replacement of finishes, ACM removal program, majority of finishes past useful life (millwork, floors, doors, ceilings)

Code/Accessibility/Life Safety ~ Several accessibility compliance issues, floor clearances/reach at entranceways, sinks, and millwork, lift at stage.

Building Systems ~ No automatic sprinkler system within building, majority of plumbing systems and fixtures are past their useful life, unit vents not functioning (fresh air), no BMS, electrical lighting and power distribution end/ past useful life.

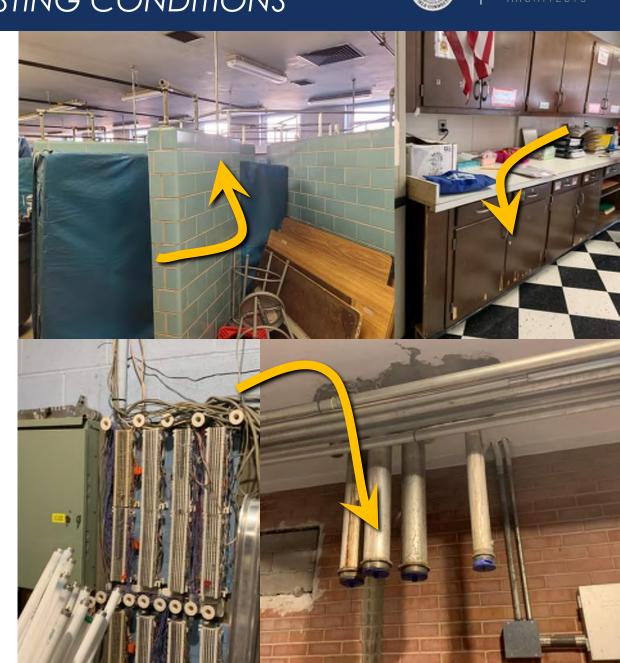
Site ~ Site conditions are in fair to poor condition for; sidewalks, curbs, paving, drainage issues, site traffic flow, parking, security major concerns. Areas of poor drainage on west/southwest side of site.

Architectural Exterior ~ Consistent roof leaks, roof replaced in phases by different contractors, majority of brick in fair to good condition, lintels are in fair to poor condition.

Code/Accessibility/Life Safety ~ 2002 upgrades addressed some code issues, accessibility compliance issues remain, floor & push/pull clearances & reach req.

Building Systems ~ Many renovations and varying vintages of systems makes for complex infrastructure, difficult to maintain, inefficient system, most major mechanical systems past or at the end of their useful life.

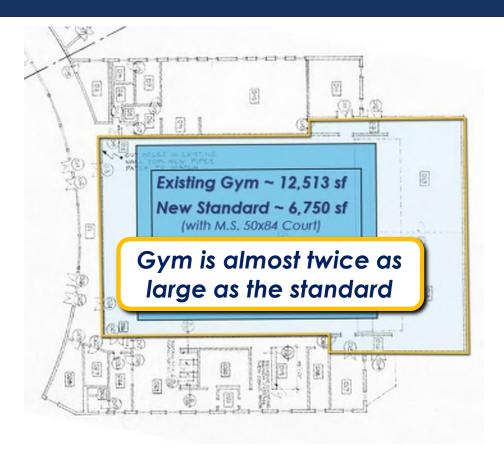
- Oversized Gym for a Middle School
- Former High School Lockers difficult to adapt and reuse for educational purposes

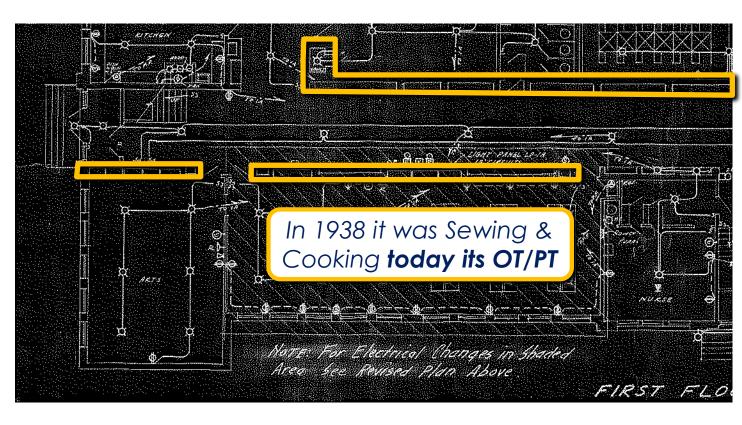
McAlister Intermediate School

- Multiple adaptations have led to variances in room size for current programs (both large and small) and inappropriate space for specialized education.
- Walls are thicker with obsolete built-ins rendering portions of the building "unusable"
