MINUTEMAN HIGH SCHOOL STRUCTURAL EVALUATION - 2012 UPDATE

758 MARRETT ROAD
LEXINGTON, MASSACHUSETTS 02421

July 30, 2012

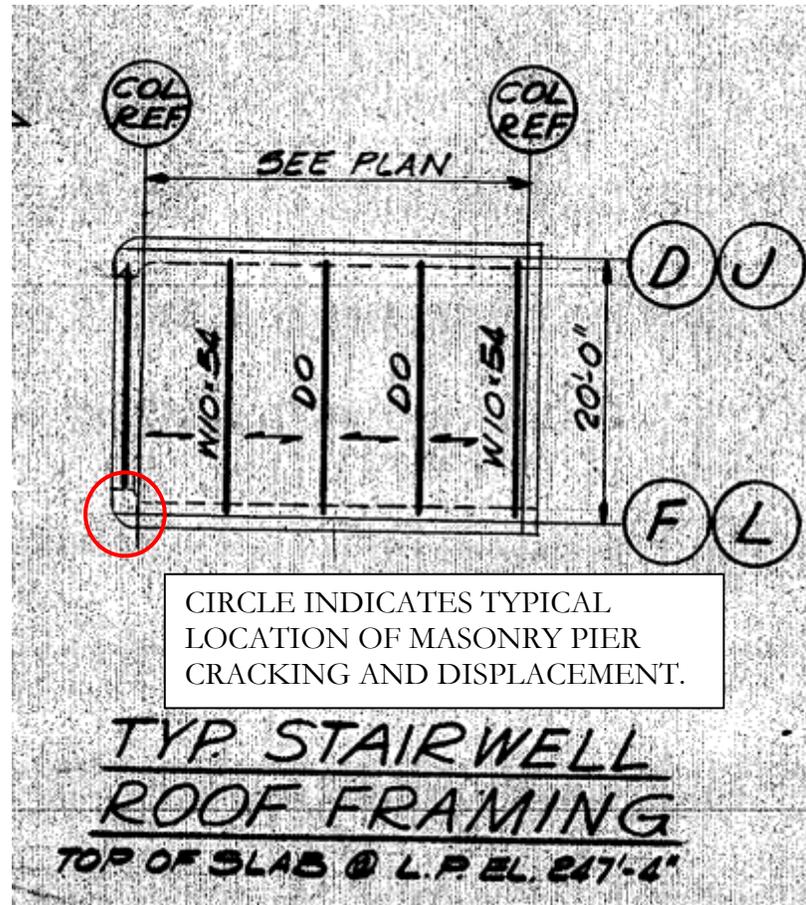
Photo #16

This photo shows a copy of the typical stairwell roof framing of the stair towers at the east and west ends of the school building.
