**LOWER LEVEL PLAN**  
**13001.00**  
**Minuteman Career and Technical High School**  
**Space Use Planning**

***Evaluation of Existing Conditions***

The following existing conditions reports for Minuteman Regional Vocational Technical School (MMRVTS) provides a detailed analysis of systems related to: Code Compliance (Building and Accessibility), Landscape, Architecture, Food Service, Structural (Building and Seismic), Plumbing, Fire Protection, Mechanical, Electrical, and Technology, Site Environmental, and Hazardous Materials. The purpose of this portion of the study is to evaluate and identify deficiencies of the existing facility as a repair only benchmark for evaluation of other alternatives for renovations, additions, or new construction.

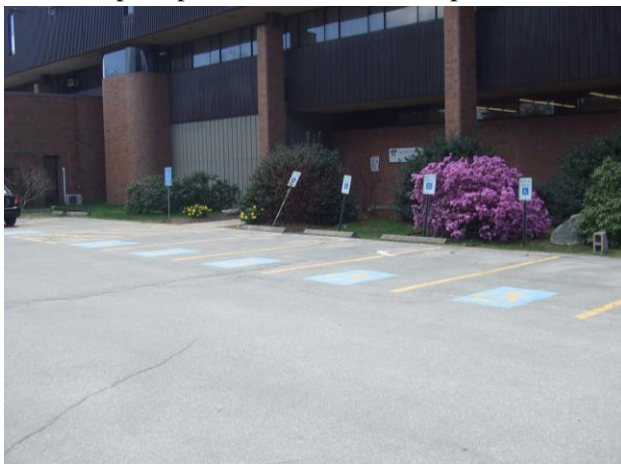
*HC parking northwest side of building*

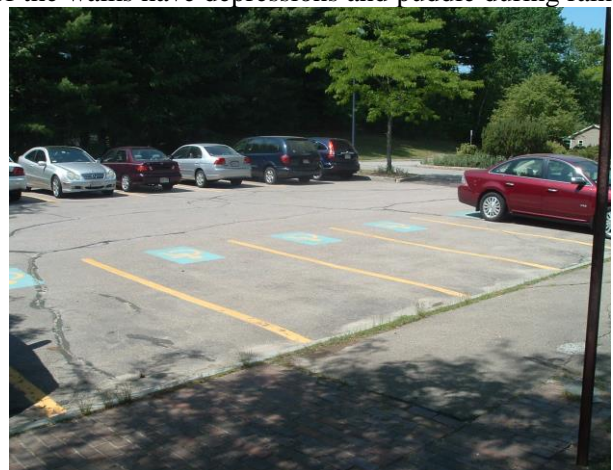
*HC parking, Main Entrance*

events or have settled at back of the curb creating tripping hazards. At the main entrance, stripes of stairs are uneven. A single ramp provides access to the main entrance. There is a brick plaza outside the pool portion of the school with seating and drainage. New picnic tables, benches and trash cans have been placed in this plaza. Drainage basins in this plaza are completely filled with sediment. Due to the sites being mostly level, there are few slope issues that would impede ADA access though it is directly due to poor drainage that has caused much of the heaving and settling of pavements. Most of the door sills for the building are accessible. Curb cuts from street to sidewalk that would allow ADA access from the school to the athletic field are lacking along those existing sidewalk paths that are separated by curbs from the adjacent roadways. Accessible paths and viewing areas are lacking to all of the athletic fields, tennis courts and a track viewing area. Some improvements to the number of ADA provided parking spaces have been completed, but most are non-compliant, since many lack striped loading areas or even access to adjacent sidewalks. The ADA parking spaces for the football field are parallel parking spaces that have no adjacent sidewalk or any loading areas. A major portion of the pedestrian site work would be dedicated to insuring access to the entire site.

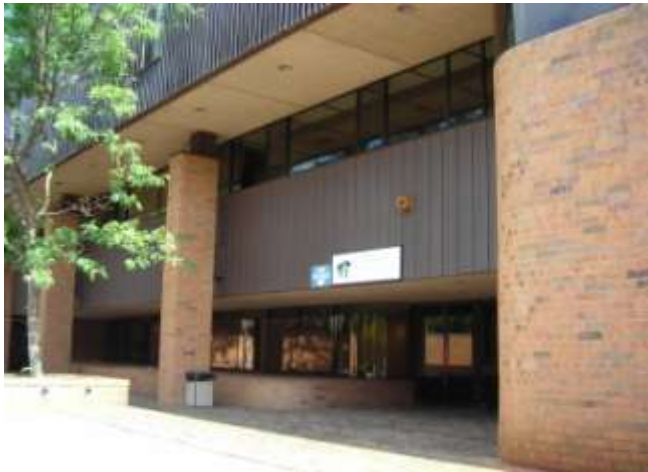
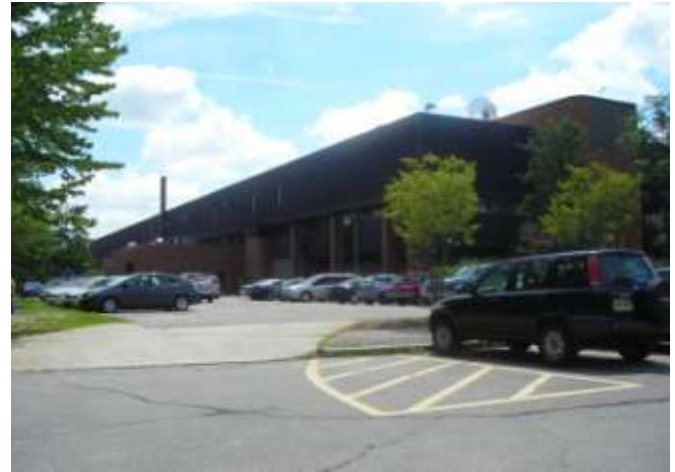
As the exterior walls have moved from thermal expansion and contraction, the sealant in the masonry expansion joints has failed and in some cases, on the interior of the building, has completely fallen out of the joints providing a source for energy loss and air infiltration.

- Recommendation: Sealant at masonry expansion joints should be replaced to mitigate air infiltration and improve energy efficiency and comfort.

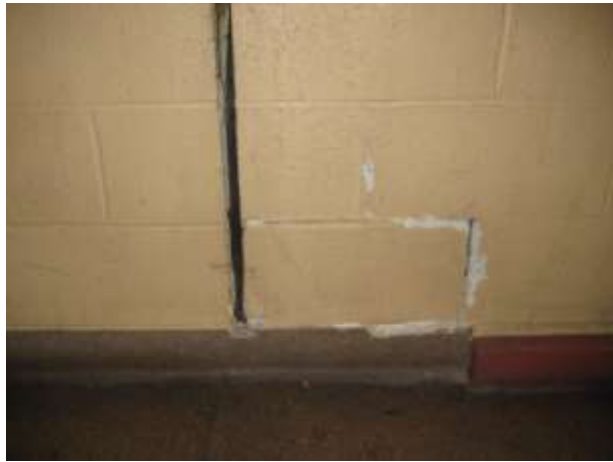
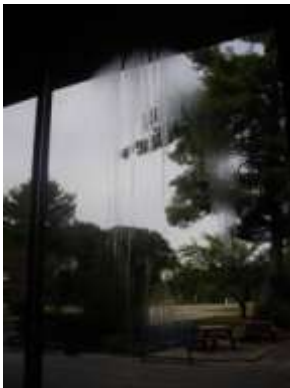
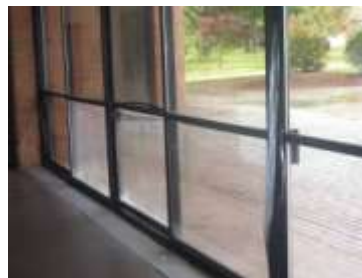
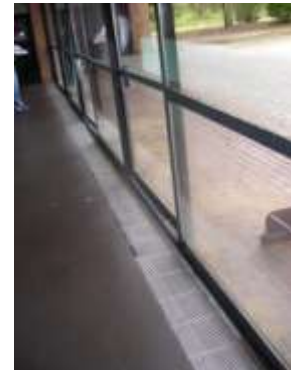
All exterior windows and storefronts are original to the 1974 building and do not comply with current IECC energy code requirements. The glazing throughout Minuteman is 1" tinted insulated glazing in non-thermally broken aluminum frames. On the second level, the window system is continuous strip windows with operators; on the third level, the window system is individual pivot windows in the metal wall panel system. Neoprene gaskets and seals at glazing have failed in several locations allowing air to infiltrate and causing deterioration of the window systems. The most extreme example of this condition is in the pool area where the sealant is failing and noticeably pulling away from the frame. Failure of these window systems affects the thermal efficiency of the building.

- Recommendation: All existing exterior aluminum windows and entrances should be replaced with new code compliant units to increase thermally efficiency and comfort.

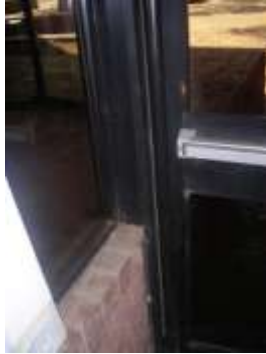
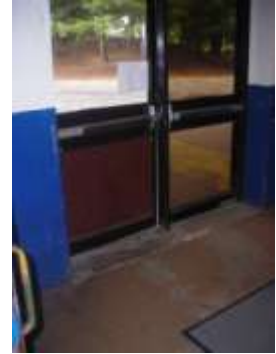
Exterior doors and frames are steel doors in hollow metal frames and aluminum doors in non thermally-broken aluminum storefront framing. Although some of the door hardware has been replaced over time, the doors and door hardware are in poor condition. Doors do not close properly, sometimes not at all, affecting both thermal efficiency and building security. The main entrance doors have had many of their pivot hinges replaced with traditional square butt hinges as these pivot hinges have failed. Thresholds at

exterior doors are not weatherproof and allow infiltration which is deteriorating the concrete flooring. The main entrance, as all exterior doors in the building, does not have an entrance vestibule to control heat loss and air infiltration.

Most of the sectional overhead doors (garage type) are original to the building and are in poor condition from almost 40 years of continued use.

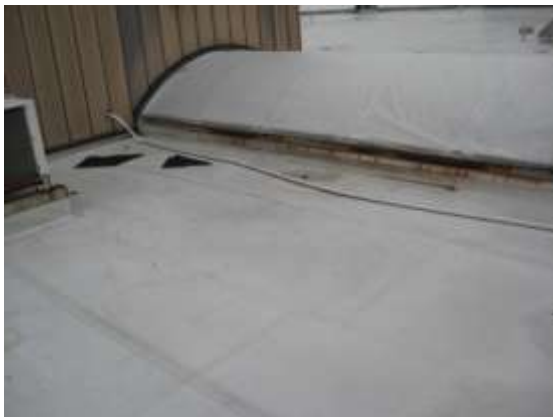
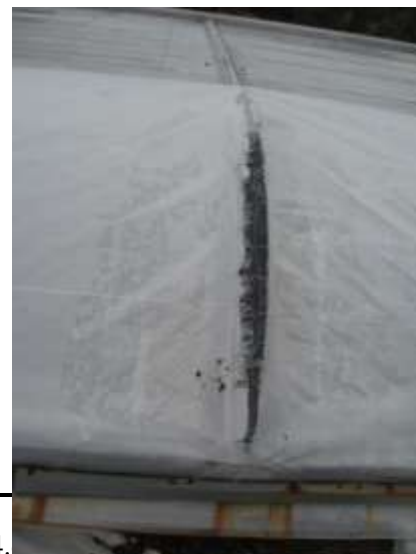
Skylights extend along the roof between the roof mechanical penthouses and are a source of water infiltration. At the penthouse walls, the skylights are not flashed properly and appear to be fastened to the face of the penthouse insulated wall panels. The skylights, in an effort to mitigate the water infiltration, are covered with translucent tarps and duct tape.

At the perimeter of the roof, a parapet is constructed by the extension of the metal wall panel siding and perimeter roof blocking. No overflow scuppers or secondary roof drains exist and water ponds extensively.

- Recommendation: As a primary concern, the entire roof assembly is recommended to be replaced with a new membrane system. Insulation provided must comply with the IECC with a minimum R-Value of 21. New overflow scuppers must be installed at the roof perimeter. At interior roof drains, secondary roof drains must be installed with new rain leader piping extending and penetration the exterior wall of the building. All skylights should be replaced with units which are compliant for thermal efficiency and fall protection. At penthouses, the skylights should be moved away a few feet and the gap infilled with new roofing structure and membrane to allow proper flashing of the penthouse wall. Over stair enclosures, skylights should be omitted and these areas infilled with new roofing structure and membrane to allow proper fire rating of stair enclosures. Eventually, the roof penthouse exterior metal wall panels should be replaced.

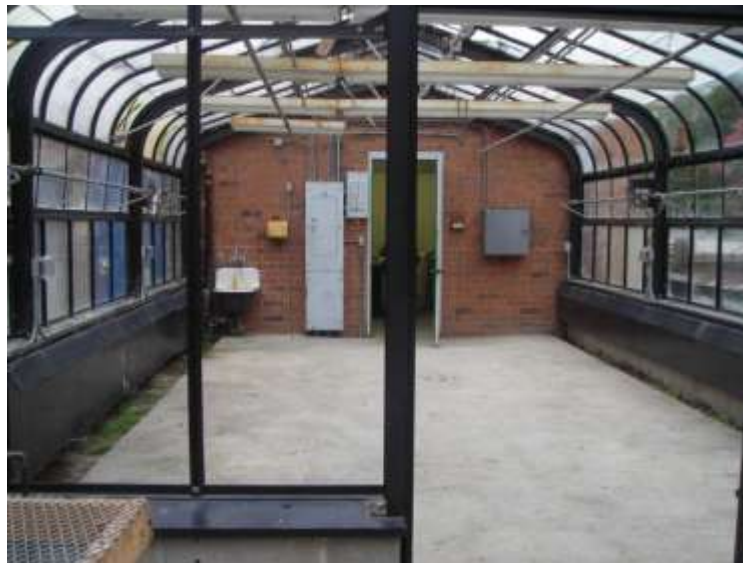
An outbuilding exists adjacent to the Main Entrance for landscape department. This building is detached from the school building and houses classrooms, a greenhouse, and a fisheries aquatics room. The building is constructed with the same materials as the main building and the condition of the exterior envelope matches that of the main building. In particular, glazing and the associated framing at the greenhouse adjacent to the Landscape Department are stained and deteriorating due to the high humidity levels that occur in that space.

- Recommendation: All existing exterior aluminum windows and entrances should be replaced with new code compliant units to increase thermally efficiency and comfort.

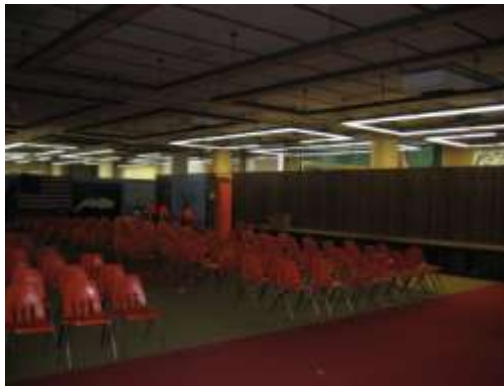
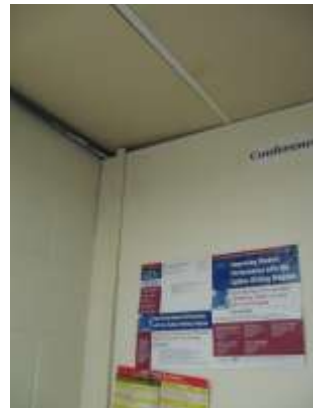
Cracking in interior masonry walls and backup cmu walls are visible throughout the facility. These are further discussed in the structural section of this study and the source of the cracking, whether from settlement and stress, is not determined. However, interior masonry walls in the building were not constructed with control joints and are not isolated from the building structure.

Over time, interior walls of different construction have been installed as part of small projects to adapt the building to new educational needs. These walls are constructed of a variety of materials including wood studs, metal studs and concrete masonry. Typically, these walls do not extend through the ceiling plane and rarely are braced to the structure above. As a result, sound transmission between rooms is not controlled and disrupts teaching. Also, as these walls are not laterally braced, they are not compliant with the IEBC for seismic stability and create a dangerous condition during a seismic event. Any walls constructed from wood stud framing are not allowed in Construction Type II-B and should be removed. Wood framed walls were recently replaced with non-combustible framing in the Trades Hall in an effort to provide a safer, compliant environment.

- **Recommendation:** All masonry partitions which are not laterally braced should extend to the deck above and be braced to the building structure. Cracking at interior masonry walls caused by stress from the building structure should be isolated with control joints and sealant. All wood stud framed walls should be removed and replaced with non-combustible framing and drywall partitions.

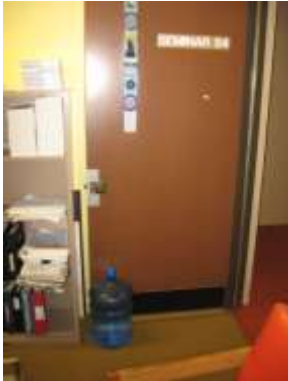
Interior doors are solid-core wood or steel in hollow metal frames. Glazing within doors, in borrowed lights, and transoms was originally wired glass however, at some locations glazing has been replaced with plexi-glass or plywood. Most doors are original to the 1974 construction and vary in condition depending on the frequency of use over the years. Doors in spaces (gym, cafeteria, and stairs) which receive the most use are in poor condition while doors in spaces which are not as frequently used (classrooms) are in good condition.

- Recommendation: All interior doors and hardware should be replaced to be accessible. Glazing in rated door openings at doors, sidelites, and transoms should be replaced with fire rated glazing. At fire door pairs, all doors and hardware should be replaced to provide two independently acting door leaves with vertical rod exit devices. At doors which do not provide accessible clearance, such as at toilet room doors, walls must be modified or automatic door operators must be installed to provide compliant access throughout the building.

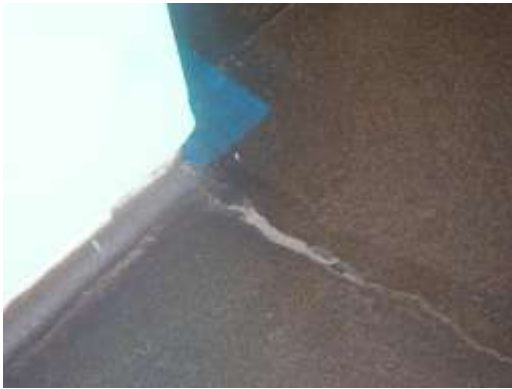
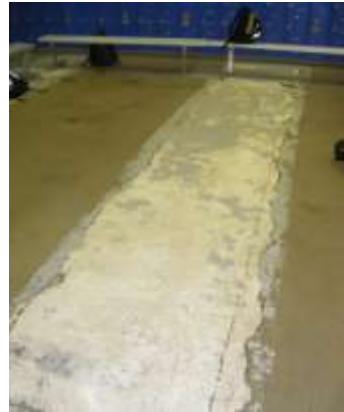
Resilient flooring was used in common areas such as the Mall, the Pool area, locker rooms, and toilet rooms. This floor finish is cracking and delaminating from the slab in some areas. The locker room floors require repair after the removal of locker bases. Moisture content of slabs-on-grade should be performed to determine if high moisture content is causing the tile adhesive to fail.

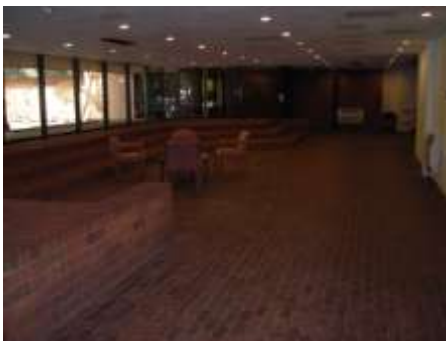
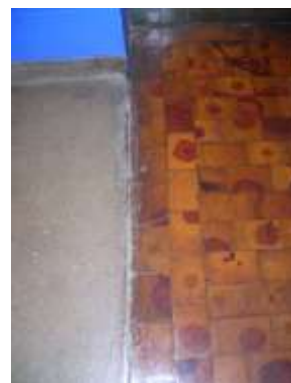
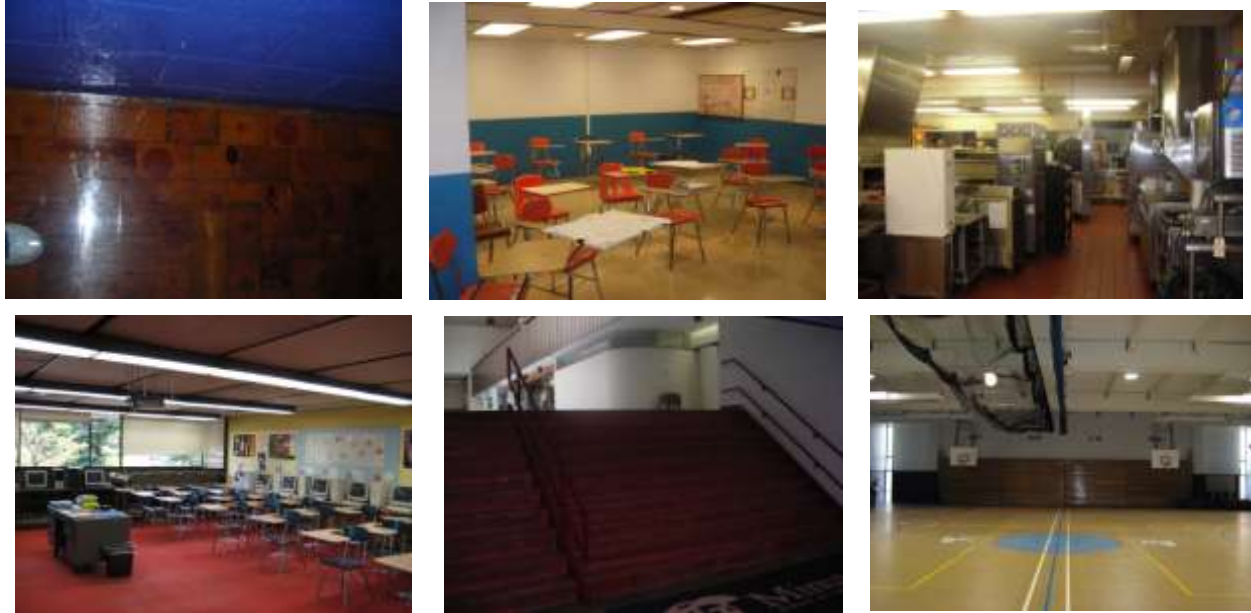
The lobby floor is an extension of the jumbo brick from the exterior and is in very good condition. The cafeteria and corridors leading up to the shop areas have a unique 4x6 wood flooring system which has been shellacked. This particular flooring system is in great shape considering its age. The shop areas are painted concrete after the Trades Hall renovation in 2011. Classrooms on the lower and upper levels have VCT which is well kept. The kitchen has quarry tile which has been well kept. Carpet was used in some of the classrooms, Administrative offices, IRC/Library, upper cafeteria and corridors and is very worn. Public stairs have rubber treads and risers adhered to the metal pan stair system. The egress stairs have sealed concrete treads and painted risers.

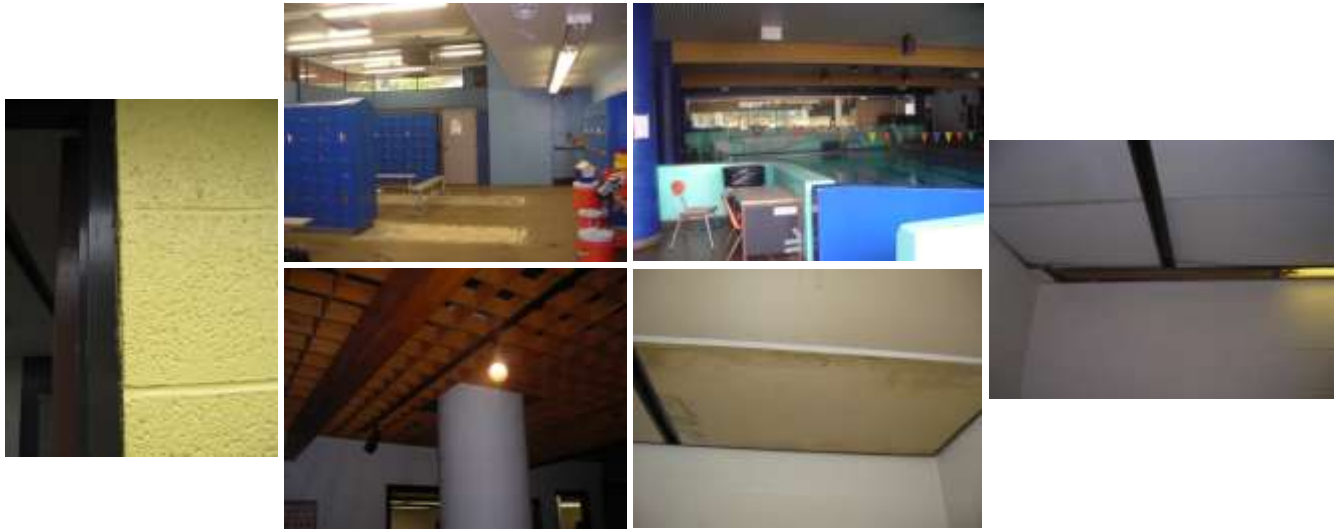
The original ceiling system still exists throughout Minuteman and consists of a lay-in type acoustical panel system that runs continuously from space to space. Water staining is prevalent throughout the ceiling system as a result of roof system failures over the years. Some spaces have updated the ceilings by inlaying new acoustical tile and additional intermediate cross grids into the original grid track. The restaurant on the mall level has an open wooded grid trellis system which is open to the typical ceiling above and is in great shape. Plaster ceilings exist in corridors, toilet rooms and locker rooms of Area A. The plaster ceilings have staining and are flaking in some areas the previously got wet.

- Recommendation: All slabs-on-grade should be tested for moisture content prior to replacement of carpet, VCT, poured epoxy, or ceramic tile flooring. A topical vapor barrier should be installed if the moisture content is higher than allowed for product system warranties. Testing of the gym floor and concrete slab should be performed to determine if mold is present and to determine the condition of the concrete slab reinforcement.

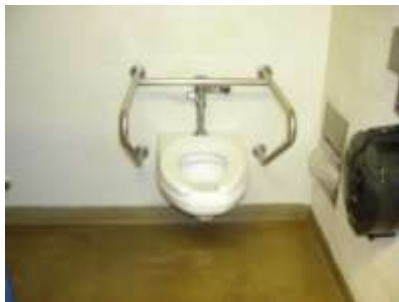
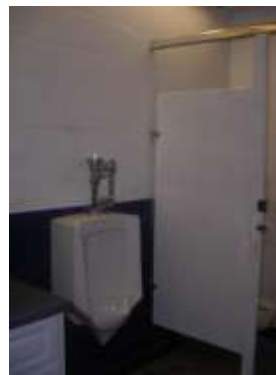
Toilet partitions have apparently been repainted several times and should be replaced during any renovation. In many instances they improperly divide the toilet rooms and create non-accessible toilet rooms. There is relatively little damage in the Toilet Rooms.

- Recommendation: Lockers should be replaced with handicapped accessible units. Lockers, where functional, should be electrostatically painted to match. Toilet partitions should be replaced to provide accessible toilet rooms.

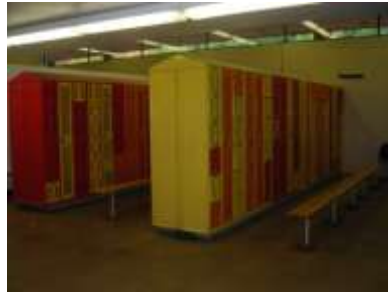
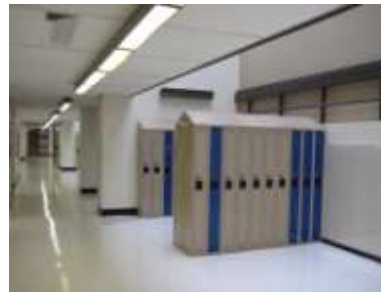
The lockers in the corridors are in good condition, however, many different locker colors and styles exist in the building. Over time, when lockers have been damaged, they have been replaced with other doors and components from other lockers which do not match the original lockers. Lockers in the Male and Female Locker rooms are in fairly good condition. The lockers in the male locker room appear to have been updated from the originals. Handicapped accessible lockers were not identified by placards throughout the building.

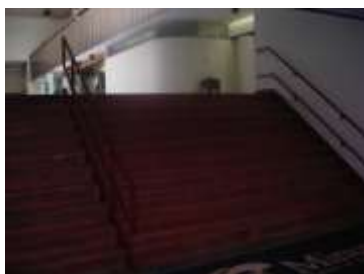
The main lobby stairs have rubber treads and risers applied to the metal pan stair system. The handrail extensions are also a code violation on these stairs as well.

- Recommendation: At stairways, stair doors and enclosures should be relocated to align on all floors as required by the IEBC. Fire rating of supporting structure must be verified and all walls and penetrations must be firestopped. Guards must be installed on all stair rails and balcony guardrails. Storage areas under stairs and within egress elements must be removed in accordance with the IEBC.

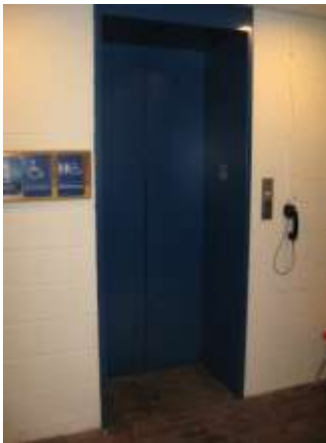
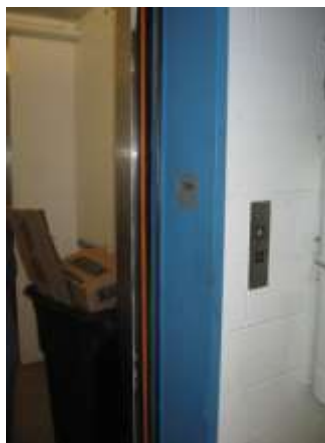
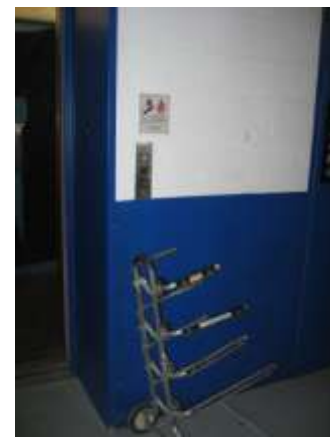
Minuteman has three elevators within the facility. There is sufficient elevator access to all levels to comply with AAB and all appear to be in working order. There is a 4000 pound passenger elevators located near the main entrance lobby, an elevator for use by the kitchen and restaurant, and a 6500 pound freight elevator in the Trades Hall and IRC. All the elevators are of adequate size, contain compliant grab bars and door openings, and have been recertified for operation.

- Recommendation: All elevators must be modified to provide signaling and controls compliant with AAB. During this renovation, it is highly recommended that the interior cabs be replaced. As the controls and pumps for these elevators are at the end of their expected life, it is also recommended that the pumps and controls be replaced.

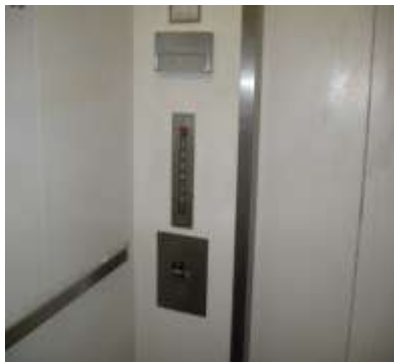
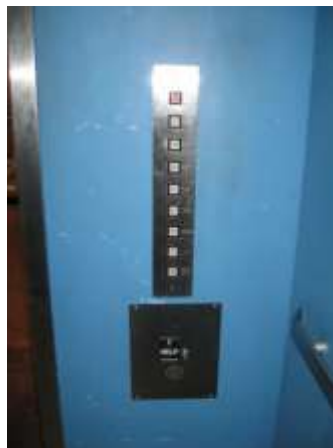
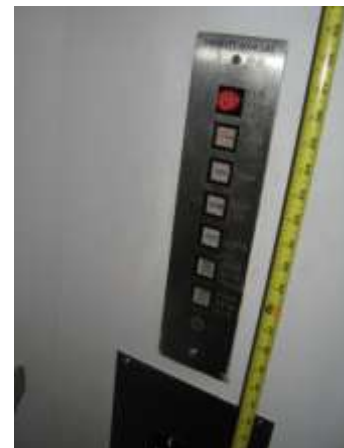
Signage and controls are deficient at all elevators. Where the main entrance elevator had adequate signage, the other elevators only had signage on the door jambs and none on the exterior face of the corridor walls that served them. In all of the elevators, the control buttons on the corridor walls were too high than the required 42" to the center of the panel.

Exterior lanterns which indicate the elevator is in use are located on the control panels however lanterns are required to be a minimum of 2-1/2" in the smallest dimension and mounted with its centerline at 72" above the finish floor. Also, hall chimes for the elevators were not operational as required by AAB.

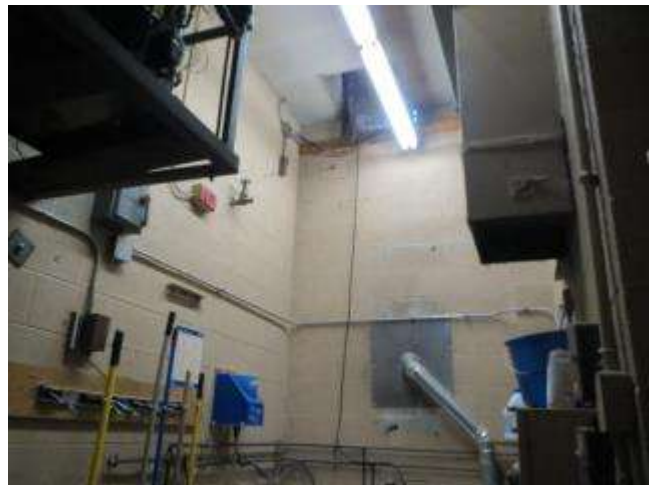
J.C. & Laundry: Unfinished ceilings, exposed piping, steel and machinery.

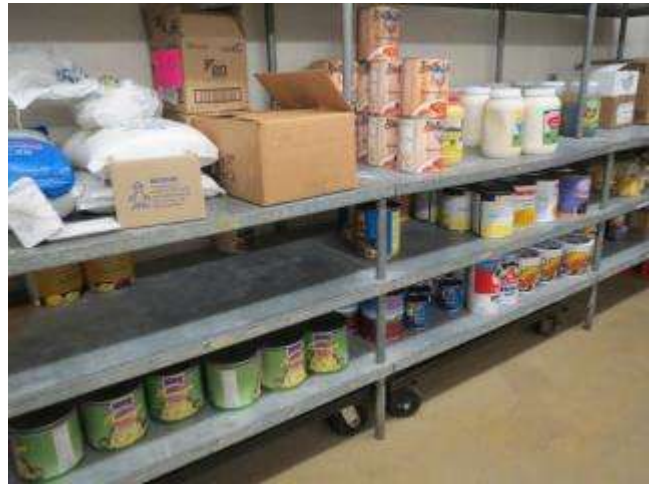
Dry Food & Paper Storage Room: Shelving is constructed of inappropriate materials.

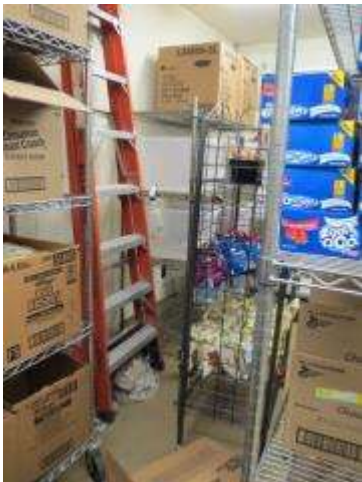
Dry Food & Paper Storage Room: Some detergents and custodial items were located in this area; not code compliant.

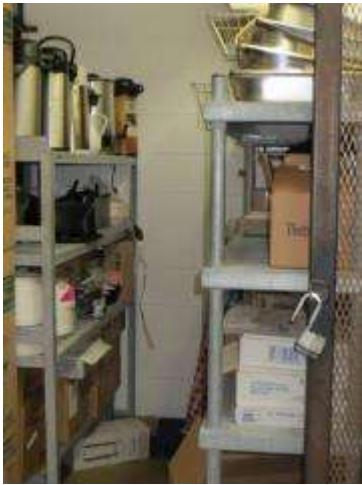
**Catering/Special Function Storage:** Area is extremely congested. Area is located off the kitchen production area. Wire gate tends to collect dust, unsanitary.

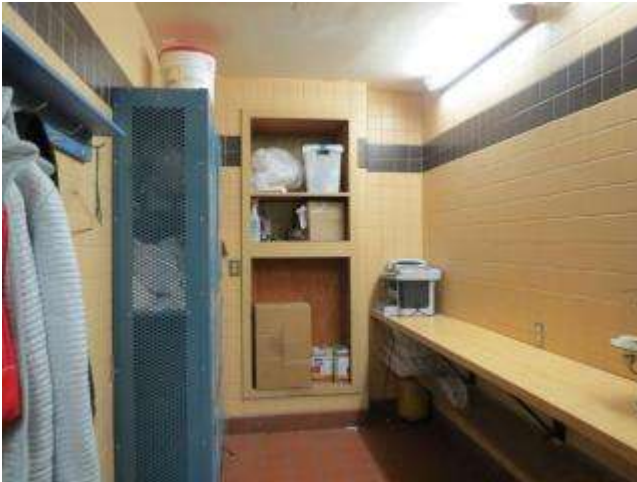
**Staff Lockers:**

Lockers are inconveniently located in a undesignated area.

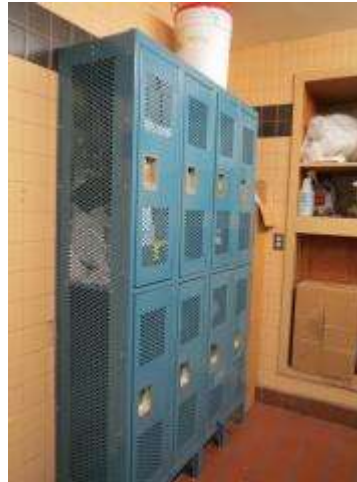
**Staff Lockers:**

Quantity of lockers is insufficient for a staff of twelve (12).

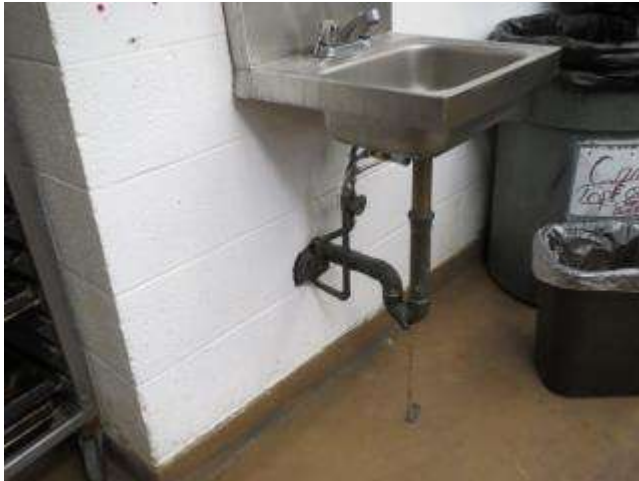
Preparation: There is an insufficient quantity of code mandated hand sinks. Walls have degraded, unsanitary. Scouring pad is used to plug hole at waste pipe.

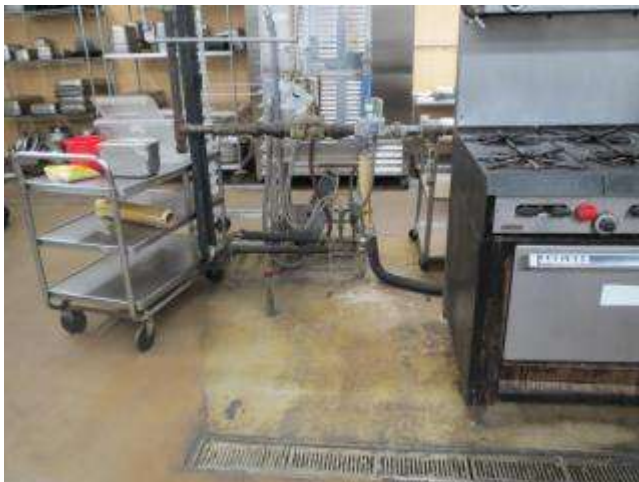
Cooking Equipment: Cooking battery is under-equipped. Some equipment is antiquated and unsanitary.

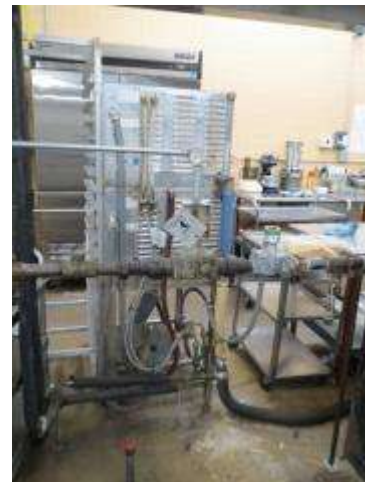
Cooking Equipment: Exposed piping renders this area impossible to maintain as a sanitary environment.

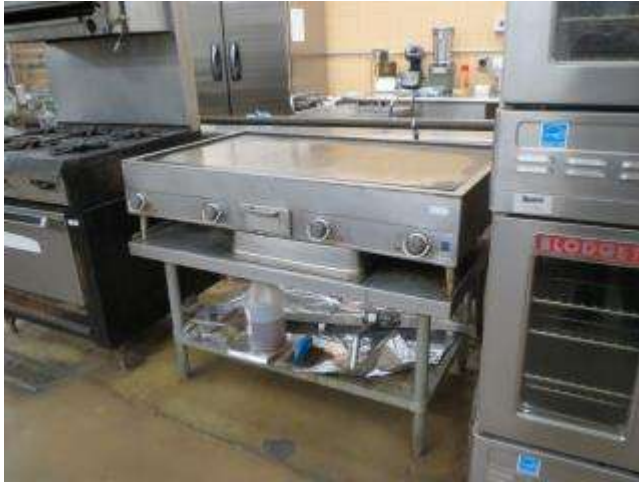
**Cooking Equipment:** No splash guards at the griddle. Piping at rear tends to collect dust and grease. Piping is exposed foods being cooked, poses a threat of cross-contamination and fire.

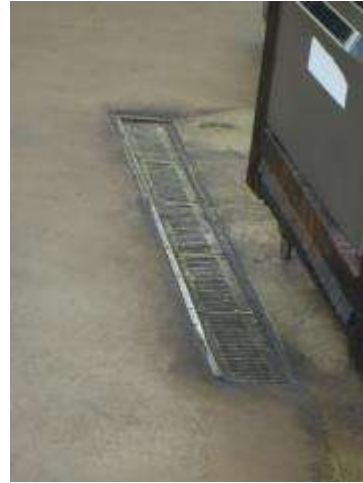
**Cooking Equipment:** Floors have severely degraded and are unsanitary. Existing trough has degraded and poses a hazard to foot traffic.

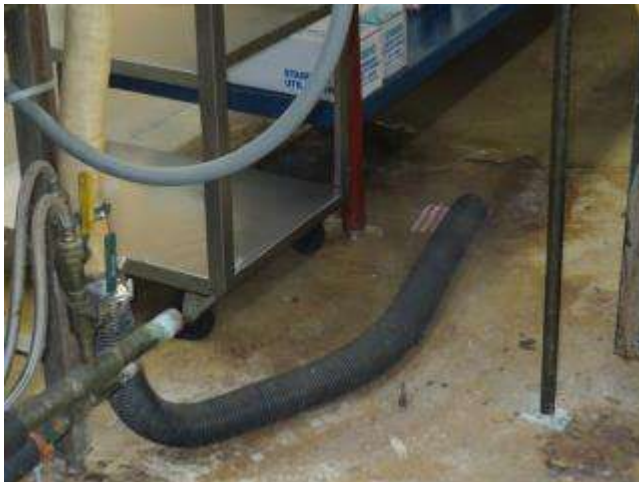
**Cooking Equipment:** Flexible plastic indirect drain piping is inappropriate. Floor drain appears to be clogged and drainage is extremely poor. Hot water puddles throughout this area. This situation will pose a significant hazard to foot traffic.

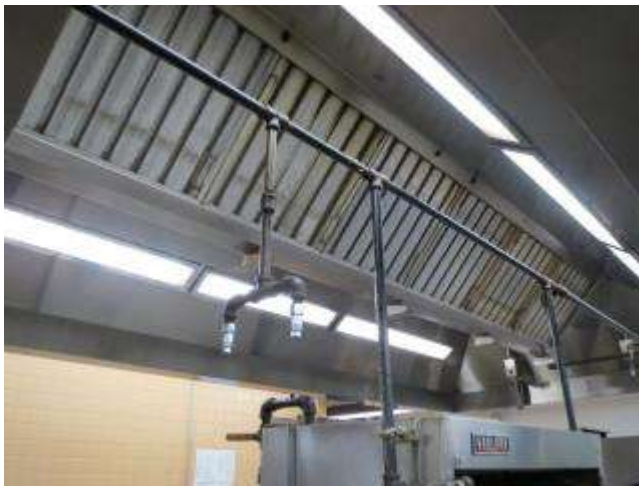
**Exhaust Hoods over Cooking Equipment:** The “grease filters” located in the center of the plenum chamber are inefficient and accumulate grease rather than filter the air stream. No grease capture gutters.

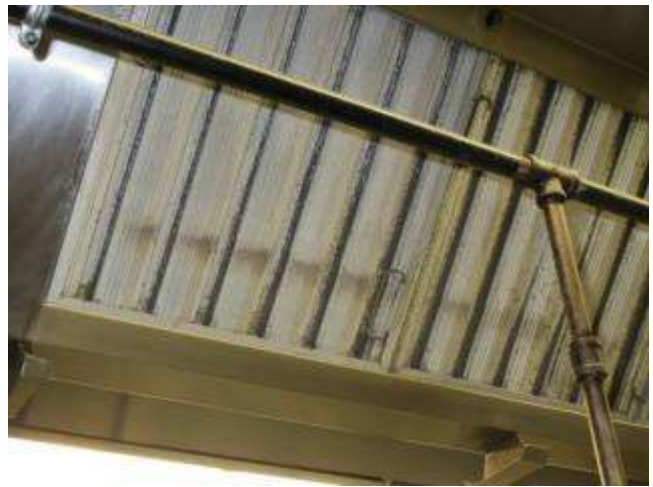
**Exhaust Hoods over Cooking Equipment:** The exhaust assemblies are antiquated and should be considered unsanitary. Grease and dust build-up is unsanitary and poses a risk of cross-contamination.

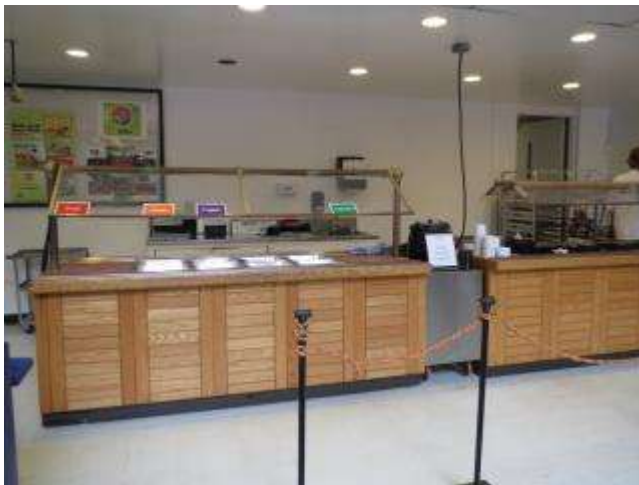
**Serving Lines (Pizza/Salad Bar):**

No code mandated refrigerated cold food serving station.

Food protectors and sneeze guards do not comply with current NSF Standards.

Electrical drops are suspended from the ceiling, unsanitary. This poses a threat of cross-contamination.

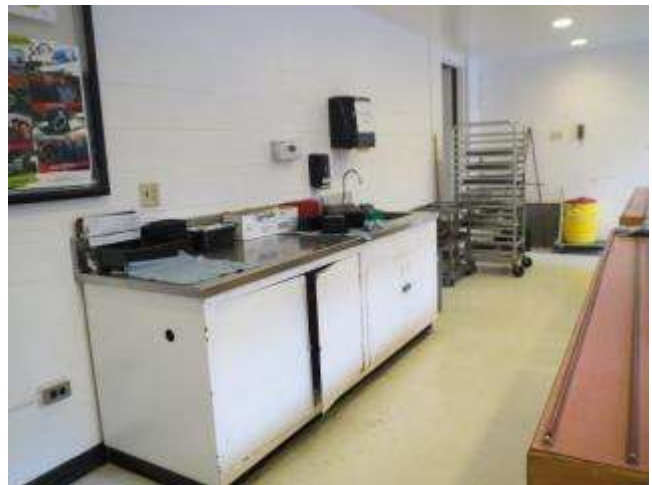
**Serving Lines (Pizza/Salad Bar):**

There are no dedicated code required hand sinks in this room. A work sink doubles as a hand sink.

Exterior base cabinetry is constructed of inappropriate materials (galvanized steel or painted steel), which have degraded and should be considered unsanitary.

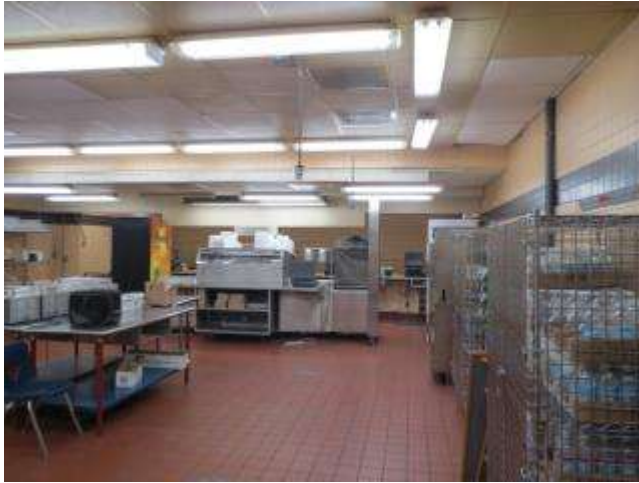
**Serving Lines (Grill Station – Full Service):**

This area was once occupied by McDonald's. Most space behind the line is under- utilized.

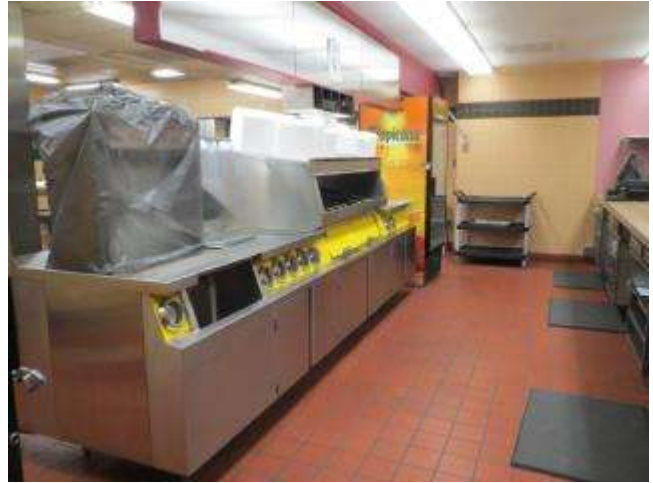
**Serving Lines (Grill Station- Full Service):**

Serving line is designed for McDonald's service, therefore; most back line equipment is not being utilized.

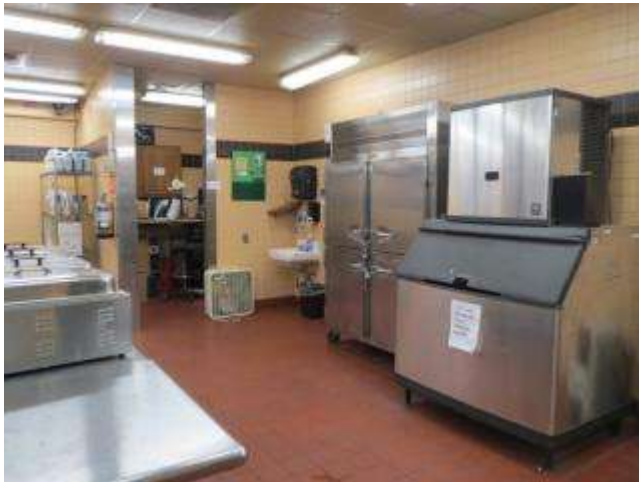
**Serving Lines (Grill Station – Full Service):**

Back of the line space is utilized for additional storage of foods and detergents. This is not code compliant.

Fans are used to circulate air. Fans tend to spread dust throughout the entire food facility, unsanitary.

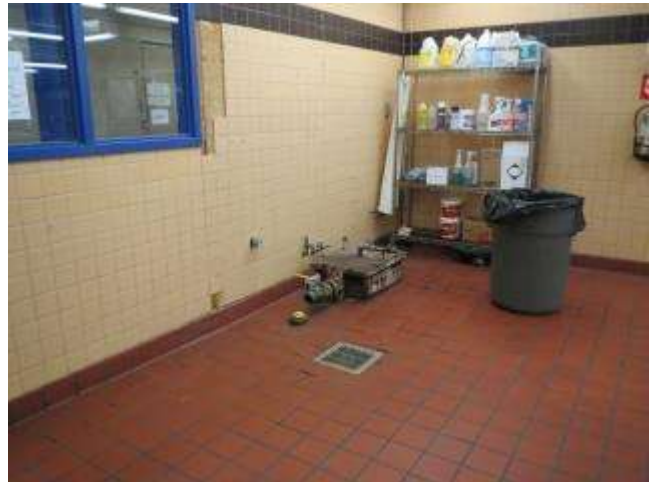
**Serving Lines (Grill Station- Full Service):**

Detergent storage is located opened to the serving room. Not code compliant.

A deteriorated grease trap located on the floor and degrading walls should be considered unsanitary.

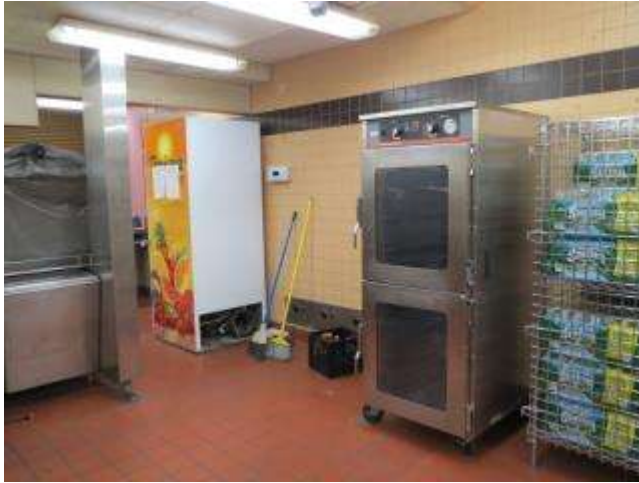
**Serving Lines (Grill Station – Full Service):**

Open trash receptacles and housekeeping items such as mops, buckets, brooms and detergents were located in this area during serving.

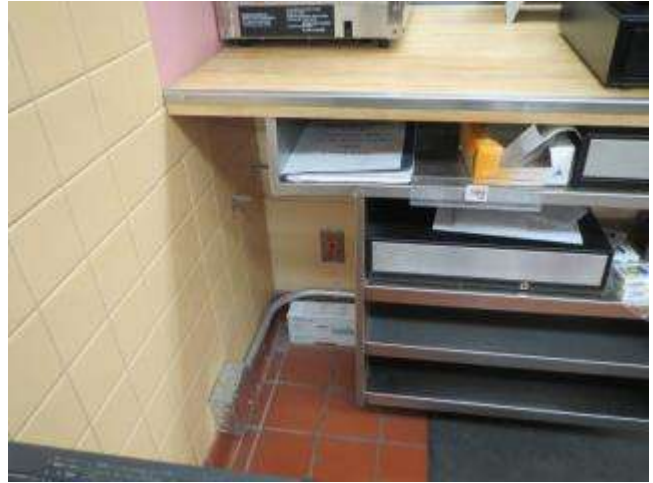
**Serving Lines (Grill Station- Full Service):**

There appears to be evidence of insect/rodent infiltration throughout this area.

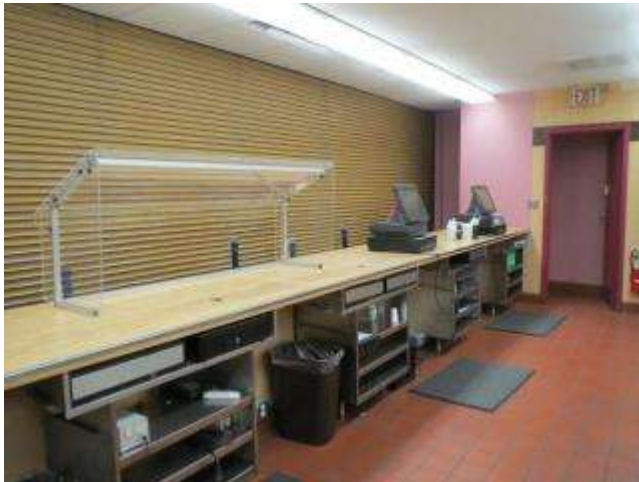
**Serving Lines (Grill Station – Full Service):**

Serving line operates “McDonald’s” style. Each operator acts as order taker, server and cashier. The lines are time consuming and labor intensive.

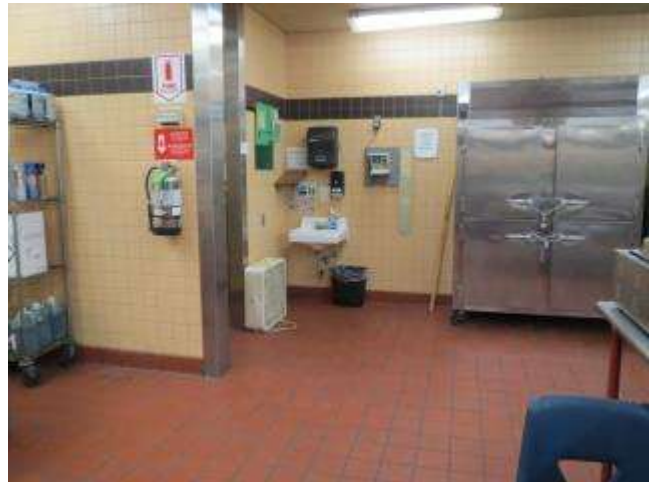
**Serving Lines (Grill Station- Full Service):**

This is the only hand sink located in this room. There are no code mandated hand sinks at the serving line.

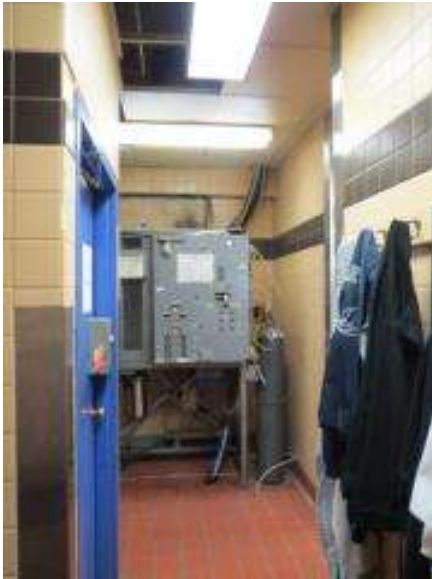
Serving Lines (Grill Station – Full Service):  
In operable soda system with syrup lines and CO2 tanks. This area is nearly impossible to clean. Unsanitary.

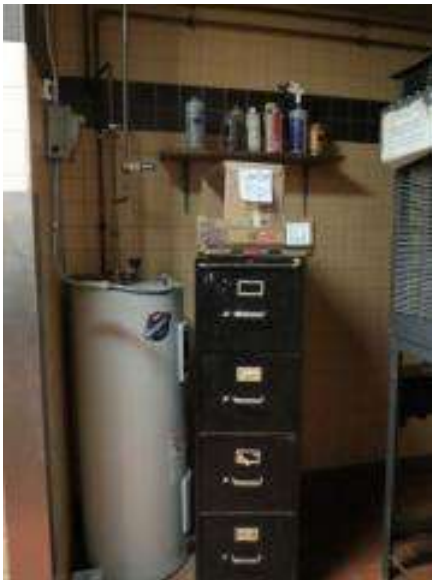
Serving Lines (Grill Station – Full Service):  
Exposed piping, conduit and detergents; unsanitary. Additional staff office space is required for files, equipment, etc.

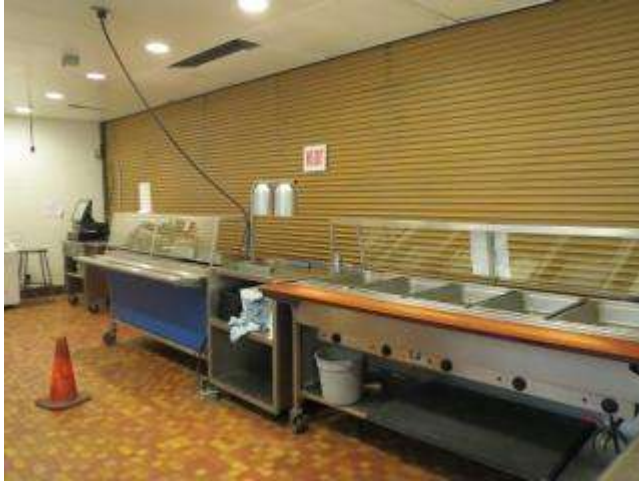
Serving Lines (Deli & Hot Food Station):

The serving line does not have code mandated refrigerated cold food serving station.

Electrical drops are suspended from the ceiling; unsanitary. This poses a threat of cross-contamination.

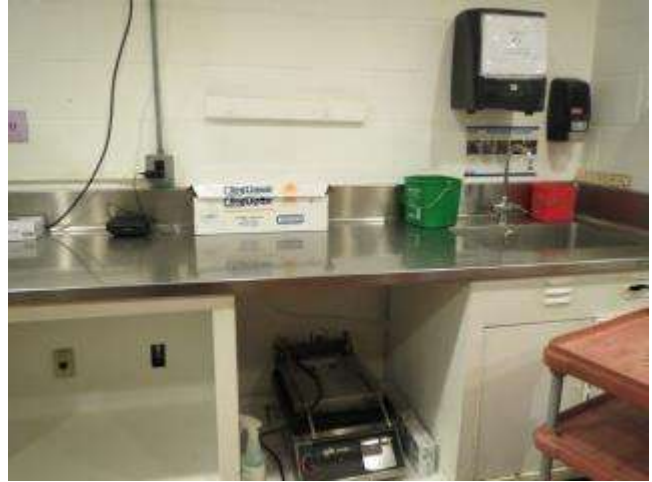
Serving Lines (Deli & Hot Food Station):

There are no dedicated code required hand sinks in this room. A work sink doubles as a hand sink.

Exterior base cabinetry is constructed of inappropriate materials (galvanized steel or painted steel), which have degraded and should be considered unsanitary.

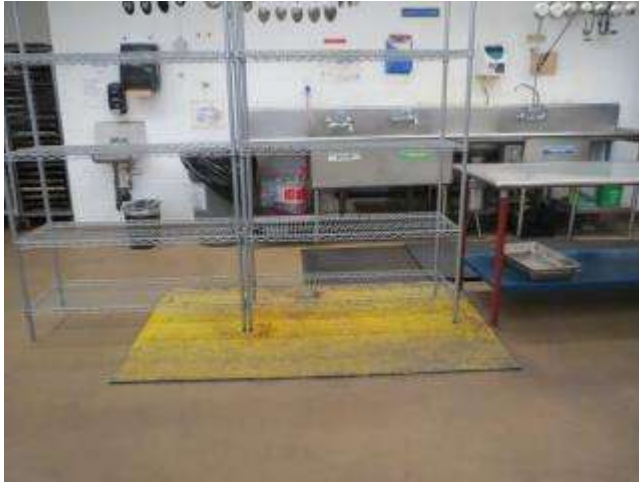
**Ware Washing /Pot Washing Area:**

Floor surfaces are slippery when wet. Rubber mats are used throughout the food facility to prevent falls. This is unsanitary and hazardous to foot traffic. Access floor panel is also hazardous to foot traffic.

Table understructure has degraded and should be considered unsanitary.

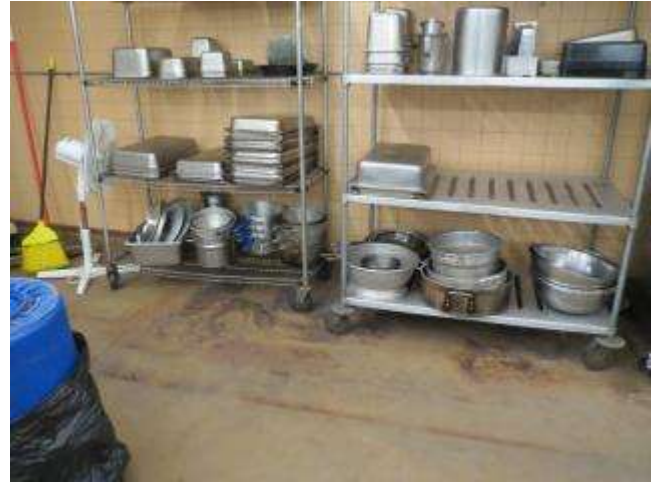
**Ware Washing /Pot Washing Area:**

Floors have severely degraded and are unsanitary.

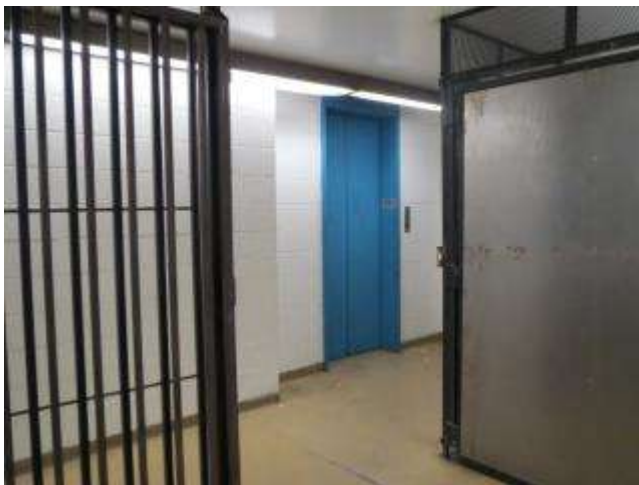
Receiving Interior 1<sup>st</sup> Floor: Deliveries must pass through the main kitchen's production and soiled areas to access elevator located in a general corridor.

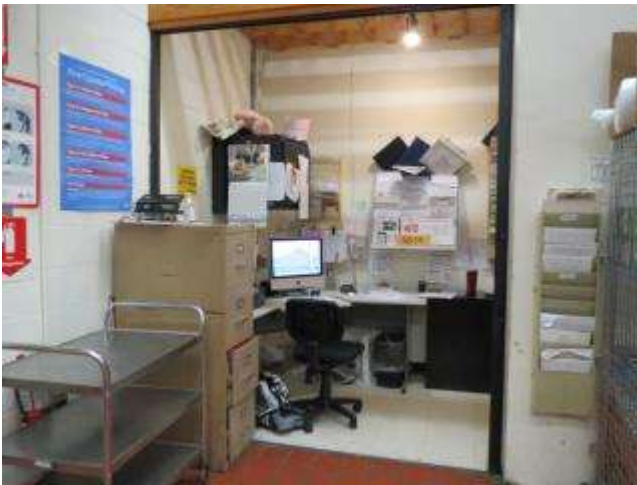
**Culinary Office – Head Chef:** This area is congested. Desk and documents are open to all production traffic. No provide or secured area.

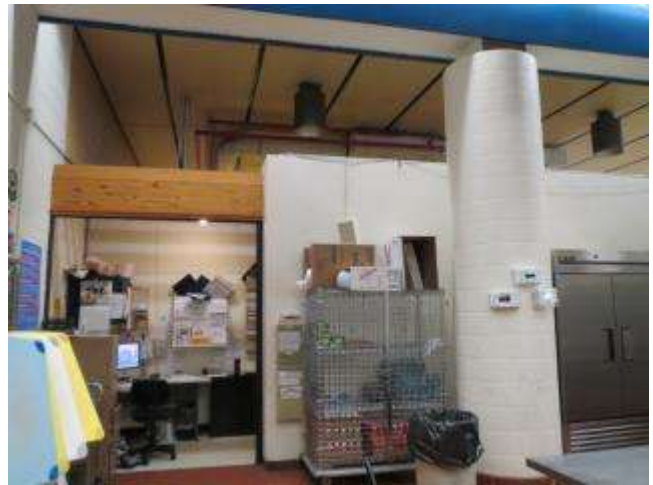
**Culinary Office – Head Chef:** All traffic between preparation, pot washing and cooking must pass through this space.

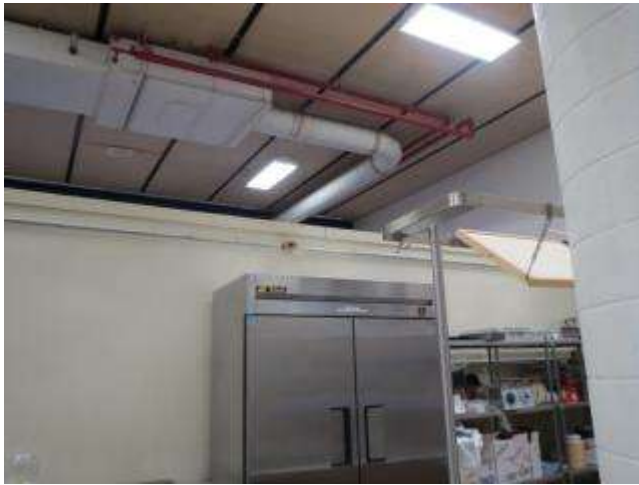
Culinary Arts Preparation: There are unfinished ceilings with exposed piping, conduit, steel and duct work. Unsanitary and poses a threat of cross-contamination.

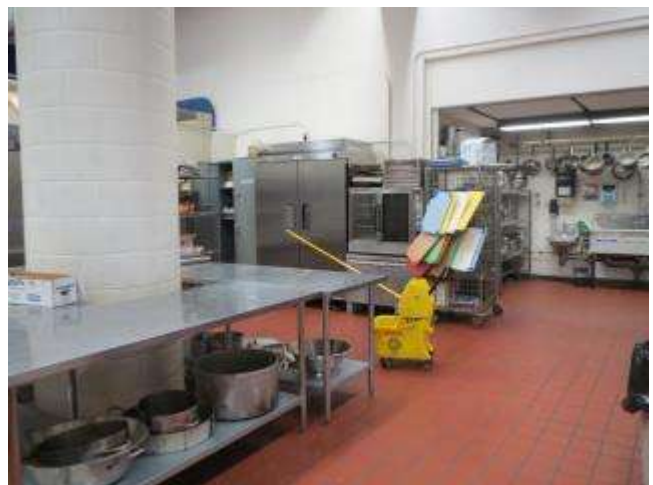
Culinary Arts Preparation: There is no code mandated hand sink in this preparation area. The closest hand sink is located in the pot washing area.

Housekeeping items such as brooms, mops, trash cans, detergents, etc. are located throughout this area.
