**LOWER LEVEL PLAN**  
**13001.00**  
**Minuteman Career and Technical High School**  
**Space Use Planning**

***Evaluation of Existing Conditions***

The following existing conditions reports for Minuteman Regional Vocational Technical School (MMRVTS) provides a detailed analysis of systems related to: Code Compliance (Building and Accessibility), Landscape, Architecture, Food Service, Structural (Building and Seismic), Plumbing, Fire Protection, Mechanical, Electrical, and Technology, Site Environmental, and Hazardous Materials. The purpose of this portion of the study is to evaluate and identify deficiencies of the existing facility as a repair only benchmark for evaluation of other alternatives for renovations, additions, or new construction.

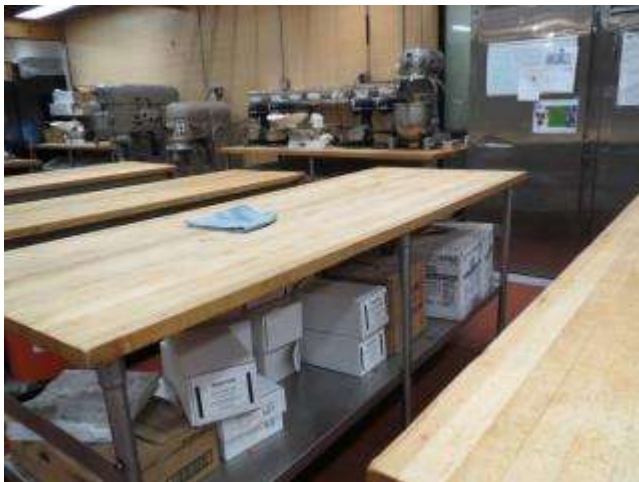
Bakery Preparation: Wood-tops are in good condition, however, impossible to be properly sanitized them due the type of wood. No longer NSF compliant.

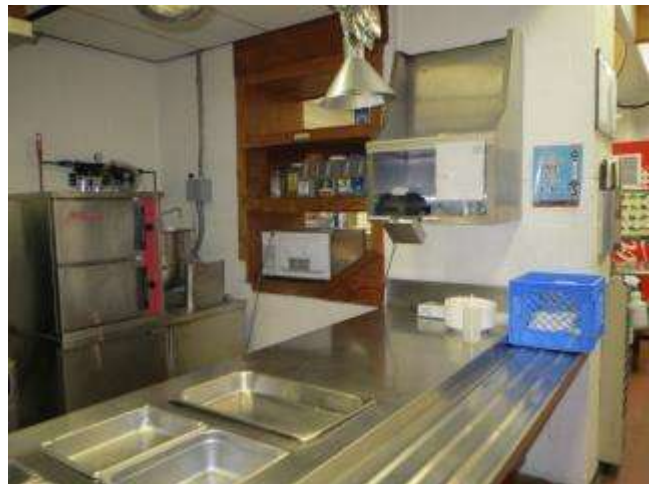
**Culinary Arts Cooking Equipment:** A convection steamer and tilting kettle are not positioned under the exhaust ventilator with fire suppression system. This is a life safety issue and not code compliant, however, final determination for code compliance is subject to local authorities have jurisdiction.

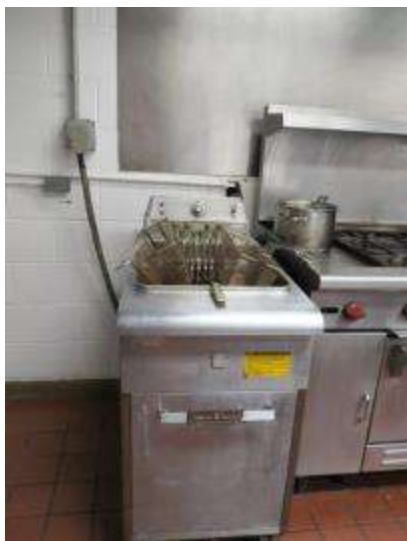
**Culinary Arts Cooking Equipment:** Fryer is antiquated and not energy efficient.

Exposed piping and conduit between and behind the cooking equipment is unsanitary as it is difficult to access for cleaning and maintenance.

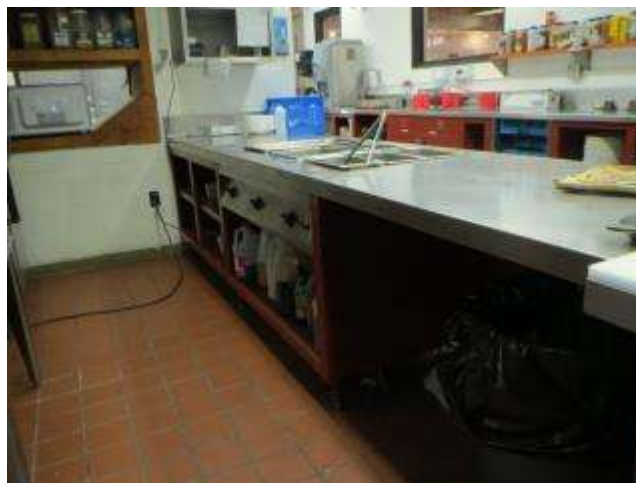
**Culinary Cook's Counter:** Understructure is constructed of inappropriate materials (galvanized steel or painted steel), which have degraded and should be considered unsanitary.

Electrical line running along the floor to access outlet. This condition will pose a hazard to foot traffic.

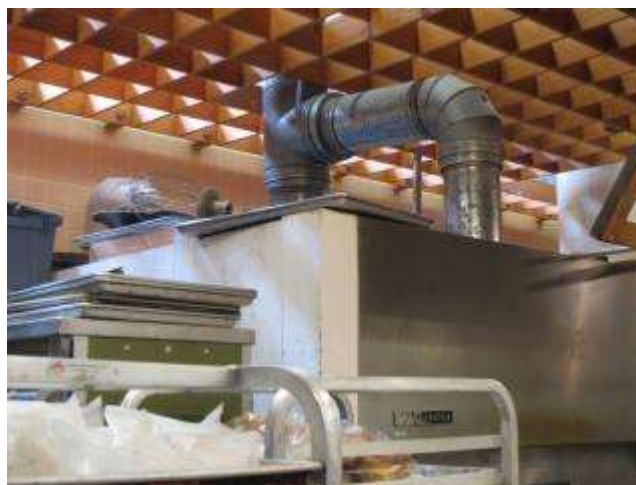
**Bakery Cooking Equipment:** Revolving oven is antiquated but currently operational. Unit is exhausted above through unfinished ceiling. This should be considered unsanitary. There is no fire suppression system.

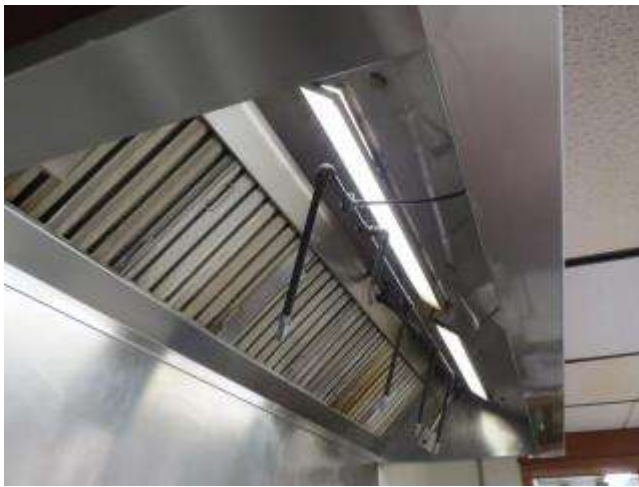
**Culinary Arts Exhaust Hood over Cooking Equipment:**

The exhaust assembly is undersized and antiquated. Protective covers at light fixtures have degraded.

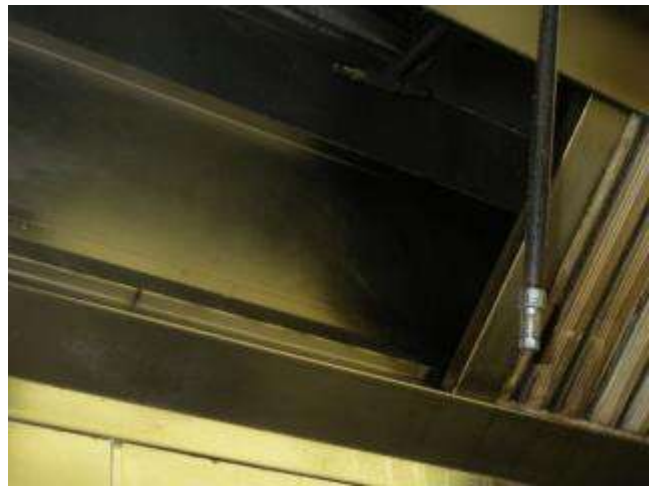
**Culinary Arts Exhaust Hood over Cooking Equipment:**

The “grease filters” located in the center of the plenum chamber are inefficient and accumulate grease rather than filter the air stream. No grease capture gutters.

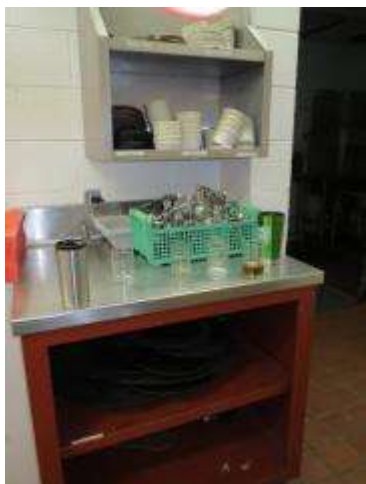
Culinary Arts Wait Stations: Counter understructures are unsanitary. Storage is minimal.

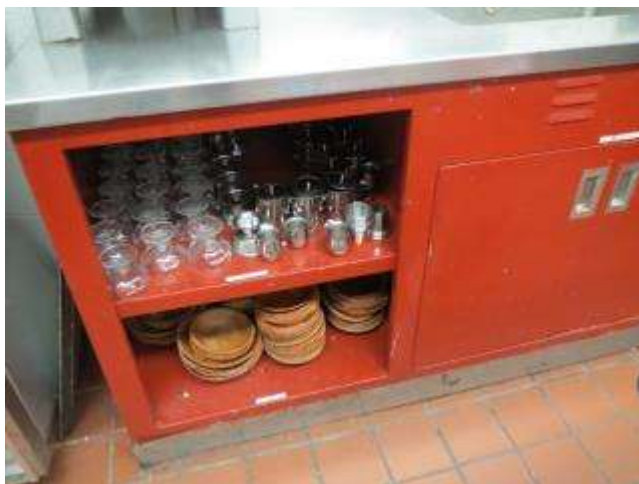
Culinary Arts Wait Stations: Counter understructures should be considered unsanitary.

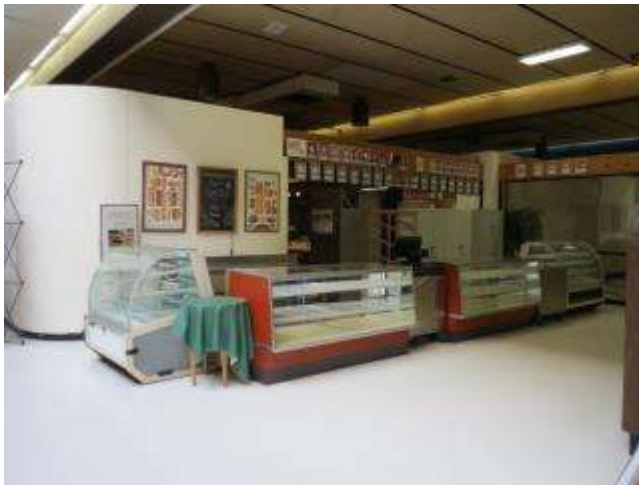
**Bakery Service Station:** Bakery service station is located in an open space. Area cannot be secured.

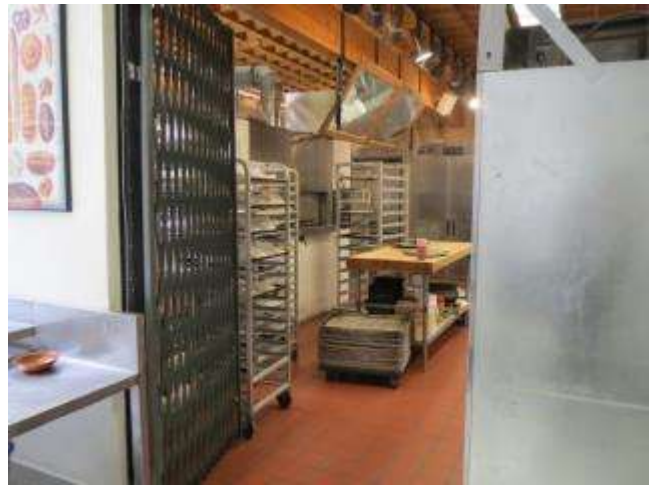
**Bakery Service Station:** Gate is used to secure the back of the house. Gates are difficult to clean; tends to collect dust.

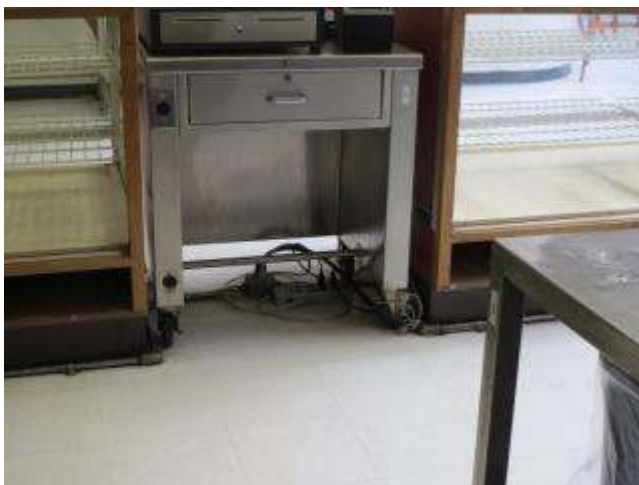
**Bakery Service Station:**

Electrical conduit, outlets and line cords are running along the floor hinder housekeeping efforts.

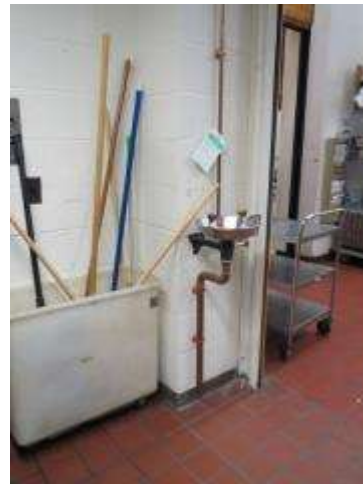
Culinary Arts Pot Washing Area: There are no dedicated janitorial areas on this level. Housekeeping items such as brooms, mops, trash cans, detergents, etc. are located throughout the facility.

There are an inadequate number of floor drains to enhance housekeeping. No drainage at emergency eye-wash station.

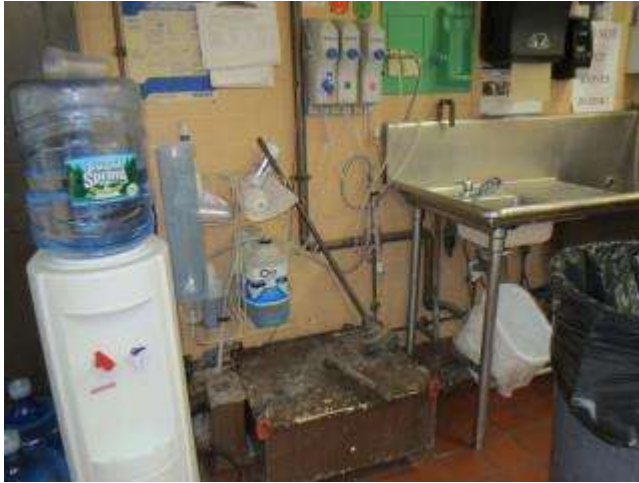
**Bakery Pot Washing Area:** Area is totally congested. No separation of clean and soiled wares.

The code mandated three-bay pot sink assembly does not provide adequate drain-board surface and sink compartments are undersized for large wares. Understructure has degraded. An unsanitary and deteriorating grease trap is located under table.

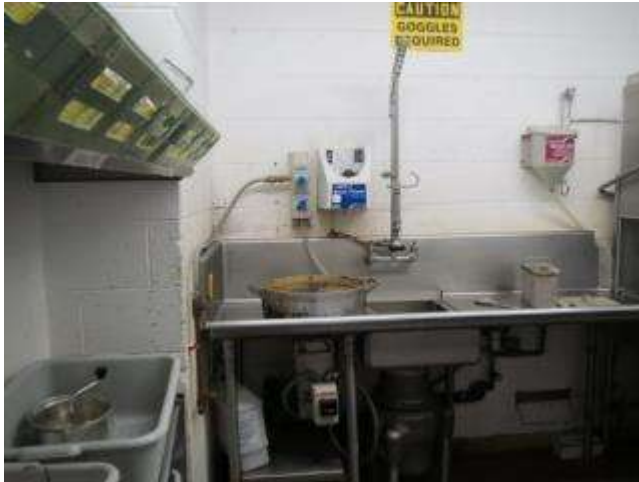
Culinary Arts Ware Washing Area: Soiled dish table is undersized and antiquated. Pre-rinse faucet lacks handles.

Clean wares are located in close proximity to soiled activities.

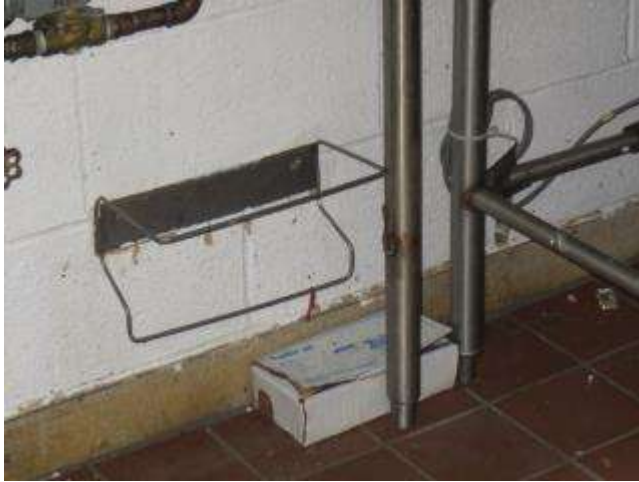
Culinary Arts Ware Washing Area: There appears to be evidence of insect/rodent infiltration throughout this area.

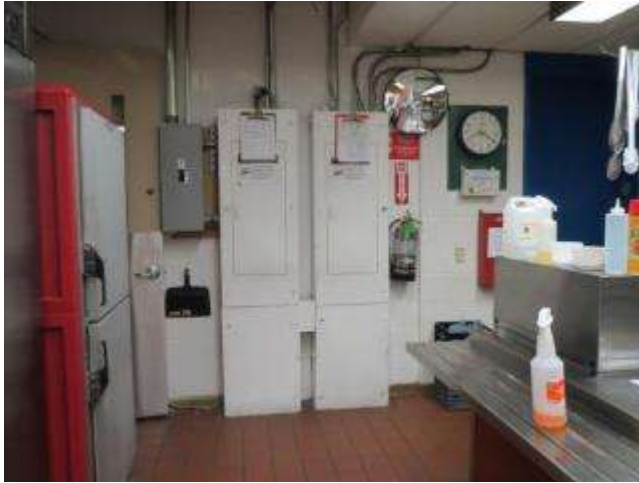
Culinary Arts General Area Conditions: Electrical panels, exposed piping and electric conduit render this area almost impossible to maintain as a sanitary environment.

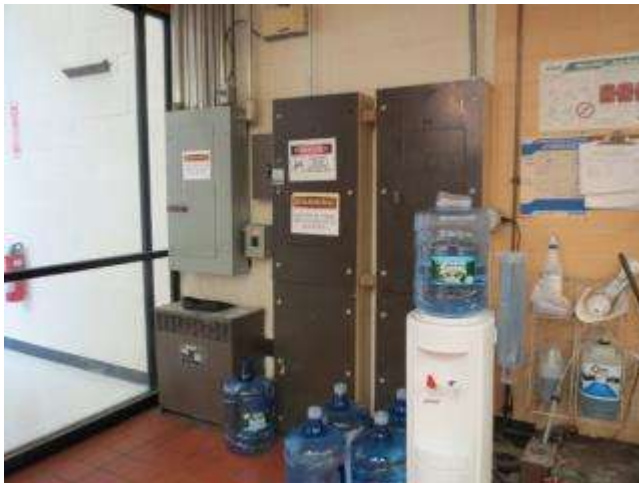
Bakery General Area Conditions: Electrical panels, exposed piping and electric conduit render this area almost impossible to maintain as a sanitary environment.

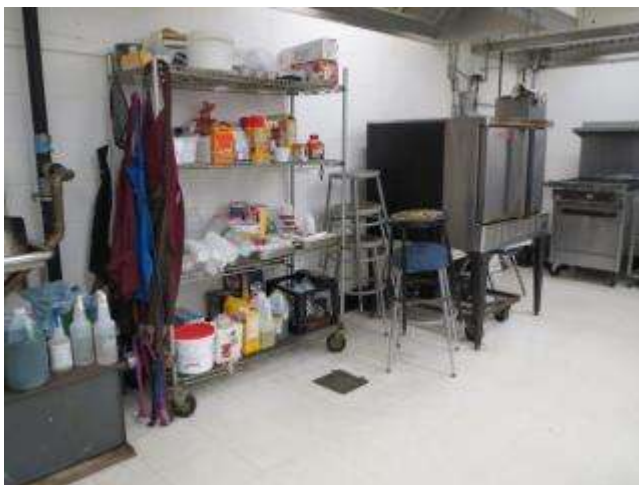
### **Dry Food & General Storage Room:**

All dry food, paper and detergent storage are located throughout this area.

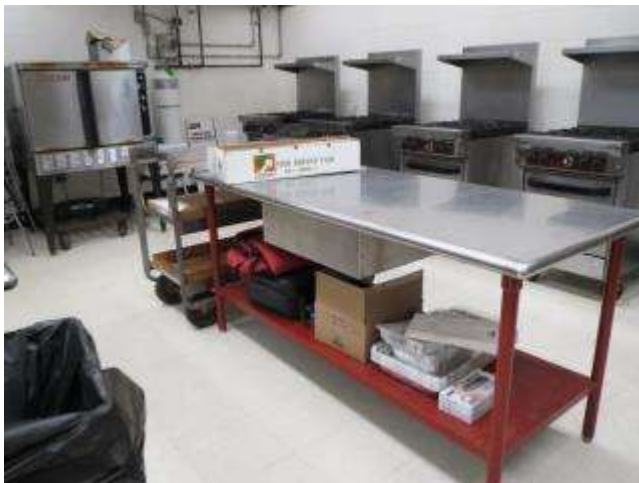
**Preparation:** Most table understructures are constructed of inappropriate materials (galvanized steel or painted steel), which have degraded and should be considered unsanitary.

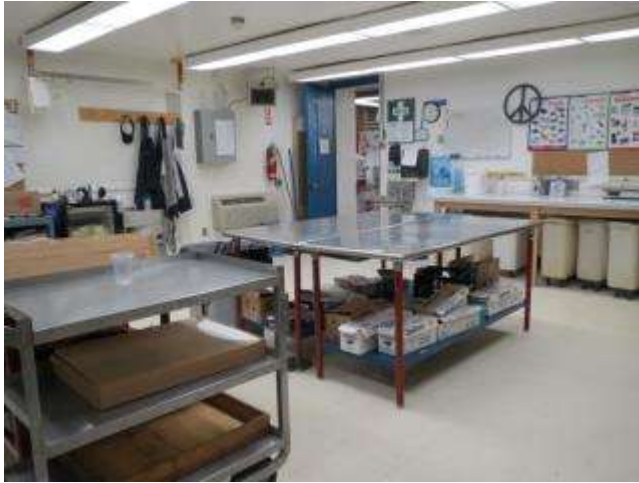
Preparation:

Ceilings and walls appear to be in good condition.

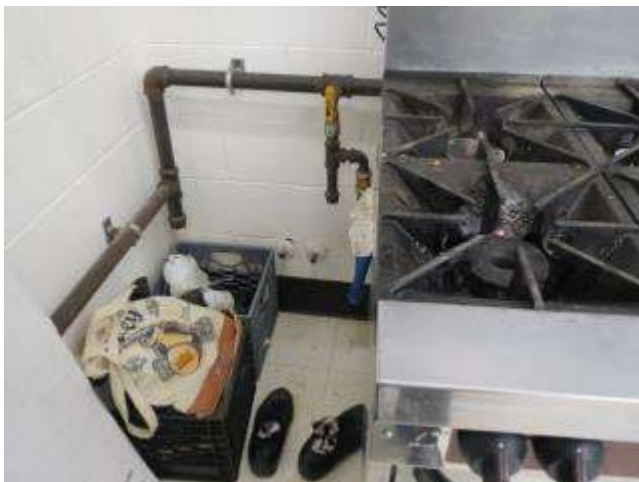
Cooking Equipment:

Exposed piping between and behind the cooking equipment is unsanitary as it is difficult to access for cleaning and maintenance. Area extremely difficult to maintain as a sanitary environment.

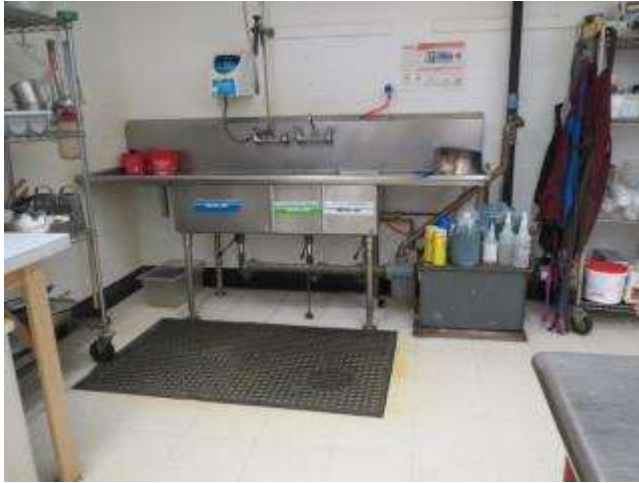
**Pot Washing Area:**

- There is no dishwasher for this kitchen. The code mandated three-bay pot sink assembly does not provide adequate drain-board surface, however, sink compartments are undersized for large kitchen wares. Understructure has degraded. An unsanitary and deteriorating grease trap is located under table.
- Housekeeping items such as brooms, mops, trash cans, detergents, etc. are located throughout this area.
- Exposed piping and conduit render this area nearly impossible to maintain as a sanitary environment.
- There are an inadequate number of floor drains to enhance housekeeping.
- Floor surfaces have degraded and are slippery when wet. Rubber mats are used to prevent falls. This is unsanitary and hazardous to foot traffic.

All the above is unsanitary and poses a threat of cross-contamination.

An unsanitary and deteriorating grease trap is located under table.
