758 MARRETT ROAD  
LEXINGTON, MASSACHUSETTS 02421

Michael McKeon  
**Kaestle Boos Associates**  
325 Foxborough Boulevard #100  
Foxborough, Massachusetts 02035  
October 29, 2013

This updated structural evaluation of the Minuteman High School, located at 758 Marrett Road in Lexington, MA, was undertaken at the request of Mr. Michael McKeon, AIA, of Kaestle Boos Associates, Foxborough, Massachusetts.

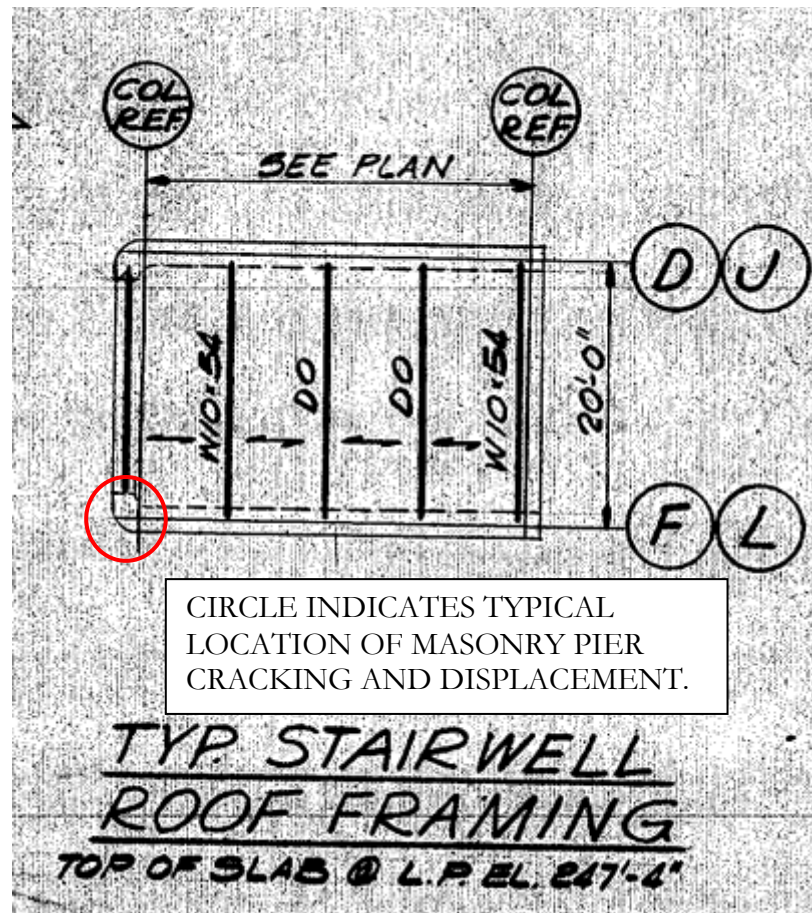
Photo #16

- **The load-bearing masonry block walls at the two pairs of stair towers located at the east and west ends of the school building are cracked and displaced:** The masonry block walls at the two pairs of stair towers are cracked and displaced. The most significant cracks occur in the masonry pillars on each side of the window openings just below the high roof framing elevation. **(Photos #12 to #16.)**

- **COMMENT:** Based on our recent examination of these structures, it appears that the cracking and displacements of the load-bearing masonry block walls of these stair towers may be due to the movement of the steel frame of the building from thermal expansion and contraction (see discussion of improperly constructed roof expansion joints below), and/or from lateral wind loads.  
Additionally, the tall slender nature of the masonry pillars (which appear to be unreinforced), make them particularly susceptible to flexural cracking due to lateral movement of the stair tower. At the high roof level, the stair structure is not tied back to the main superstructure and therefore these pillars may be moving excessively under wind loads.  
In order to mitigate additional cracking and deterioration of the masonry stairway walls, Odeh Engineers recommends that the slender “pillars” at the top of each stairwell be removed and reconstructed using solid grouted and reinforced masonry piers.

*This photo shows a copy of the typical stairwell roof framing of the stair towers at the east and west ends of the school building.*

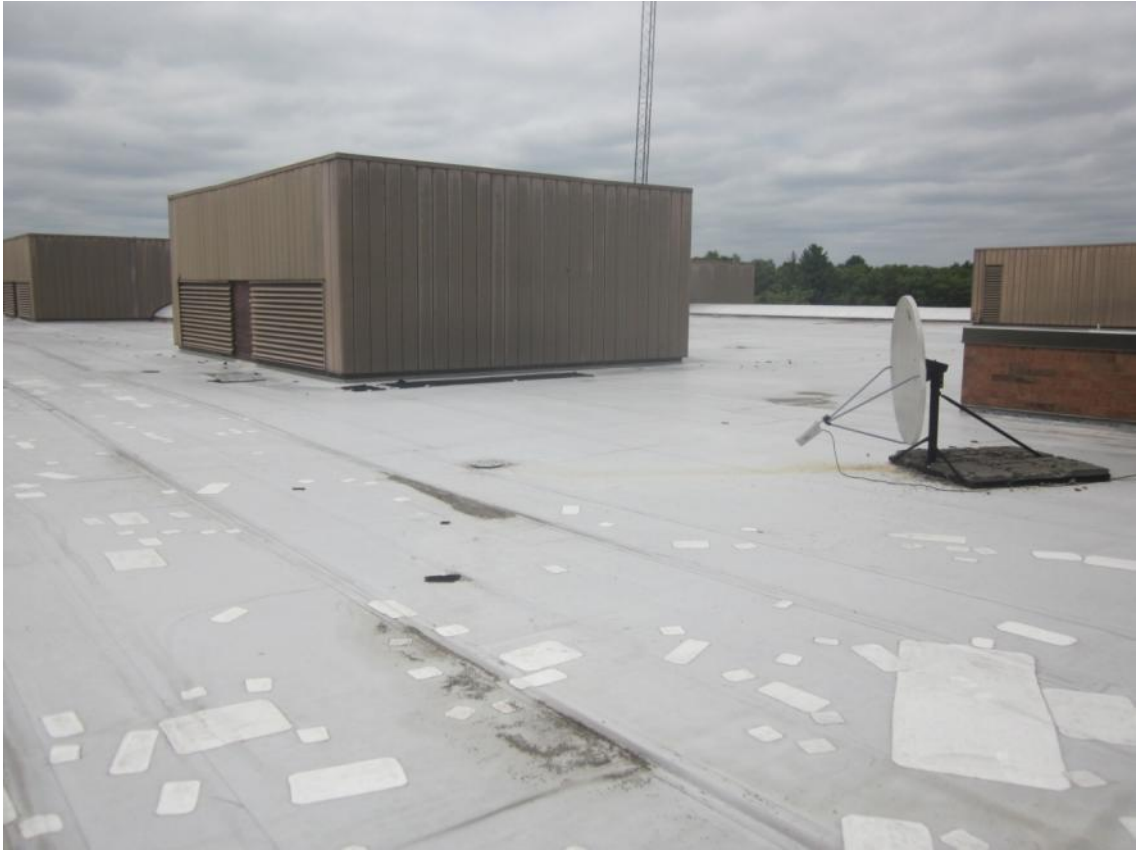
**Photo #17**

***This photo shows some of the many patches in the aged roofing system on the school building roof.***

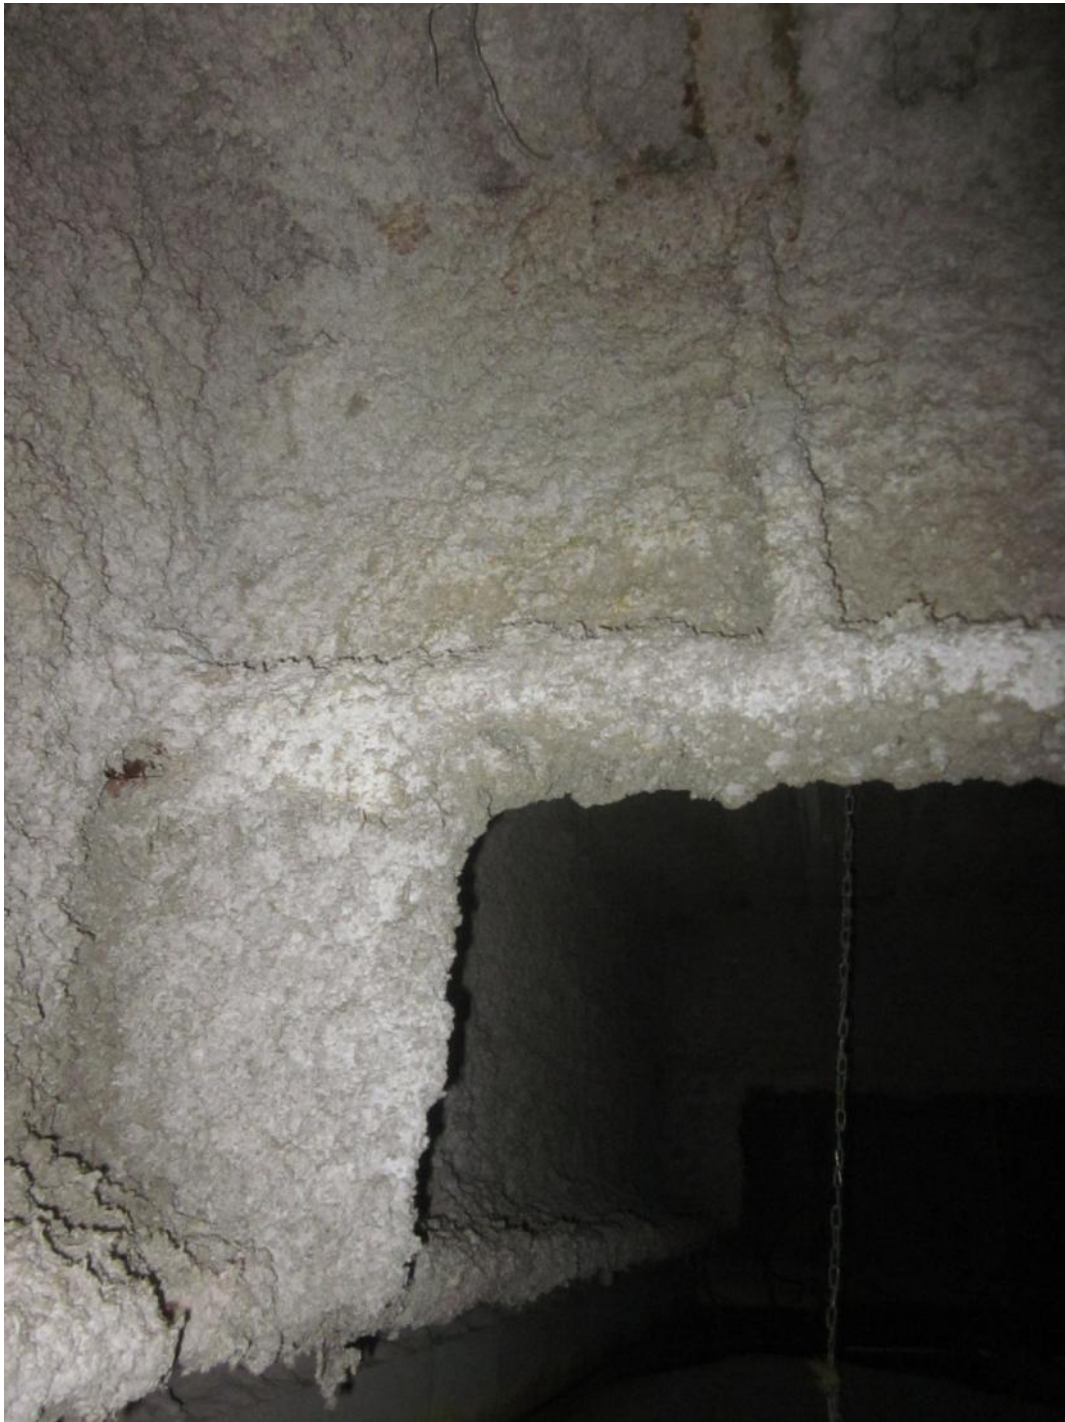
Photo #29

*This photo shows another of the sliding-bearing assemblies located along the west expansion joint of the multi-story building. Again no evidence of the expected movement of the framing members on opposing sides of the joint can be seen.*

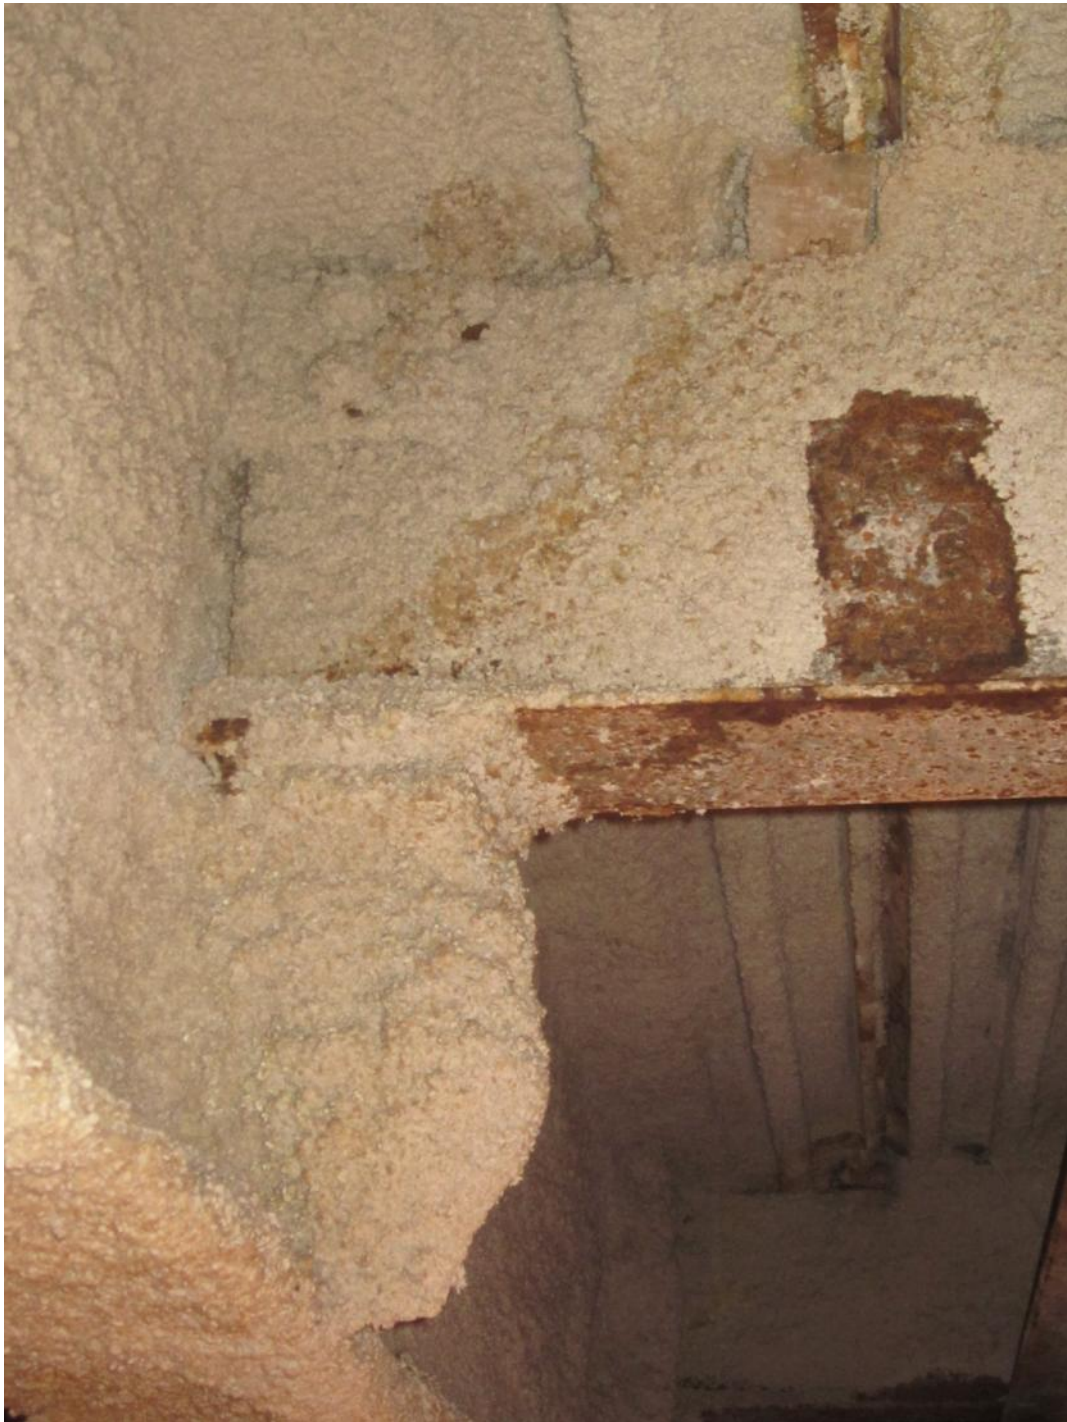
**Photo #30**

*This photo shows the sliding-bearing assembly located along the east expansion joint of the multi-story building. Note the lack of the bent plate and the installation of the metal roof decking between the roof girder and the joint.*

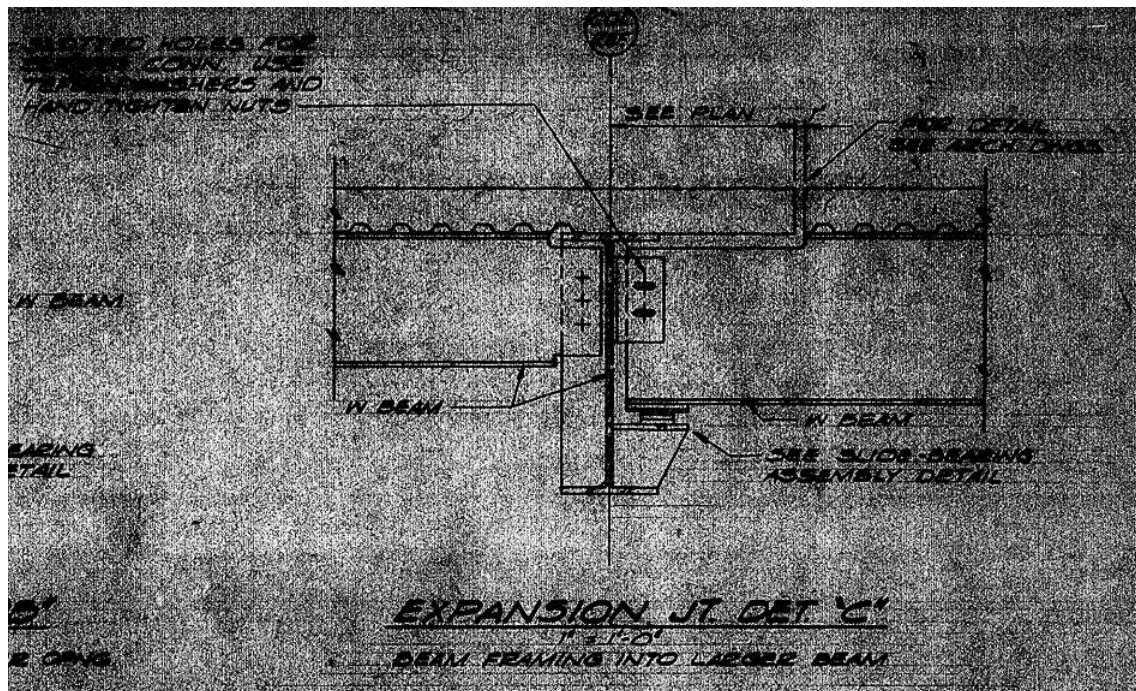
Photo #31

*This photo shows a copy of the typical roof framing level expansion joint detail in the multi-story building. Notice the steel bent plate that was to extend from the roof girder to the slab expansion joint.*

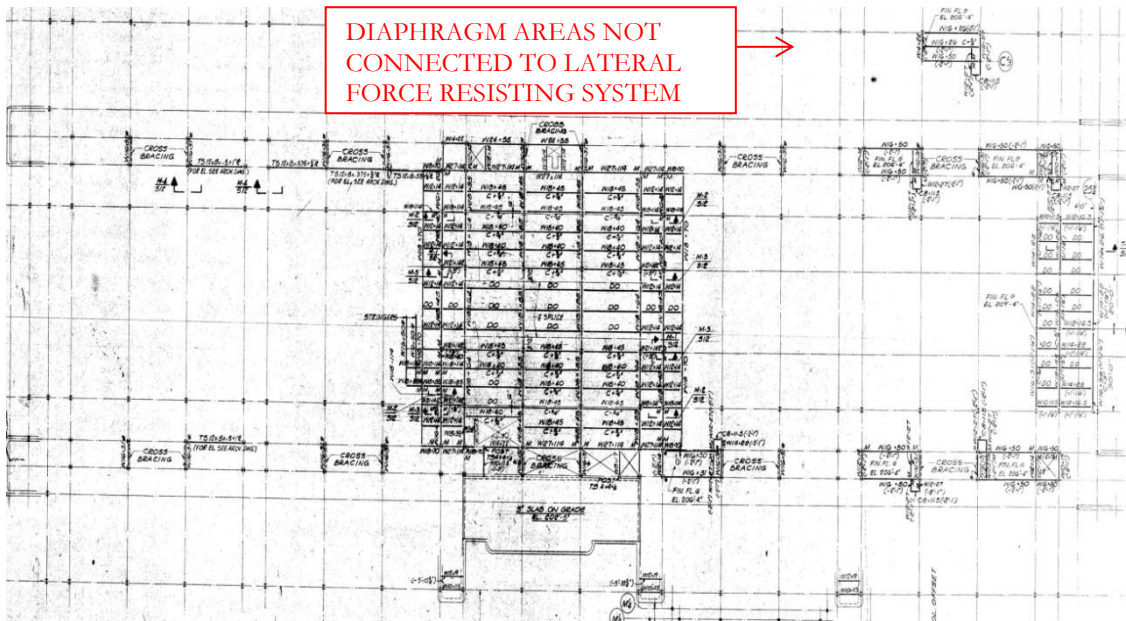
**Figure 4: Mall Framing Plan (scan of original design drawing)**

- Note that in several areas of the intermediate Mall level, diaphragms are not directly attached to the vertical bracing or moment frame lines, meaning that these areas do not have an explicitly designed bracing system. See Figure 4.

**Comments:** Various areas at the east side of the building, such as at the low roof overhang above the loading dock at the east façade, as shown on “Figure 4: Mall Framing Plan” do not appear to be connected to steel moment frames or cross-bracing. Therefore there is no lateral load path to resist lateral loads in these isolated diaphragms.

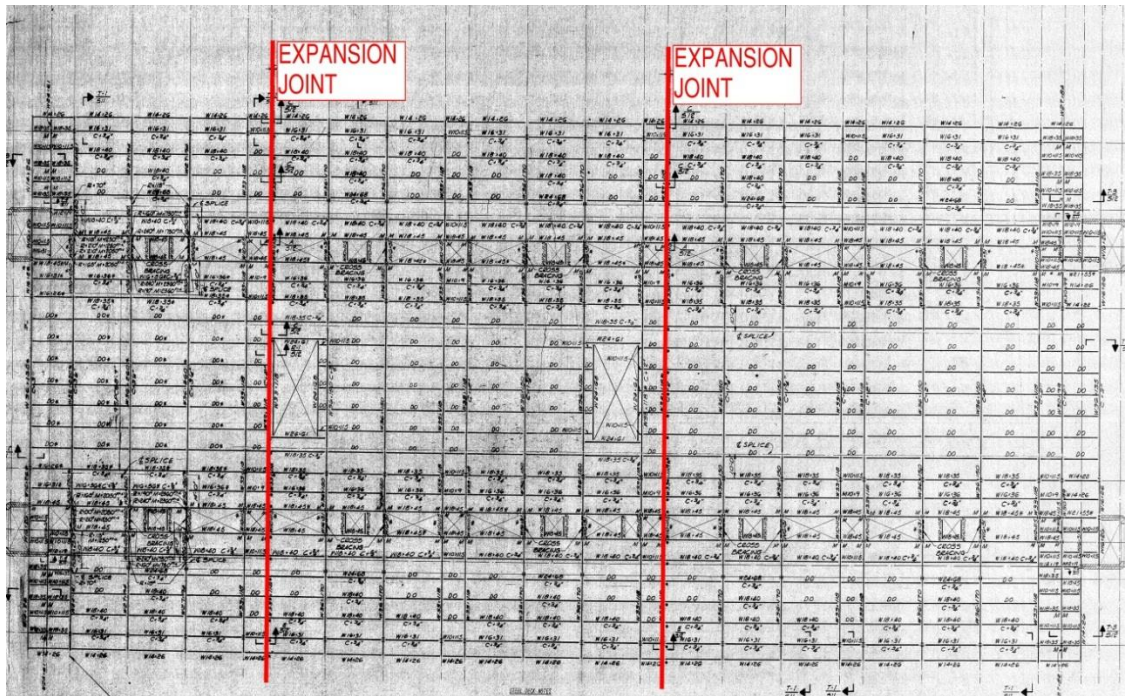
**Figure 7: Roof Framing Plan showing Expansion Joints**

The original structural drawings indicate two expansion joints, running north/south through the multi-story building at approximately the one-third points in the school building, See

Figure 7.

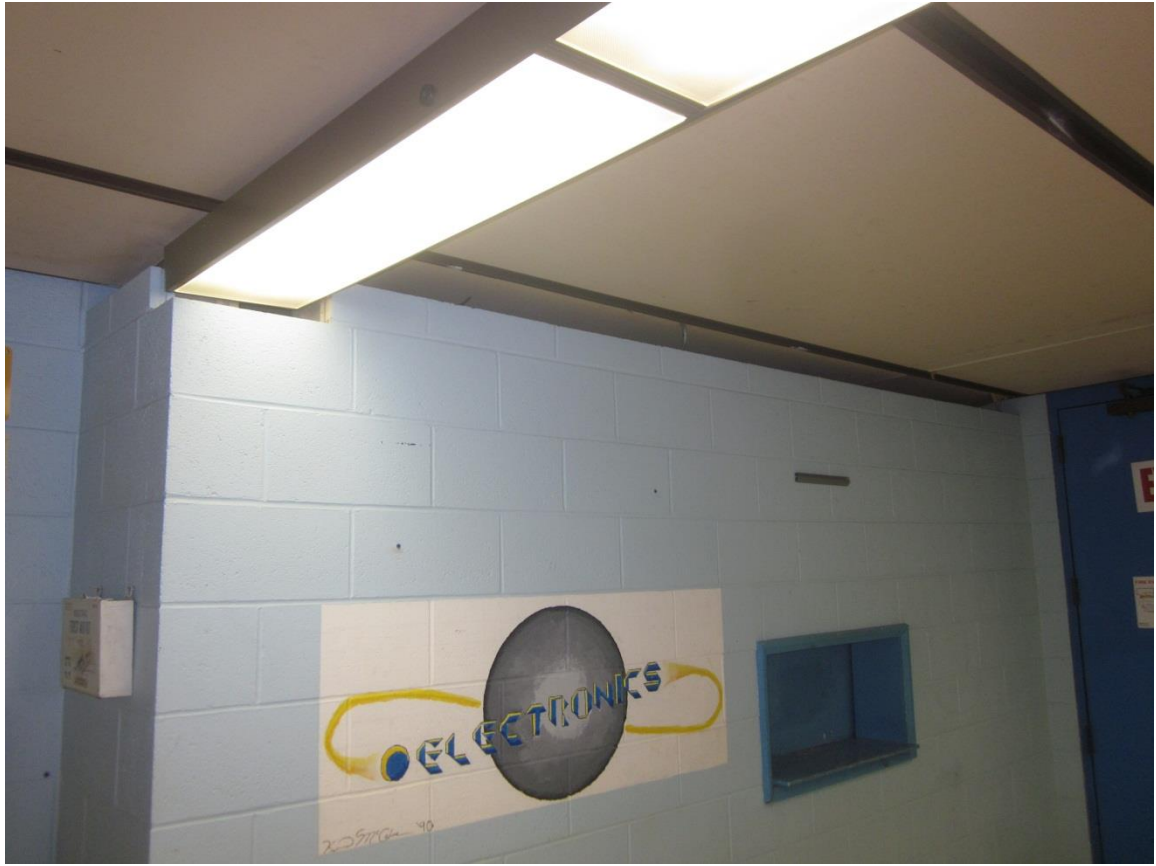
**Photo #4**

**Comments:** Unreinforced masonry did not appear to be braced at a spacing of 10 feet or less at various locations throughout the building. See photo #4 for a typical example of this condition.

*This photo shows a typical unreinforced masonry wall which is not braced at a spacing equal to or less than 10 feet.*

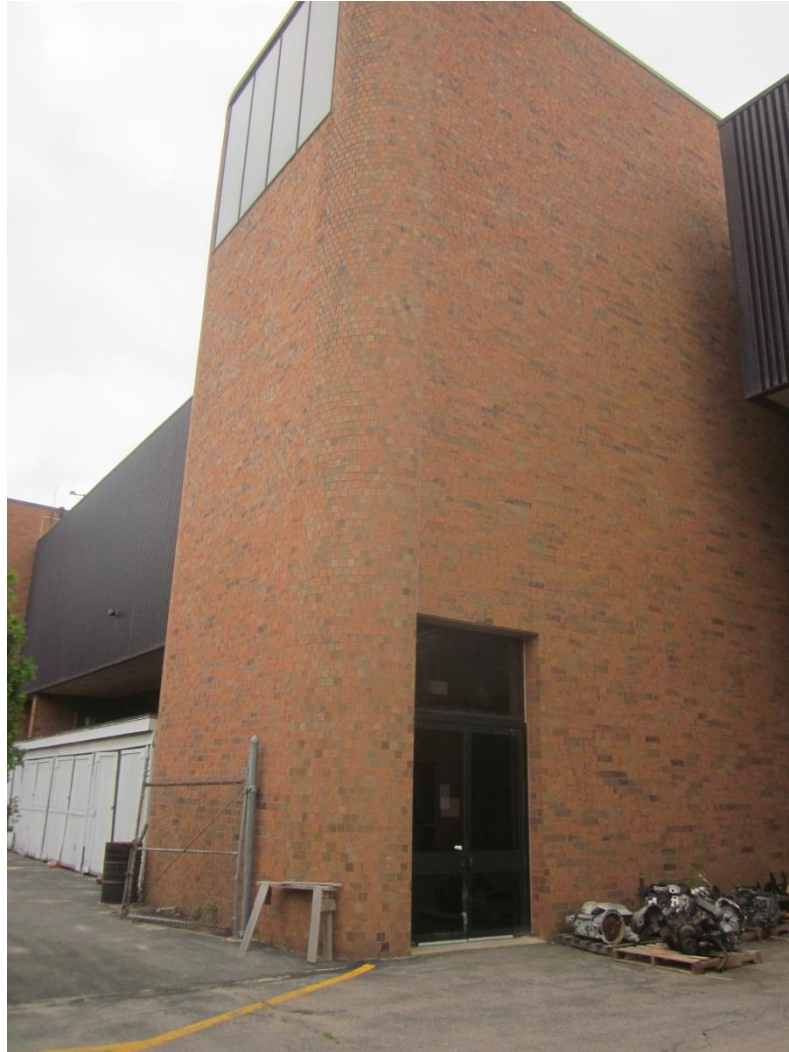
**Photo #5**

**Comments:** Shelf angles did not appear to be present in masonry veneer walls spanning more than 30 feet, such as at the exterior stair cores, which are over 40 feet high. See Photo #5.

***This photo shows one of the exterior stair cores. The masonry veneer is over 40 feet high and no shelf angles appear to be present.***

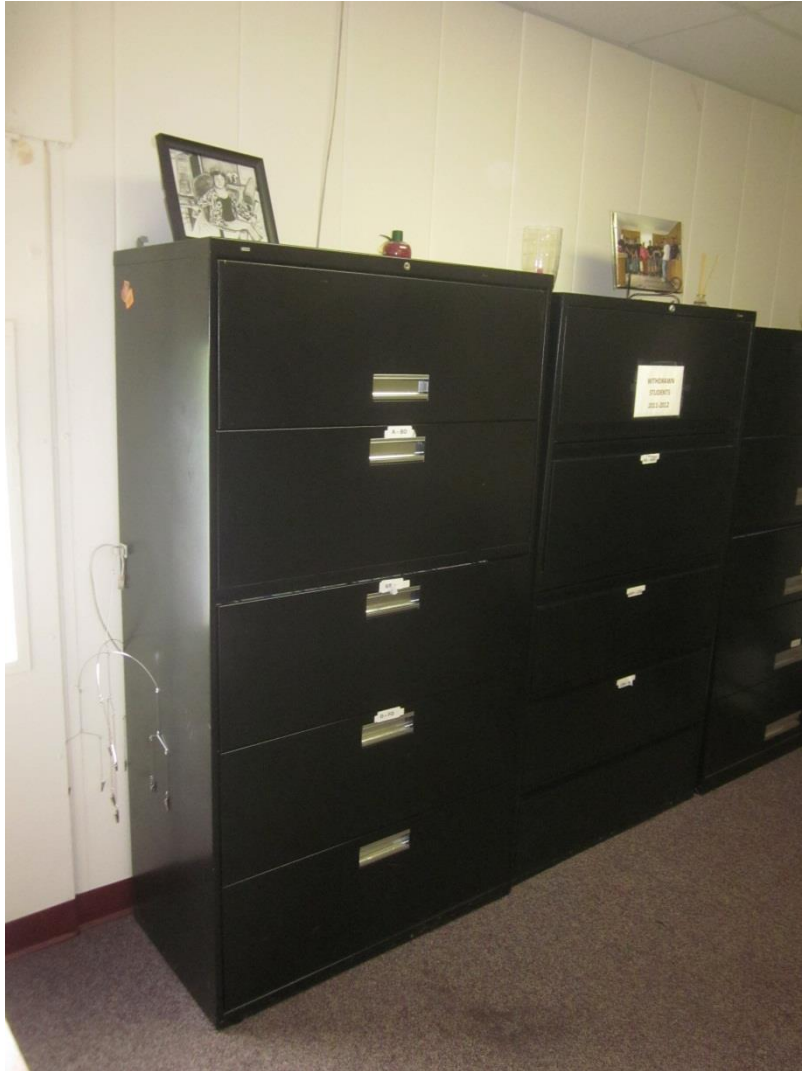
**Photo #6**

**Comments:** Various contents throughout the building do not meet this criterion. “Contents” are defined as any non-structural element inside of the building, such as furniture, cabinets, and equipment. The filing and storage cabinets in the Special Education area do not meet this criterion. See photos #6 and #7.

*This photo shows filing cabinets that are not anchored to the floor slab or adjacent structural walls.*

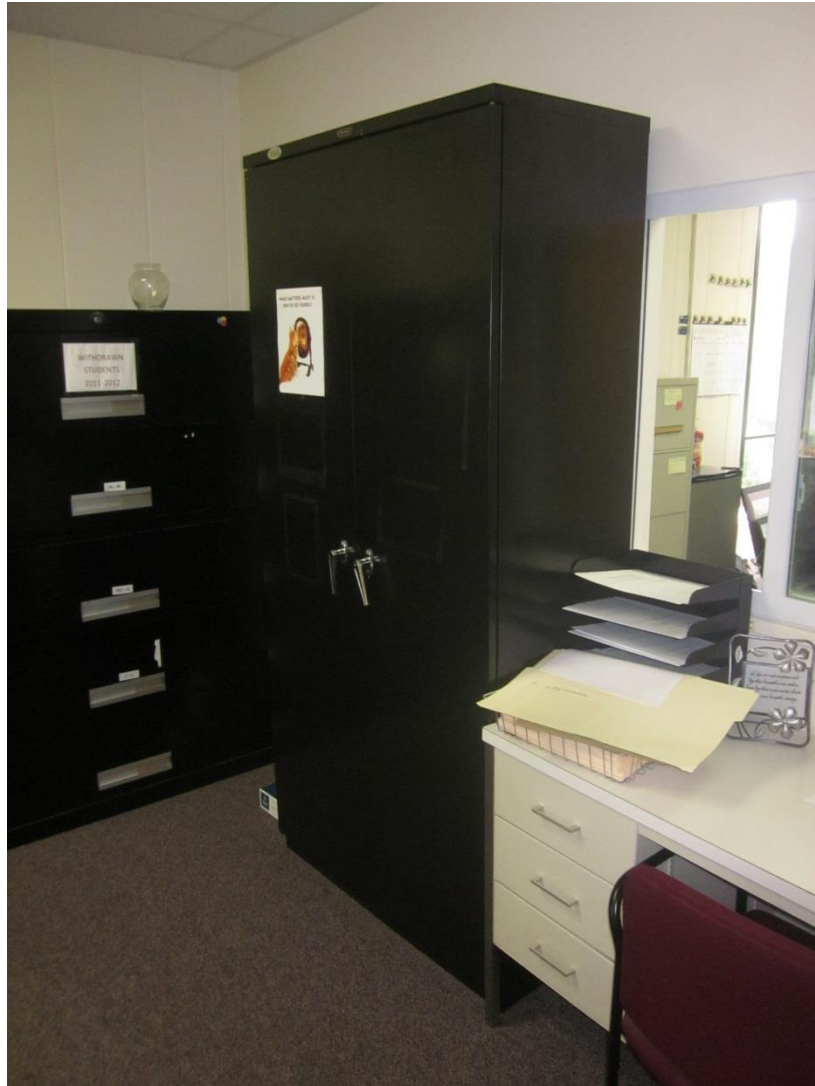
**Photo #7**

***This photo shows other piece of large equipment that is not anchored to the floor slab or adjacent structural walls.***

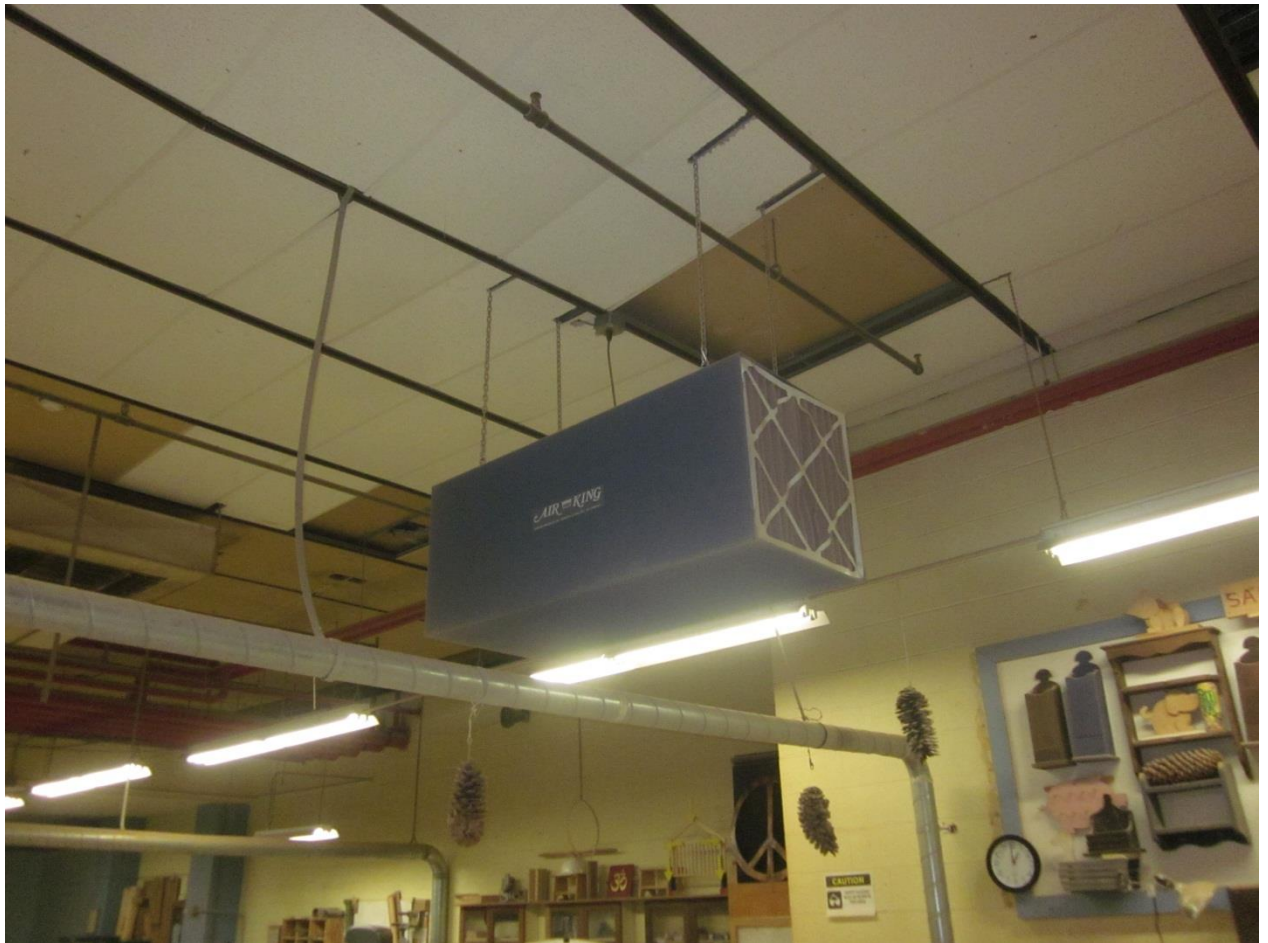
**Photo #8**

**Comments:** Various mechanical units and other equipment hanging from the ceilings and attached to walls are not braced. See photos #8 and #9.

*This photo shows a piece of equipment suspended from the ceiling with no lateral bracing present.*

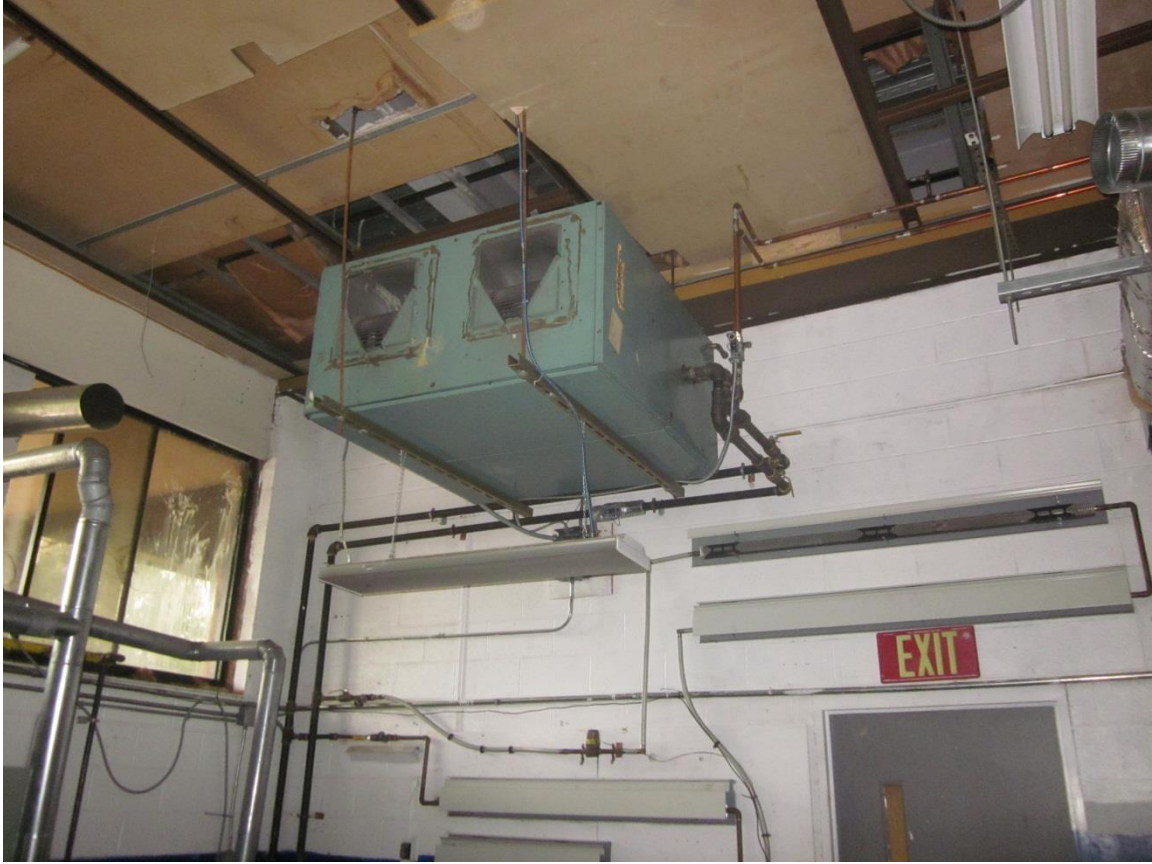
**Photo #9**

*This photo shows another mechanical unit suspended from the ceiling with no lateral bracing present.*

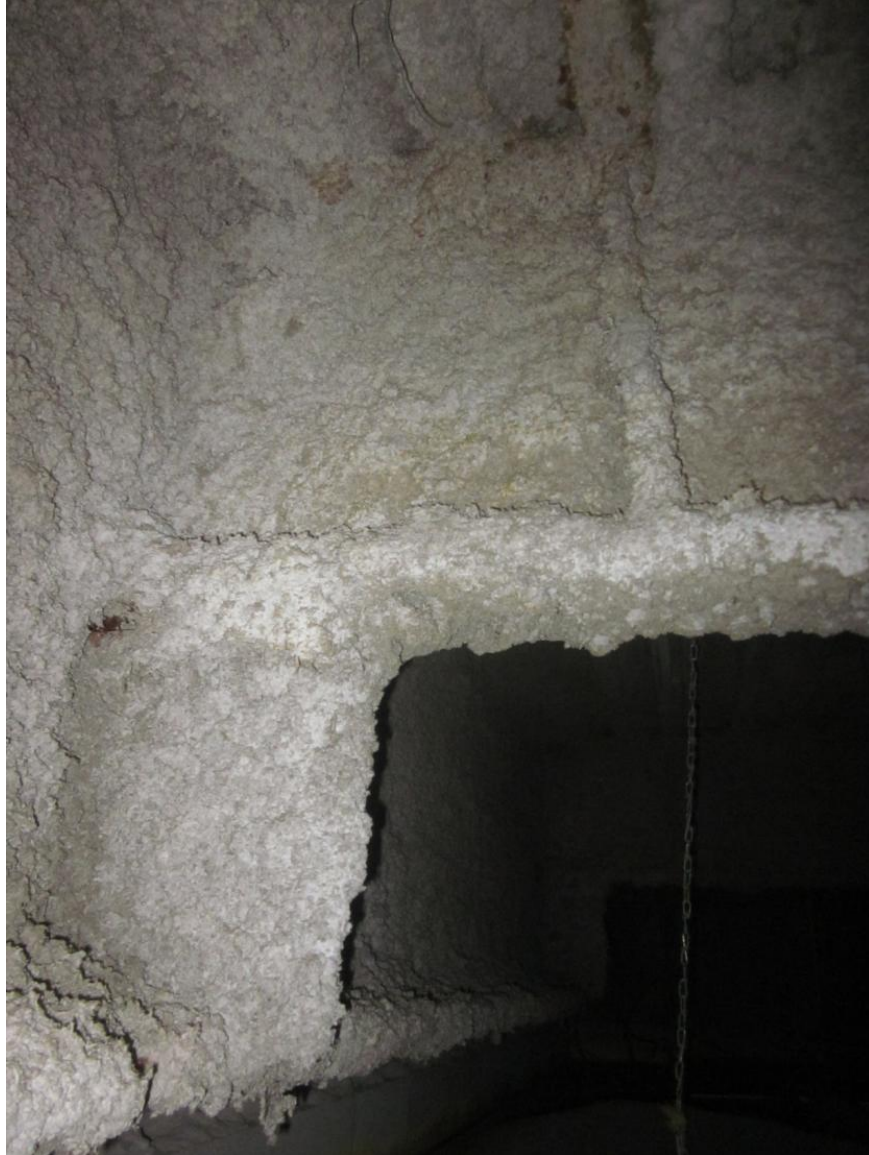
**Photo #10**

expansion joints were not constructed in conformance with the structural details on the original structural design drawings, see Figure 8 below. Instead of providing for a sliding joint in the roof plane (as indicated in the drawings), we observed that the joint in fact appears to be rigidly connected and unable to displace independently on each side as originally intended in the design (see photographs #10 and #11).

The roof framing members at the expansion joints are typically covered with a thick, stiff coating of spray-applied fire resistance material (SFRM), which appears to be original to the structure and is undisturbed even though it bridges between structural elements to either side of the expansion joint (see photos #10 and #11). Assuming that the expansion joints were functioning properly, cracks should have developed in the SFRM where the opposing sides of the roof framing structural members at the expansion joints would move relative to each other. No cracks in the SFRM or any other indications of movement of the opposing members on each side of the expansion joints were in evidence as would be expected if the expansion joints were moving.

*This photo shows one of the sliding-bearing assemblies located along the west expansion joint of the multi-story building. No evidence of the expected movement of the framing members on opposing sides of the joint can be seen.*

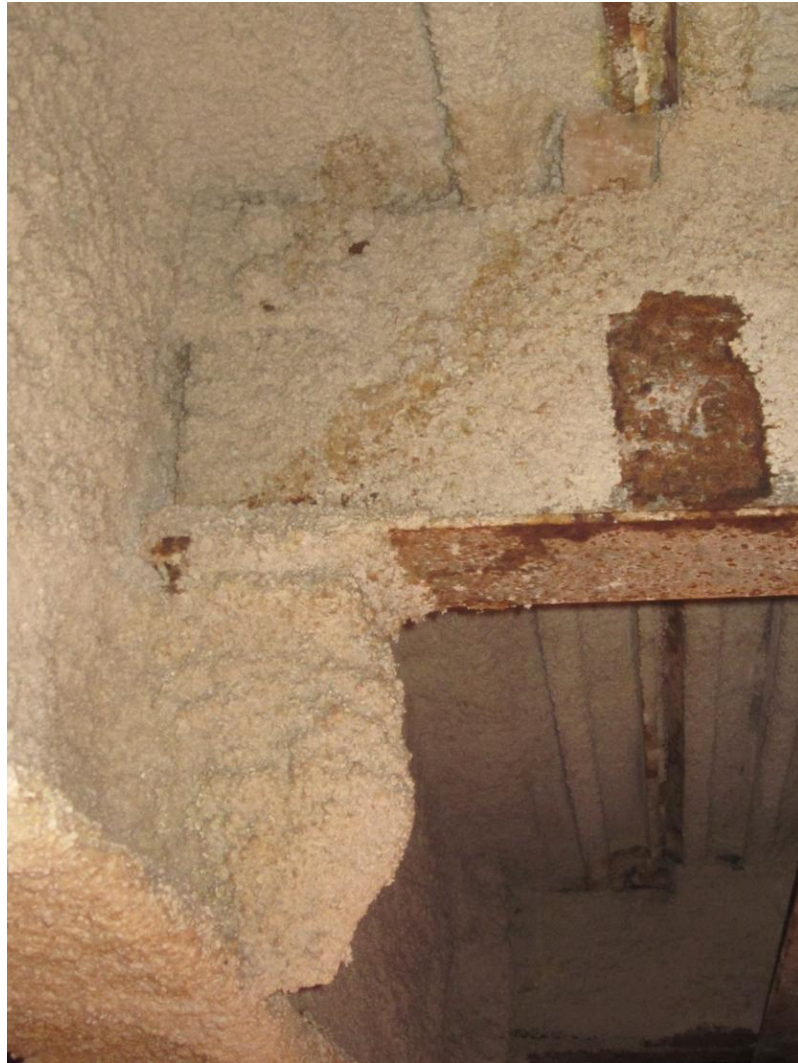
**Photo #11**

*This photo shows another of the sliding-bearing assembly located along the east expansion joint of the multi-story building. Note the installation of the metal roof decking between the roof girder and the joint, contrary to what was shown on the structural drawings. There are also 2x shims installed between the deck and the beam below, which do not appear to coincide with the design intent of the joint.*

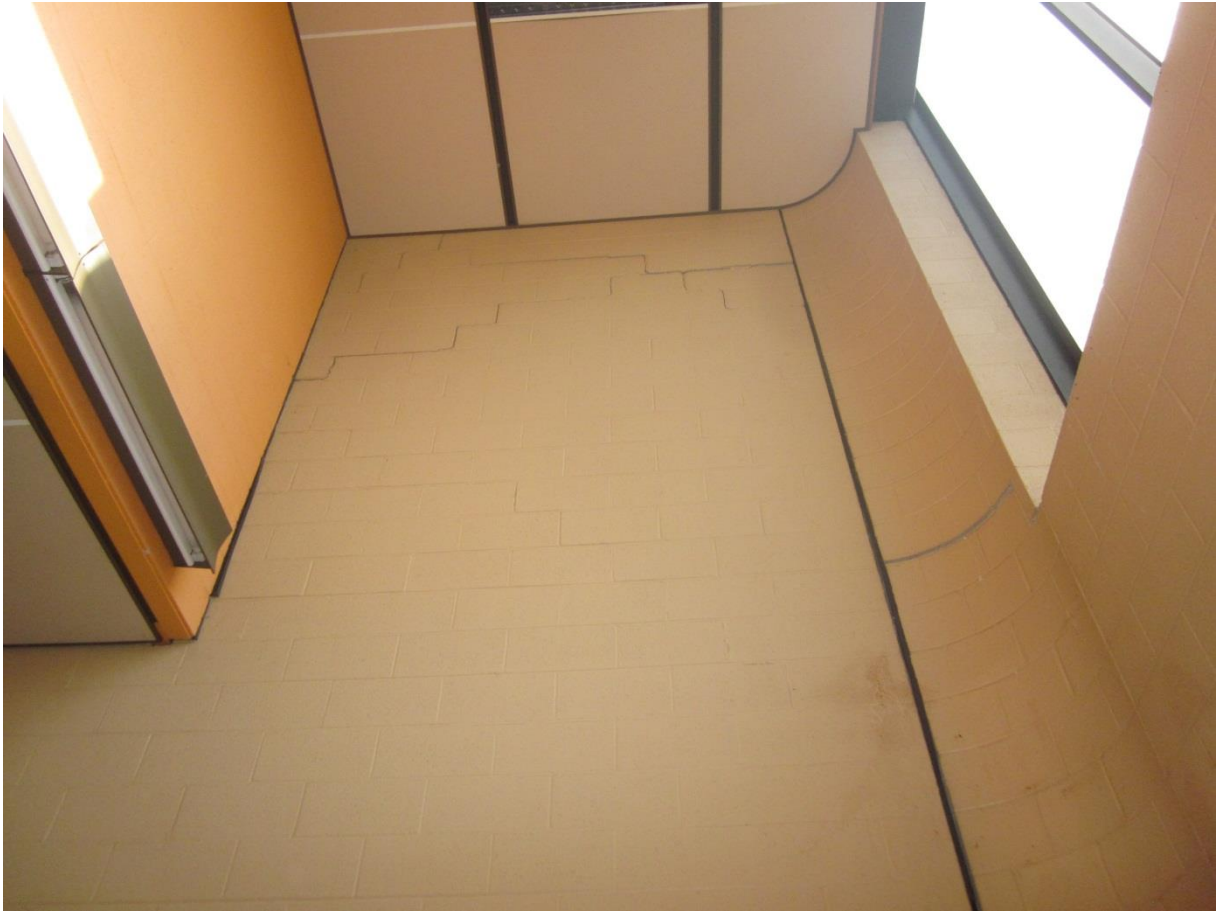
**Photo #12**

conformance with the original design details and intent thus resulting in the concrete roof slab effectively tying together both sides of the expansion joint, likely restraining the movement of the joint. The apparent lack of functioning expansion joints may cause excessive movements of the steel framing over the length of the building and may be exacerbating the cracking and displacements of the masonry walls found throughout the building, especially at the stair towers (see photos #12 and #13).

*This photo shows the typical cracking of the masonry block walls found at each of the multi-story stair towers located at the east and west ends of the school building.*

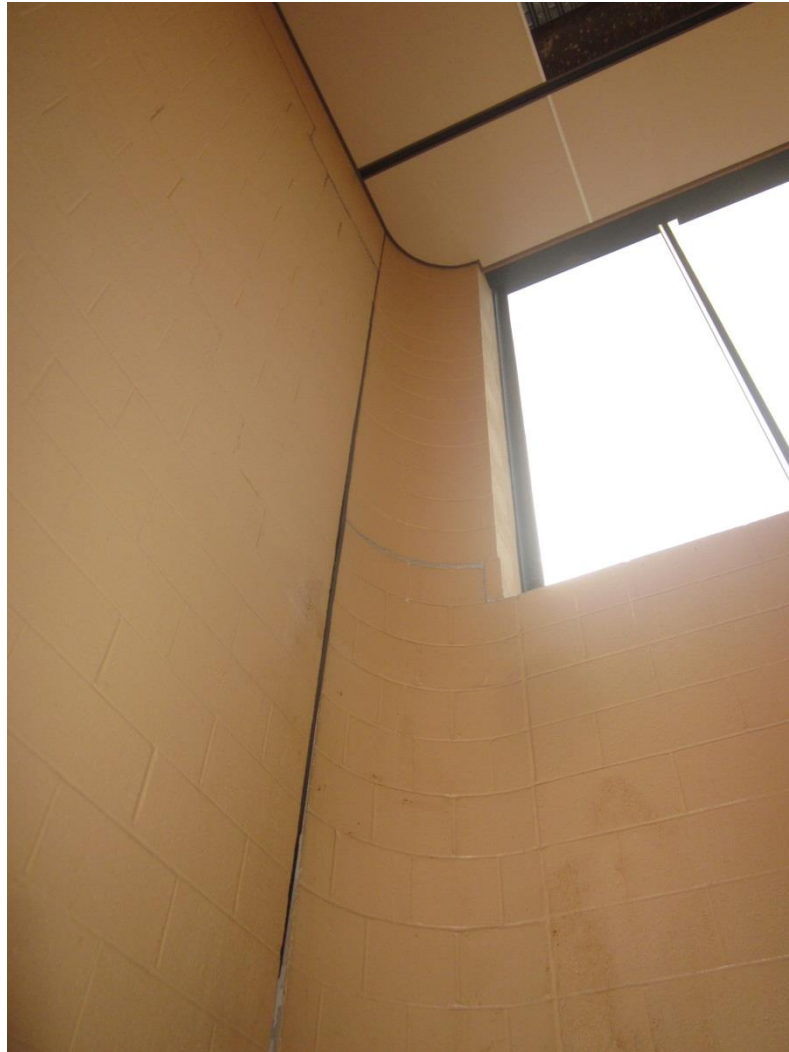
**Photo #13**

*This photo shows the vertical crack in the load-bearing masonry block walls of one of the multi-story stair towers at the east and west ends of the building.*

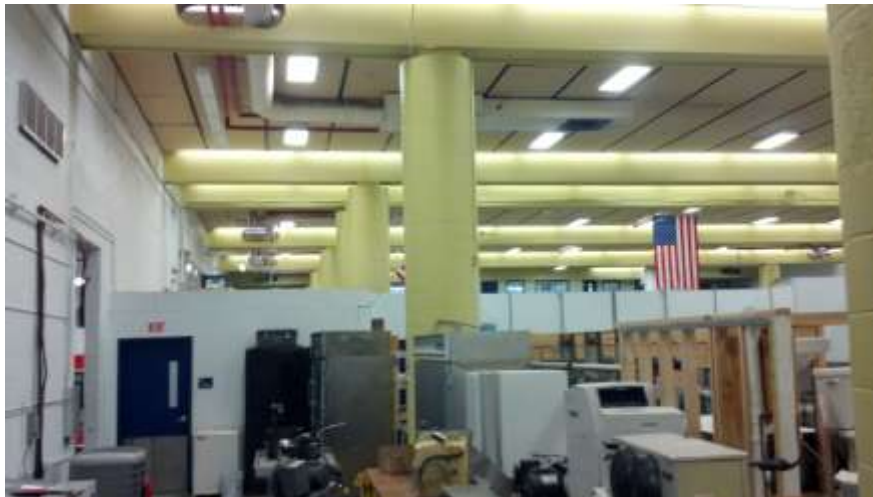
At the discharge of each velocity reduction terminal unit, is a small length of un-insulated galvanized sheet metal ductwork with a single supply diffuser for providing ventilation and temperature air to each occupied area. All ceiling diffusers are noted to have surface soiling with overall condition consistent with their age.

All supply ductwork was soiled on the exterior, however, was not damaged and can be reused. All velocity reduction terminal units, discharge ductwork beyond the velocity reduction terminal units reached their maximum serviceable life and should be replaced with new pressure independent document control VAV boxes with new hot water coils.

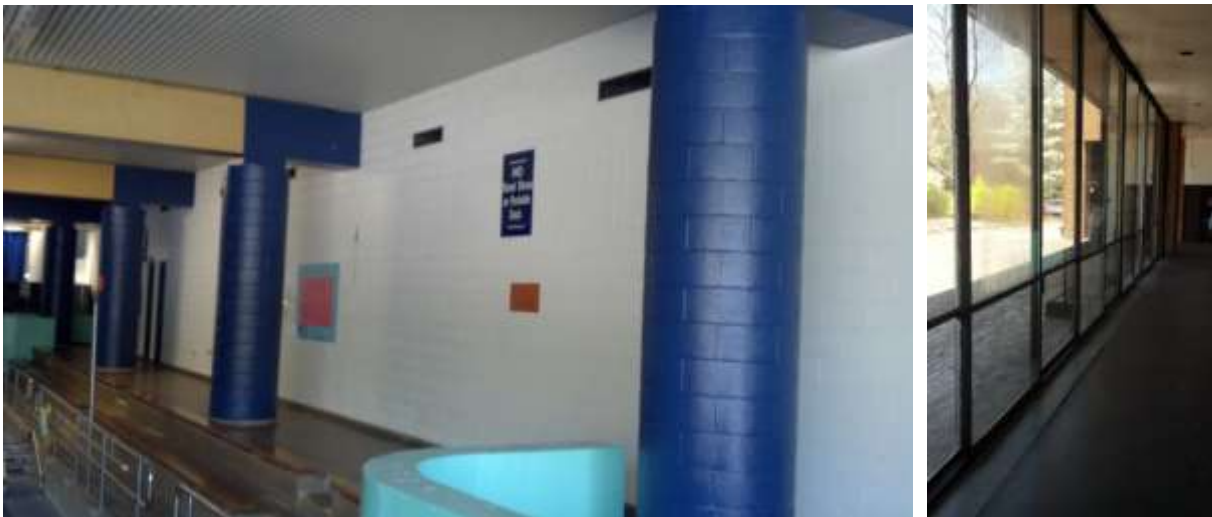
The pool area is provided with typical velocity reduction terminal units which are typically located throughout the entire building. All equipment was noted to be in similar condition to the remainder of the building. Air distribution for the pool area utilizes side wall supply registers located approximately 16 feet above the floor which discharge horizontally across the pool area. All supply registers are noted to have surface soiling and contamination and generally have reached their maximum serviceable life.

There is no dehumidifier or control scheme to address humidity generated by the pool.

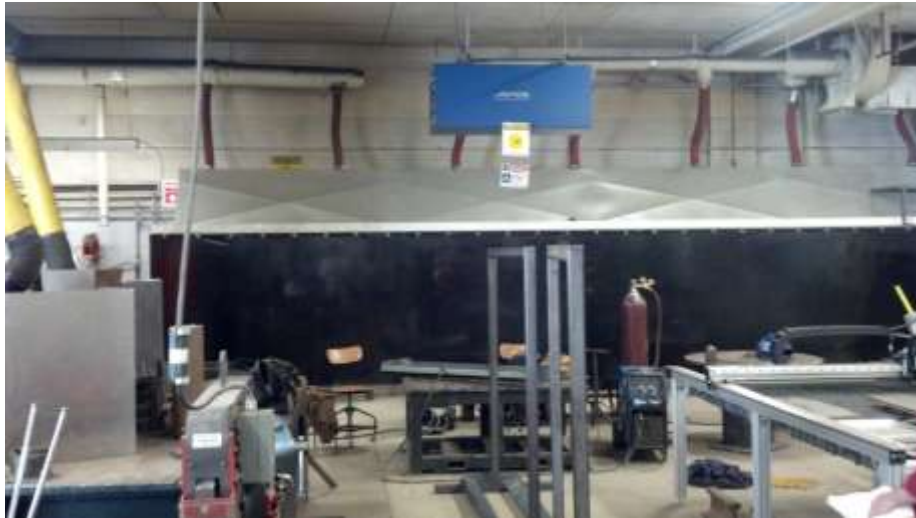
The welding area is provided with a series of welding benches located at one side of the space. A canopy type capture hood was recently installed over the bank of benches, replacing a flexible exhaust snorkel system. This canopy hood is ducted to a space mounted centrifugal exhaust fan. Other stand-alone welding benches are provided with a flexible exhaust capture type snorkel system that ties into an overhead common exhaust duct which is ducted to a space mounted centrifugal exhaust fan. The exhaust system does operate and appears to be sized with common industrial ventilation standards. Because of its use, the system is extremely contaminated and replacement is recommended.

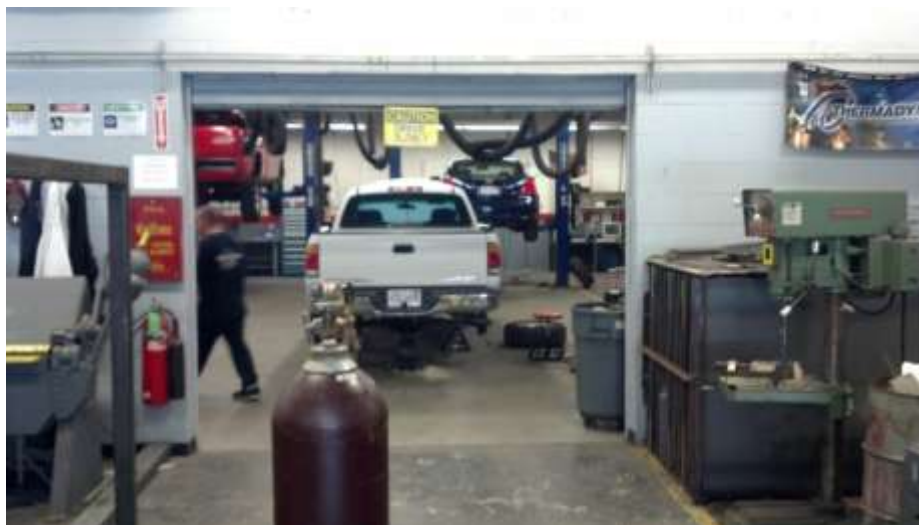
The automotive repair area is provided with an under floor vehicle capture exhaust system which through the use of flexible hoses connected to the exhaust tailpipes, other vehicles ventilate exhaust gases to the exterior of the building. The sheet-metal ductwork which is located between the floor and the fan is damaged and vented. It does appear that the system is sized in accordance with the common industrial ventilation standards, however considering its age and use, replacement is recommended. The under floor vehicle capture exhaust system is constant volume, rather than variable volume depending upon the number of hoses in use.

It appears that there is no interlock between these vocational area exhaust fans and the Penthouse air handlers supplying air to the spaces. Depending on how many exhaust fans are operating, the vocational areas could be starved for make-up air, which reduces the effectiveness of the exhaust system. The Penthouse air handler outside air dampers should be interlocked to the number of operating exhaust fans so the space receives adequate make-up air.

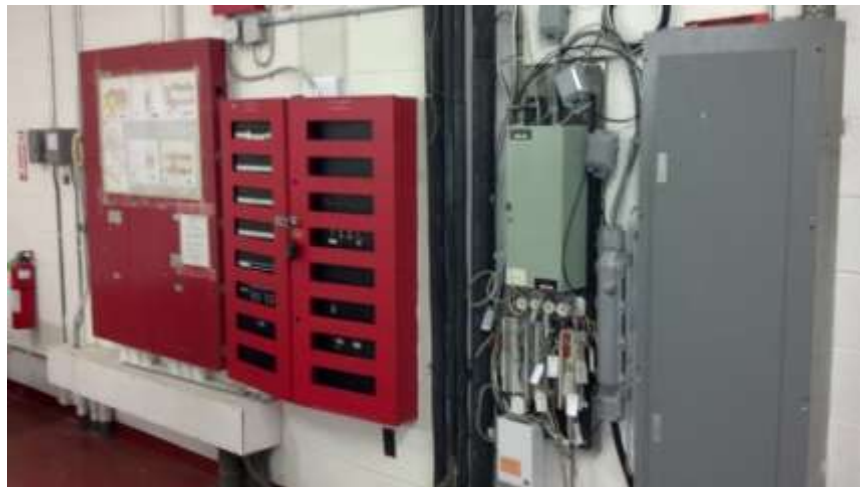
The existing fire alarm system consists of a conventional Faraday fire alarm control panel located in the fire alarm control panel room. System smoke detector coverage consists of mainly smoke detectors adjacent to corridor smoke doors only. Horn/strobe units exist mainly in corridors and are generally not of the ADA type. Some ADA compatible horn/strobe units have been added within one wing but mounting heights exceed ADA guidelines. The system transmits a signal to the fire department via a digital dialer. The existing Faraday Fire Alarm system is obsolete.

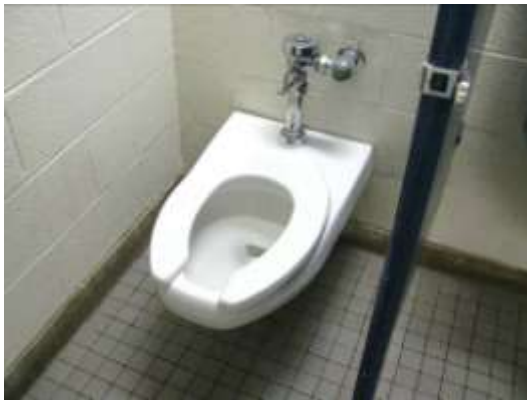
*Typical Water Closet*

The existing water closets bowls and flush valves were replaced with 1.6 GPF fixtures. The water closets are wall mounted vitreous china, flush valve type with siphon jet action. Some flush valves had the interior workings replaced to make them 1.6 GPF. Other 1.6 GPF flush valves were new and required a supply piping offset. The water closets are in good condition.

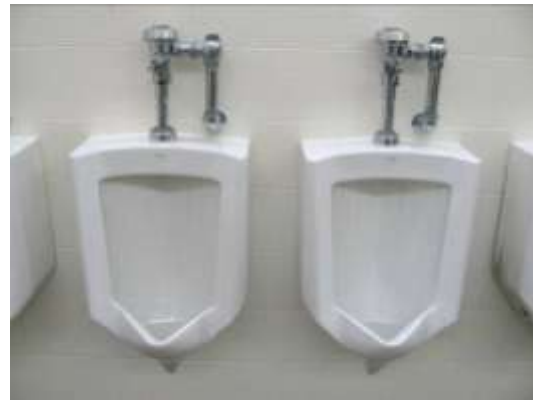
*Typical Urinal*

The urinals and flush valves have been replaced with 1.0 GPF fixtures. Some of the flush valves required a supply piping offset, see picture. The urinals are wall hung, vitreous china, flush valve type with siphon jet action. The urinals are in good condition.
