758 MARRETT ROAD  
LEXINGTON, MASSACHUSETTS 02421

Michael McKeon  
**Kaestle Boos Associates**  
325 Foxborough Boulevard #100  
Foxborough, Massachusetts 02035  
October 29, 2013

This updated structural evaluation of the Minuteman High School, located at 758 Marrett Road in Lexington, MA, was undertaken at the request of Mr. Michael McKeon, AIA, of Kaestle Boos Associates, Foxborough, Massachusetts.

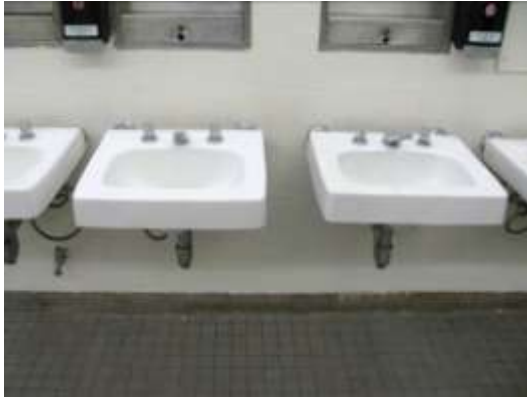
*Typical lavatories in large toilet rooms*

Lavatories in large toilet rooms are wall hung vitreous china. In smaller toilet rooms the lavatories are a mixture of china and stainless steel self-rimming bowls in a vanity. The faucets are widespread 8" metering type faucet with hot and cold water push buttons and a separate spout. The lavatories are in fair condition.

- Provide water conserving handicap accessible fixtures throughout the building in compliance with current code.
- If a major building up-grade is not done, refer to the following items.
- Replace all lavatories with new low flow fixtures, including handicap accessible fixtures.
- Replace all electric water coolers with new, including handicap accessible fixtures.
- Replace all mop receptors and janitor sinks with new fixtures and provide backflow protection for soap dispensers to comply with code.
- Replace showers with new low flow fixtures, handicap accessible fixtures. Replace floor drains and mixing valves
- Replace emergency showers with accessible fixtures with tempered water with a recirculation system.
- Water of the appropriate temperature would need to be supplied to fixtures whether by a two temperature piping system or through the use of tempering valves and/or fixtures.

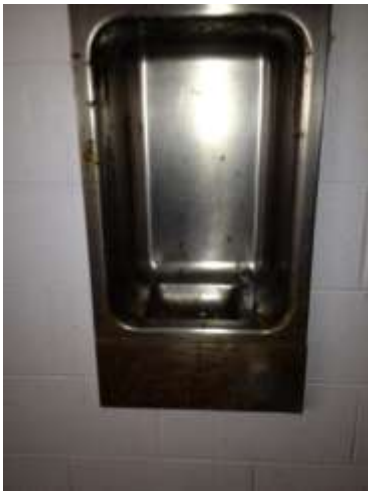
*Typical Drinking Fountain*

The electric water coolers and drinking fountains are fully recessed, all stainless steel finish with pushbutton control. Water drinking fountains area are rusted and in poor condition and non ADA compliant.

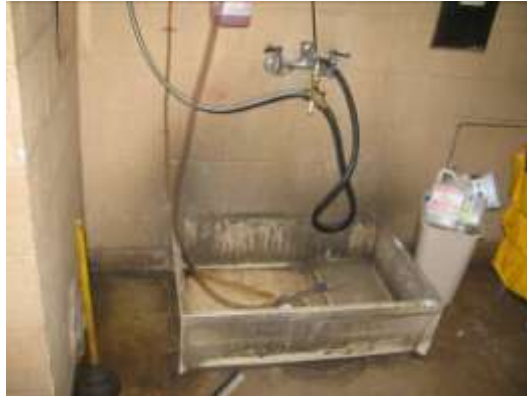
*Typical Mop Receptor*

The janitor's sinks are cast iron rolled rim wall hung type with stainless steel rim or heavily stained molded stone mop receptors. The wall hung faucets have been replaced and now have vacuum breakers. The mop receptor basins are in poor condition. Janitors sinks do not have proper backflow prevention.

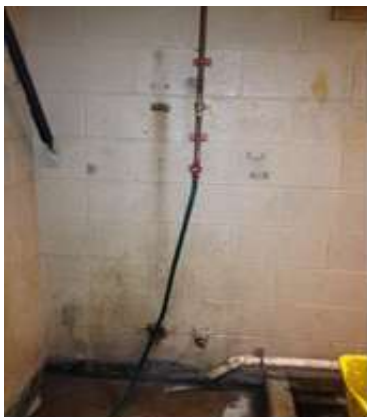
*Hose Connection without Vacuum Breaker*

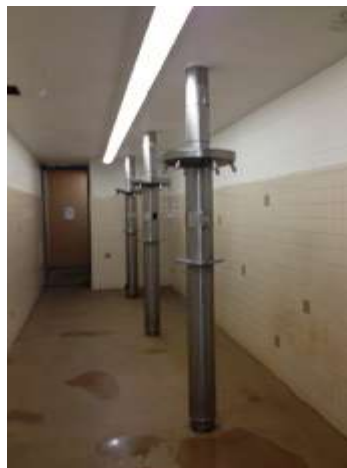
*Showers in locker Room*

The locker room showers are old but appear to be in fair condition. Some modifications have been made due to failure of the shower valve controls. A mixing valve is located above the ceiling. Some of the shower heads are not functional.

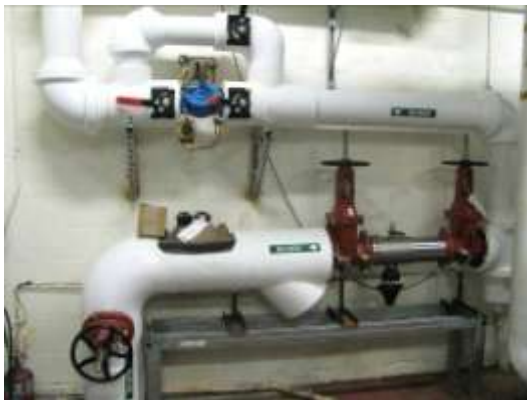
*Boiler Room Water Service*

The building is supplied with two domestic water services, one from the north and the other from the south which have had their curb stops, water meters, pressure reducing valves, backflow preventers and shutoff valves replaced recently. The north side domestic water service is a 4" service and the south side domestic water service is a 6" service. The domestic water pressure is approximately 90 psi.

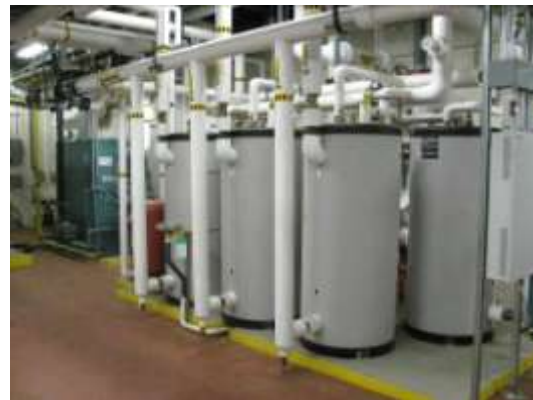
*Water Heaters Fed from Boilers*

The domestic hot water heating equipment has recently been replaced and is now indirect fired off the building heating boilers. There are five domestic hot water storage tanks each with heat exchanger. There are 2 large boilers and 1 small summer boiler. There are two master thermostatic mixing valves on the system in parallel however a single valve meets the present load. The system distributes 140 degree hot water to the kitchen and 120 degree water to the rest of the building and the swimming pool. There are three return systems with aquastats and circulator pumps. The circulating pump are old and appears to be in damaged condition. There are reports that it is difficult to obtain hot water in some areas of the building indicating possible problems with the 120 degree recirculation system. Piping in pool equipment room copper piping and supports are severely corroded.

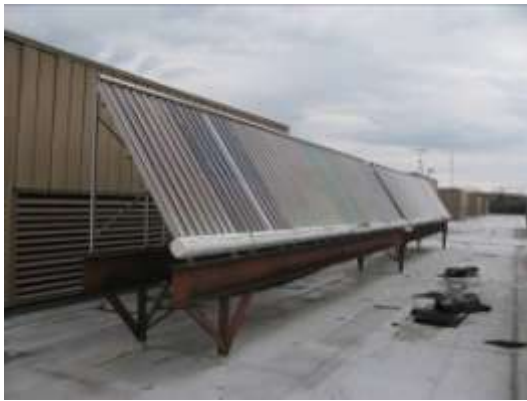
*Abandoned Solar Collector*

There are two abandoned geothermal tanks and one abandoned solar hot water tank. Both of these systems are abandoned in place. The late 1970's solar collector tubes have failed and are

no longer available so they are abandoned on the roof. The 140 degree electric point-of-use hot water booster heater in the kitchen is no longer required and has been abandoned in place.

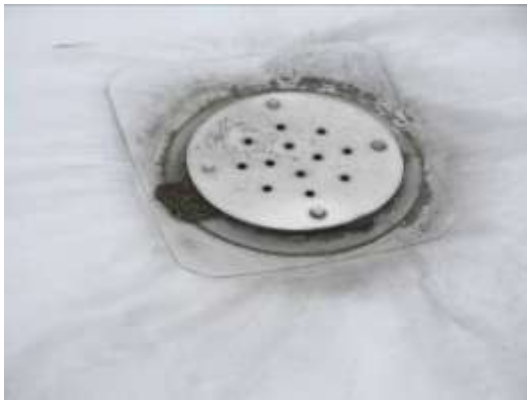
*Typical Roof Drain*

The sanitary and storm drainage piping systems are cast iron. The exposed piping is visibly in good condition.

- Replace all roof drains to comply with code. Architect to provide secondary roof drainage scuppers. Horizontal above ground waste and storm piping should be video inspected for any interior corrosion and blockage. Consider replacement in its entirety if found excessive corrosion due to its age.

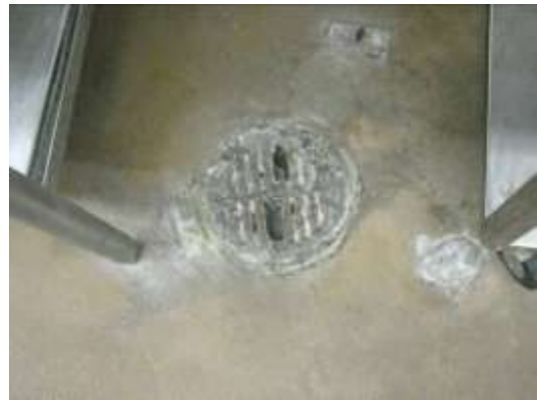
The sanitary drainage system is piped to a municipal sewer system. There are no reports or re-occurring problems with the sanitary drainage system other than the locker room floor drains drain extremely slow or not at all. The floor drains in the kitchen are in very poor condition.

*Typical Kitchen Floor Drain*

- Replace all kitchen floor drains and provide trap primers to comply with current code.
- When the kitchens are upgraded segregate waste piping and extend to an exterior grease interceptor.
- Replace locker room floor drains with ones with sediment buckets and trap primers. Rod and clean out the drainage piping.
- Update acid waste and drainage systems. Update classrooms to provide accessible workstations.

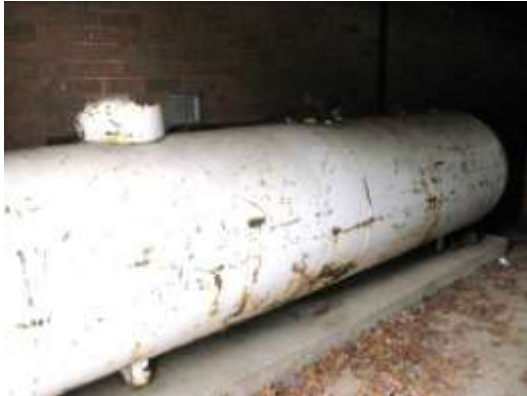
*Generator Propane Tank*

The building has 2 PSI elevated natural gas service that feeds only the three heating boilers. There are (3) 1,000 gallon, above ground propane tanks on the property, two on the north side and one on the south side of the building. Propane is provided for an exterior generator by a single 1,000 gallon tank within a shed. Propane is provided for the kitchens and science labs by two 1,000 gallon tanks within a fenced area outside. Propane is provided to the trade shops by a single 200 gallon tank located outside the shops. Each science lab has a master gas shutoff valve located in a recessed cabinet.

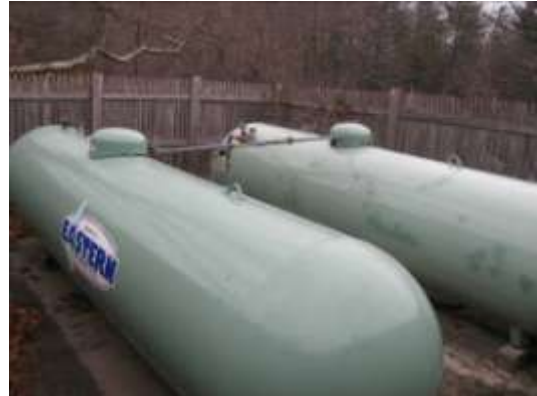
*Kitchen & Science Lab Propane Tanks*

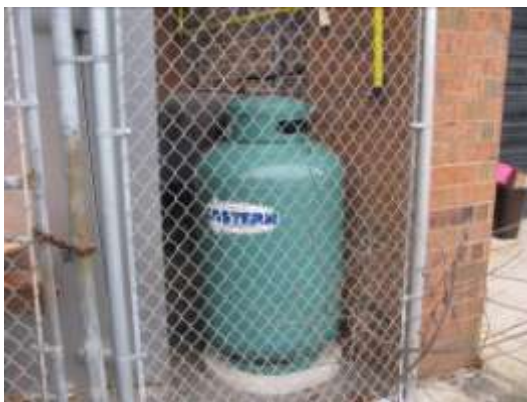
*Trade Shop Propane Tank*

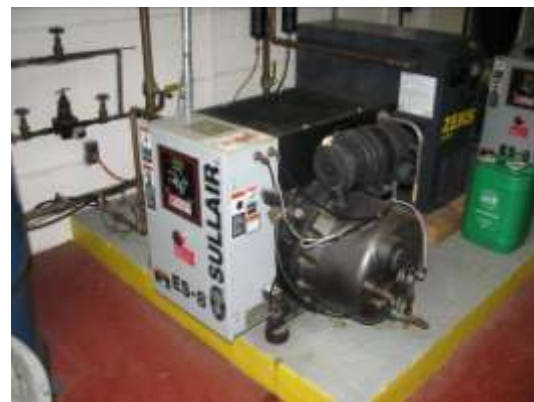
*Duplex Air Compressors & Dryer*

There is a central duplex air compressor in the boiler room that supplies the carpentry and automotive shops with multiple compressed air drops and hose reels. The compressed air distribution system pressure is 140 PSI. Each compressed air drop is provided with a quick connect fitting. The central air compressors also provide air to the science labs. The air compressors, receiver and dryer are relatively new and in good condition.

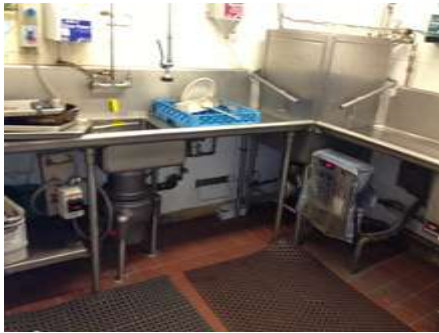
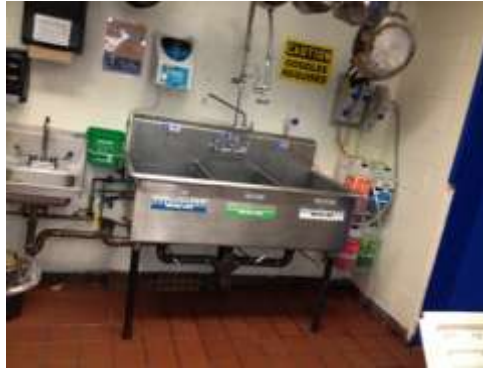
The kitchen equipment is generally aged but in working condition which indicates the vintage of the time of installation. The cooking equipment is all propane fired. There are manual emergency shutoff valves on the gas supply to the kitchen systems and training kitchen cooking equipment. Exhaust hoods are provided with fire suppression systems.

There is a three pot sink in the main kitchen that has a point-of-use grease interceptor. The three pot sink in the restaurant kitchen has a grease interceptor recessed in the floor. Kitchen has eye wash station and

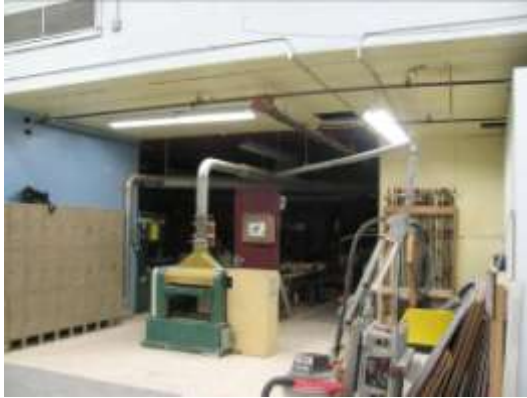
There is no fire protection sprinkler or standpipe system installed in the main building; however, there is a limited area fire protection sprinkler system in the wood shop and spray booth that is supplied off of the domestic water system. There is a 4" double check valve with a flow switch located in the wood shop. Valves are locked and chained and not properly supervised. Supply pipe from the domestic system is steel piping.

*Carpentry Shop with Sprinklers*

- Where the carpenter shop sprinkler water steel piping connects to the copper domestic water system provide a check valve to keep rusty water from entering the domestic water system.

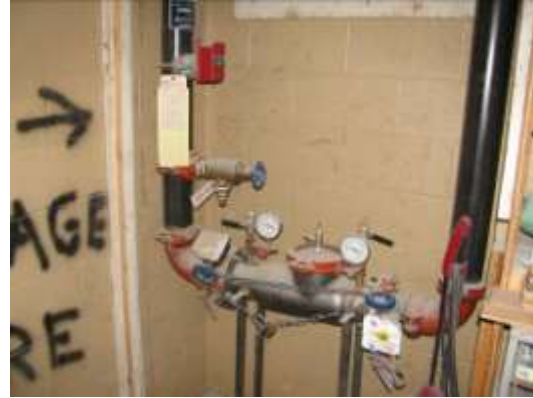
*Sprinkler System DCVA & Flow Switch*
