To: Mr. Kevin Mahoney	Date: August 11, 2014	Gale Job No. 828170 P03
Minuteman Regional High School 758 Marret Road Lexington, MA 02421	Re: Boiler Roof Replacement and Skylight Repairs Minuteman Regional Vocational Technical High School Lexington, MA	
<b>RE: Stair Materials</b>

Minuteman Roof Replacement Site Visit 8/11/2014

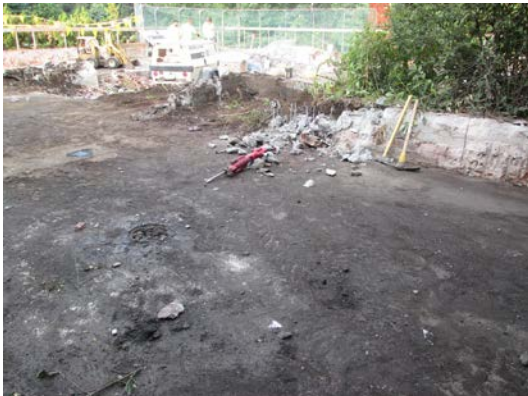
Photo A

1. Prior to the construction meeting, Gale met with Capeway and Capeway’s demolition crew to review the work progress.
2. The existing concrete roof deck appears to be in sound condition where the existing over burden has been removed; photograph A. Final cleaning of the deck will be required to remove loose dirt/debris.
3. Gale investigated the reported leak location which had occurred through the lower roof slab, into the computer room; photograph B represents the hole through the roof deck which was reportedly sealed with hydraulic cement. Refer to the meeting minutes of this date for additional information concerning interior damages.

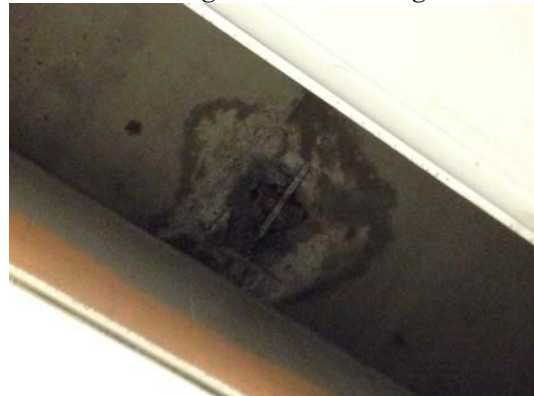
Photo B

4. Capeway's demolition crew indicated that the hole was a result of the stairway railings extending down, through the waterproofing system, and being secured to the structural concrete slab. This detail is different from that which was shown on the original building drawings, which indicates that the railing was set in light weight concrete fill, above the waterproofing system; refer to Image C for an excerpt of the original building drawing which was used as a basis for the design.

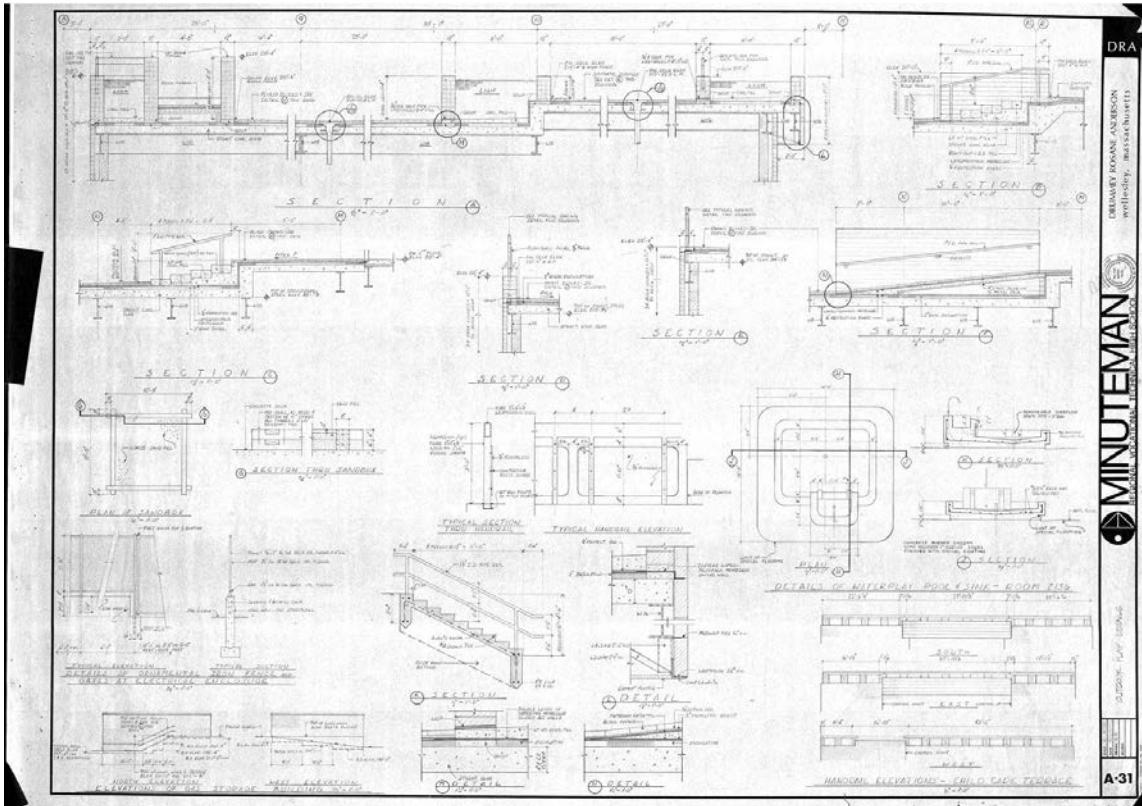
Image D – original design drawing used as a basis for design.

5. Gale was also requested to review the existing planter curbs at the site. During the design phase, Gale reviewed the available structural drawings which were provided to this office, none of which had reference to the above deck plaza components. As such, the architectural drawings were used as a basis of the design. Image D represents one of the original design drawings which were presented to Gale and shows the condition of the plaza deck components of this area.

6. Both Images E and F represent close-ups of the original design sections presented in Image D. Each of the planter walls which extend up, above the plaza deck surface are depicted with the industry standard slanted hatch, which represents brick masonry units which are set atop a layer of grout on the structural concrete deck. The planter walls also represent that there are three wythes of masonry, which is consistent with the dimensions that were presented on the original design drawings, and were used as the basis for the design.

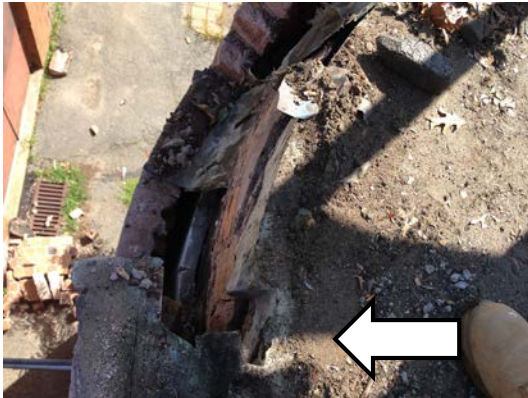
Photo G

7. This movement was reportedly a result of the concrete roof deck slab being cast around the railing on three sides, and either a lack of fastening, or fasteners that had been rusted out. Photograph G shows an area where the concrete roof deck has a notch where the railing had been placed.
8. Capeway's demolition crew indicated that the brick masonry roof edge/parapet cap was easily removed from the top of the wall, as there was no evidence of fasteners into the concrete deck to secure the masonry from lateral movement.
9. Capeway's demolition crew stated that a fabric coated copper flashing was placed intermittently between the concrete deck, and the brick masonry grout layer, which allowed the masonry to be removed easily in these locations; photograph H shows a section of flashing that had been partially removed from the wall.

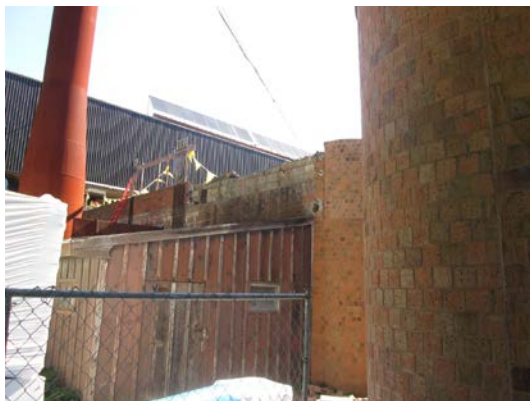
Photo A

1. Gale briefly discussed the displaced brick masonry wall conditions, throughwall flashings and potential fall hazard areas with all parties. Capeway’s demolition crew had removed the area which had been vibrating as a result of the other operations on the site; refer to photograph A.
2. All parties reviewed the areas where the existing concrete roof deck slab had been cast around the railing posts (photograph B), and noted that there were limited masonry anchor ties that could be seen in these locations.

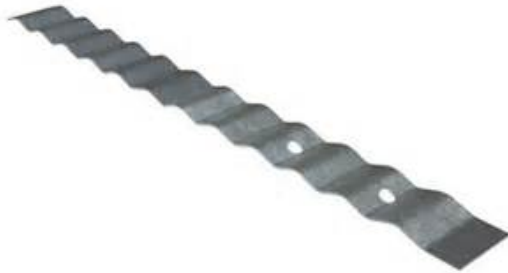
2. As directed by Minuteman, Capeway had performed four masonry test cuts in the lower elevation walls to review the existing masonry anchor conditions. Capeway’s demolition crew indicated that they found corrugated anchors at the upper limits of the wall, and adjustable pintle and eyehook anchors at the lower limits. Refer to Images C and D, which are internet images of the types of ties found.

Photo C – internet image of a corrugated wall tie (recommended for interior applications only)

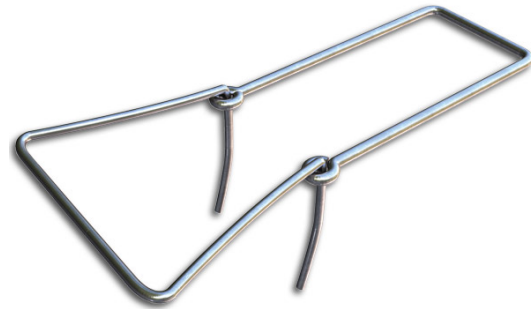
Photo D – internet image of an adjustable pintle and eyehook tie

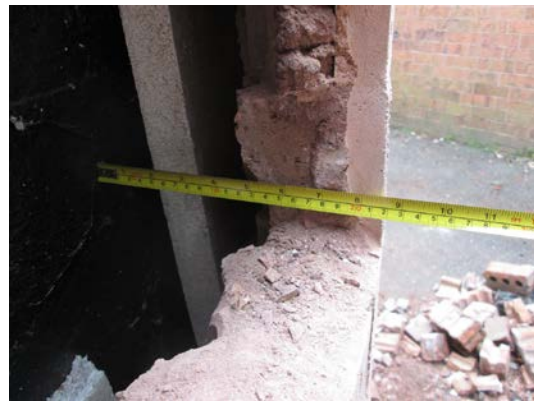
Photo J

8. The test cuts revealed multiple different conditions related to the adjustable ties, which ranged from partially engaged pintles, missing pintles, and rusted eyehooks. Refer to photographs J, K, L, M and N.

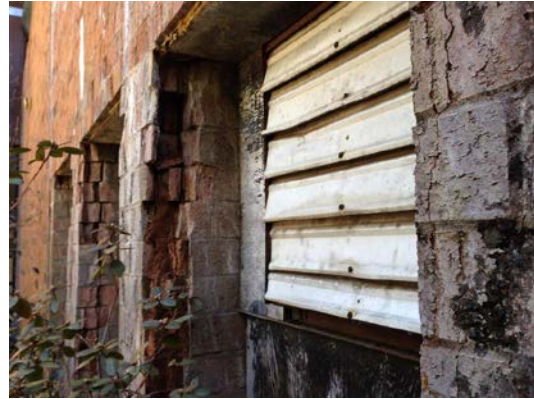
Photo B

2. Upon removal of the brick masonry, it was determined that the concrete masonry units that were used to surround the window/louvered openings, was constructed with two wythes of four (4) inch concrete masonry units (CMU), in lieu of eight inch CMU.
