# SCOPE STUDY

**Carroll County Career &  
Technology Center**

**Board of Education of Carroll County  
Westminster, MD**

**August 23, 2006**

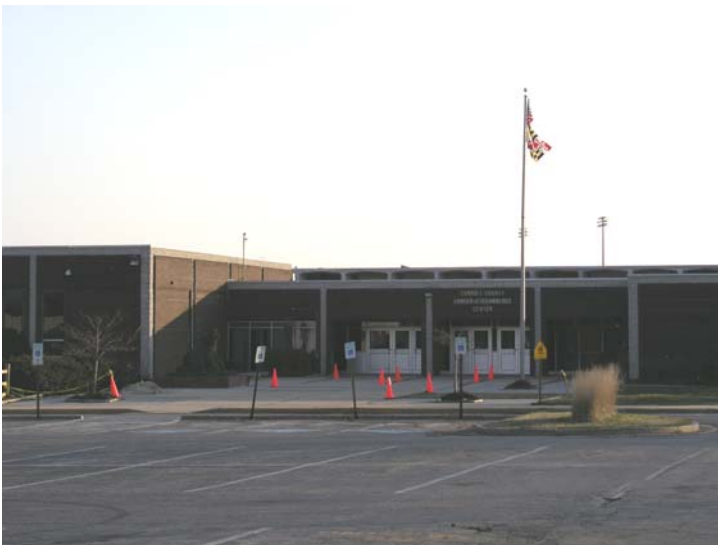
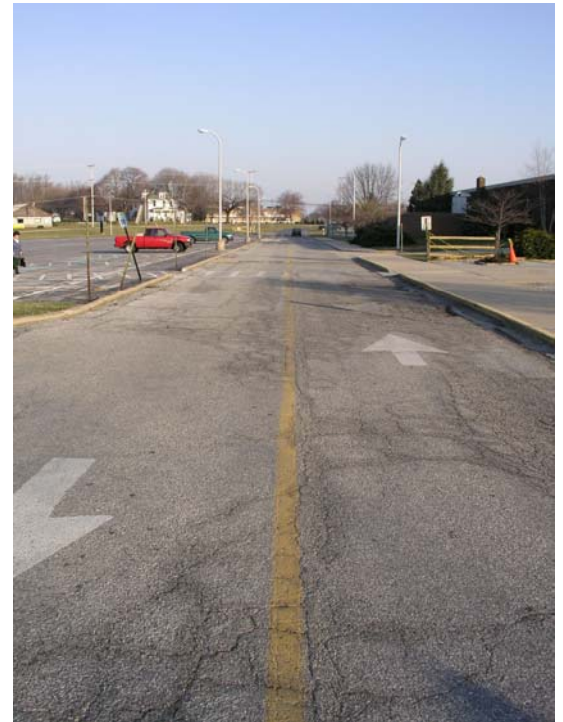
Currently, the center is accessed from a driveway leading around the perimeter of the building connecting to the access road at Westminster High school, which in turn accesses Maryland Route 32. The driveway serves as the only means of ingress and egress for the site. Consequently, there is a mixture of bus, delivery, parent, staff and service vehicles entering the site. While the adjacent photo indicates an apparent long linear access to the school, the actual access points are very limited.

Generally, the existing parking lot is in need of serious repairs. The photo on the previous page shows how the wearing surface has completely dried and demonstrates the impacts of UV rays over the years. The visible cracking will require a major expenditure to bring the surface up to a usable condition. Obviously the surface course is in the worst condition; however it is not known if the subsequent courses reflect the same type and quantity of cracking.

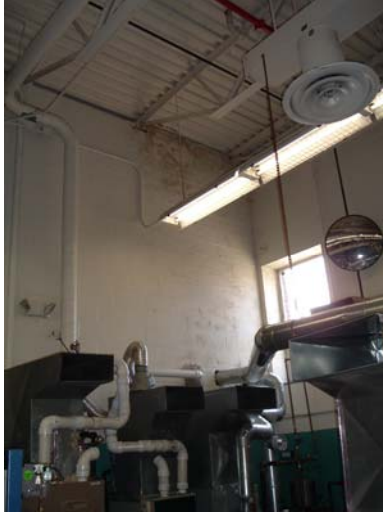
Figure 3

The mortar joints of the brick veneer appear to be in poor condition (see figure 2). Numerous leaks in the building have been occurring as a result of the failed mortar (see figures 3 & 4). This has caused damage inside the building. Select areas of mortar have been repointed at areas where leaks are active. Efflorescence is present in numerous locations, indicating heavy water penetration inside the masonry cavity. The entire building should be repointed or the brick veneer removed and replaced as part of a major renovation. The windows in the original building should be replaced with aluminum, thermally broken windows.

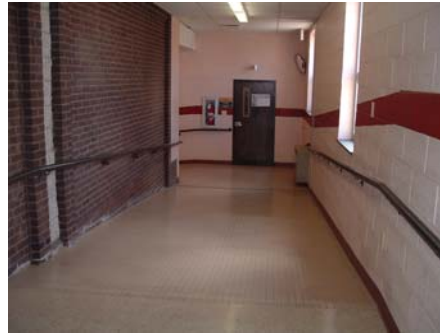
Figure 10

The school has several locations of grade-changes. Stairs are located at the end of the northwest corridor, thus not allowing at grade egress from the building. The carpentry and masonry labs both have stairs from the main corridor down into the lab and classroom. No accessible route from inside the buildings to these spaces exists. The ramp from the original building to the addition does not meet the maximum slope requirements of 1 inch rise over 12 feet of run as required by the ADA (see figure 10).

A full code analysis must be performed for the selected option. It is assumed that fire zones will need to be created, with full fire walls. Mixed-use and high hazard separation walls may be needed. All means of egress must be evaluated with doors added and/or enlarged to meet code standards. All area must be made fully accessible. Additional ramps, lifts, and other features should be explored as needed. All doors and hardware must be fully ADA-compatible and must meet all Life Safety and other requirements.

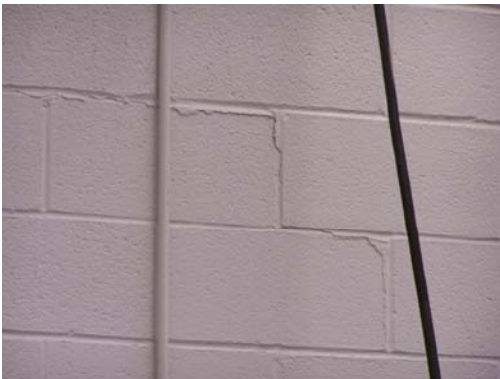
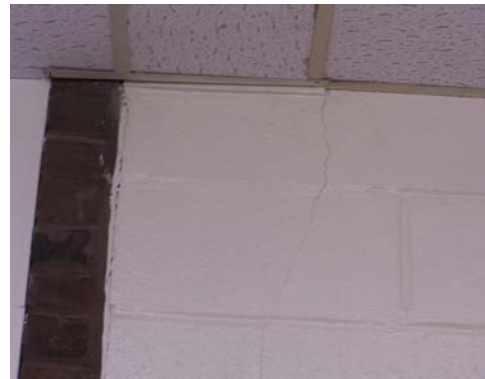
Based on our limited visual observations, the existing structure appears to be in good condition. We did not observe any signs of distress which would indicate a structural problem, and, at this time, do not anticipate any significant structural modifications other than those required for the proposed additions and renovation. The masonry walls and the brick all appear to be in good condition. A very minimal amount of cracks were observed in some of the interior masonry walls. We do not believe these pose structural concerns.

There were a few maintenance items, that although they are not a problem now, could develop into one if left as is. In a few locations, there is evidence of failing mortar joints. Continued exposure to freeze/thaw cycles will cause these joints to leak, allowing moisture into the building. We recommend these be re-pointed.
