Zsafia Pasztor

TREE RETENTION DECEMBER 2018

On November 19-20th, 2018, at your request, I performed a complete tree evaluation at the address of the Talus Middle School in Issaquah WA.

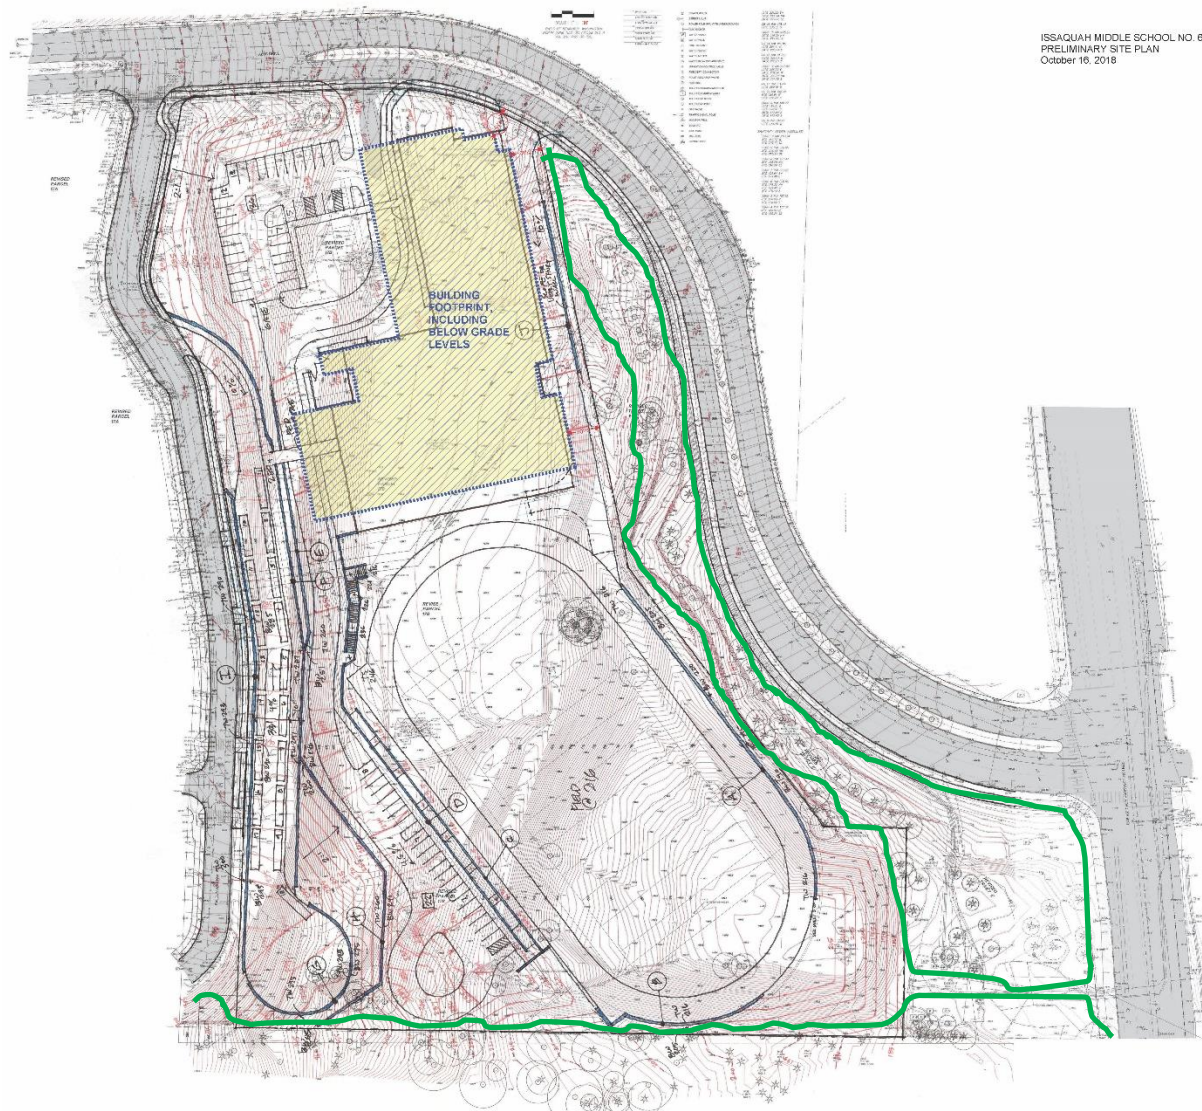
The trees on the neighboring property were tagged by the surveyor company assessing the neighbor's site. These trees are in generally poor health. The trees are on the edge of a forested area and they all show moderate to severe wind damage. Many of the trees within the forest are leaning, about to fall or already fell. Some are dying, others are dead. Roots are exposed on almost all of the trees growing on the edges. The trees need to be protected and a fence as described above need to be placed for the duration of the construction. The fence should be placed at a minimum of 70% of the tree root zone as it is listed above for each tree. Most trees can cope with 30% root loss therefore encroachment up to 30% is acceptable usually.
