FACILITY ASSESSMENT REPORT
FOR

Swimming Pool
and
Bathhouse
at
Horowitz Pool at Henry Park

**Horowitz Pool and Bathhouse
Henry Park
Vernon, Connecticut**

**Structural Condition Assessment
Survey and Report**

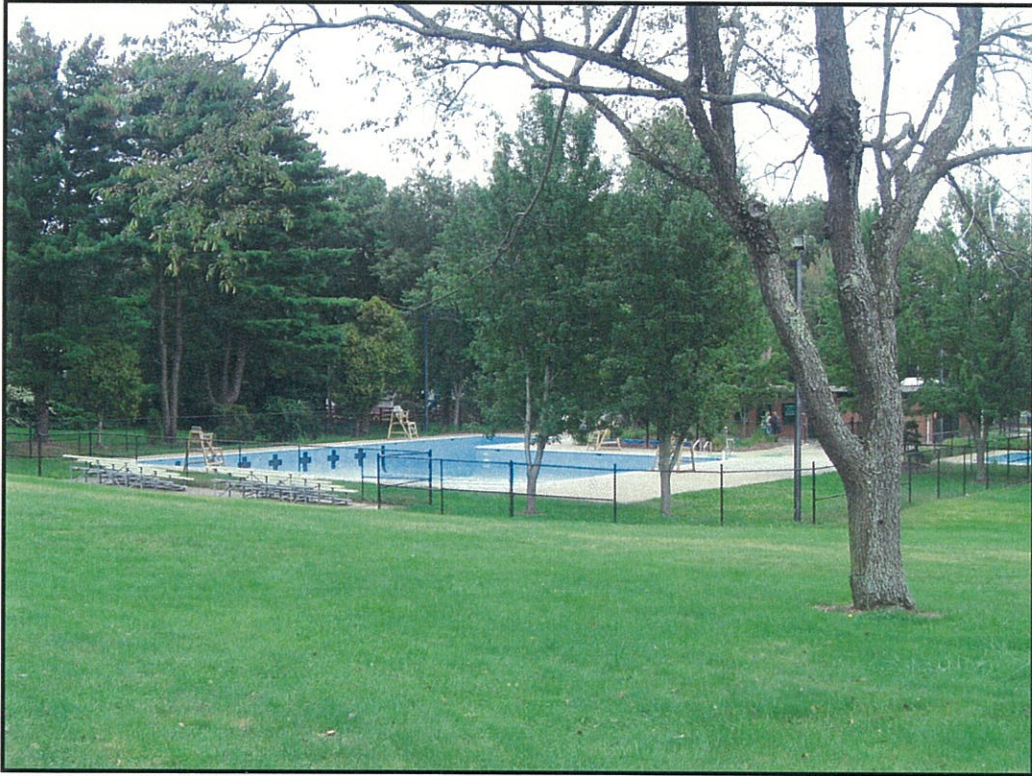
Photo P-1: Existing Pool and Surrounding Site

The existing L-shaped gunite pool at Henry Park is believed to have been constructed in 1990 to replace an earlier 1953's pool. The original pool was built at the time when the flat roof brick veneer bathhouse building was constructed, 1953. **(See Photos P-1 and P-2).** The gunite material from
