# SAYREVILLE BOARD OF EDUCATION

## JESSE SELOVER SCHOOL FACILITY ASSESSMENT

School Name: Jesse Selover School

School Address: 150 Lincoln Street, South Amboy, New Jersey 08879

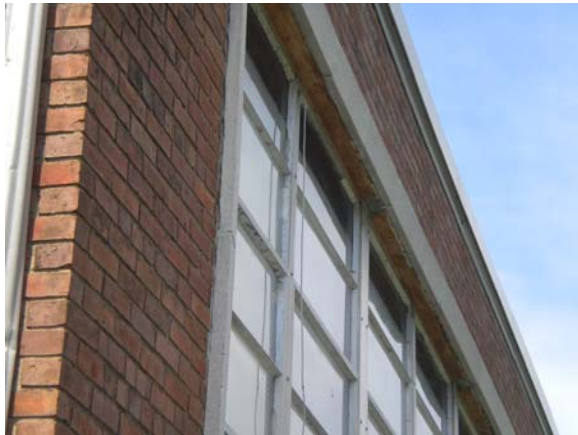
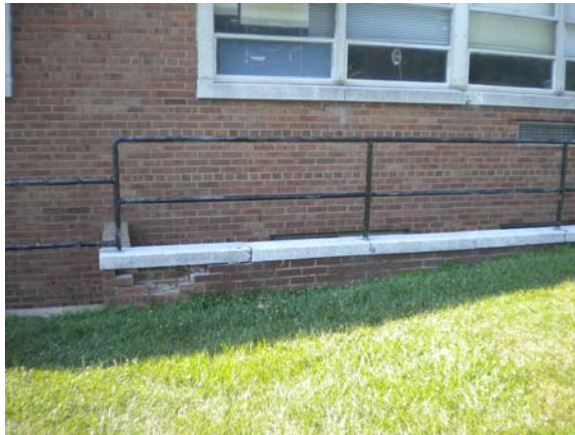
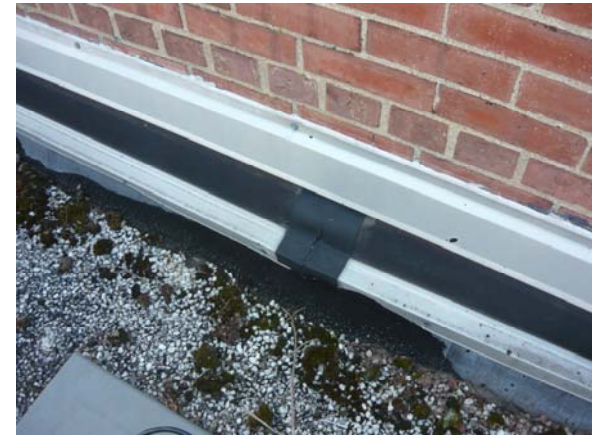
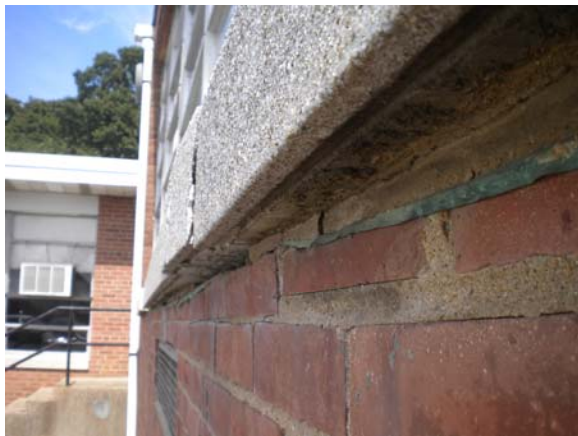
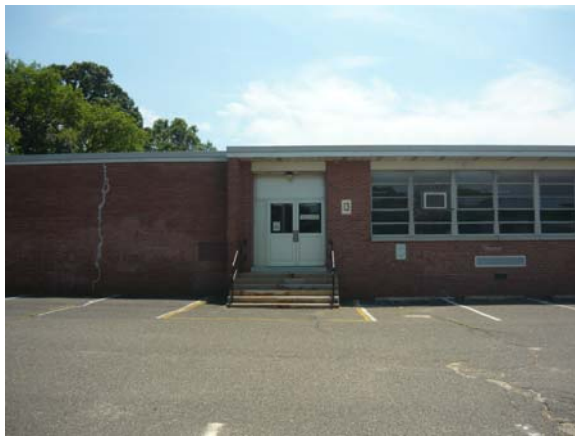
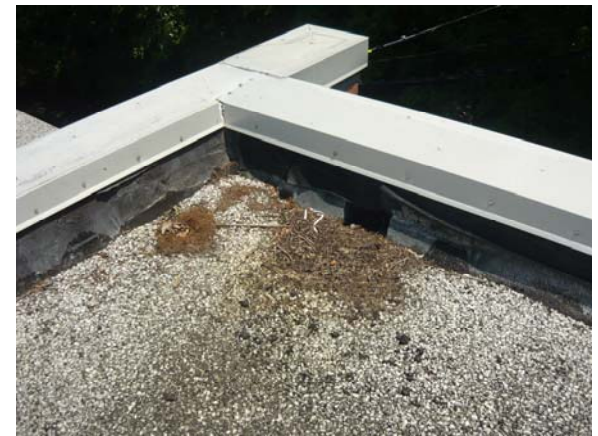
Existing masonry walls are in a poor condition. The cracking which has occurred is indicative of settling foundations and freeze/thaw damage due to water infiltration. Some of these cracks have been filled with caulk, but many remain untreated. These cracks are allowing for water to penetrate the building and increase the damage via thermal expansion and contraction. Signs of cracking/settlement are most evident at the rear of the building and should be addressed promptly.

The existing roof field is blistering and splitting, a severe condition which leads to roof failure and water infiltration. The top ply of roofing is worn so deeply that the reinforcing fabric within the ply has been exposed at the base of each parapet wall. The existing metal soffits are missing or damaged and are allowing additional water to infiltrate the school above the windows. The existing roof-mounted ventilation equipment should be removed and reinstalled on curbs of an appropriate height off of the roof surface.

The lintels have swelled and displaced brick units, creating openings in the exterior walls for moisture infiltration. It is highly recommended that the compromised lintels as well as the existing windows be replaced.

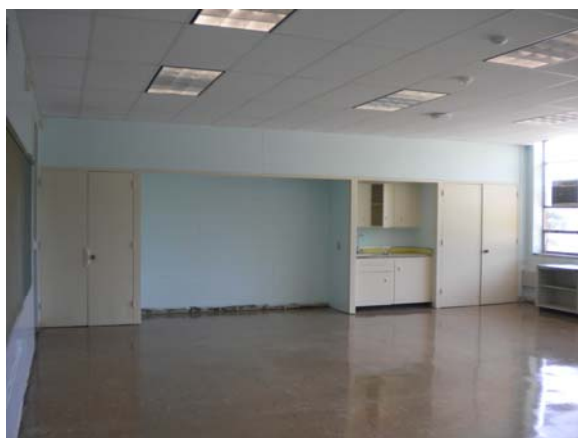
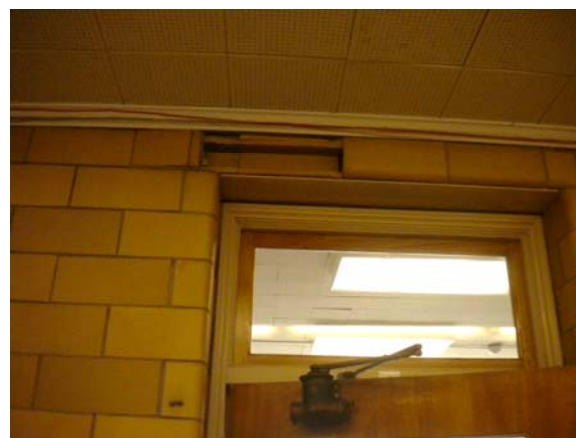
### Casework/Storage/Cubbies

Most classrooms currently have a sink, some closet storage and open shelving. Most, if not all classrooms will require the addition of student cubbies and coat storage. The classrooms in the original 1954 building will require added shelving under the windows. The existing condition of some of the sinks and storage closets and cabinets is fair to good, however none are barrier free and none have properly functioning bubblers.

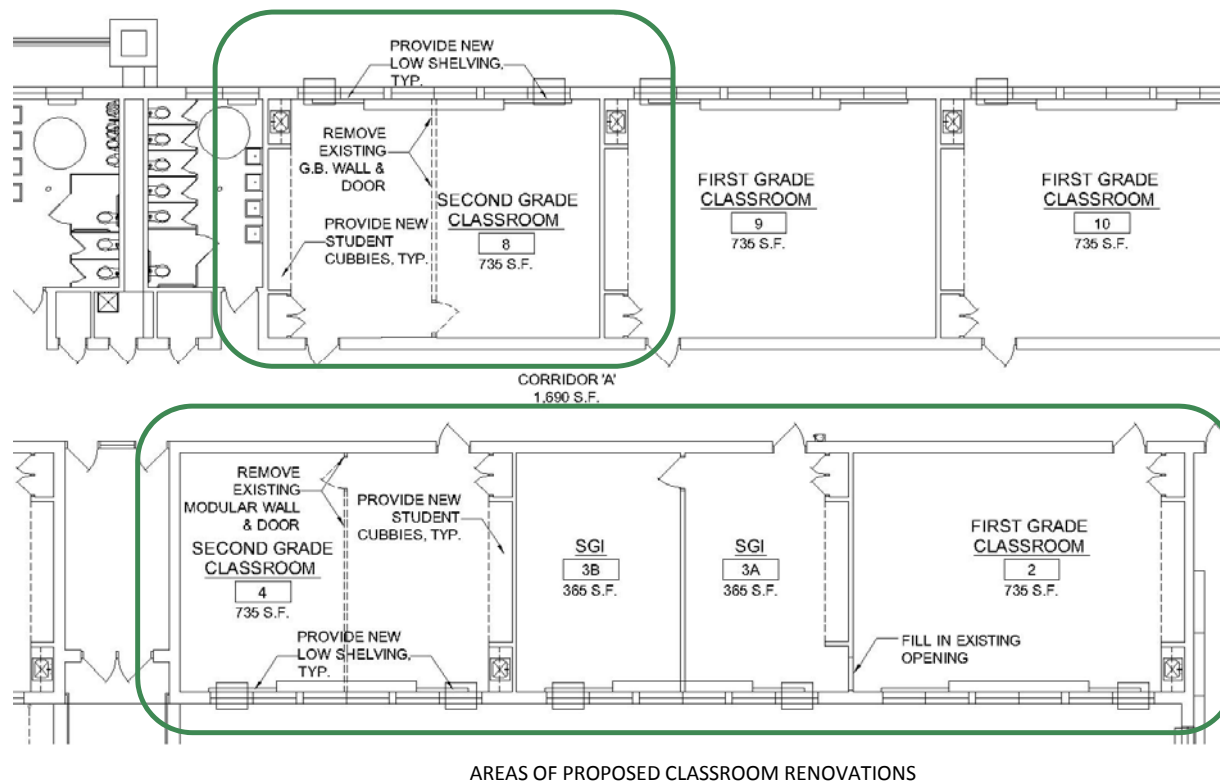
Classroom #2 has existing ceiling fans that will need to be caged or removed.

Based on our assessment we are recommending the renovation of classrooms #2,3,4 and 8.

New students cubbies and under window shelving should be added, which is a typical recommendation for each classroom.

New acoustical tile ceiling and energy efficient lighting with occupancy sensors are recommended upgrades along with new unit ventilators.

During this renovation the existing wood frame door and glass transom should be removed and a fire rated door and transom installed with security hardware.

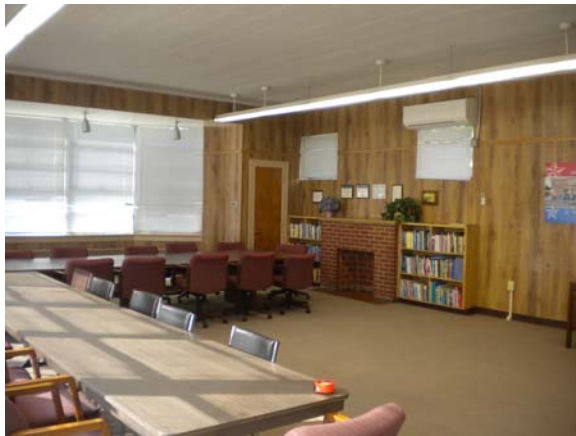
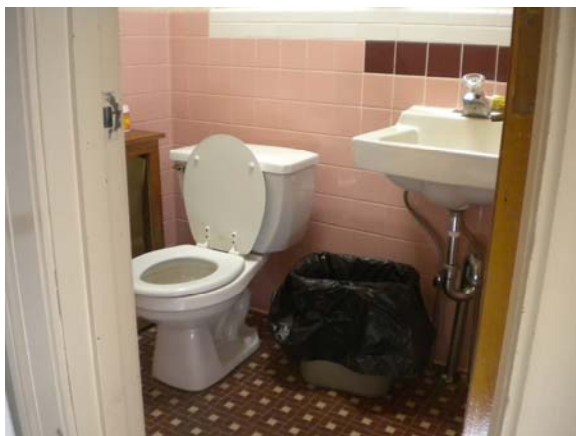
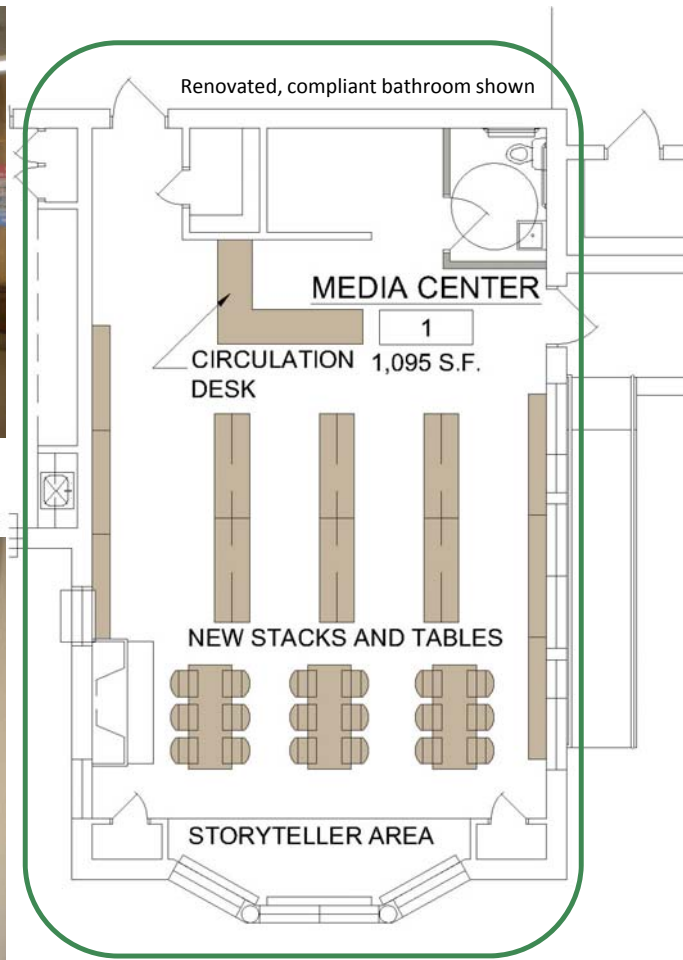
### Media Center

Existing carpet with VAT underneath are to be removed/remediated.

New carpet flooring is recommended in the space for better sound control however VCT is also an alternative.

The existing 12" x 12" spline ceiling should be repaired and eventually replaced with new acoustical tile ceiling panels and new energy efficient lighting with a minimum of 50 footcandles at the level of the work surface/desk.

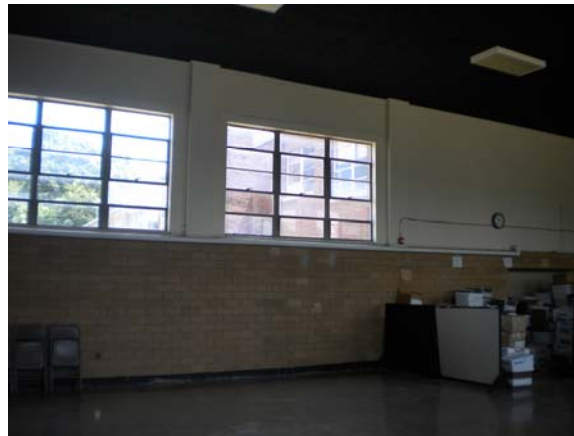
### Multi-Purpose Room

The existing multi-purpose room consists of glazed block walls, a compromised VAT floor and no finished ceiling with any acoustical value (existing spline ceiling removed).

The stage does not include a wheelchair lift or other means of ADA-compliant access, nor does it contain stage rigging such as curtains, etc.

While the space may serve adequately as a Cafeteria based on the adjacent warming kitchen, its size is not conducive for use as a gymnasium. If used temporarily as a true multi-purpose room including curriculum for physical education, the space will need to be outfitted with wall-padding, a new floor system, lighting and an appropriate ceiling. Other concerns for utilizing this space as a gym are the existing windows, glazed block walls and deteriorating VAT flooring. This space will serve as the school's only lunch room as well as gym, which may lead to some scheduling conflicts (unless students eat lunch in their classrooms).

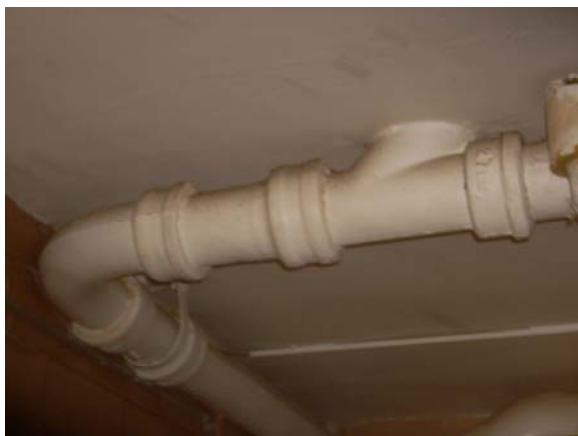
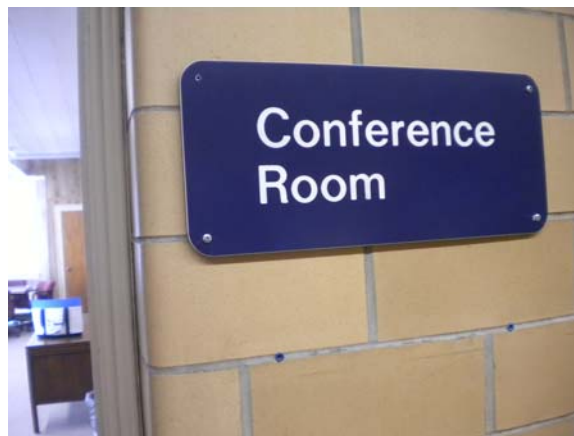
### ADA Compliant Signage

None of the existing building signs, including door frame mounted room numbers, office signage or toilet signs comply with current required codes. A full signage replacement will be required prior to student's arrival.

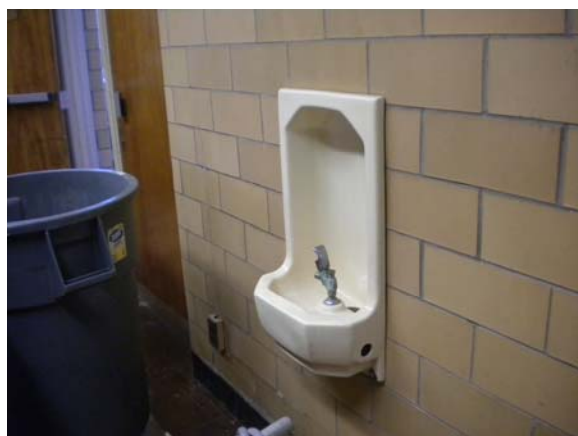
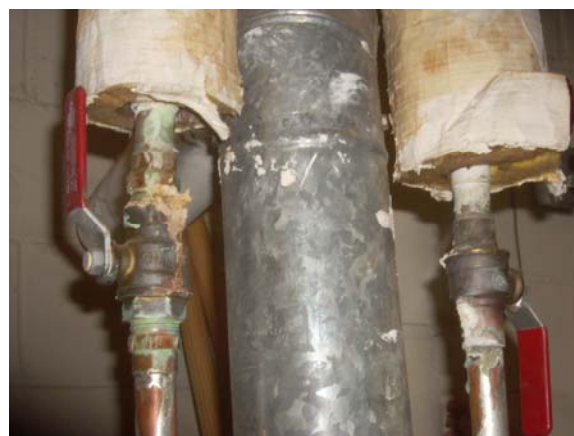
### Drinking Fountains

The existing drinking fountains do not function, and will need to be replaced. While the number of fixtures is adequate, the units are outdated and at the end of their useful life.

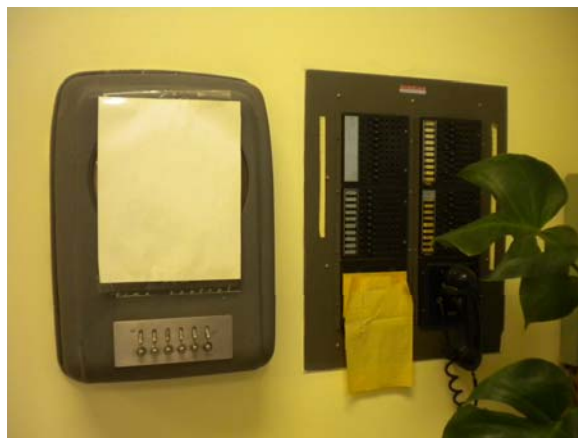
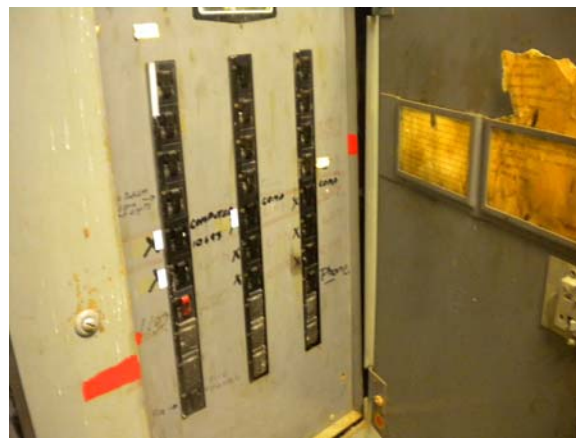
### Master Clock and P.A. System

Existing master clock and P.A. system will need to be completely upgraded. Currently, most classrooms do not have any clock or communication system available. The original P.A. system appears to be in the Main Office on the side wall. The new P.A. system should be a low-voltage system capable of multiple, simultaneous conversations on separate channels throughout the facility through call in switches and loudspeaker assemblies. A programmable master clock system is usually integrated with the P.A. system and telephone systems so that any telephone in the facility can, with the proper authorization code, make announcements over the P.A. system. The system should be expandable to meet future addition needs and be programmable from a master computer terminal located in the Main Office.

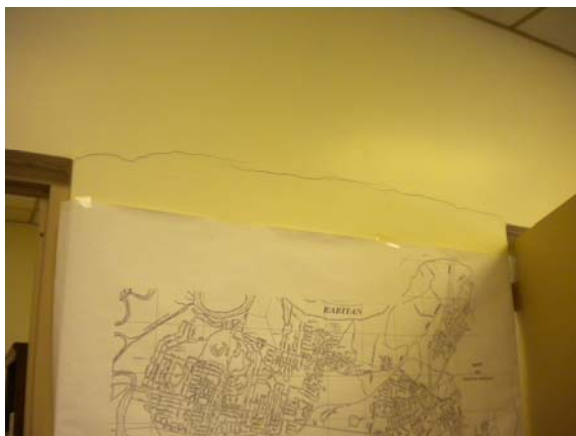
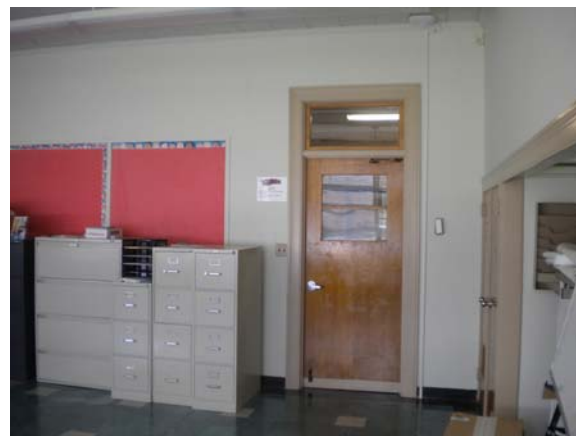
The classroom doors in the 1959 wing are wood with steel frames and in many locations do not open or close properly. All existing classroom doors require door closers and to close fully to provide proper security during a lockdown. The classroom door levers and locks are currently being replaced (summer 2014) with cylindrical hardware under a 7-year warranty. At that time, hardware could be upgraded to fully mortised locksets.

The 1954 original school building classroom doors are wood framed with full glass transoms above. In Classrooms #14, 15, 22, 23 existing exterior door panic hardware is mounted too low at 28" above the finished floor. This needs to be moved to 34" minimum to 48" maximum above the finished floor.

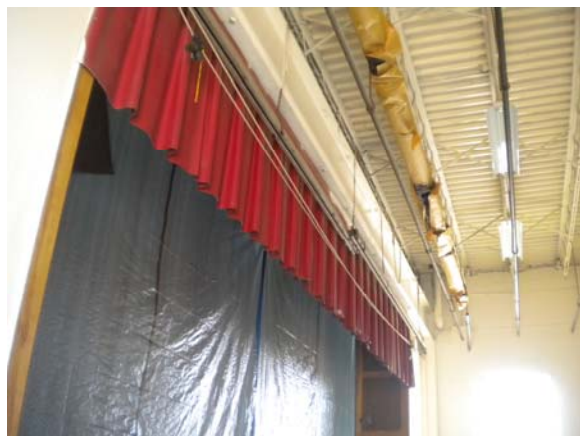
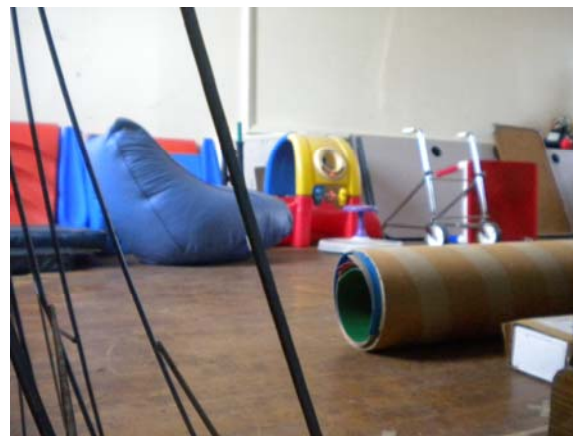
The stage is in fair condition, however the doors and stairs to the stage are not Barrier Free.

Some stage rigging appears to be in place along with some stage lighting.

The front curtain valance is in place, however the flame-spread rating is probably inadequate, and no other stage curtains are presently installed.

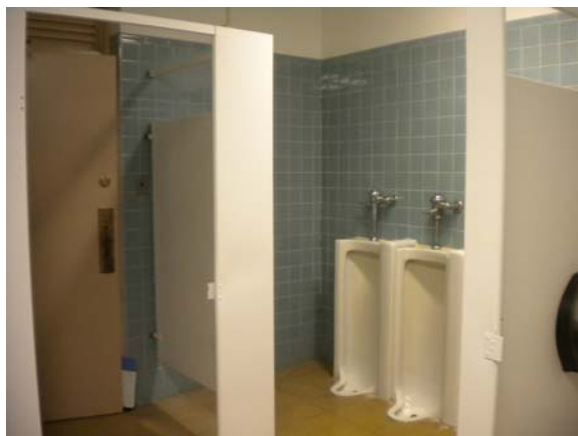
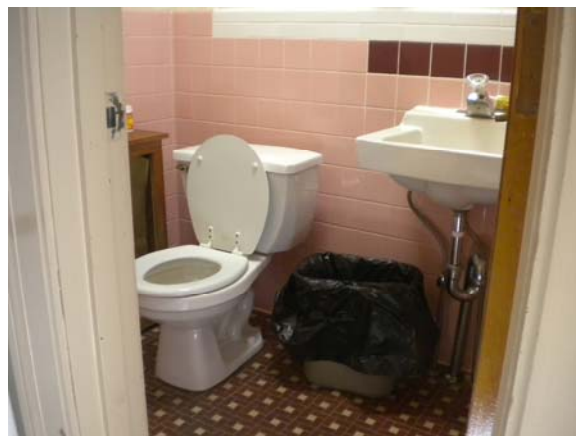
### Single Occupancy Toilet Rooms

Each proposed Kindergarten classroom is equipped with a single occupancy toilet and lavatory which does not comply with the overall size required for barrier free access. Two of the existing toilets will need to be replaced to comply with the lower height required in Kindergarten classroom facilities. These classroom toilets do have an exhaust fan installed through the existing window and a large radiator under the window which are recommended to be replaced with updated, energy efficient models.

There are four single occupancy toilets located off the Main Office, the proposed Nurse's Office, the proposed Media Center and on the lower level in a storage area. None of these rooms are barrier free due to dimensional issues with doorways, fixtures and accessories.

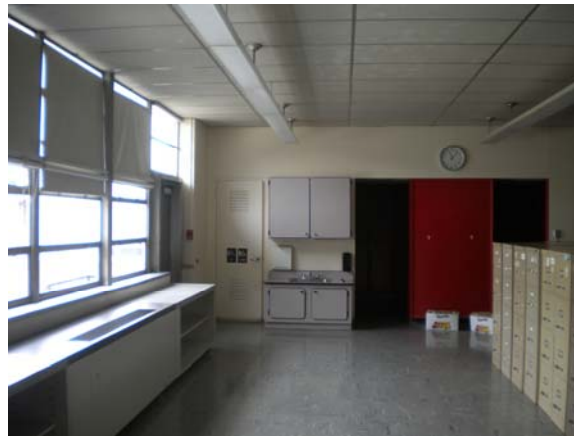
### Interior Lighting

Lighting is a major energy consumer within any building, accounting for approximately 26% of electrical costs in schools. The integration of occupancy sensors within the existing classrooms can help to minimize electrical costs. Light fixtures which produce both direct and indirect light would be the most desirable.

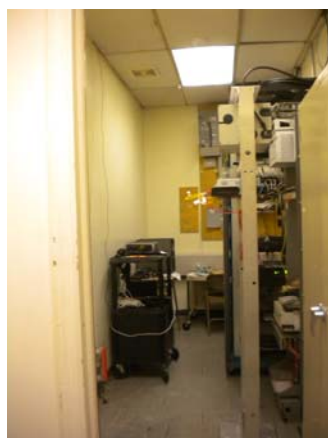
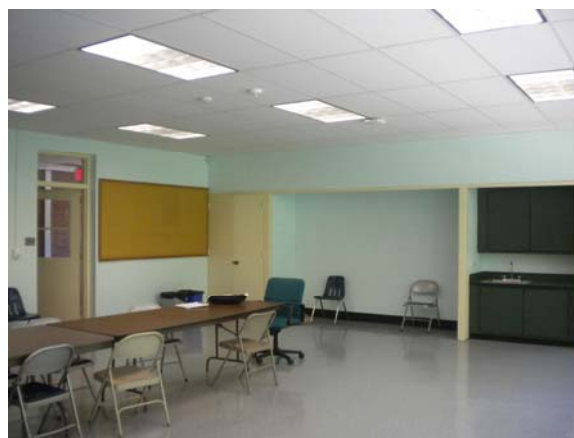
### MDF/Technology Upgrades

Classrooms are currently set up for wireless connectivity. Additional data drops may be required in some classrooms for smart boards, TVs, projectors, telephone and other devices. The current MDF (main distribution frame) appears to be slightly undersized.

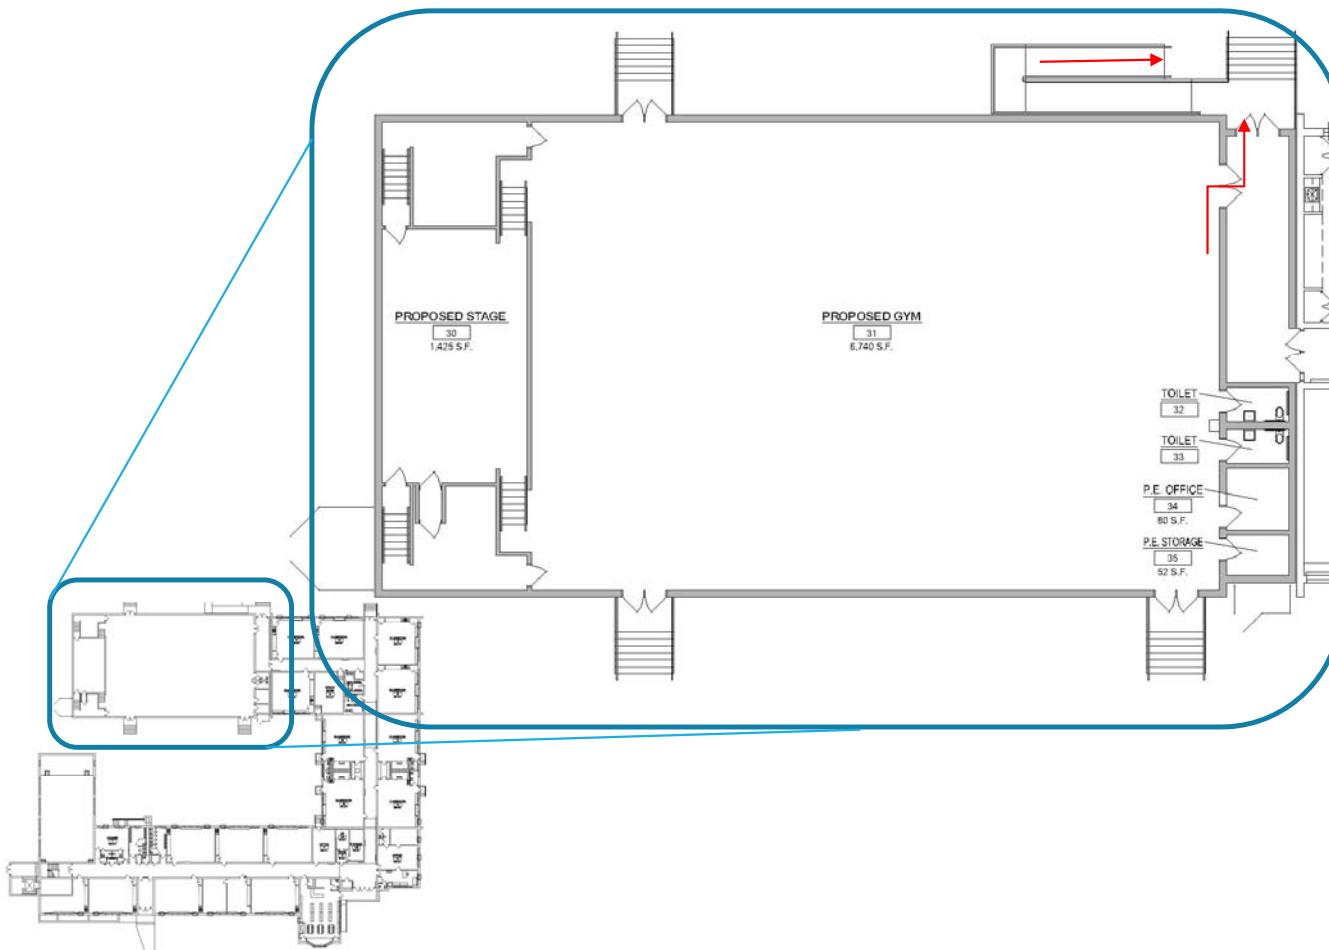
### Gym Addition

In order to achieve some level of parity with the other district elementary schools it would be possible to construct a gymnasium addition off of the 1959 classroom wing which includes typically ancillary spaces and a more reasonably sized stage area for assemblies. This would also allow the existing multi-purpose room to serve exclusively as a lunch room if necessary.

The addition would also result in a more secured playground area bound by the various wings of the school building. The addition as shown would be approximately 9,300 s.f. with an estimated construction cost of \$2.3 - \$2.8 million.

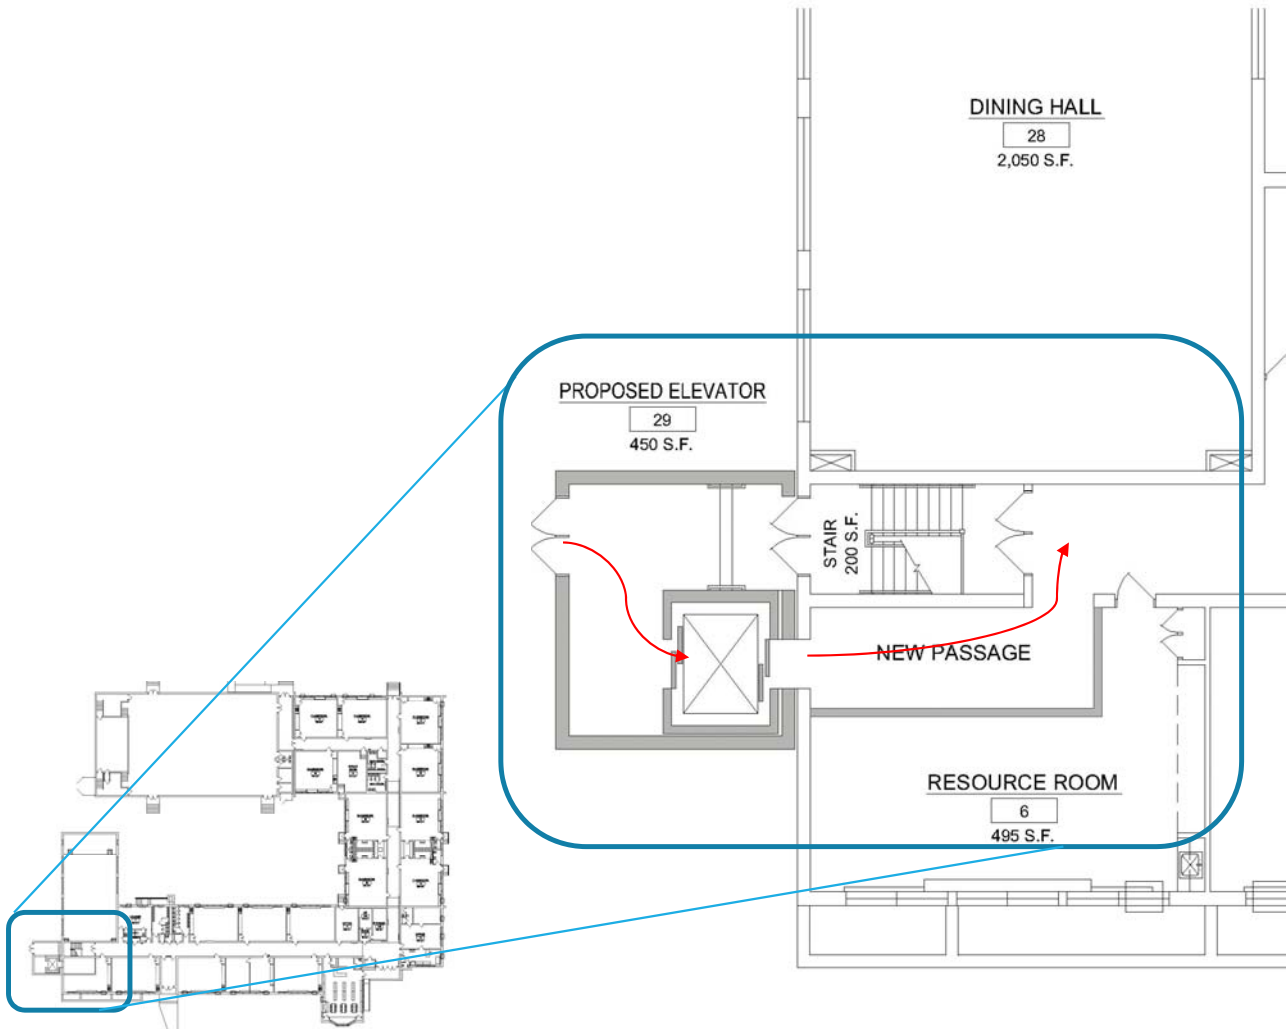
### Elevator Addition

Based on the previously noted Rehabilitation Subcode and the current building Use Classification, the addition of an elevator is not required in order to move students into the facility. As such, this improvement has not been listed as an Immediate Need, however, it is highly recommended as a future improvement. An Elevator would provide an accessible connection from the lower level to the upper level and the elevator lobby would serve as a primary entrance/drop-off area for parents as the proximity to Lincoln Street and Woodland could work effectively.

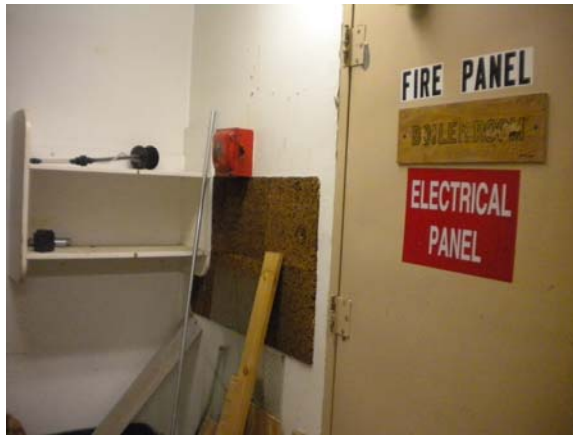
### Security System

Existing motion detectors appear to be located in a ceiling corner in all rooms. The main panel appears to be in the lower level boiler room.

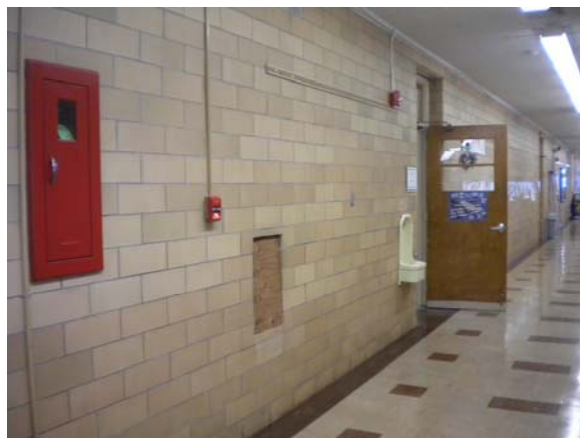
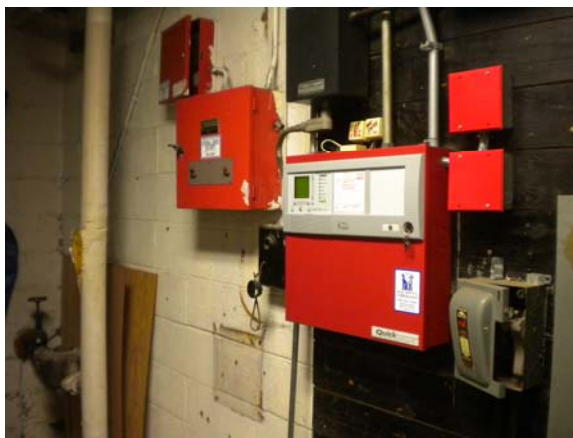
### Fire Alarm

QuickStart brand Fire Alarm panel located in lower level boiler room. It appears to have been updated or installed in 2008. The extent to which the current panel can be expanded has not been confirmed. It does appear to be an addressable system. The panel would better serve the facility if it were located in the Main Office.
