PEDESTRIAN  
ACCESSIBILITY  
STUDY

Medford, Massachusetts

June 2021

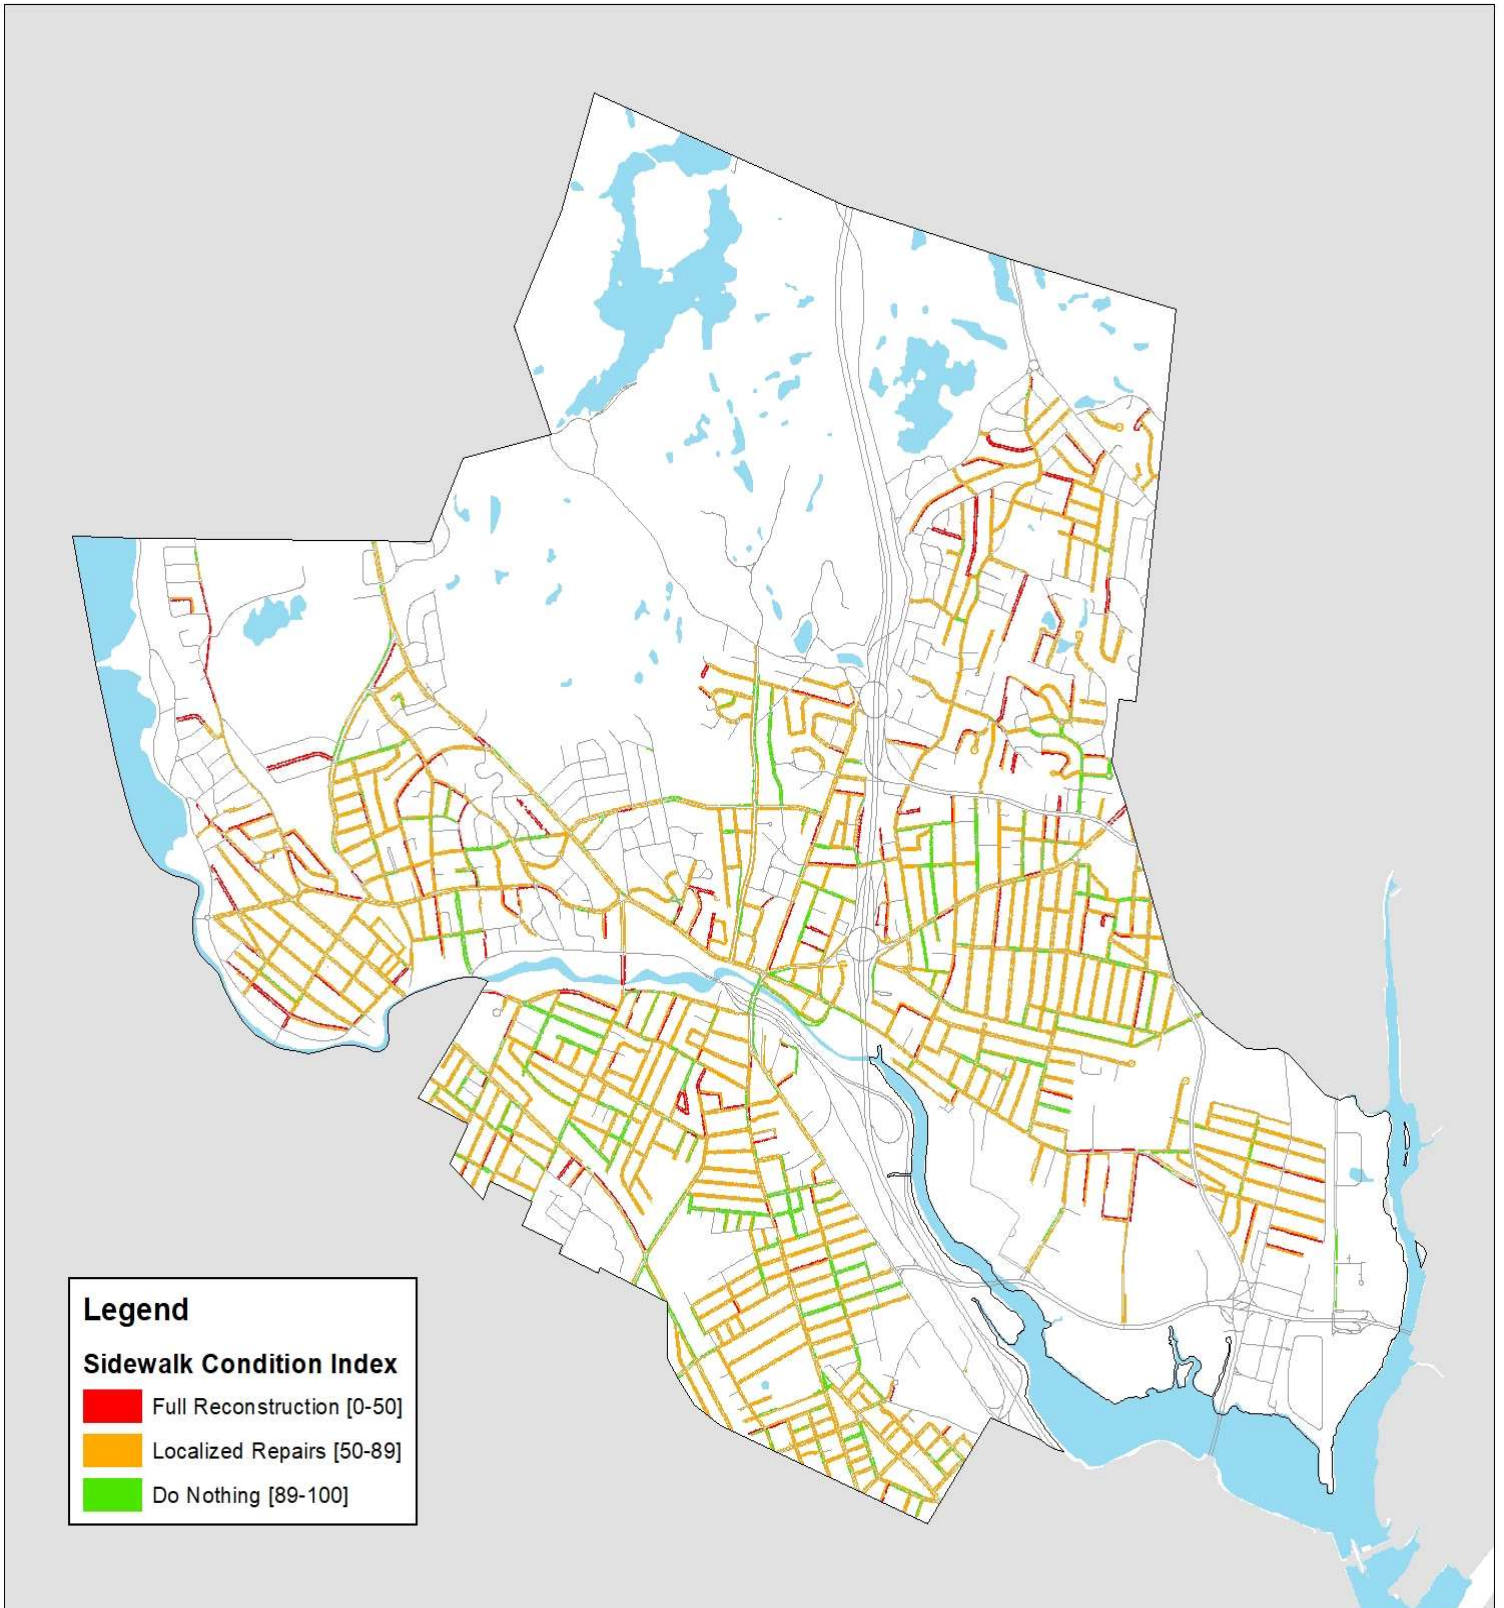
**Figure 2**  
**SCI of Sidewalk Network**

The average based SCI in Medford is **76.6**, which puts average conditions at the border of fair/good condition. With 75% of the sidewalk network in the 'Localized Repair' treatment band. Figure 2 below shows the distribution of the SCI treatment bands throughout the City.

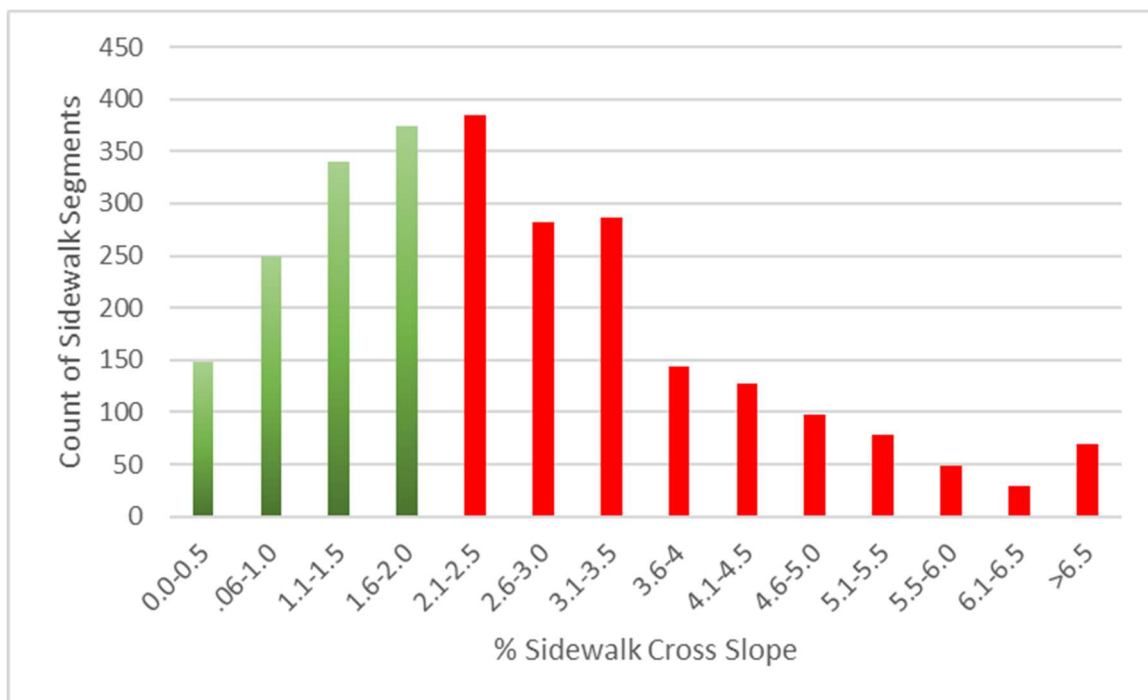
**Figure 3 Distribution of Sidewalk Cross-Slope**

Street furniture, buildings, or other hardscape obstructions that prevented passage along the sidewalk was also located. Figure 3 displays the cross-slope measurements where green bars represent likely compliant slopes, and red bars represent likely non-compliant slopes. It can be seen from these that the primary reason for likely non-compliance in Medford is the sidewalk cross-slope since the majority of sidewalk widths surpass the 3 foot threshold.

For this report, a sidewalk was considered likely compliant if the cross slope was less than 2%, width greater than 3 feet, and a overall condition that was not considered poor or failing for a likely compliant sidewalk. Within those

thresholds, it was determined that only 17% of sidewalks in Medford are likely compliant.

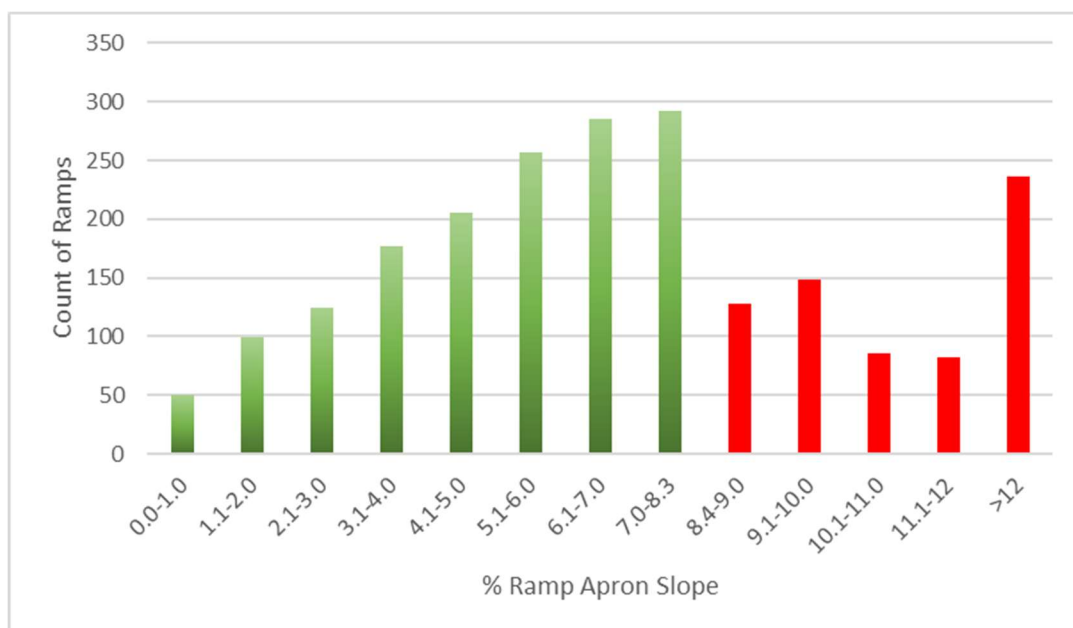
**Figure 5**  
**Distribution of Apron Slope Percentage**

The distribution of apron slopes City-wide are relatively good as most ramps achieve an acceptable MAAB slope less than 8.3%. However, there are a significant number of ramps which have apron slopes exceeding 12% which significantly impedes accessibility. A majority of these ramps are made of portland concrete cement and are found through out the city. A few examples of these are shown below.

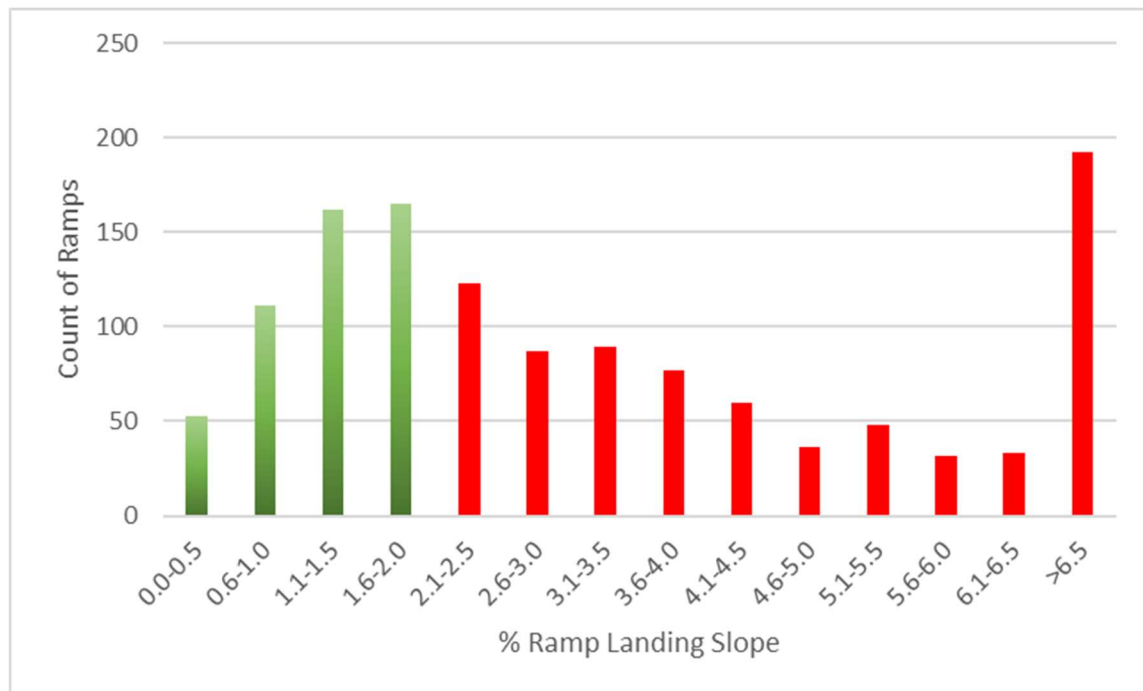
**Figure 6**  
**Distribution of Landing Slope Percentage**

Note: Figure 6 excludes ramps in which no level landing was present. In determining likelihood of MAAB compliance, several inspection attributes were used:

Otherwise the ramp was determined to not be MAAB/ADA compliant. In using these, it was determined that **96%** of the existing ramps in Medford (excluding missing ramps) are likely not compliant with MAAB standards. In most cases, ramps failed because there was no adequate size landing, followed by landing slope >2%.
