Edison Elementary School

EDISON ES
4/30/2012

Alameda USD Facilities Assessment

Edison Elementary School
Facility Assessment Spreadsheet

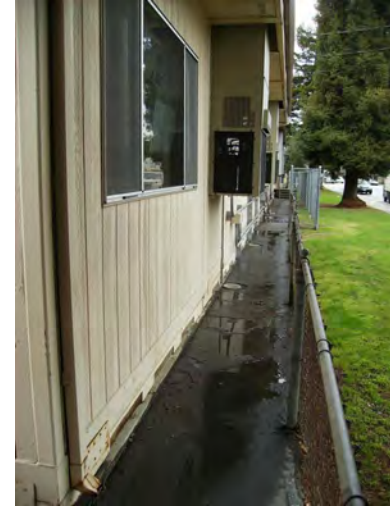
CATEGORY		DESCRIPTION	PHOTO & SITE PLAN	ESTIMATED TAKE OFF		COST / UNIT	TOTAL COST
				Quantity	Unit		
10	Existing Deficiency	There is a 4"-5" drop at the rear exit from the library to the adjoining flatwork.	10				
	Recommended Remedy	Construct a level landing at the door, with a transition walk down to grade at 5% max along the building wall. Remove/replace existing flatwork as necessary to install new work.		300	SF	\$22	\$6,600
11	Existing Deficiency	Existing pavement is deteriorating.	11				
	Recommended Remedy	Crack seal, edge grind, pavement fabric, and 1.5" minimum overlay of these areas.		34,200	SF	\$6.00	\$205,200
ii) FIRE/LIFE SAFETY/HAZ MAT							
1	Existing Deficiency	The interconnected nature of the buildings will likely result in a large fire area, and correspondingly high required fire flows, which the surrounding hydrants may not be able to meet.					
	Recommended Remedy	Add fire sprinklers to existing buildings to reduce required fire flow.		25,550	SF	\$12	\$306,600
