Henry Haight Elementary School

HENRY HAIGHT ES
4/30/2012

Alameda USD Facilities Assessment

Haight Elementary School
Facility Assessment Spreadsheet

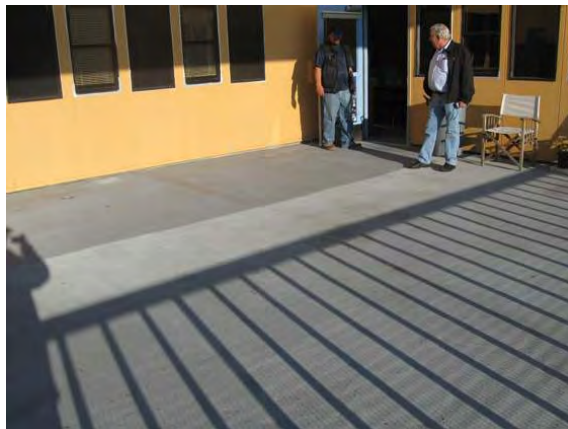
3

CATEGORY	DESCRIPTION	PHOTO & SITE PLAN	ESTIMATED TAKE OFF		COST / UNIT	TOTAL COST
			Quantity	Unit		
6 Existing Deficiency	C24 Modular: plywood siding/ trim and downspouts damaged	#3, #4, #10				
Recommended Remedy	Replace east wall with cement board panel/ trim and repaint. Replace downspouts with RWL		480	SF	\$9	\$4,320
7 Existing Deficiency	C25 Portable: wood foundation has dry rot; missing vent screens	#5, #6				
Recommended Remedy	Replace wood foundation with concrete.		15	CY	\$900	\$13,500
8 Existing Deficiency	C26 & C27 Portables: wood foundation has dry rot; damaged/ missing downspouts and no site drainage.	#11, #16, #17				
Recommended Remedy	Replace wood foundation with concrete, add site drainage and RWLs		30	CY	\$900	\$27,000
