Donald Lum Elementary School

Alameda USD Facilities Assessment

**Lum Elementary School
Facility Assessment Spreadsheet**

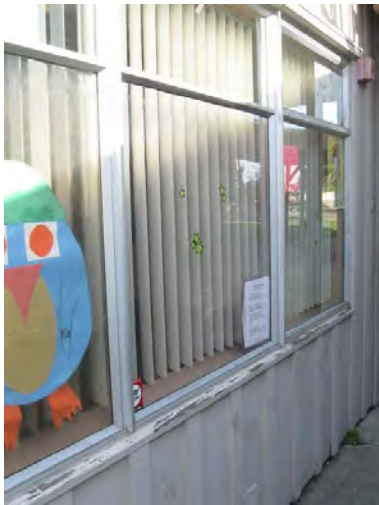
CATEGORY	DESCRIPTION	PHOTO & SITE PLAN	ESTIMATED TAKE OFF		COST / UNIT	TOTAL COST
			Quantity	Unit		
4 Existing Deficiency	Shingle and BUR roofing has reached end of service life					
Recommended Remedy	Replace all shingle roofs with S.S. metal roofing, and BUR with 30-yr BUR and cool roof coating. Also new fascia, gutter, and RWL.		36,150	SF	\$9	\$325,350
5 Existing Deficiency	Exterior windows w/ Plexiglas beyond Service life					
Recommended Remedy	Replace all windows with Alum. frame & dual pane glass		3,400	SF	\$44	\$149,600
6 Existing Deficiency	Exterior doors beyond service life					
Recommended Remedy	Replace all ext. doors with metal frame and FRP door		28	EA	\$4,400	\$123,200
7 Existing Deficiency	No Trash Enclosure at this Site					
Recommended Remedy	Install a 2-Bin Trash Enclosure per Health Dept. standards		1	EA	\$15,000	\$15,000
8 Existing Deficiency	B3 & B4 Portables: wood foundation dry rot; no site drainage; wood panel dry rot & roof leaks	#6, #8, #9, #11

Recommended Remedy	Replace with concrete foundation; add site drainage and new RWLs; replace (E) units with new.		30	CY	\$1,500	\$45,000
9 Existing Deficiency	Music Portable: wood panel and foundation dry rot; no site drainage; metal frame and ramp rust; faded paint with different colors.	#12, #13, #14, #15				
Recommended Remedy	Replace with concrete foundation/ ramp; add site drainage and new RWLs; replace (E) unit with new.		18	CY	\$1,000	\$18,000
10 Existing Deficiency	B1 & B2 Portables: gutter down spout missing; no site drainage on west elevation;	#10, #17, #18				
Recommended Remedy	Replace wood foundation and ramps with concrete; add site drainage and new RWLs; repaint		2,000	SF	\$4	\$8,000
11 Existing Deficiency	Day Care Modular: damaged downspout; steel corrosion; ivy growth; wood paneling/trim damage; excess pine tree litter on roof and gutters.	#10, #16, #19, #20, #21				
Recommended Remedy	Remove all growth from perimeter; add 12" conc. mow strip and site drainage; repair/replace wood panel/trim with cement board and repaint; replace downspouts with RWLs; remove Pines adjacent to roof.		6,400	SF	\$8	\$51,200

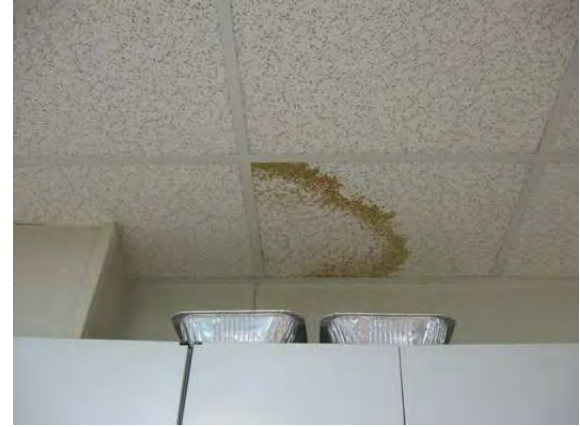
24

5	Existing Deficiency	B3 & B4 Portables: damages ceiling tiles; worn out floor carpet; aged wall paneling, windows, & door	#24, #25				
	Recommended Remedy	See Item #8 above. Provide new modular		1	LS	103000	\$103,000
6	Existing Deficiency	Music Portable: classroom sink is non-accessible; replace ceiling tiles	#22, #26				
	Recommended Remedy	See Item #8 above. Provide new modular		1	LS	103000	\$103,000
7	Existing Deficiency	Day Care Modular: damaged ceiling tile from roof leaks	#23				
	Recommended Remedy	Reseal/ repair roof and replace damaged tiles; replace carpet with resilient tile and carpet walk-off entry		1,200	SF	\$12	\$14,400
