Paden Elementary School

PADEN ES
4/30/2012

Alameda USD Facilities Assessment

**Paden Elementary School
Facility Assessment Spreadsheet**

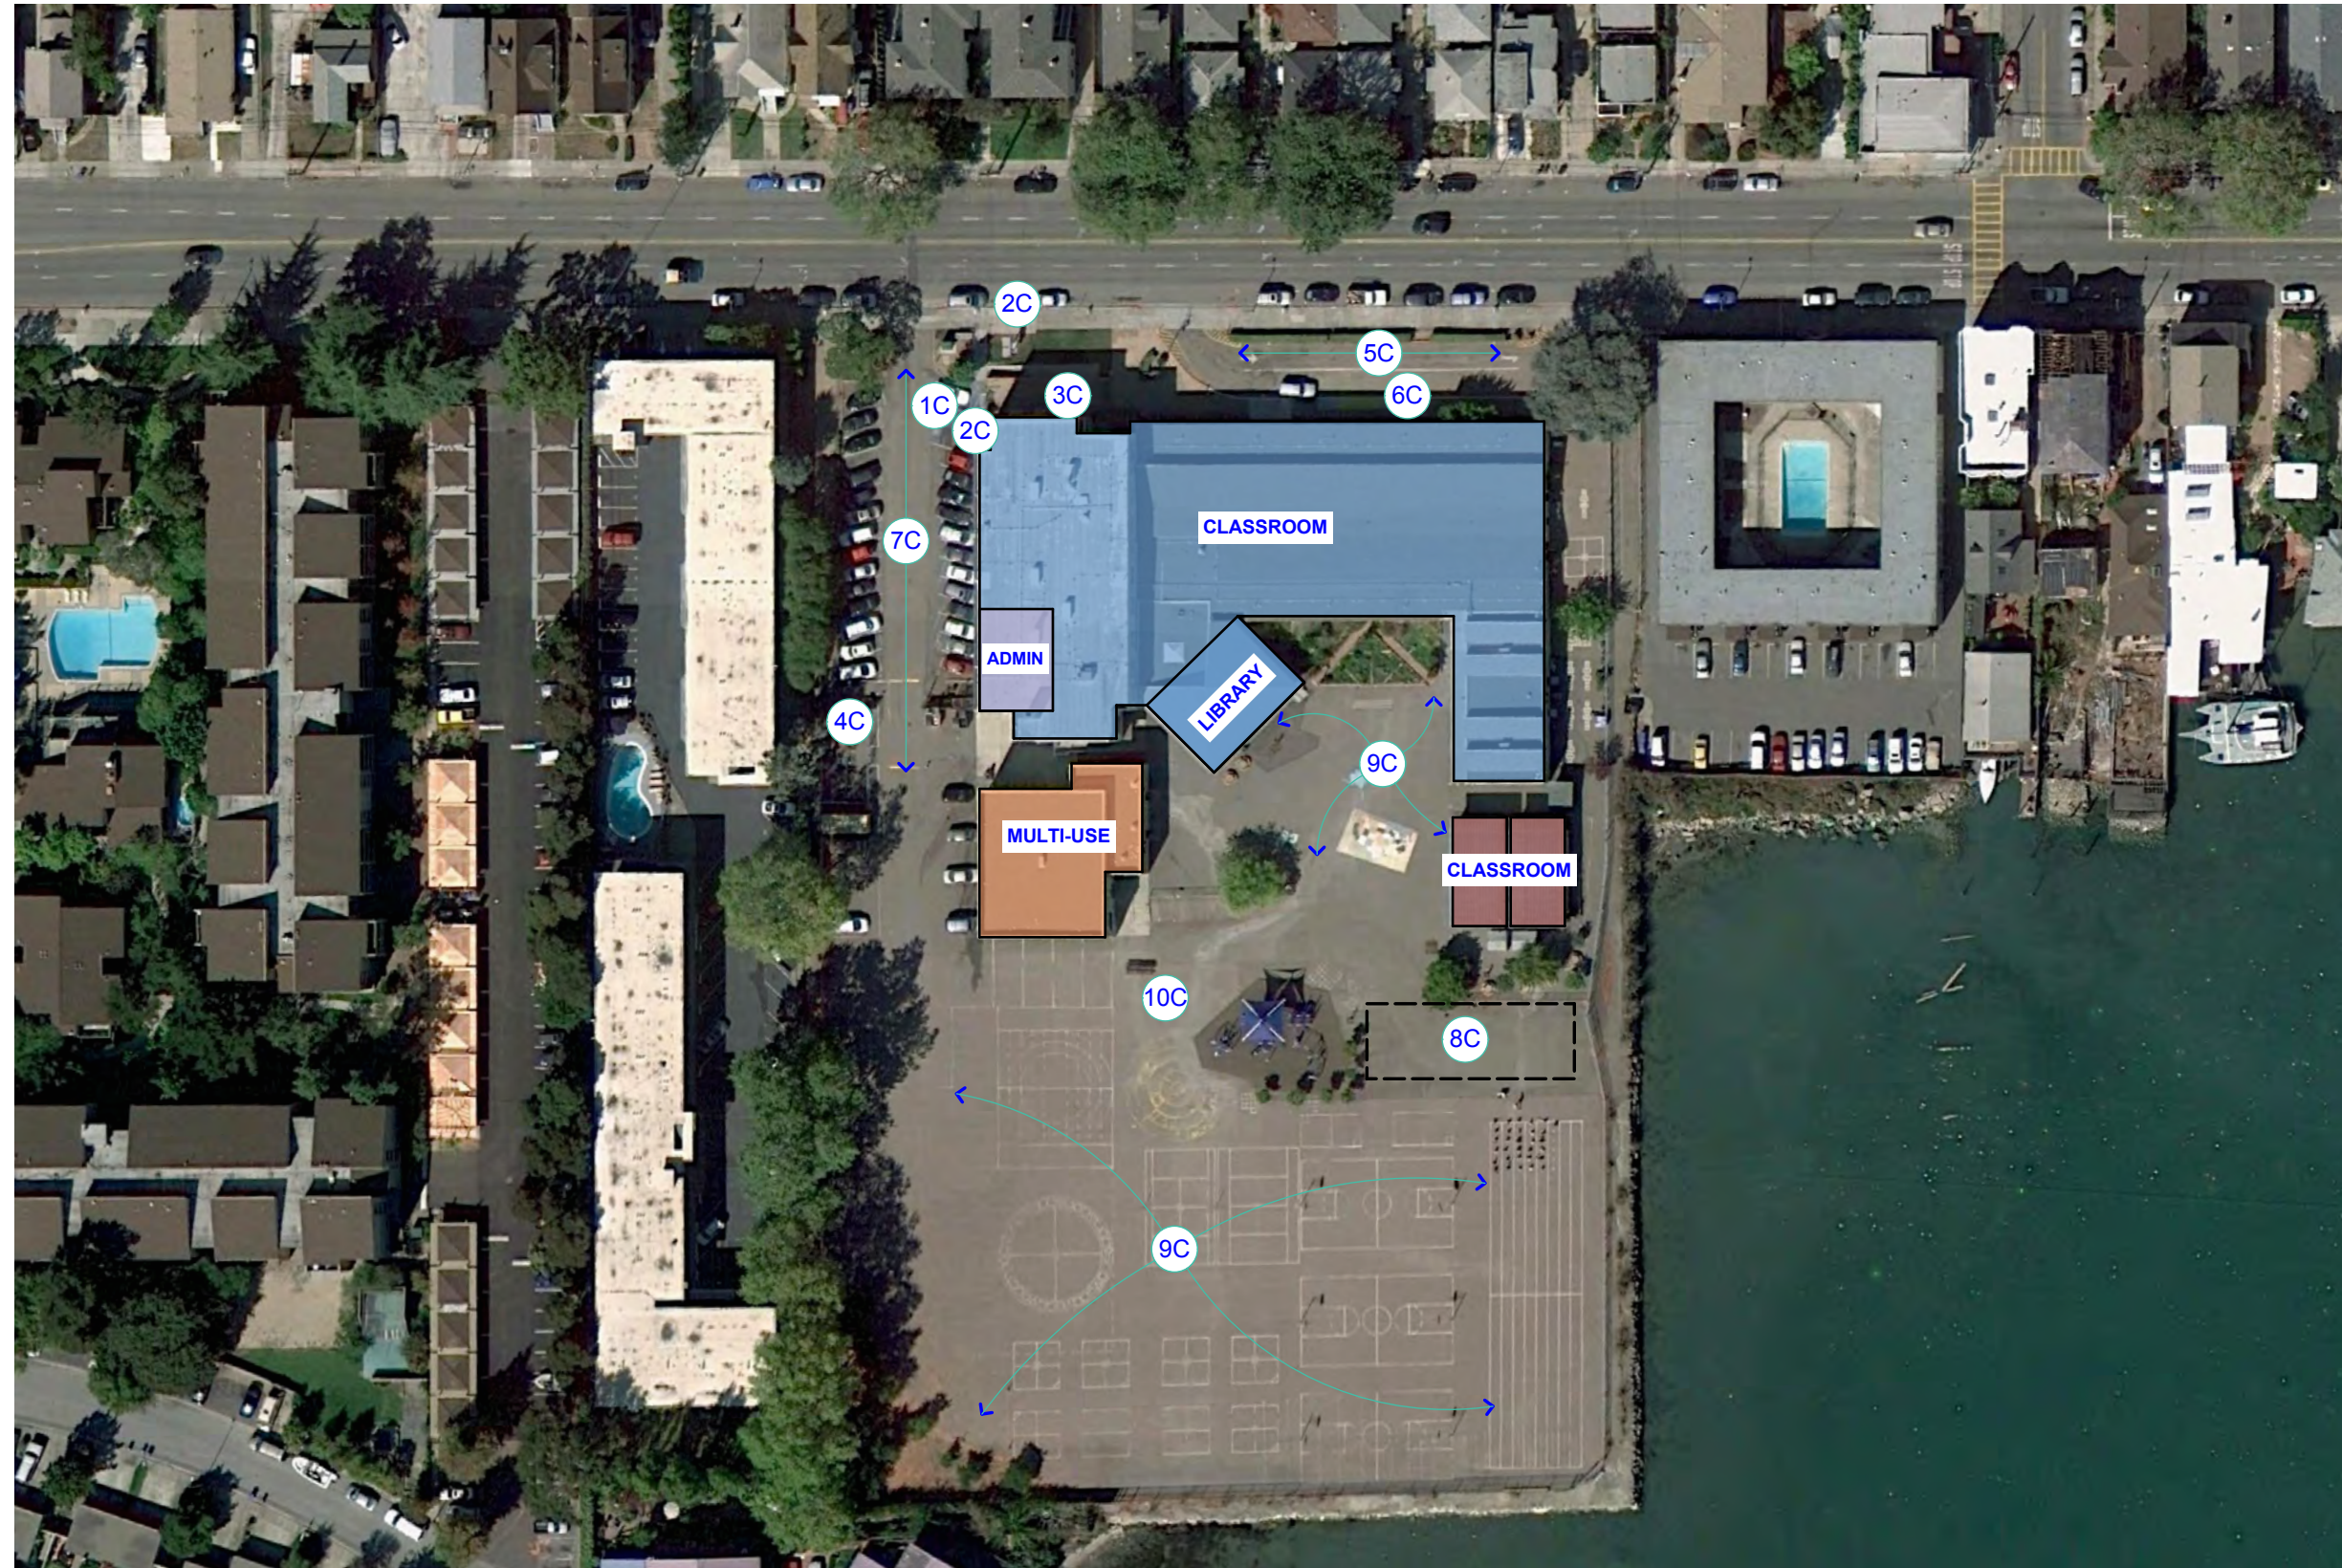
| CATEGORY | DESCRIPTION | PHOTO & SITE PLAN | ESTIMATED TAKE OFF | COST / UNIT | TOTAL COST | |
|---|--|---|---|---|---|---|
| 1 Existing Deficiency | Slope in ADA stalls varies from 2.3% to 4%; signage out of date. | 1C | | | | |
| 2 Existing Deficiency | ADA parking lot entrance sign not located at parking lot entrance. | 2C | | | | |
| 3 Existing Deficiency | Landing outside of main doors is 3% cross slope. | 3C | | | | |
| 4 Existing Deficiency | Cross slope on Asphalt path adjoining north side of bike enclosure exceeds 2%. | 4C | | | | |
| 5 Existing Deficiency | Drop-Off Zone: Pavement badly deteriorated. | 5C | | | | |
| 6 Existing Deficiency | ADA student drop off zone lacking signage. | 6C | | | | |
| 7 Existing Deficiency | Pavement in the parking stalls is deteriorated; pavement in the drive aisle is deteriorating. | 7C | | | | |

| CATEGORY | | DESCRIPTION | PHOTO & SITE PLAN | ESTIMATED TAKE OFF | | COST / UNIT | TOTAL COST |
|---|---|---|---|---|---|---|---|
| 8 | Existing Deficiency | Pavement in this portion of paved playcourts is deteriorated. | 8C | | | | |
| 9 | Existing Deficiency | Play Ground: Pavement in paved playcourts is deteriorating. | 9C | | | | |
| 1 | Existing Deficiency | Poor hydrant coverage for entire campus, particularly the south side of the buildings. | 10C | | | | |

| CATEGORY | DESCRIPTION | PHOTO & SITE PLAN | ESTIMATED TAKE OFF | COST / UNIT | TOTAL COST | |
|---|--|---|---|---|---|---|
| Recommended Remedy | Edge grind perimeter of stalls and out into drive aisle. Install variable depth asphalt overlay to reduce slope in ADA stalls and unloading zones to 2% max. Update signage, and restripe stalls. | | 720 | SF | \$5.00 | \$3,600 |
| Recommended Remedy | Relocate sign to parking lot entrance. | | 2 | EA | \$550.00 | \$1,100 |
| Recommended Remedy | Reduce slope to 2% max for 5 ft by either installing a concrete leveling course, or removing and replacing the concrete flatwork outside the main doors to work with the threshold and the stairs. | | 300 | SF | \$17.00 | \$5,100 |
| Recommended Remedy | Remove existing asphalt, and repave for 2% max cross slope. | | 300 | SF | \$8.00 | \$2,400 |
| Recommended Remedy | Grind existing asphalt for possible reuse elsewhere as CI 2 AB. Repave with 3" min. new asphalt. Restripe per existing. | | 7,400 | SF | \$7.00 | \$51,800 |
| Recommended Remedy | Add compliant signage for drop off. | | 1 | EA | \$550.00 | \$550 |
| Recommended Remedy | Grind existing asphalt for possible reuse elsewhere as CI 2 AB. Re-grade for drainage & repave with 3" min. new asphalt. Restripe per existing. | | 3,900 | SF | \$3.15 | \$12,285 |

| CATEGORY | | DESCRIPTION | PHOTO & SITE PLAN | ESTIMATED TAKE OFF | | COST / UNIT | TOTAL COST |
|---|---|---|---|---|---|---|---|
| | Recommended Remedy | Edge grind, fill cracks, install pavement fabric and 1.5" min overlay. | | 3,900 | SF | \$3.15 | \$12,285 |
| | Recommended Remedy | Fill cracks, seal coat, and restripe. | | 78,900 | SF | \$0.64 | \$50,496 |
| | Recommended Remedy | Construct a private fire service and hydrant at the south central portion of the campus. | | 1 | EA | \$18,000 | \$18,000 |
