Will C. Wood Middle School

WOOD MS
4/30/2012

Alameda USD Facilities Assessment

**Wood Middle School
Facility Assessment Spreadsheet**

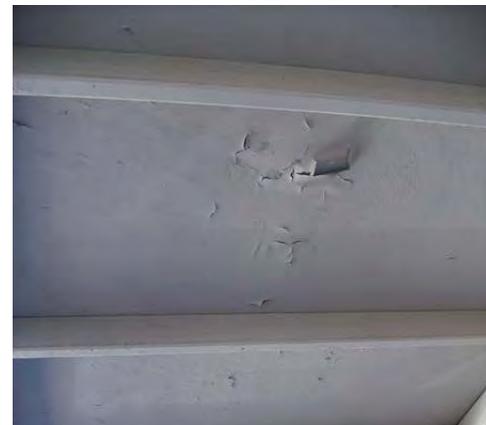
19

5	Existing Deficiency	Exterior painted finish is deteriorated	NA			
	Recommended Remedy	Reseal and repaint all exterior walls, trims fascia, etc.		63,870	SF	\$2
6	Existing Deficiency	Exterior doors beyond service life	NA			
	Recommended Remedy	Replace all ext. doors with metal frame and FRP door		45	EA	\$4,400
7	Existing Deficiency	3-Story Bldg: steel moment frames need constant painting and are unsightly	#7	Allow		
	Recommended Remedy	Design and place non-corrosive metal clad sheathing		1	LS	\$90,000
8	Existing Deficiency	Modular Wings A,B, & C: exterior paneling at end of service life; steel frame corrosion; paint chipping/ spalling	#13,14,15, 16,17,18			
	Recommended Remedy	Replace with new modulares.	#19, 20, 21, 25	13,440	SF	\$71.00
