# Alameda High School

ALAMEDA HS  
04/30/2012

# Alameda USD Facilities Assessment

**Alameda High School**  
**Facility Assessment Spreadsheet**

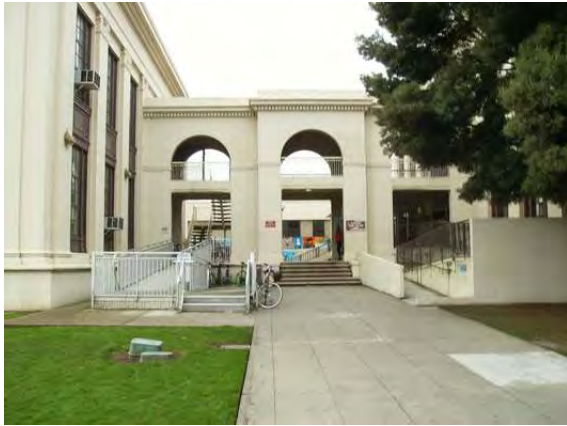
i) <b>ACCESS</b>							
1	Existing Deficiency	<b>West Wing Bridge:</b> plaza area trip hazards	#1, #2 Pavement	300	SF	\$18	\$5,400
	Recommended Remedy	* See ZFA Report for structural bracing; At Plaza, remove pavement, regrade, and replace with concrete pavement.	Steel Bracing	6	Tons	\$3,500	\$21,000
2	Existing Deficiency	<b>Tech Arts Accessable Ramp:</b> non compliant where landing exceeds 6" to adjacent pavement	#3				
	Recommended Remedy	Add 6" high concrete curb from hand rail to bottom of landing.		40	LF	\$30	\$1,200
3	Existing Deficiency	<b>Tech Arts Exercise Gym:</b> Exterior classroom door non accessible	#4				
	Recommended Remedy	Replace steel door frame and install threshold.		1	EA	\$3,500	\$3,500
4	Existing Deficiency	<b>West Wing 1st Floor:</b> Small Gym is non accessible; East Corridor entry is non compliant to plaza level	#5, #9				
	Recommended Remedy	Demo floor and install ramp into Gym; Redesign existing stairs to include accessible ramp/rail.	Allow	240	SF	\$155	\$37,200

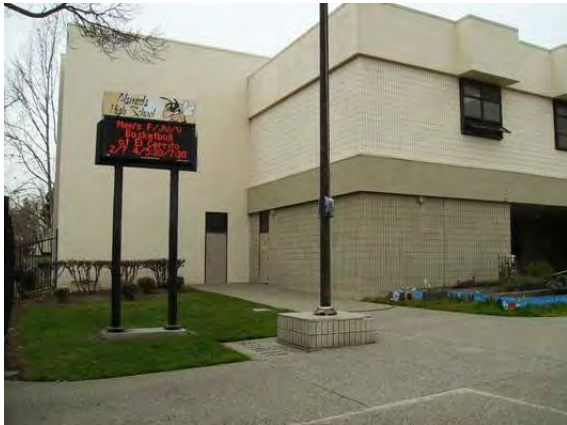
10

Recommended Remedy	Investigate w/ Garland for cause and remedy	ALLOW	33,000	SF	\$9	\$297,000
8	Existing Deficiency	<b>Academic Bldg:</b> Street Entry plaza and flag pole base damage	#10, #11				
	Recommended Remedy	Repair / replace pole base cap; investigate soil stability for pavement heave.	Allow	1	LS	\$1,500	\$1,500
9	Existing Deficiency	<b>West Wing Bridge:</b> Corrosion and paint deterioration on all railings; missing 2nd Fl. Handrail	#12,16, 17 & 18				
	Recommended Remedy	Replace all stair railing		100	LF	\$150	\$15,000

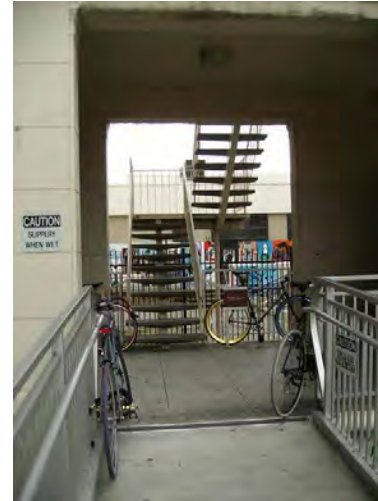
19

CATEGORY		DESCRIPTION	PHOTO & SITE PLAN	ESTIMATED TAKE OFF		COST / UNIT	TOTAL COST
Quantity	Unit						
10	Existing Deficiency	<b>West Wing Bridge:</b> Egress Stair not structurally compliant; rebar corrosion and concrete spalling;	#13, #14, #19				
	Recommended Remedy	Replace Stair with new compliant design; use specialty epoxy concrete repair		14	CY	\$850	\$11,900
11	Existing Deficiency	<b>West Wing Bridge:</b> terrazzo and concrete steps deteriorating	#15, #16				
	Recommended Remedy	Repair or replace treads		144	SF	\$14	\$2,016
12	Existing Deficiency	<b>West Wing:</b> Loading Dock function & stair damage					
	Recommended Remedy	Reconfigure dock with tailgate lift; repair concrete stair and install new guard/ handrails	Allow	1	LS	\$20,000	\$20,000
13	Existing Deficiency	<b>West Wing East elevation;</b> rails non compliant; <b>North/South elevations:</b> All rails have excessive corrosion with deterioration.	#21,22,26, &27
