# Encinal High School

## Alameda USD Facilities Assessment

**Encinal High School**  
**Facility Assessment Spreadsheet**

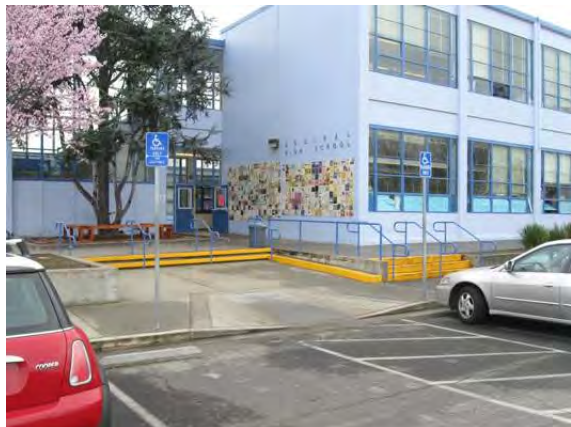
i) ACCESS							
	1 Existing Deficiency	ADA signage out of date.	1C				
	Recommended Remedy	Add "\$250 fine" signs at all locations.		2	EA	\$500.00	\$1,000
	2 Existing Deficiency	With the path of travel at the hend end of these stalls, the ADA stalls are three feet too short.	2C				
	Recommended Remedy	Remove AC dike along the frontage of the three stalls. Pave a 4 ft extension of the asphalt into the adjoining planting area, and reinstall an AC dike. Relocate the wheelstops, and refresh the striping. Relocate the ADA stall parking signs to behind the new AC dike. remove ADA parking lot entry sign currently located at these stalls.		200	SF	\$6.00	\$1,200
	3 Existing Deficiency	There is no accessible parking in this portion of the site.	3C				
	Recommended Remedy	Use a combination of grinding and overlay to create a single ADA stall with an adjoining 8 ft unloading zone at the northeast side of this area.		360	SF	\$6.00	\$2,160

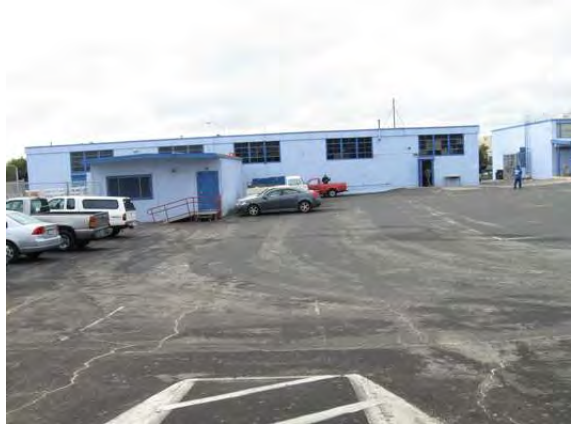
4 Existing Deficiency	The landings (concrete flatwork) at the bottom of the various main entry stairs are not level as required by code.	4C				
	Recommended Remedy	Making these compliant requires removal and replacement of concrete flatwork at the bottom of the stairs, out to the curb. It appears also necessary to remove curb and replace it with a higher curb, so that the new flatwork could be placed at 2% max cross slope.		400	sf	\$20.00	\$8,000

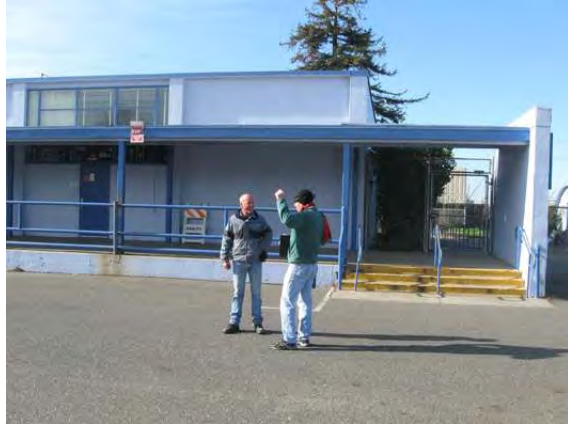
CATEGORY		DESCRIPTION	PHOTO & SITE PLAN	ESTIMATED TAKE OFF Quantity Unit		COST / UNIT	TOTAL COST
5	Existing Deficiency	The approach to these main doors far exceeds 2% slope.	5C				
	Recommended Remedy	Repair of this deficiency complicated by the steep walk slopes continuing down a from doors, to adjoining ramp leading to the parking lot. Removing the existing walk flatwork and repouring at 2% max adjoining the doors, will leave the new walk surface higher than the upper end of the ramp. This ramp appears to be about 30 ft long currently, but has a slope of only 5.2%. Any effort to lengthen the ramp will require complete removal of the existing ramp and railings; construct a new ramp at 8.33% max with an intermediate landing, and new railings, as required to successfully complete the transition to the lower walkway.		240	SF	\$35.00	\$8,400
6	Existing Deficiency	A total of 14 room entry doors in these two wings have 1" to 1 1/2" thresholds that transition from the finished floor to the adjoining covered walk with short concrete transitions. There are no level landings at the doors.	6C
