Building Information - Yellow Springs Exempted Village (45674) - Mills Lawn Elementary / Middle School

Building Pictures - Yellow Springs Exempted Village(45674) - Mills Lawn Elementary / Middle School (24919)

47,324 Total Existing Square Footage
1952,1957,2002 Building Dates
K-6 Grades
374 Current Enrollment
25 Teaching Stations
8.84 Site Acreage

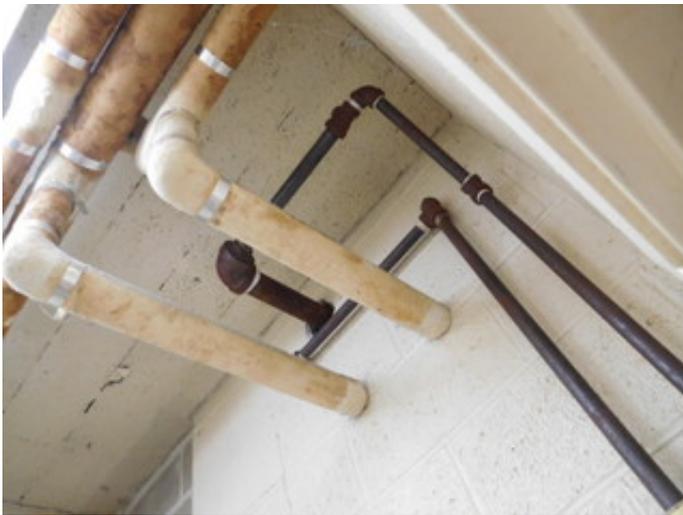
1952 Original Construction Typical Roof Construction

Recommendations: Refer to Item A for funding of architectural soffits to accommodate HVAC, electrical, and plumbing scopes of work. Existing conditions require no renovation or replacement at the present time.

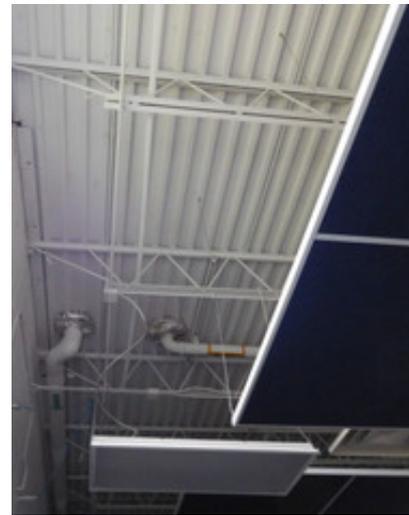
2002 Addition Typical Roof Construction

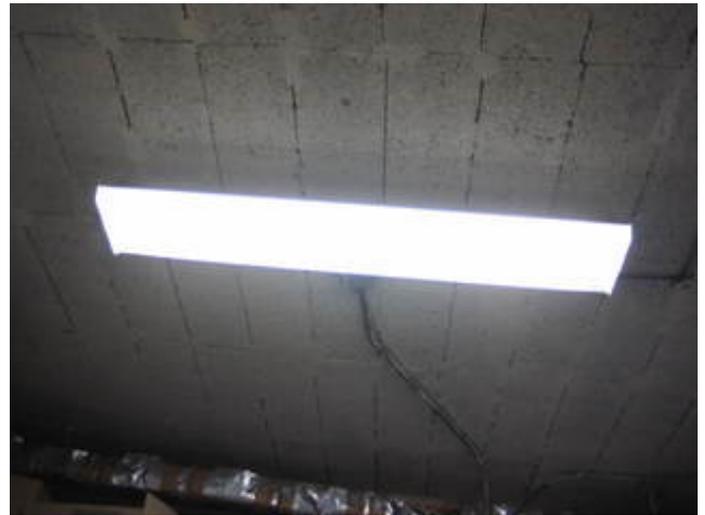
Service Area Fluorescent Light Fixture

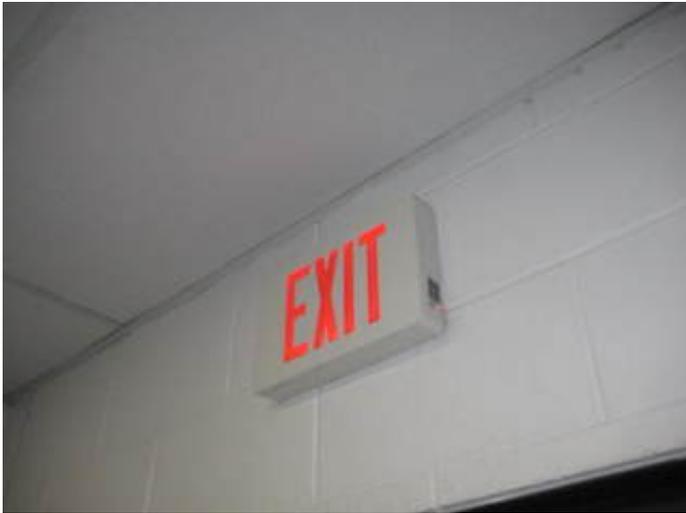
Exit Sign

Recommendations: Provide complete replacement of emergency / egress lighting system to meet Ohio School Design Manual and Ohio Building Code guidelines.

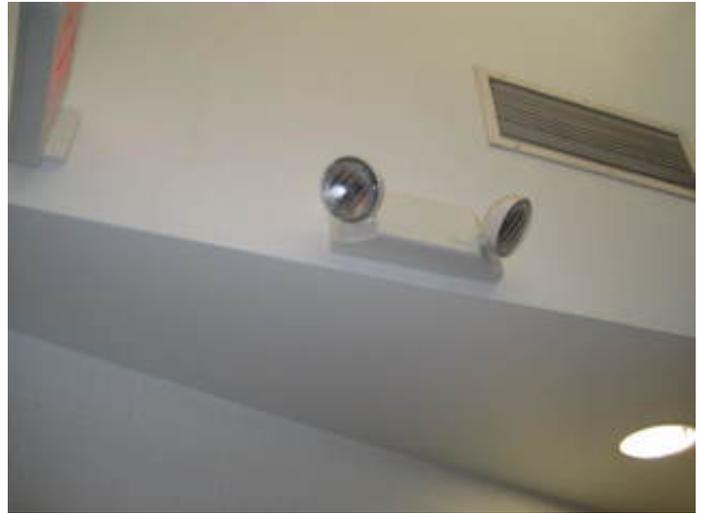
Emergency Egress Light Fixture

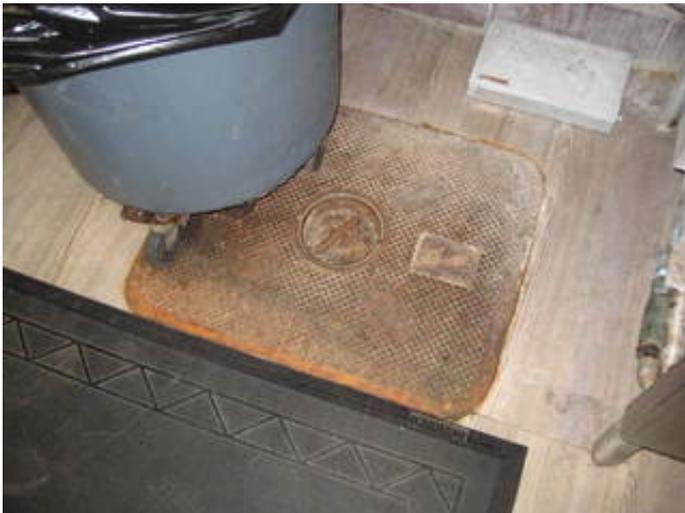
Kitchen Grease Trap Interceptor

Recommendations: Existing conditions require no renovation or replacement at the present time.

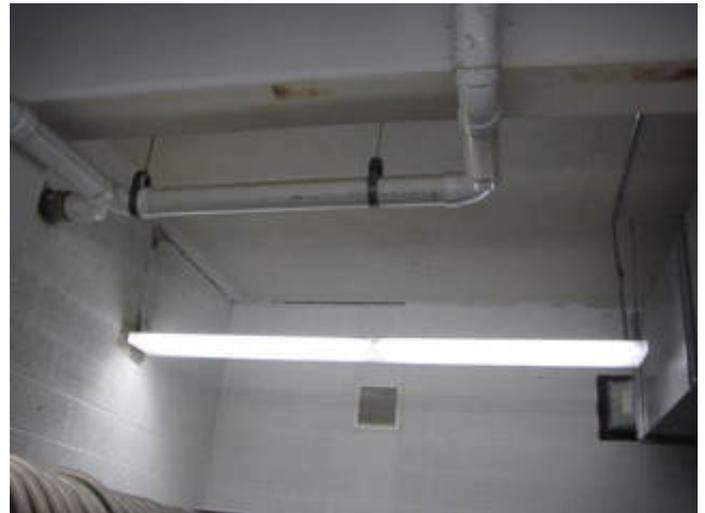
Sanitary Waste Piping

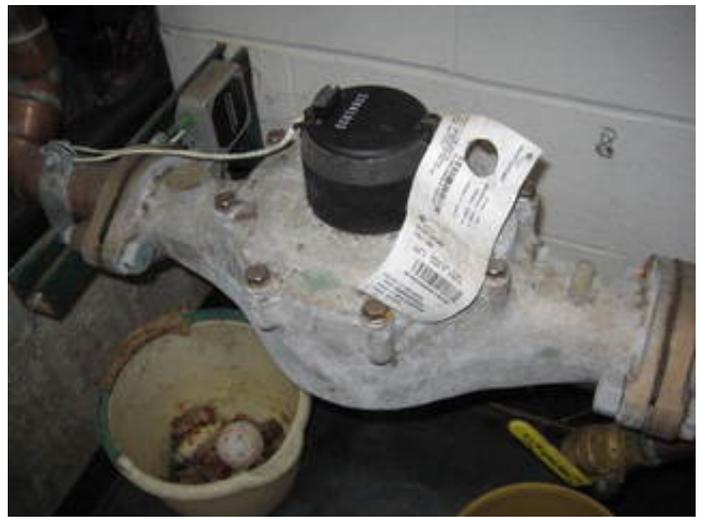
Incoming Domestic Water Meter

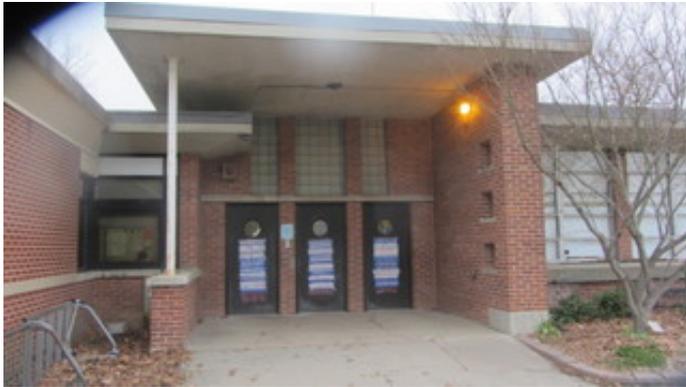
1952 Original Construction Main Entry Doors

Recommendations: Replace all exterior doors in the 1952 Original Construction and 1957 Addition, due to poor condition and to comply ADA and Ohio School Design Manual guidelines. Replacement of single glazed door vision panels in the 2002 Addition is addressed in Item F. Replacement of interior fire doors as noted in the School District provided AHERA reports included in Item J, with abatement included in Item T. POST-ASSESSMENT NOTE: Rii 1-9-18 Providing funding for replacement of Fire Doors per EEHA and Item T.

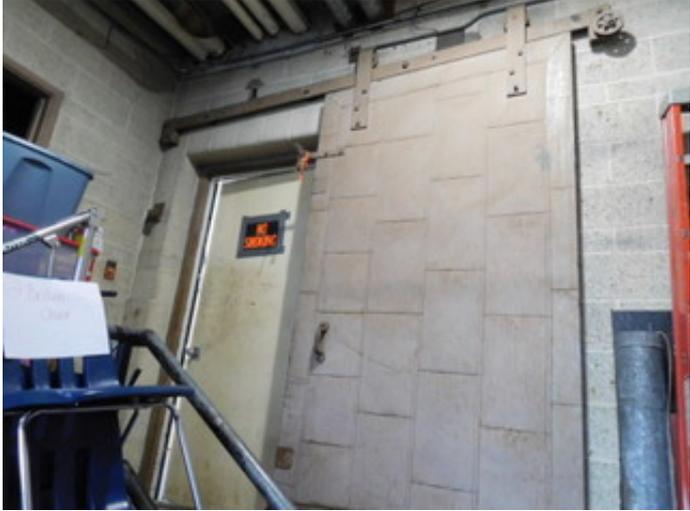
Fire Door

Dismantling of Boiler/Furnace/Incinerator	\$2,000.00	each		2 Required	0 Required	0 Required	\$4,000.00	
Hard Plaster Removal	\$7.00	sq.ft. (Qty)		0 Required	3,250 Required	0 Required	\$22,750.00	See J
Fire Door Removal	\$100.00	each		16 Required	4 Required	0 Required	\$2,000.00	See S
Non-ACM Ceiling/Wall Removal (for access)	\$2.00	sq.ft. (Qty)		1,912 Required	813 Required	0 Required	\$5,450.00	See J
Window Component (Compound, Tape, or Caulk) - Reno & Demo	\$300.00	each		255 Required	105 Required	0 Required	\$108,000.00	
Window Component (Compound, Tape, or Caulk) - Reno Only	\$300.00	each		255 Required	105 Required	0 Required	\$108,000.00	
Resilient Flooring Removal, Including Mastic	\$3.00	sq.ft. (Qty)		15,061 Required	8,525 Required	0 Required	\$70,758.00	See J
Carpet Mastic Removal	\$2.00	sq.ft. (Qty)		0 Required	2,575 Required	0 Required	\$5,150.00	
Carpet Removal (over RFC)	\$1.00	sq.ft. (Qty)		11,957 Required	6,572 Required	0 Required	\$18,529.00	See J

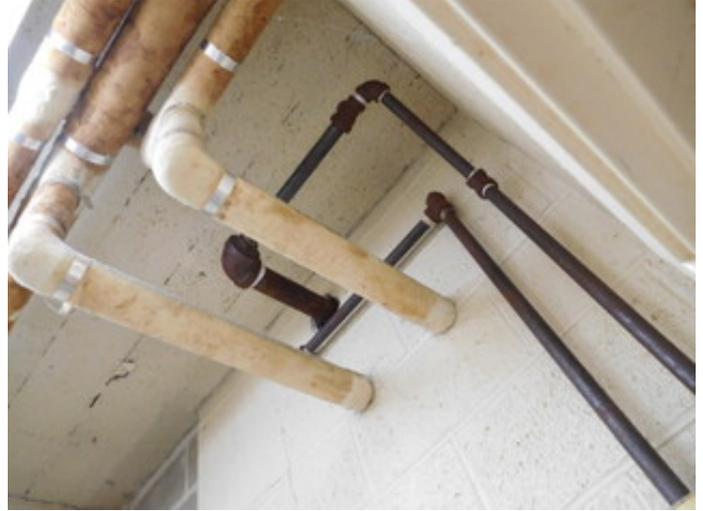
Pipe Insulation

Acoustical Tile Mastic Removal	\$3.00	sq.ft. (Qty)		15,726 Required	0 Required	0 Required	\$47,178.00	
Sink Undercoating Removal	\$100.00	each		13 Required	6 Required	0 Required	\$1,900.00	
Other: Chalkboard Mastic Removal	\$2.00	sq.ft. (Qty)		1,530 Required	630 Required	840 Required	\$6,000.00	Provide for removal of chalkboard mastic
Other: Cove Base Mastic Removal	\$1.00	ln.ft.			725 Required	750 Required	\$1,475.00	Provide for removal of cove base mastic
Other: Stage Curtain Removal	\$1.00	sq.ft. (Qty)				600 Required	\$600.00	Provide for the removal of the stage curtains
Sum:			\$437,587.40	\$301,512.00	\$131,719.30	\$4,356.10

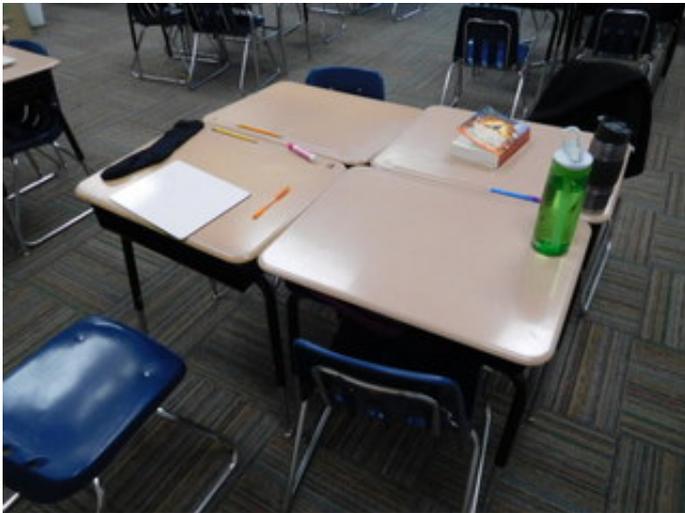
Typical Student Desk and Chair

Recommendations: Provide for replacement of outdated or inadequate furnishings.

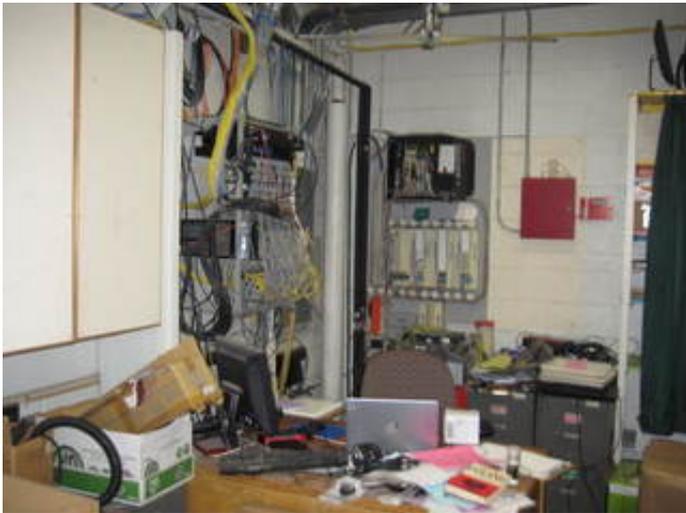
IT System Data Rack

Recommendations: Provide complete replacement of technology systems to meet Ohio School Design Manual requirements.

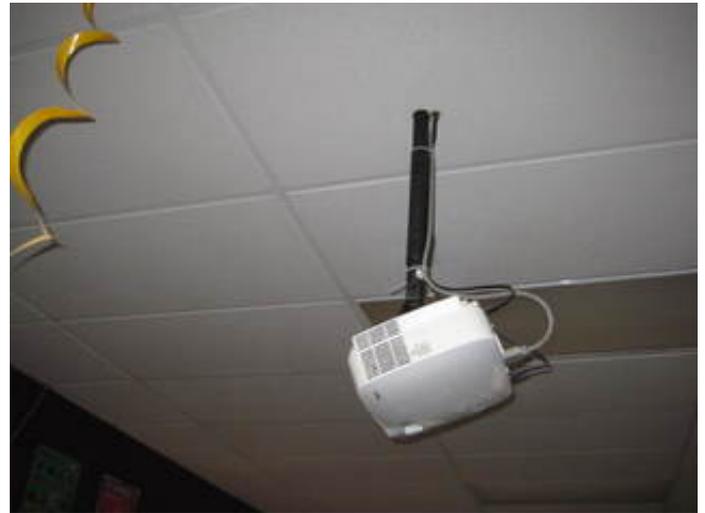
IT System Classroom Projector
