Building Information - Yellow Springs Exempted Village (45674) - Yellow Springs High School/McKinney Middle School

Program Type	Expedited Local Partnership Program (ELPP)
Setting	Small City
Assessment Name	Yellow Springs High with EEA Update & Related Scope Adjustments
Assessment Date (on-site; non-EEA)	2017-03-29
Kitchen Type	Full Kitchen
Cost Set:	2018
Building Name	Yellow Springs High School/McKinney Middle School
Building IRN	42416
Building Address	420 East Enon Road
Building City	Yellow Springs
Building Zipcode	45387
Building Phone	(937) 767-7224
Acreage	37.82
Current Grades:	7-12
Teaching Stations	22
Number of Floors	3
Student Capacity	412
Current Enrollment	383
Enrollment Date	2017-03-29
Enrollment Date is the date in which the current enrollment was taken.	
Number of Classrooms	1
Historical Register	NO
Building's Principal	Mr. Tim Krier
Building Type	Middle/High

Yellow Springs High School/McKinney Middle School, which is not on the National Register of Historic Buildings, and originally constructed in 1963, is a three story, 74,229 square foot brick, painted corrugated galbestos panels, EIFS, insulated metal panels, and painted concrete building located on the outer edge

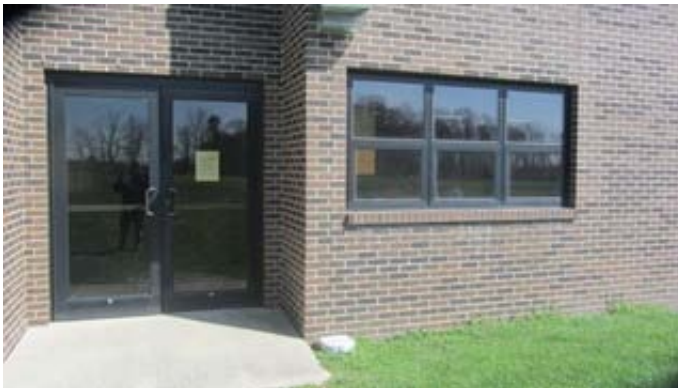
2002 Addition Exterior Door and Window

Recommendations: Replace exterior doors in the 1963 Original Construction and 1999 Addition, due to condition and compliance with ADA and Ohio School Design Manual guidelines. Replacement of single glazed door vision panels in the 1988 and 2002 Additions is addressed in Item F.
 POST-ASSESSMENT NOTE: Rii 5-26-18 Fire Door replacement scope added to coordinate with Item T and PSI EEHA.

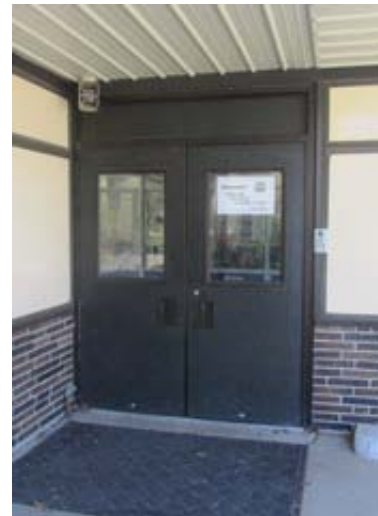
1963 Original Construction Main Entry Doors

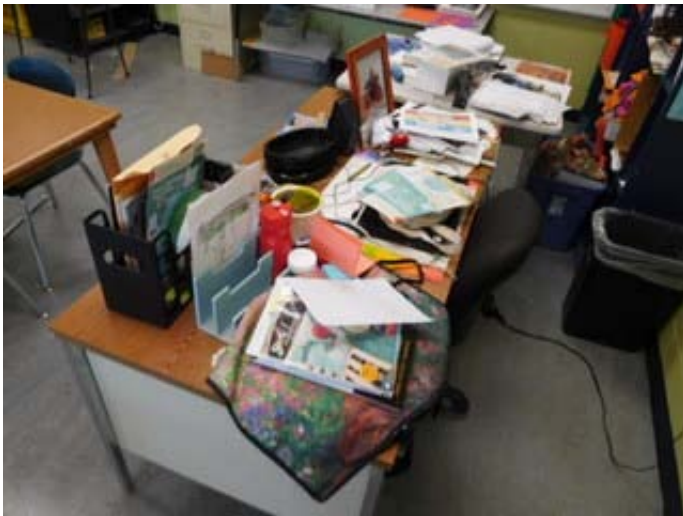
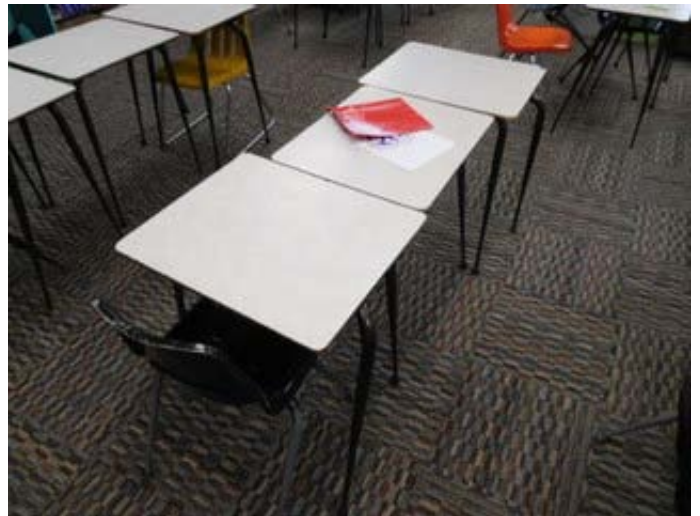
Typical Teacher Desk and Chair

Typical Student Desk and Chair

Recommendations: Provide for replacement of outdated or inadequate furnishings.

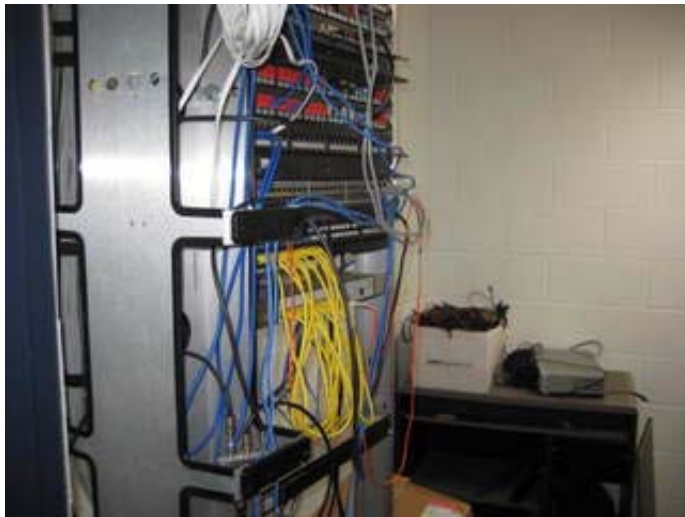
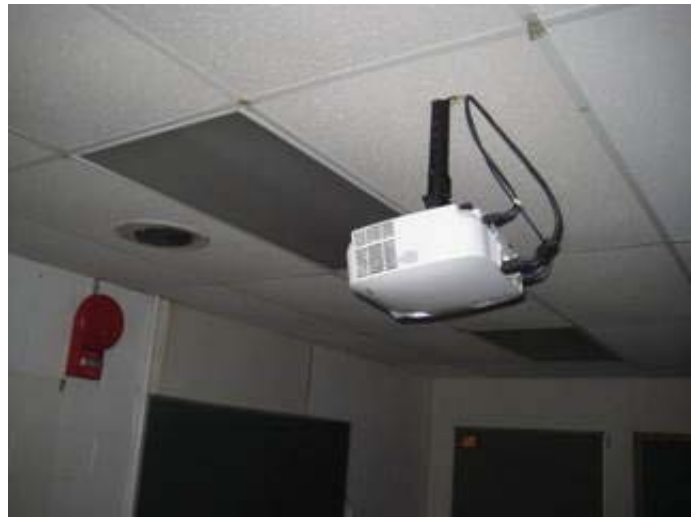
IT System Data Rack

IT System Classroom Projector

Recommendations: Provide complete replacement of technology systems to meet Ohio School Design Manual requirements.
