Physical Building and Educational
Assessment
Yellow Springs Schools
Yellow Springs, Ohio

Project No. 219001.00

May 22, 2019

Physical Building and Educational Assessment

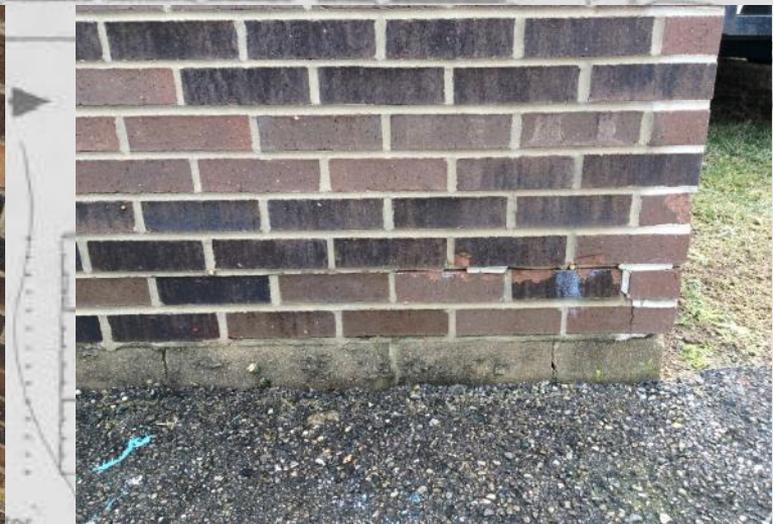
Basement

The foundation is in relatively good condition; however, there are various areas of cracked concrete wall, and/or open joints that should be addressed, as well as addressing the leaks at the exterior walls of the mechanical room.

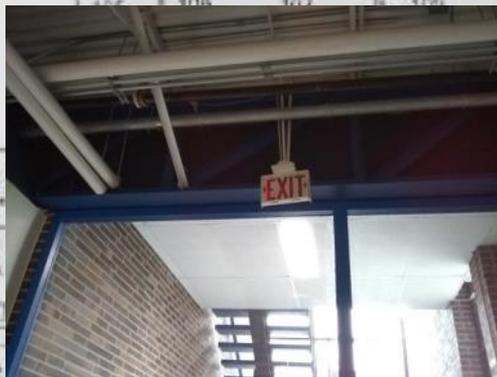
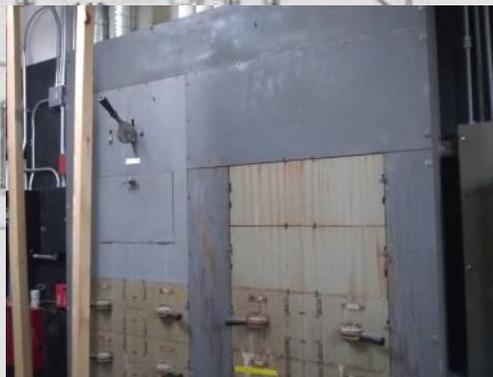
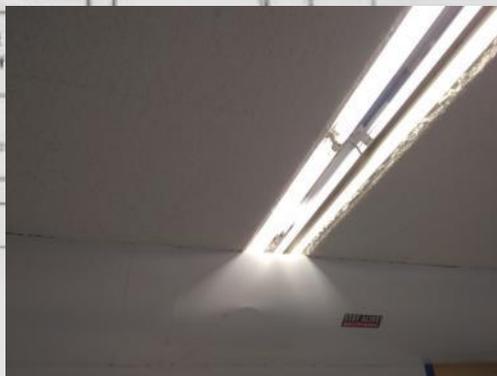
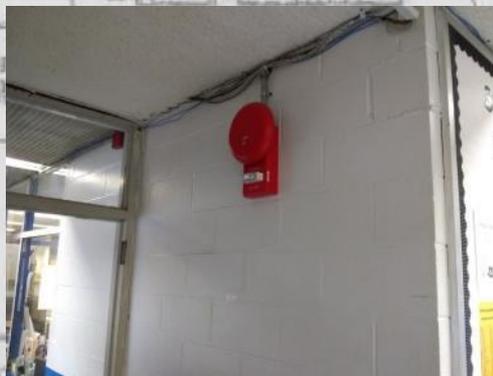
- Fire alarm functional, but outdated
- Majority of panel boards are too old for replacement parts.
- Lighting mostly fluorescent, becoming expensive with LED trend.
 - Emergency and exit lights aged past being reliable

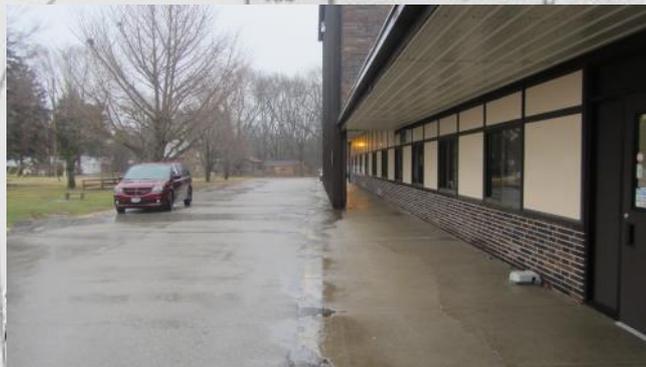
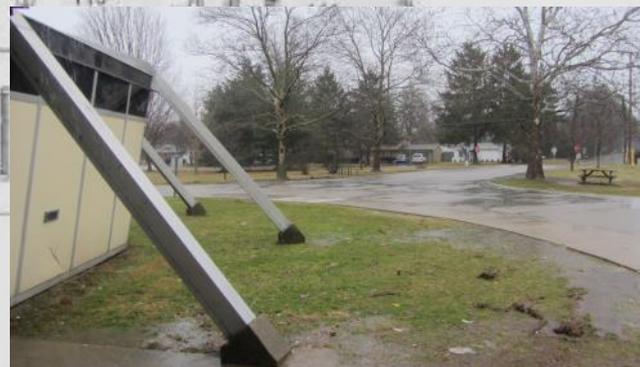
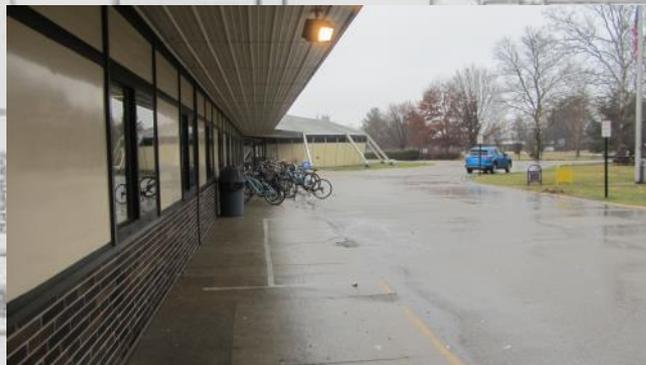
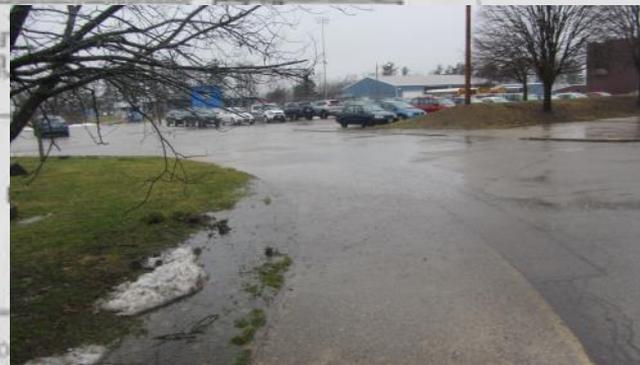
Drainage issues, bicycle storage area blocks pathways to main entrances, no separation of pedestrian and vehicular traffic, lack of adequate storm system to manage runoff.

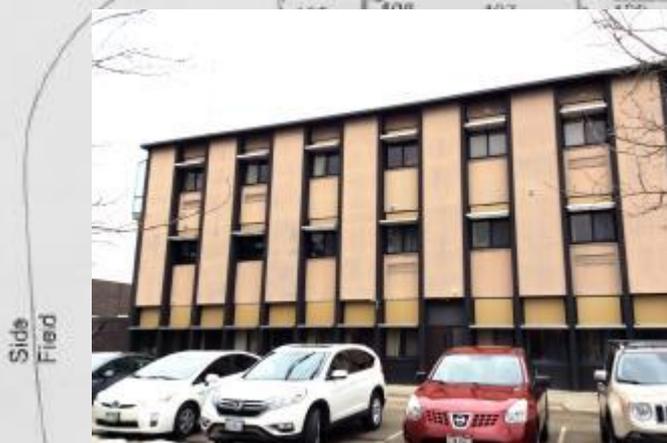
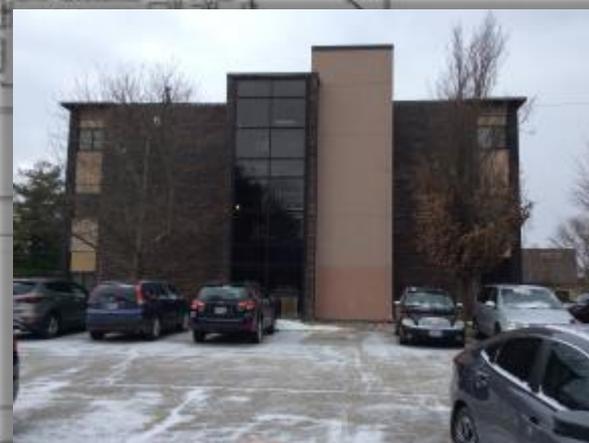
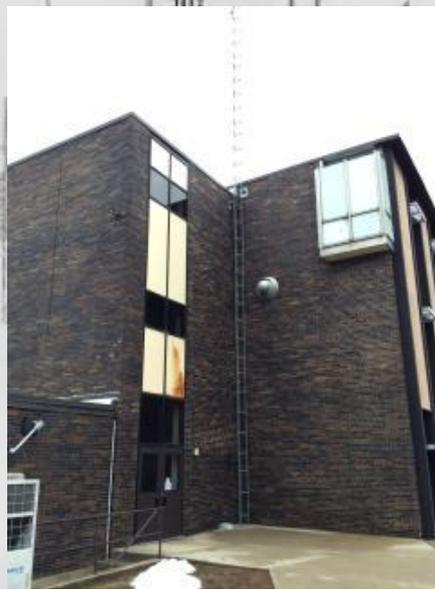
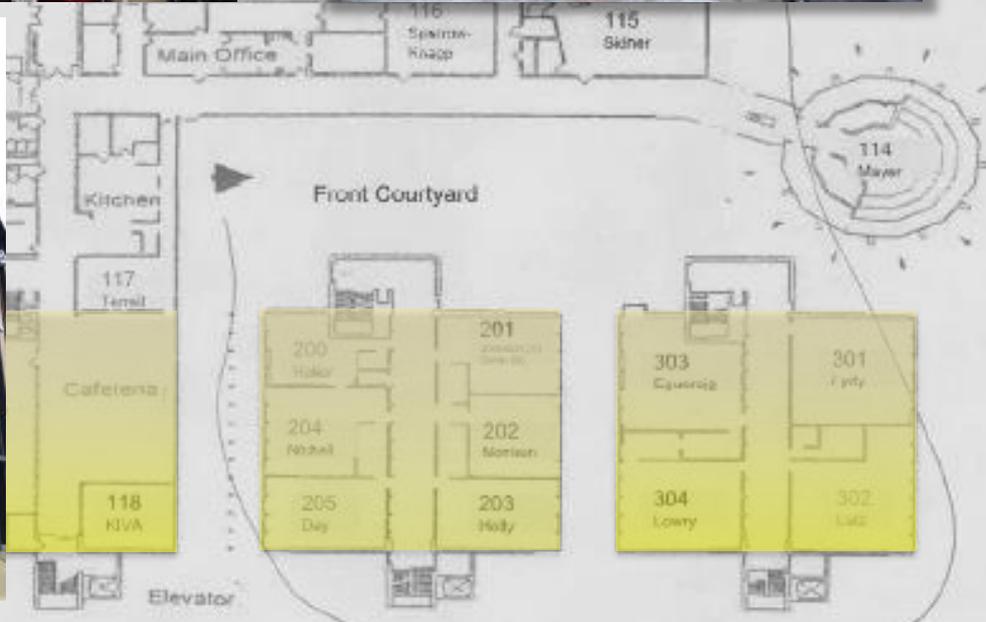
Dated

Not inspiring

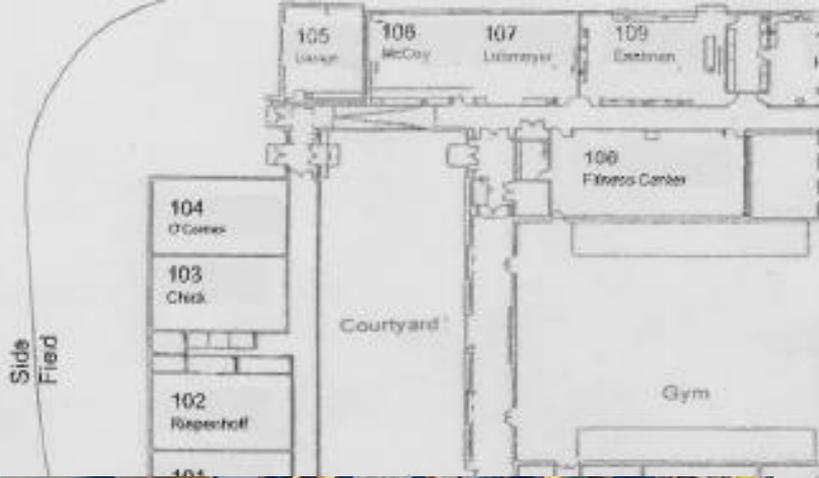
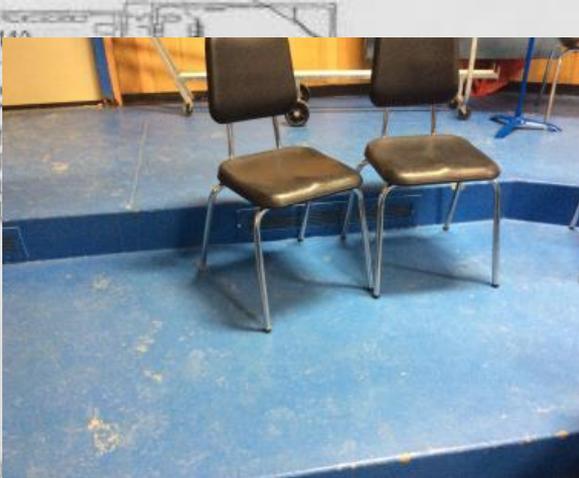
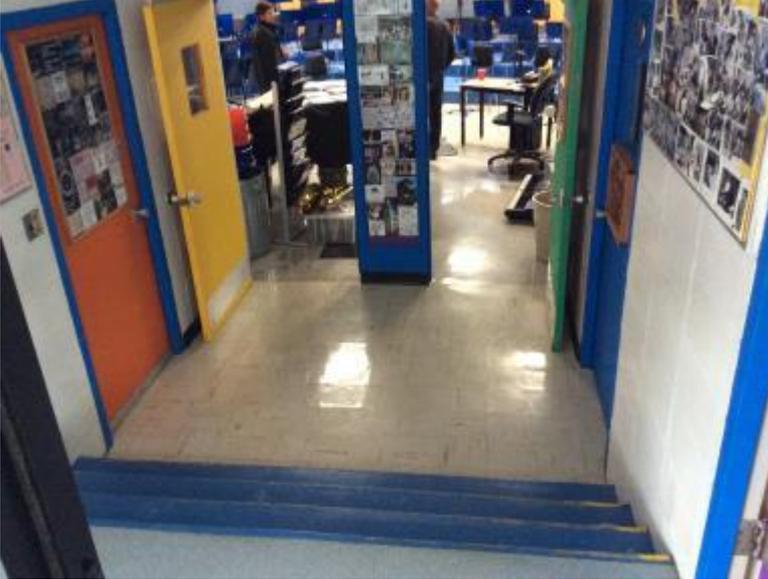
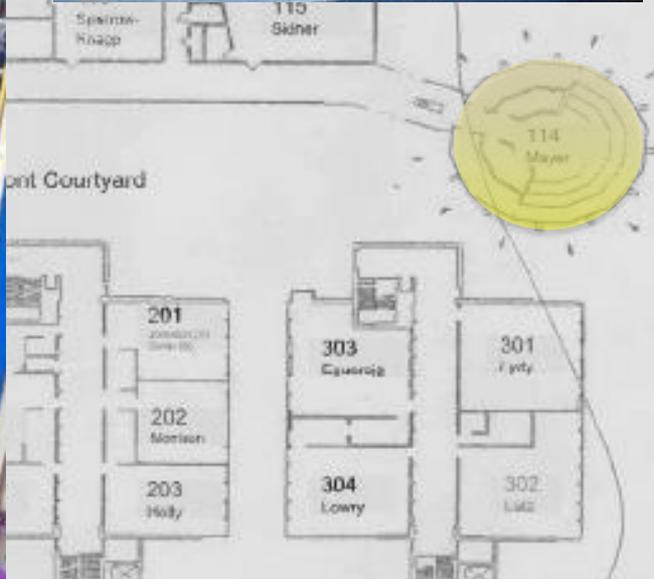
Feels like an
annex

Odd shapes and
angles

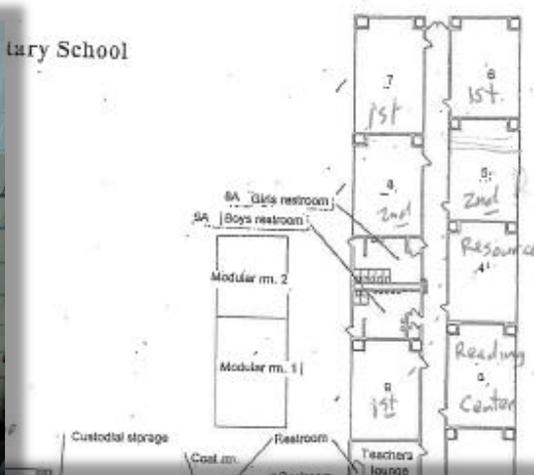
Lack of space for
small group work

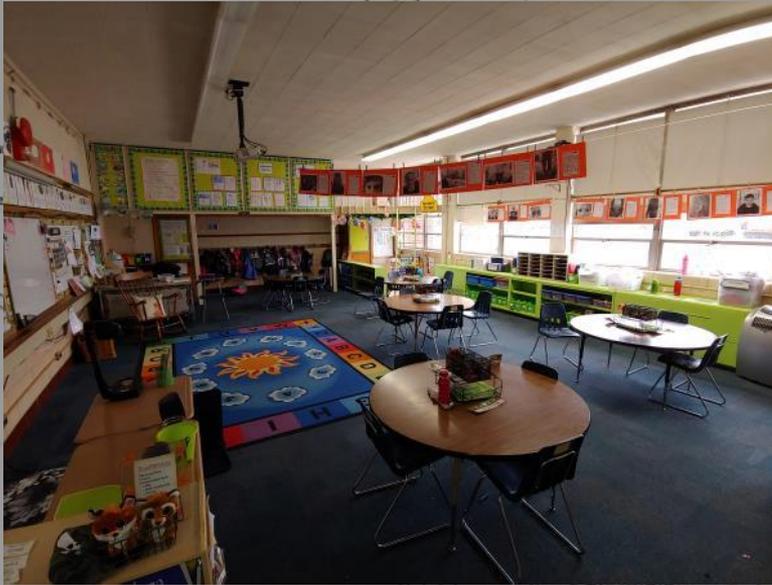
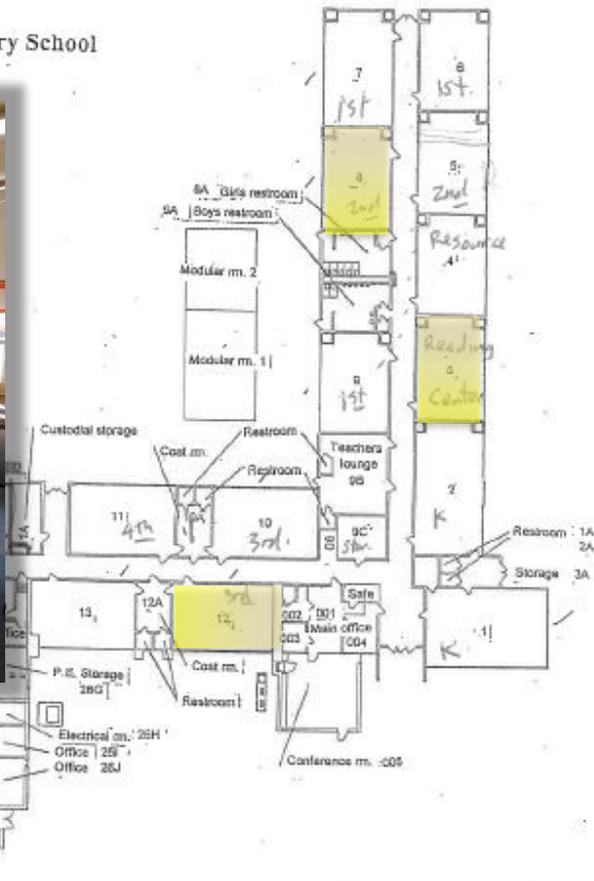
Narrow gauge footprint – long and narrow classrooms
