## PROPERTY CONDITION ASSESSMENT Long Lots Elementary School

Colliers Project Leaders USA NE, LLC ("CPL") is pleased to present the Property Condition Assessment (PCA) for Westport Public Schools. The purpose of this PCA is to determine the current condition of Long Lots Elementary School and provide recommendations for repairs and upgrades.

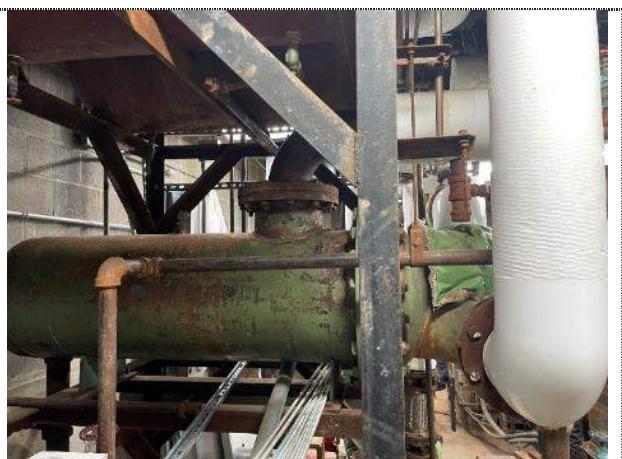
Figure 4: Steam to hot water HX in the boiler room

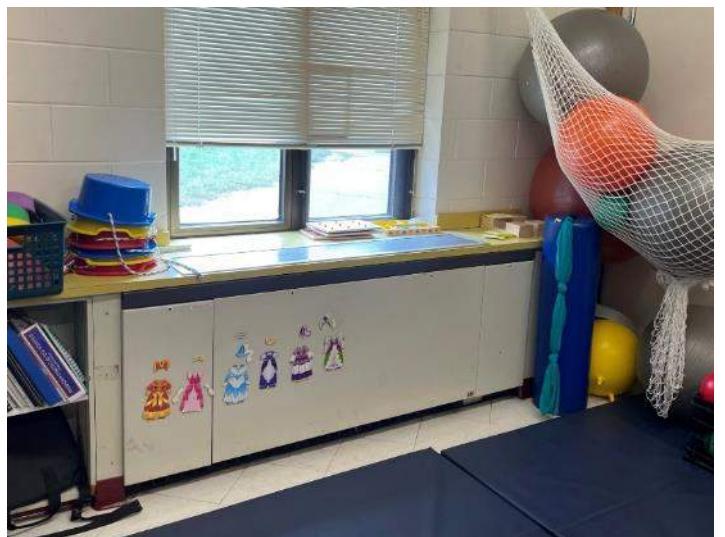
Figure 8: Unit ventilator with hot water heat and DX cooling original to the 200-Wing construction.

All of the unit ventilators for 200-wing have pneumatic control valves for heating hot water. The valves are controlled by electric thermostat using EP switches. The units can be controlled and monitored from the BMS.

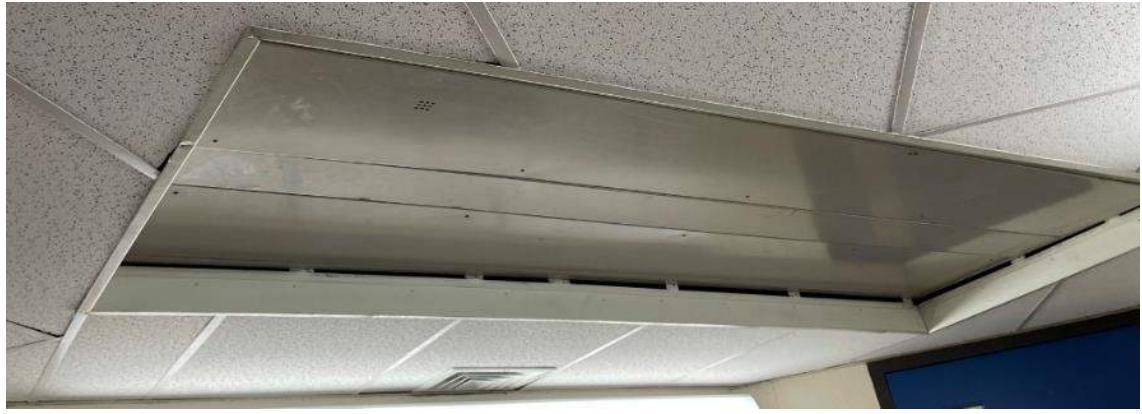
The South-West classrooms (room 5, 6, 7, 101, 103 and 105) are served by 4pipe fan coil units with outdoor air damper for ventilation. The heating and cooling are provided by hot water and chilled water respectively.

Figure 9: Four-Pipe Fan Coil Unit.

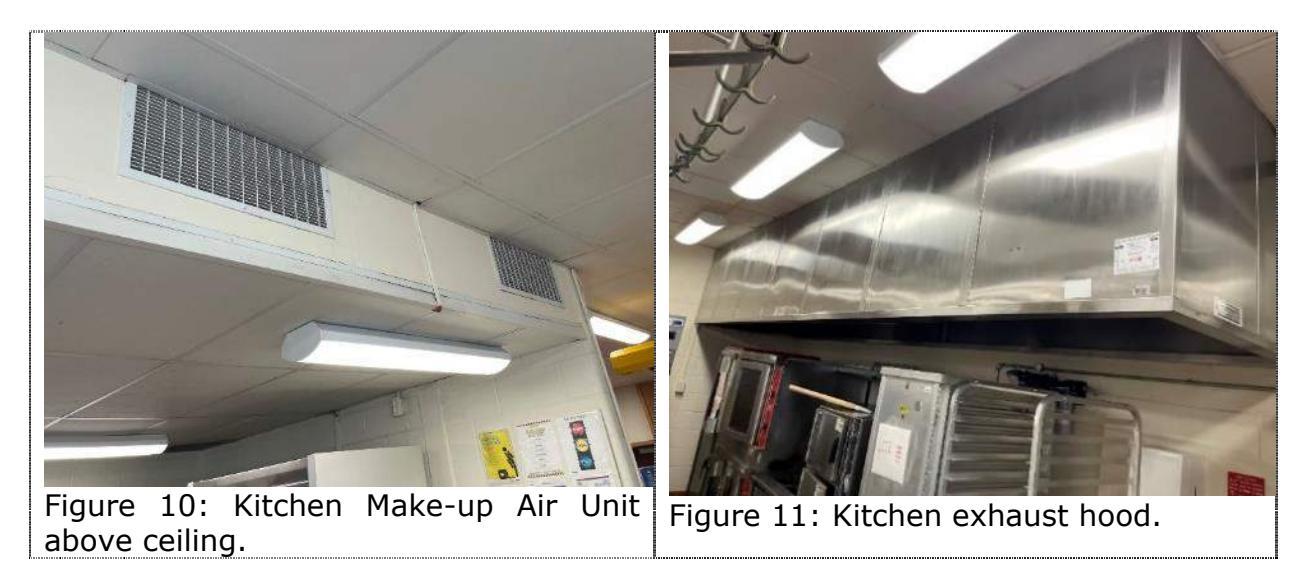
The kitchen is served by a 100% outdoor air unit with pneumatic controls and steam heating coil. The unit serves the kitchen and café area. It is reported that the kitchen hood exhaust unit is not interlocked with the make-up unit.

A makeup air unit should be provided to correct the negative air balancing issue in the kitchen.

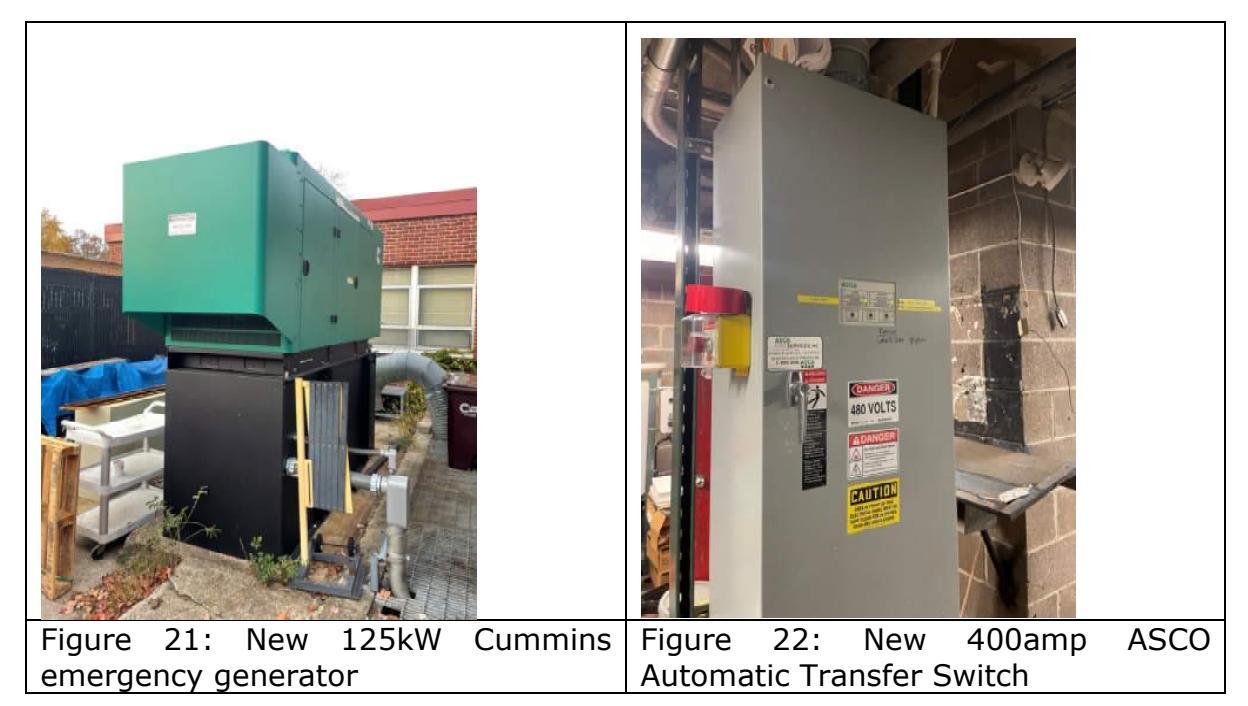
Emergency power is provided to the building from a new exterior mounted Cummins 125kW diesel generator. The generator, installed in 2021, has a sub-mounted fuel tank. The unit is in new condition and should not be scheduled for replacement for two decades if maintained properly.

The emergency generator is connected to a 400 amp 480 volt ASCO automatic transfer switch (ATS). The ATS is in new condition and should be relatively maintenance free for a number of years.

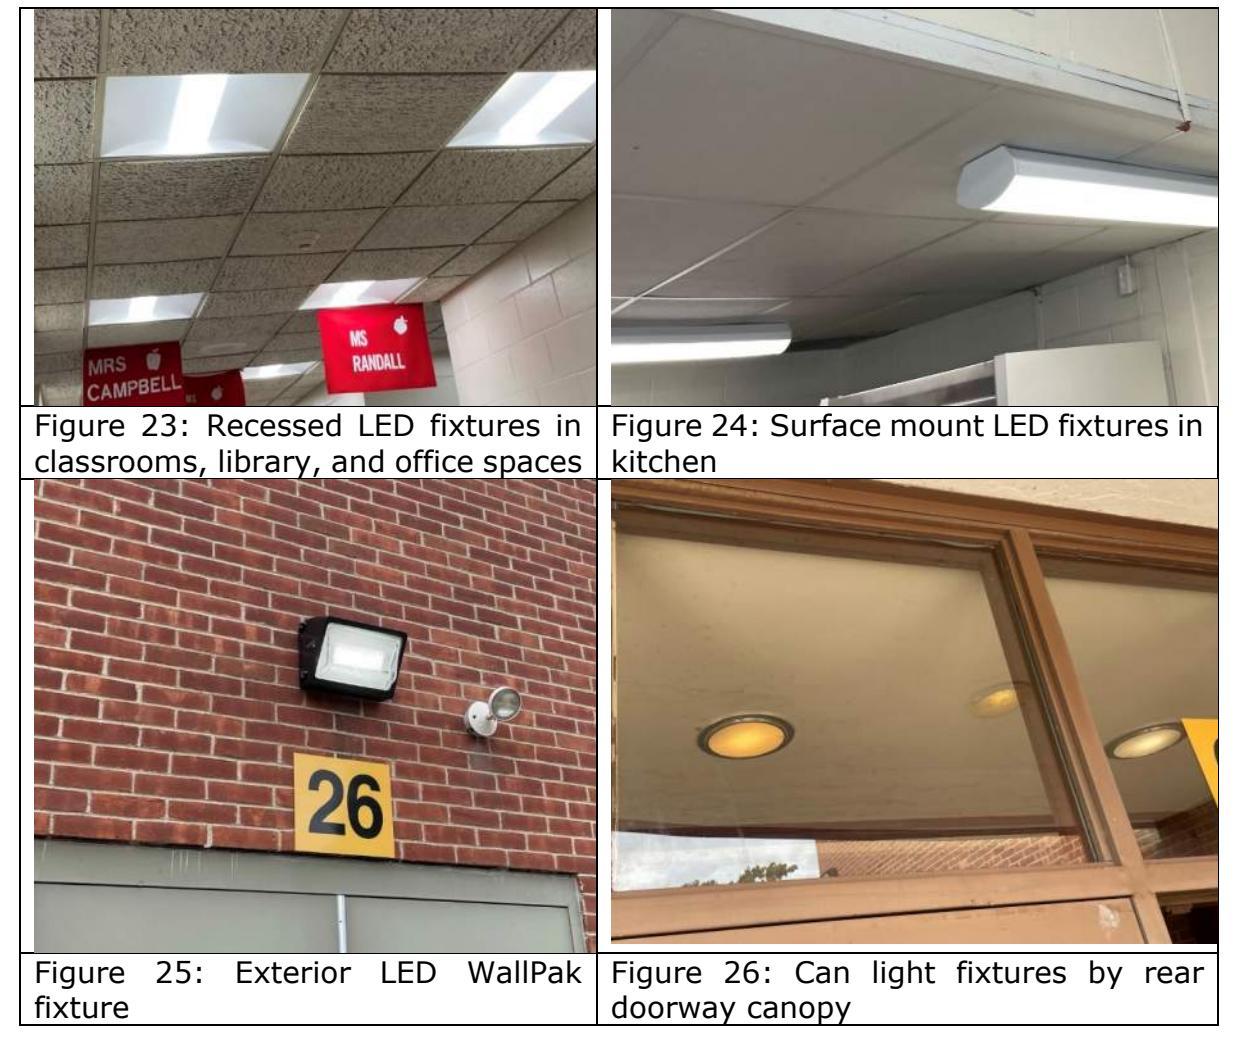
All of the interior spaces were observed to have recessed or surface mount LED fixtures. Occupancy sensors were observed in classrooms. The hallway in the old section of the school appears to have LED lamps retrofitted in existing linear florescent fixtures.

The building exterior lighting was observed to be LED WallPak fixtures. Some of the interior and exterior canopy can light fixtures appeared to be older fixtures and may consist of incandescent or metal halide light bulbs. Several of the exterior light fixtures were observed to be operating during daytime. The exterior lighting is controlled by a timeclock.

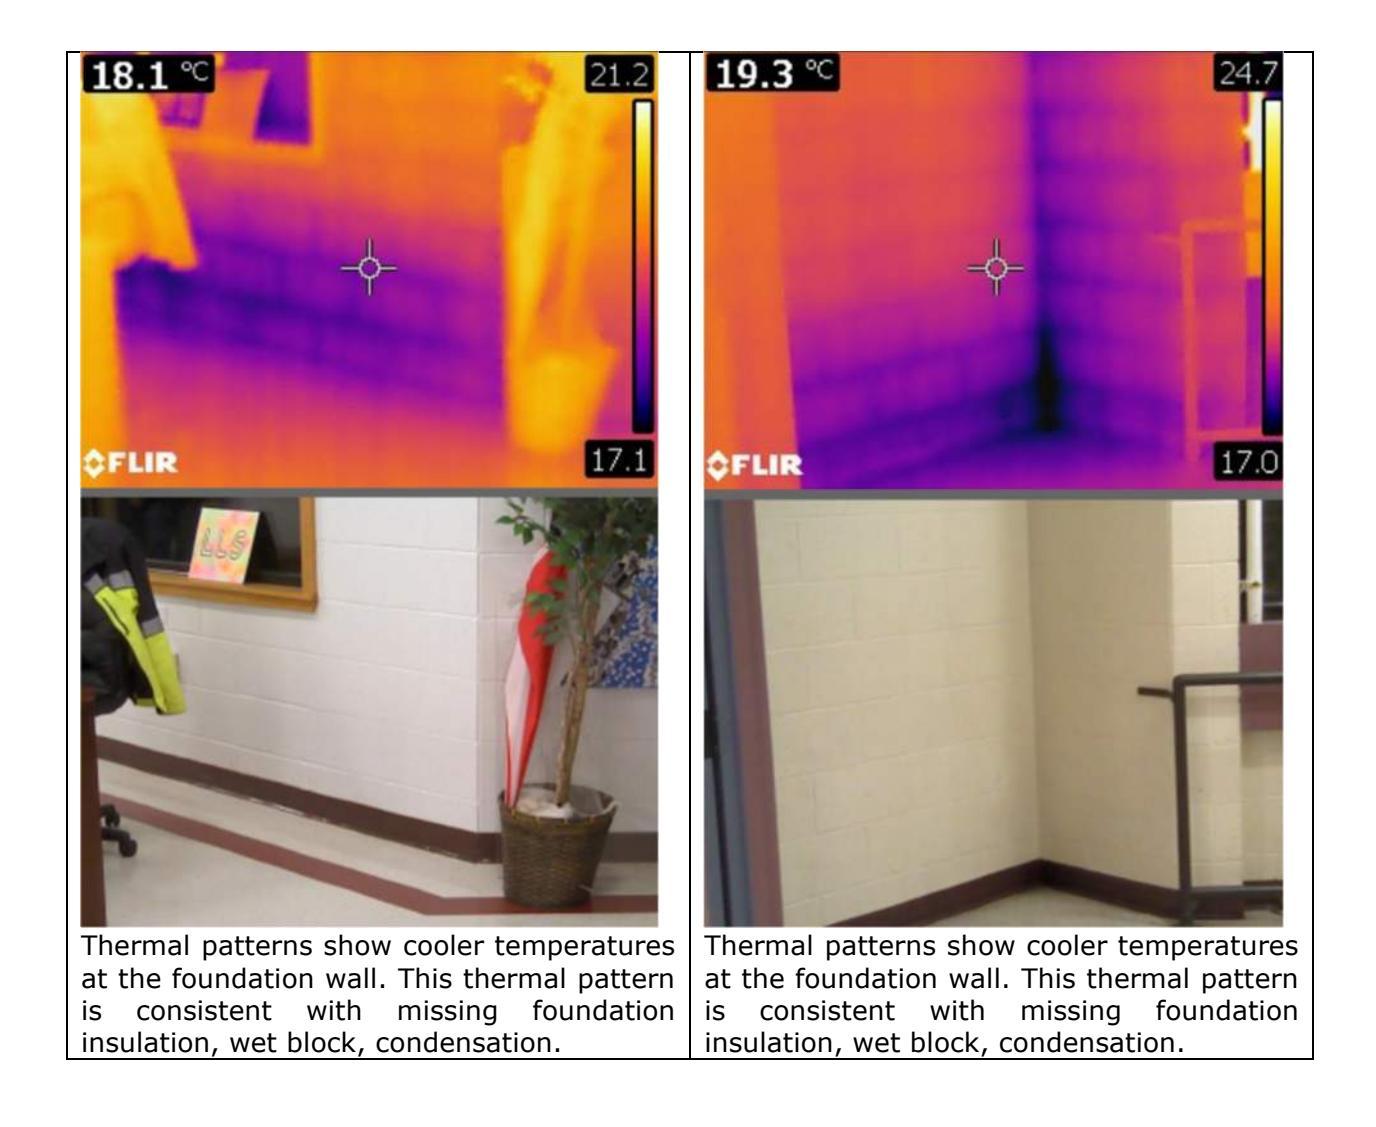
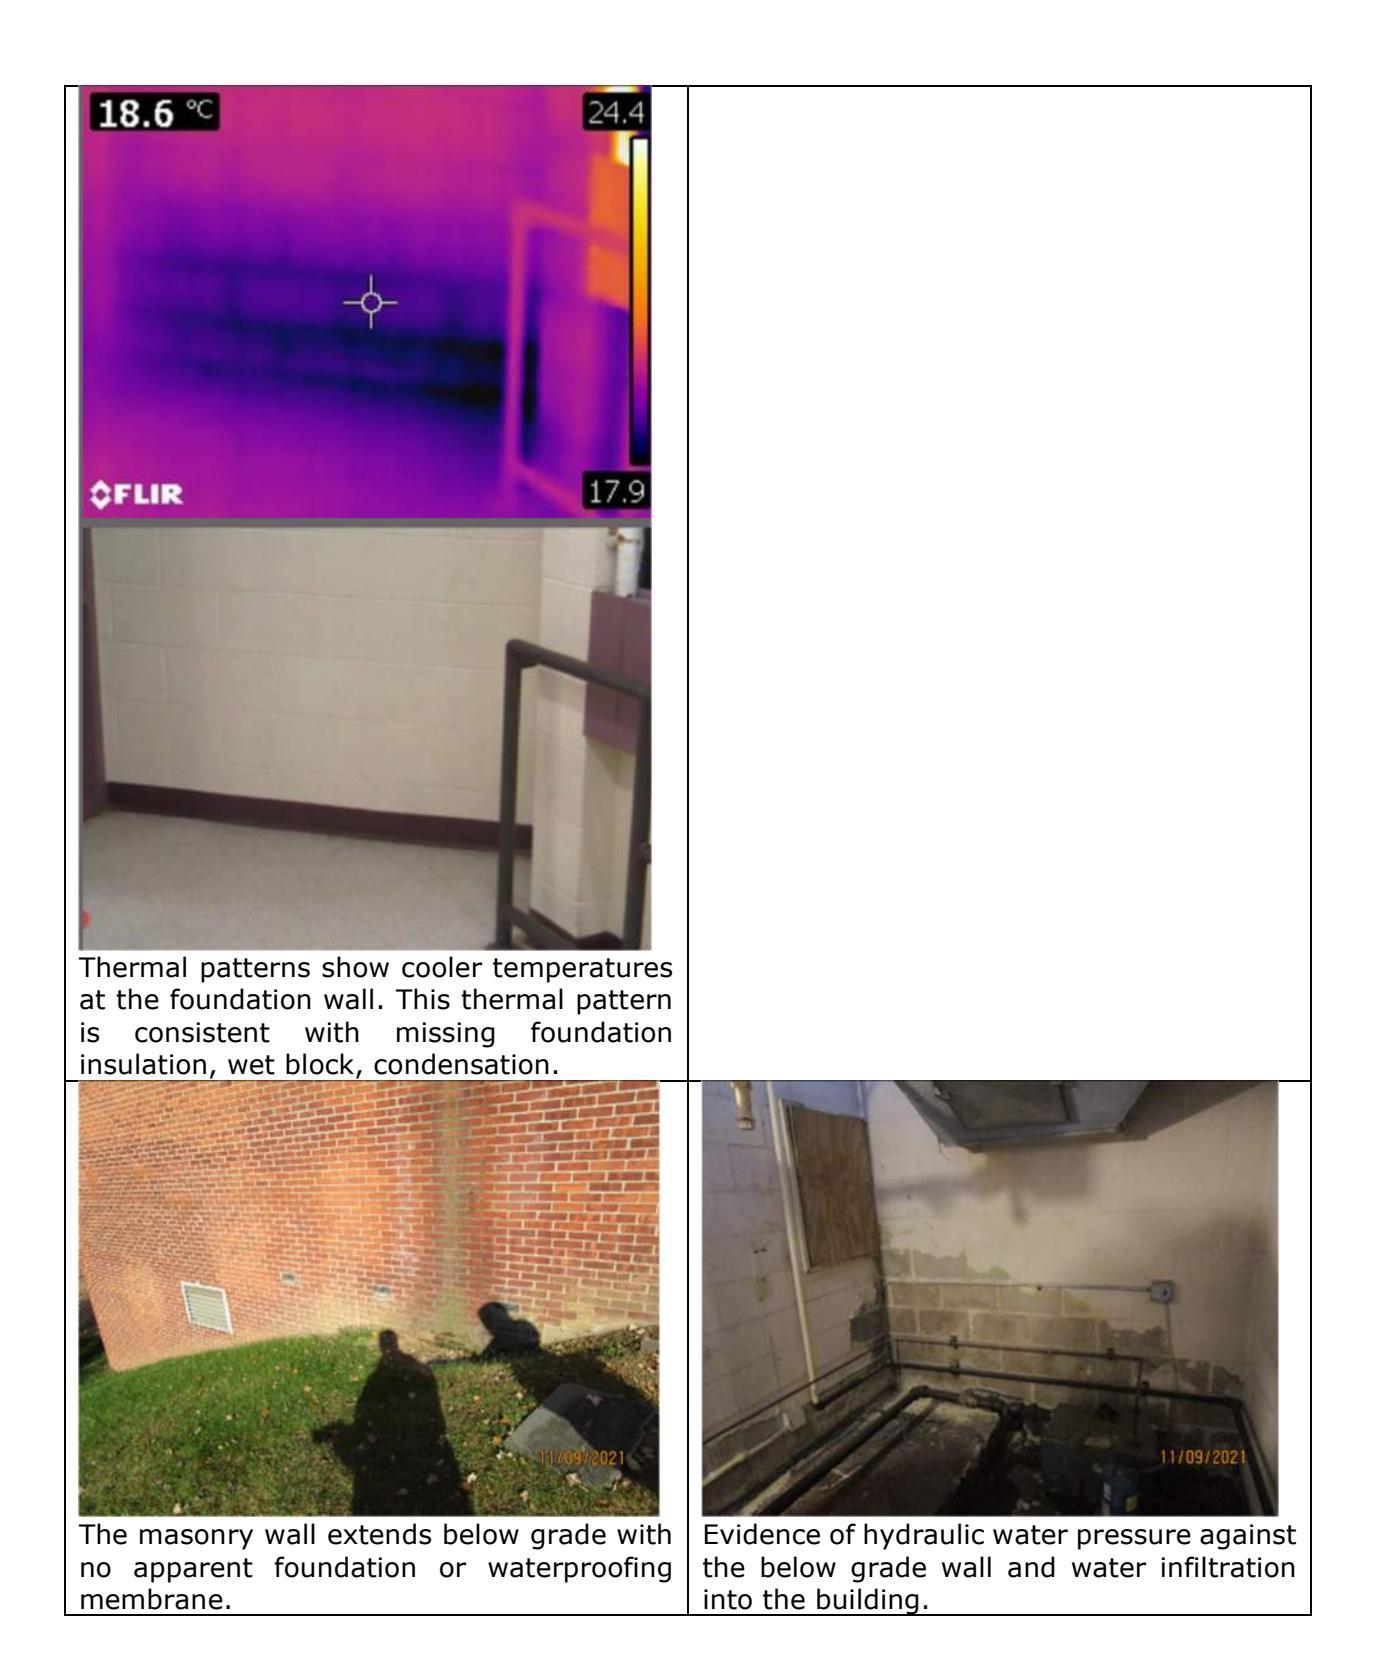
Thermal patterns show cooler temperatures at the foundation wall. This thermal pattern is consistent with missing foundation insulation, wet block, condensation.

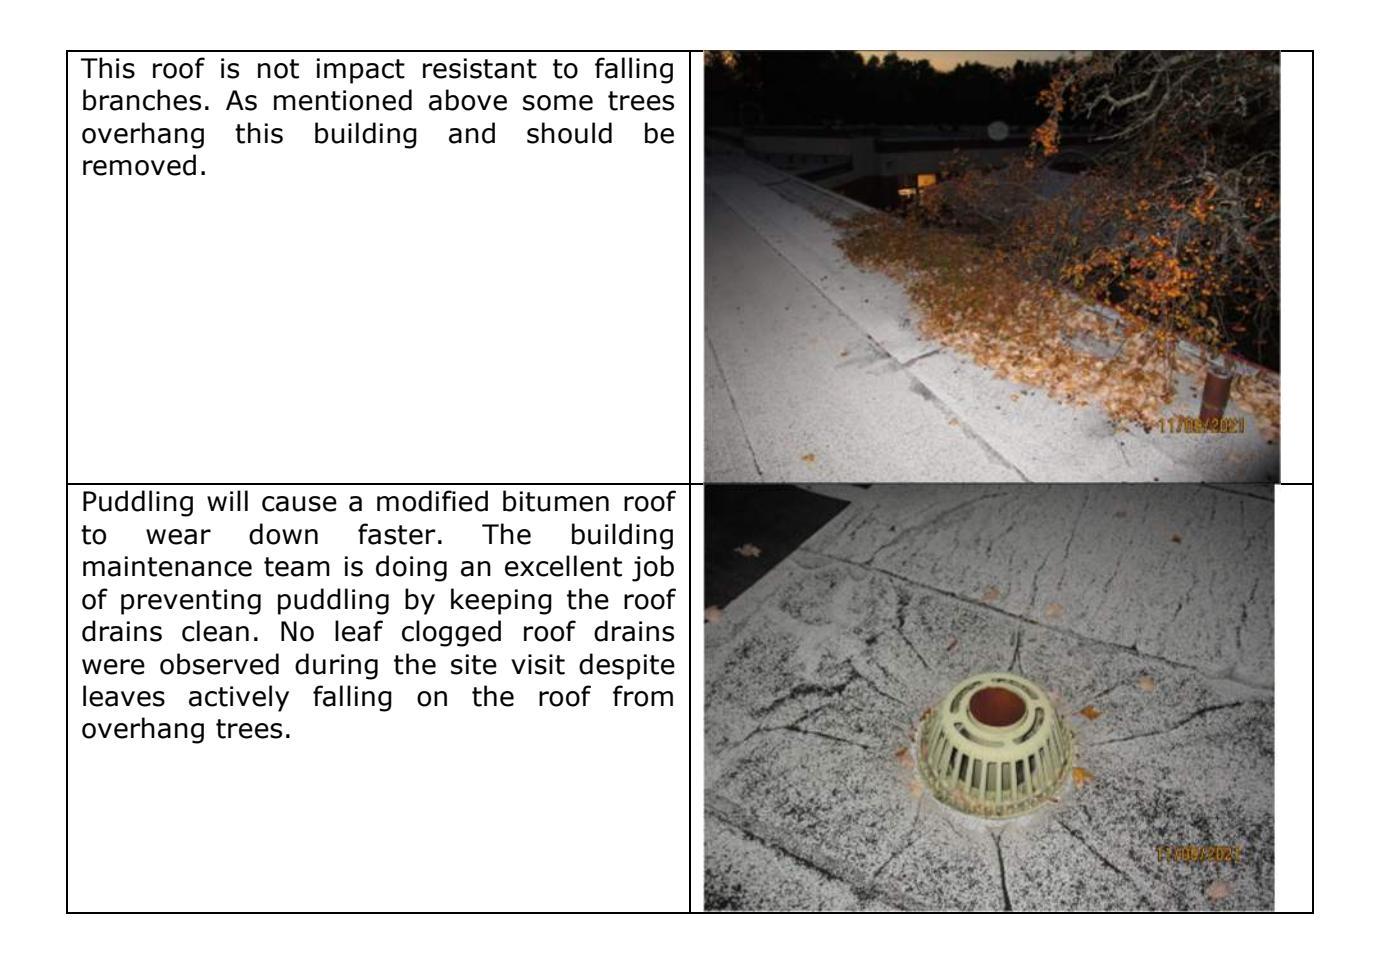
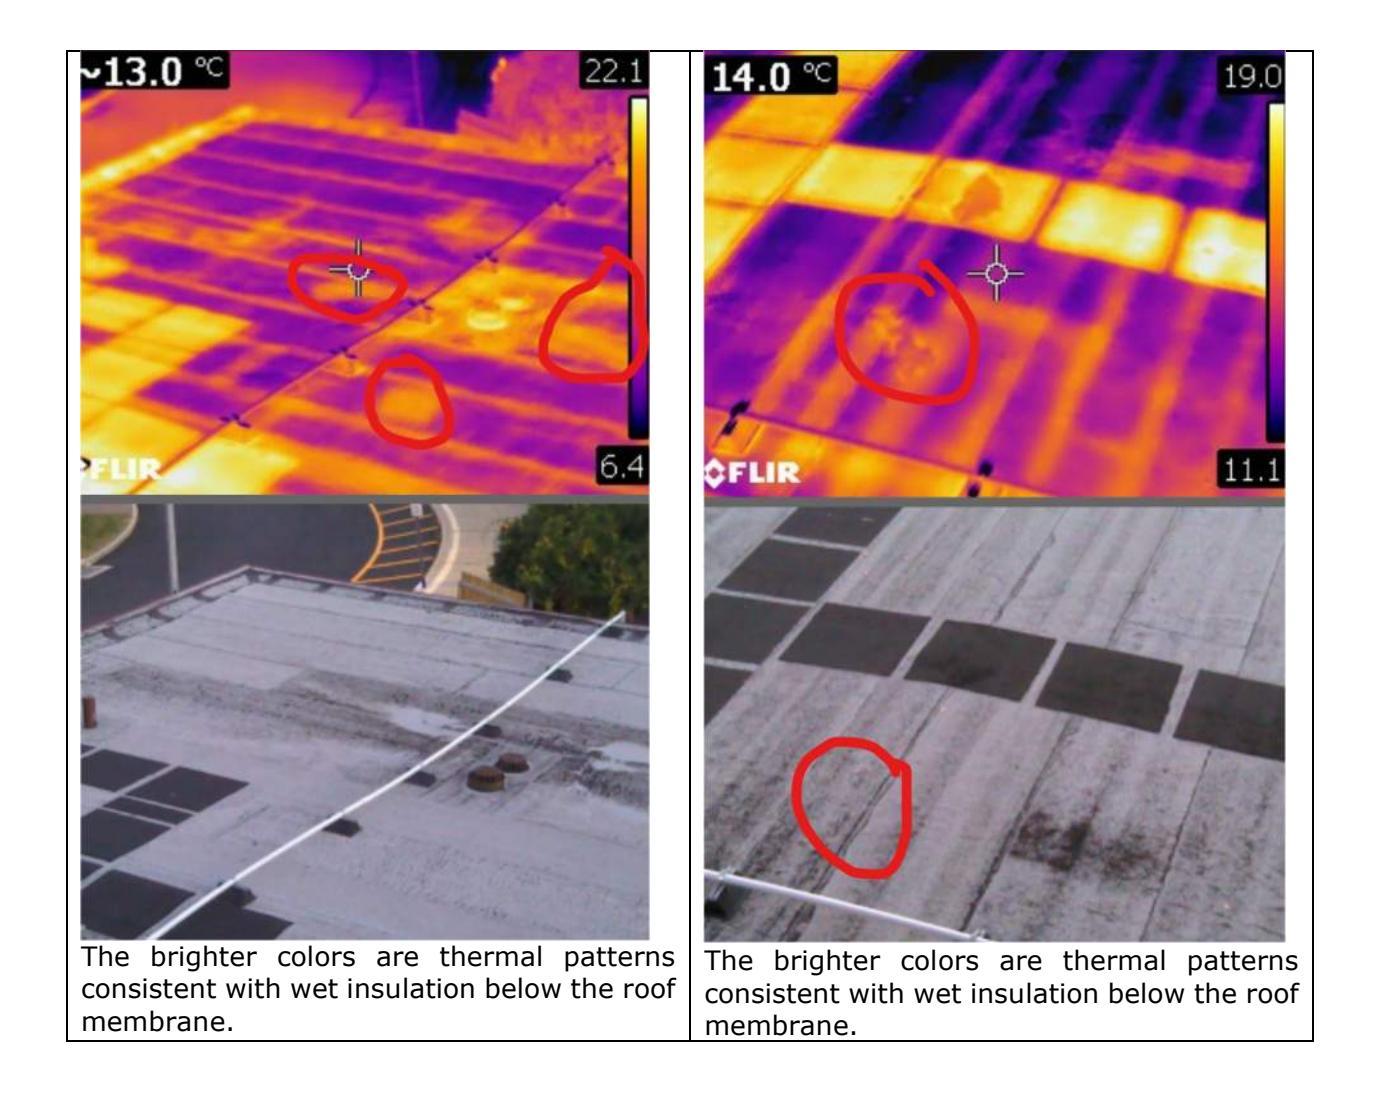
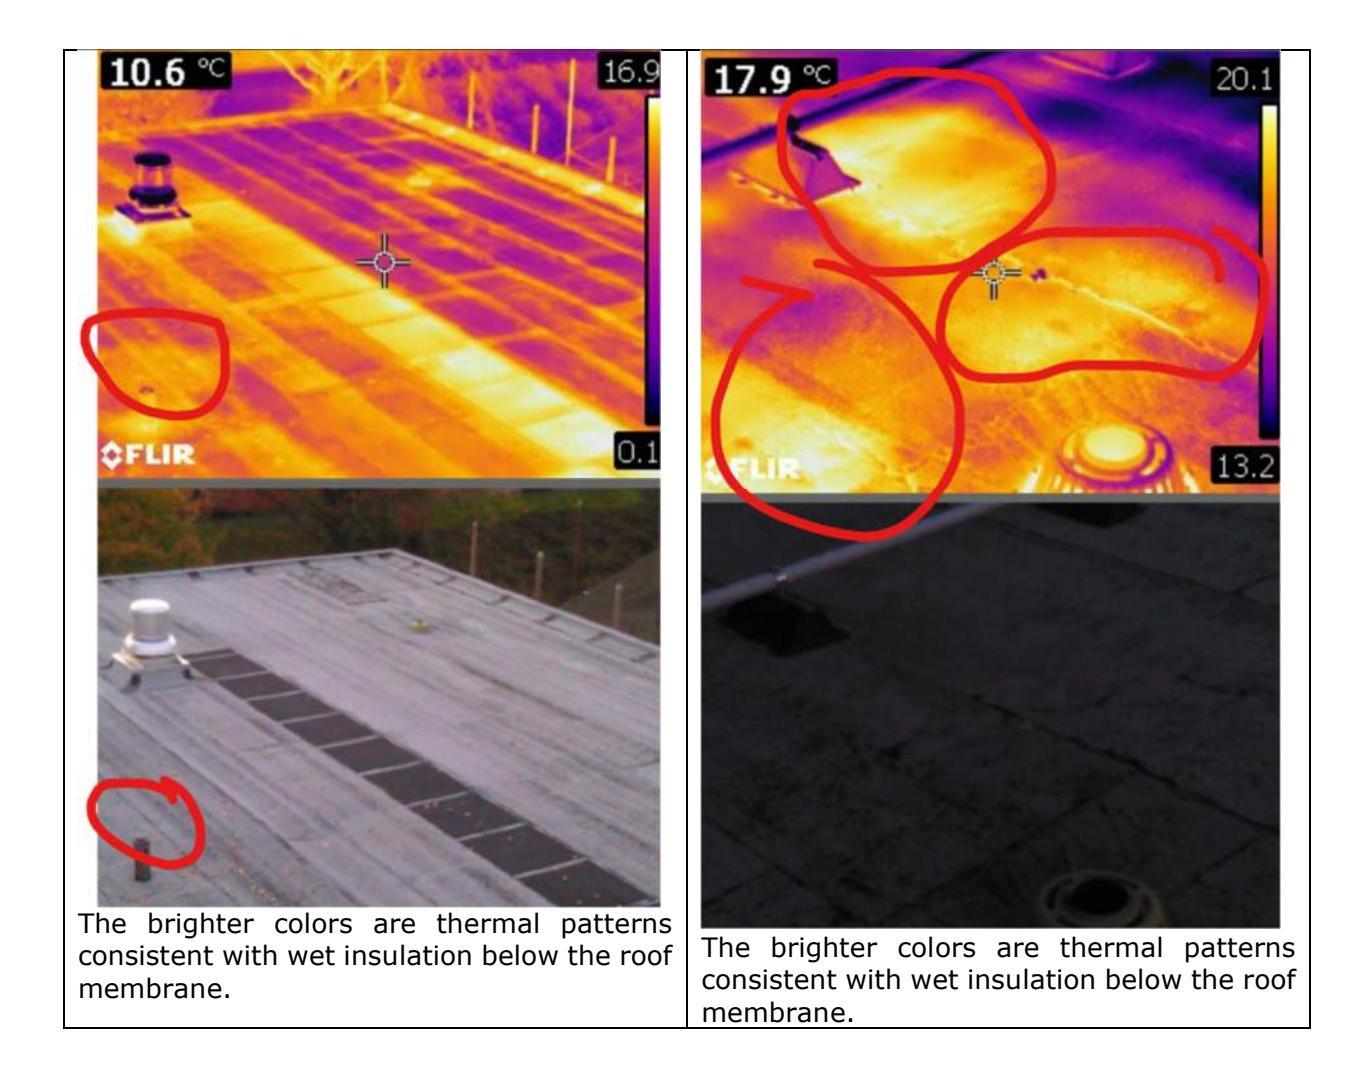
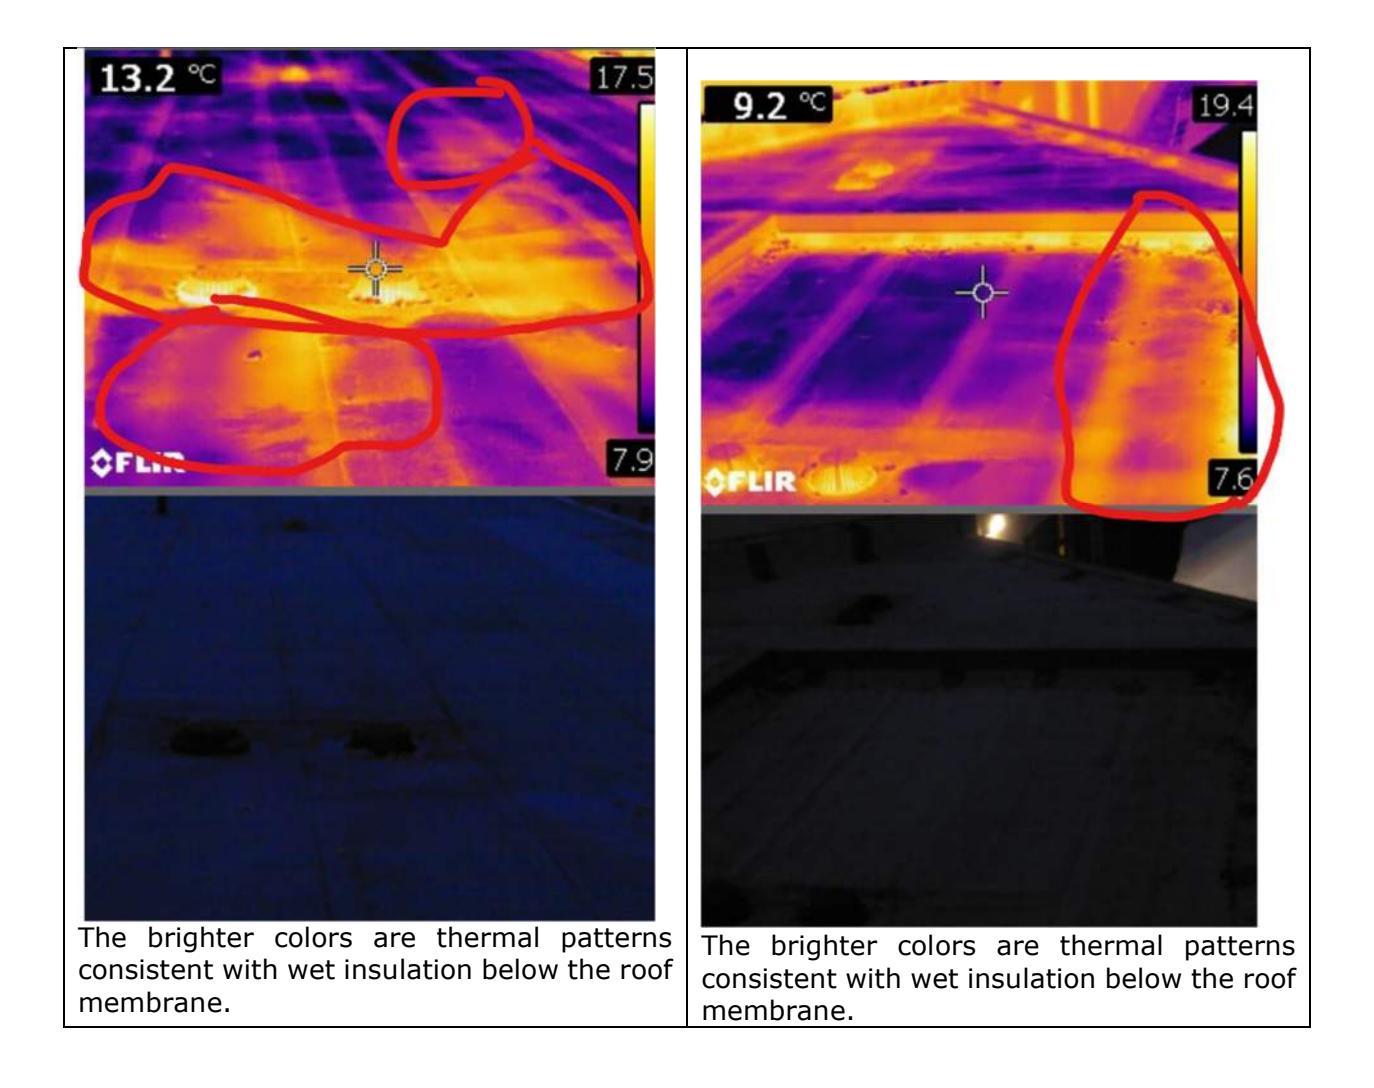
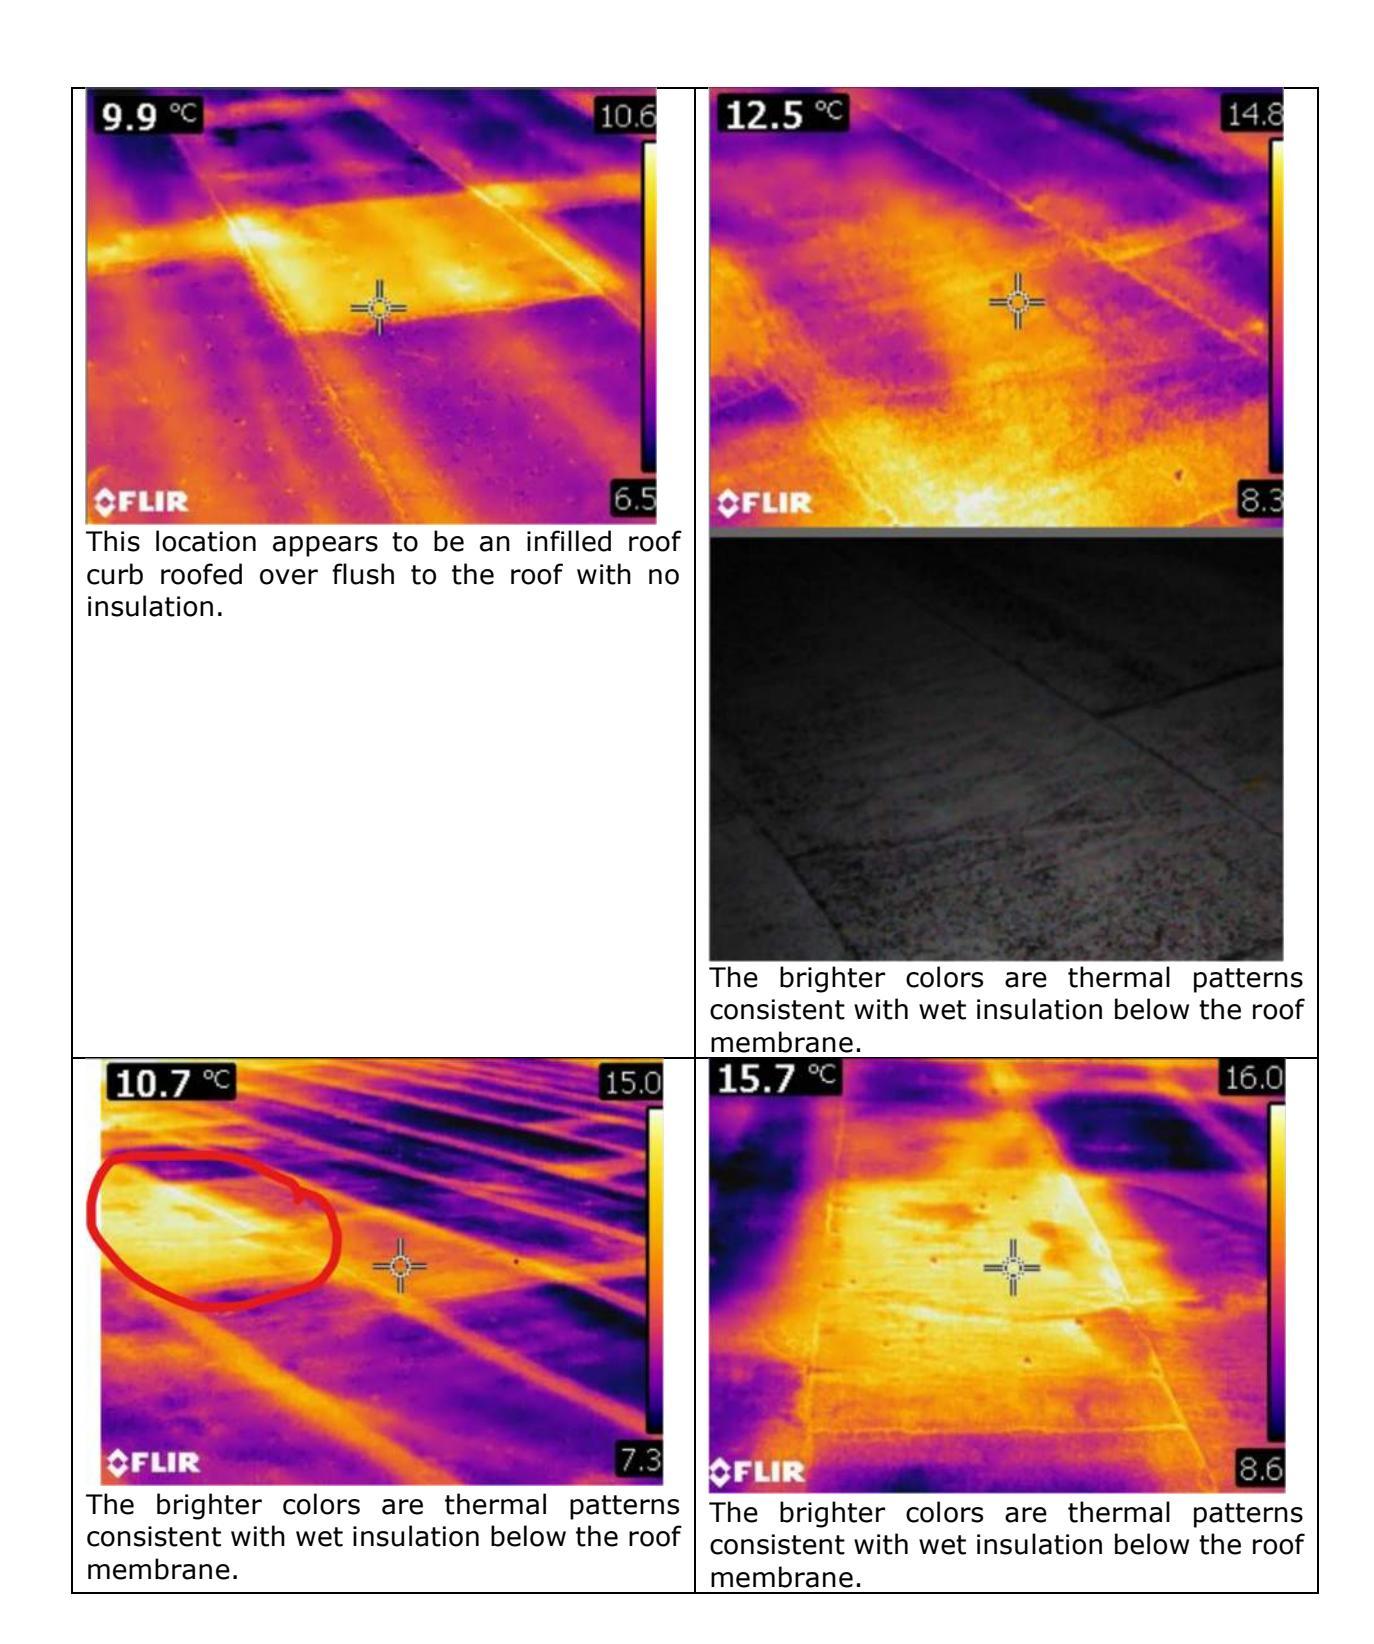
Roofing cap sheet is delaminated from the lower plies of roofing. The roof blisters are causing water infiltration to the lower plies of roofing both through cracks in the cap sheet and condensation building up in the blisters. The moisture trapped in the blisters will deteriorate the roof at an accelerated rate.	
Annual and semi-annual roof inspections are performed on Long Lots. The maintenance of the roof is evident. Leaks have been chased for years with new sealant observed at cracks, joints, pitch boxes and repairs.	11/09/2021
The roof is very fragile. The blister spots are easy to damage if walked on especially in the colder temperatures in addition the bitumen is getting cracked and brittle. The life expectancy of this roof is 10 – 20 years and it is showing signs of wear.

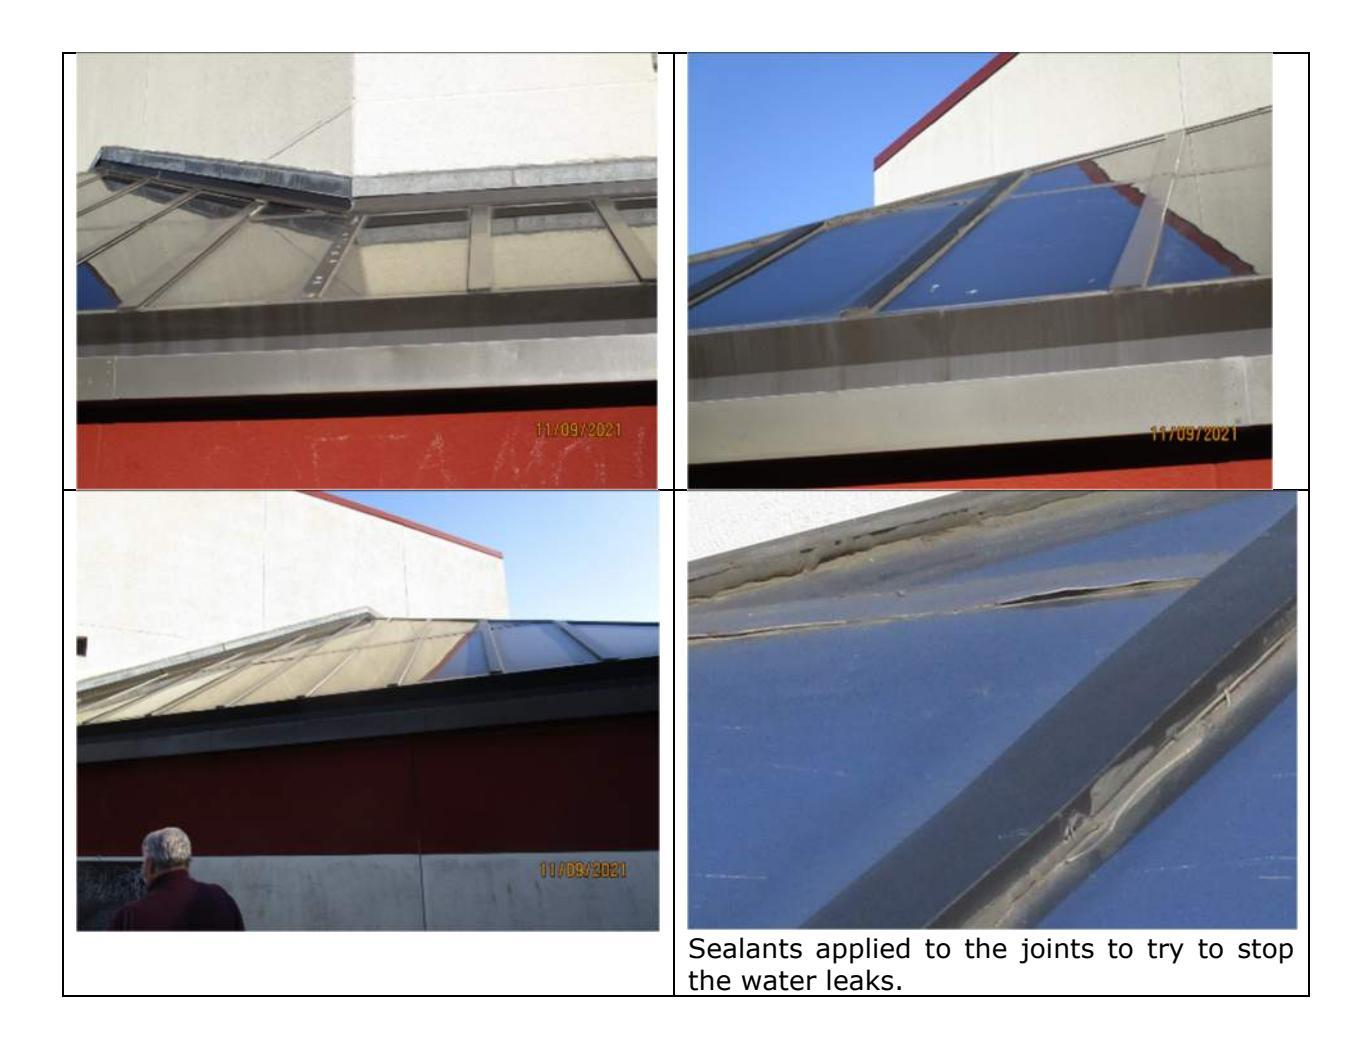
#### Skylight issues in Room 6

On-going issue with the skylights. Water infiltration issue has been on-going, and several attempts have been made to mitigate the water leaks. Sealant has been applied to the skylight joints. Solar heat gain issue – the skylight has been whited out to try to reduce the amount of solar heat gain in the space.

Sr.#	Equipment / System	<b>Observation Narrative</b>	Recommendation
9	Skylight in Room 6	<ul> <li>The skylight system above room six has had many leaks and shows signs of many repairs</li> </ul>	$\circ$ The skylight should be replaced with roofing.
10	Building Roof	<ul> <li>The roof has become brittle as the delaminating cap sheet blisters and has had many maintenance issues</li> </ul>	<ul> <li>Roof is recommended to be replaced in the next five years.</li> </ul>
11	Building Roof	<ul> <li>Roof top unit gaskets and pans are leaking.</li> </ul>	<ul> <li>The RTU replacement is covered in the MEP portion. This estimate covers the curbs and associated roof work.</li> </ul>
12	Building Roof	<ul> <li>Roof drain system and piping is in poor condition</li> </ul>	$\circ$ Replace the entire roof drain piping system.
13	Window System	<ul> <li>The single pane curtainwall and window systems are leaking and have no seals</li> </ul>	<ul> <li>Kalwall panel system and windows are recommended to be replaced.</li> </ul>

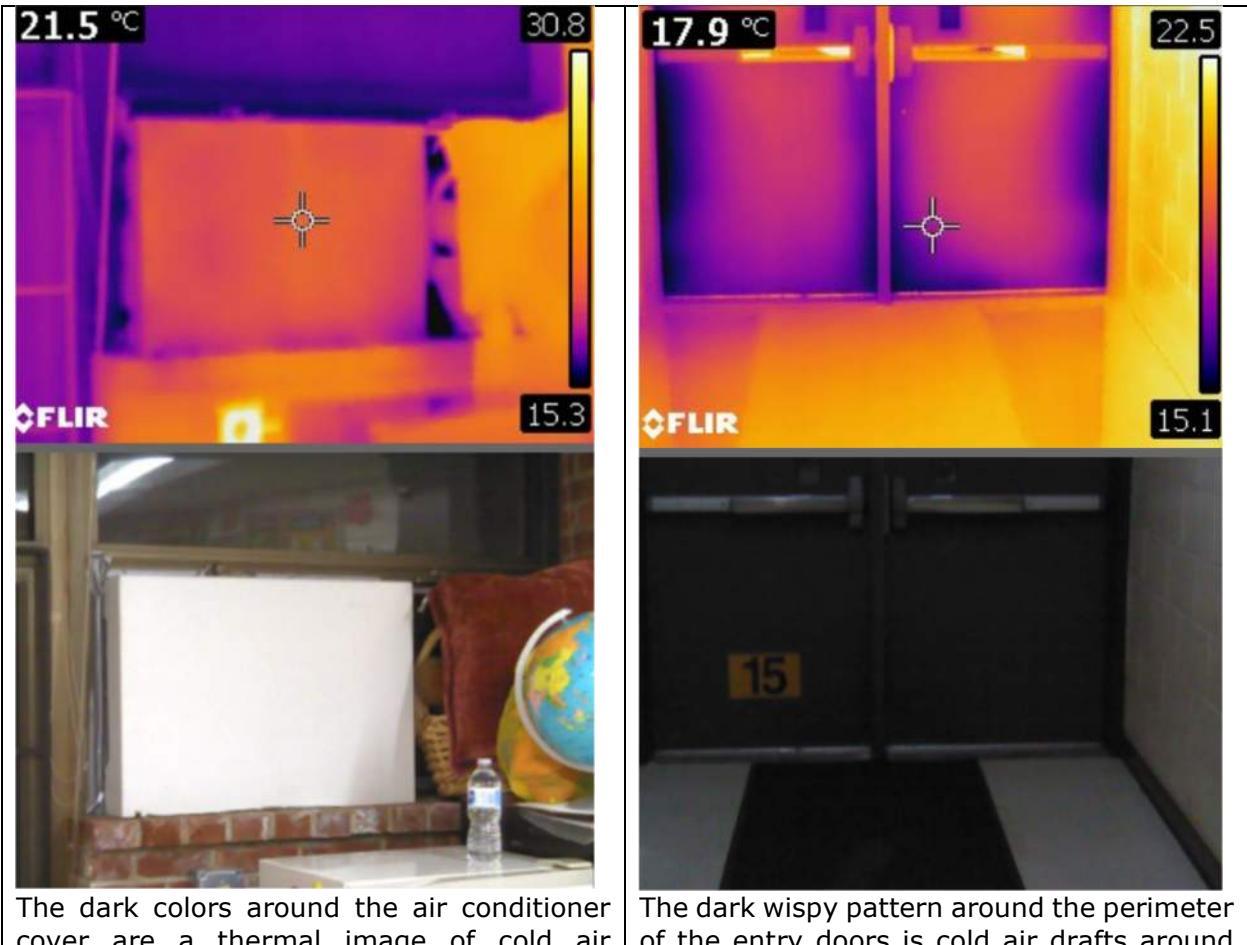
cover are a thermal image of cold air entering the building. Duct tape is being used to try to mitigate this air infiltration.

of the entry doors is cold air drafts around the entire perimeter of the pair of doors.

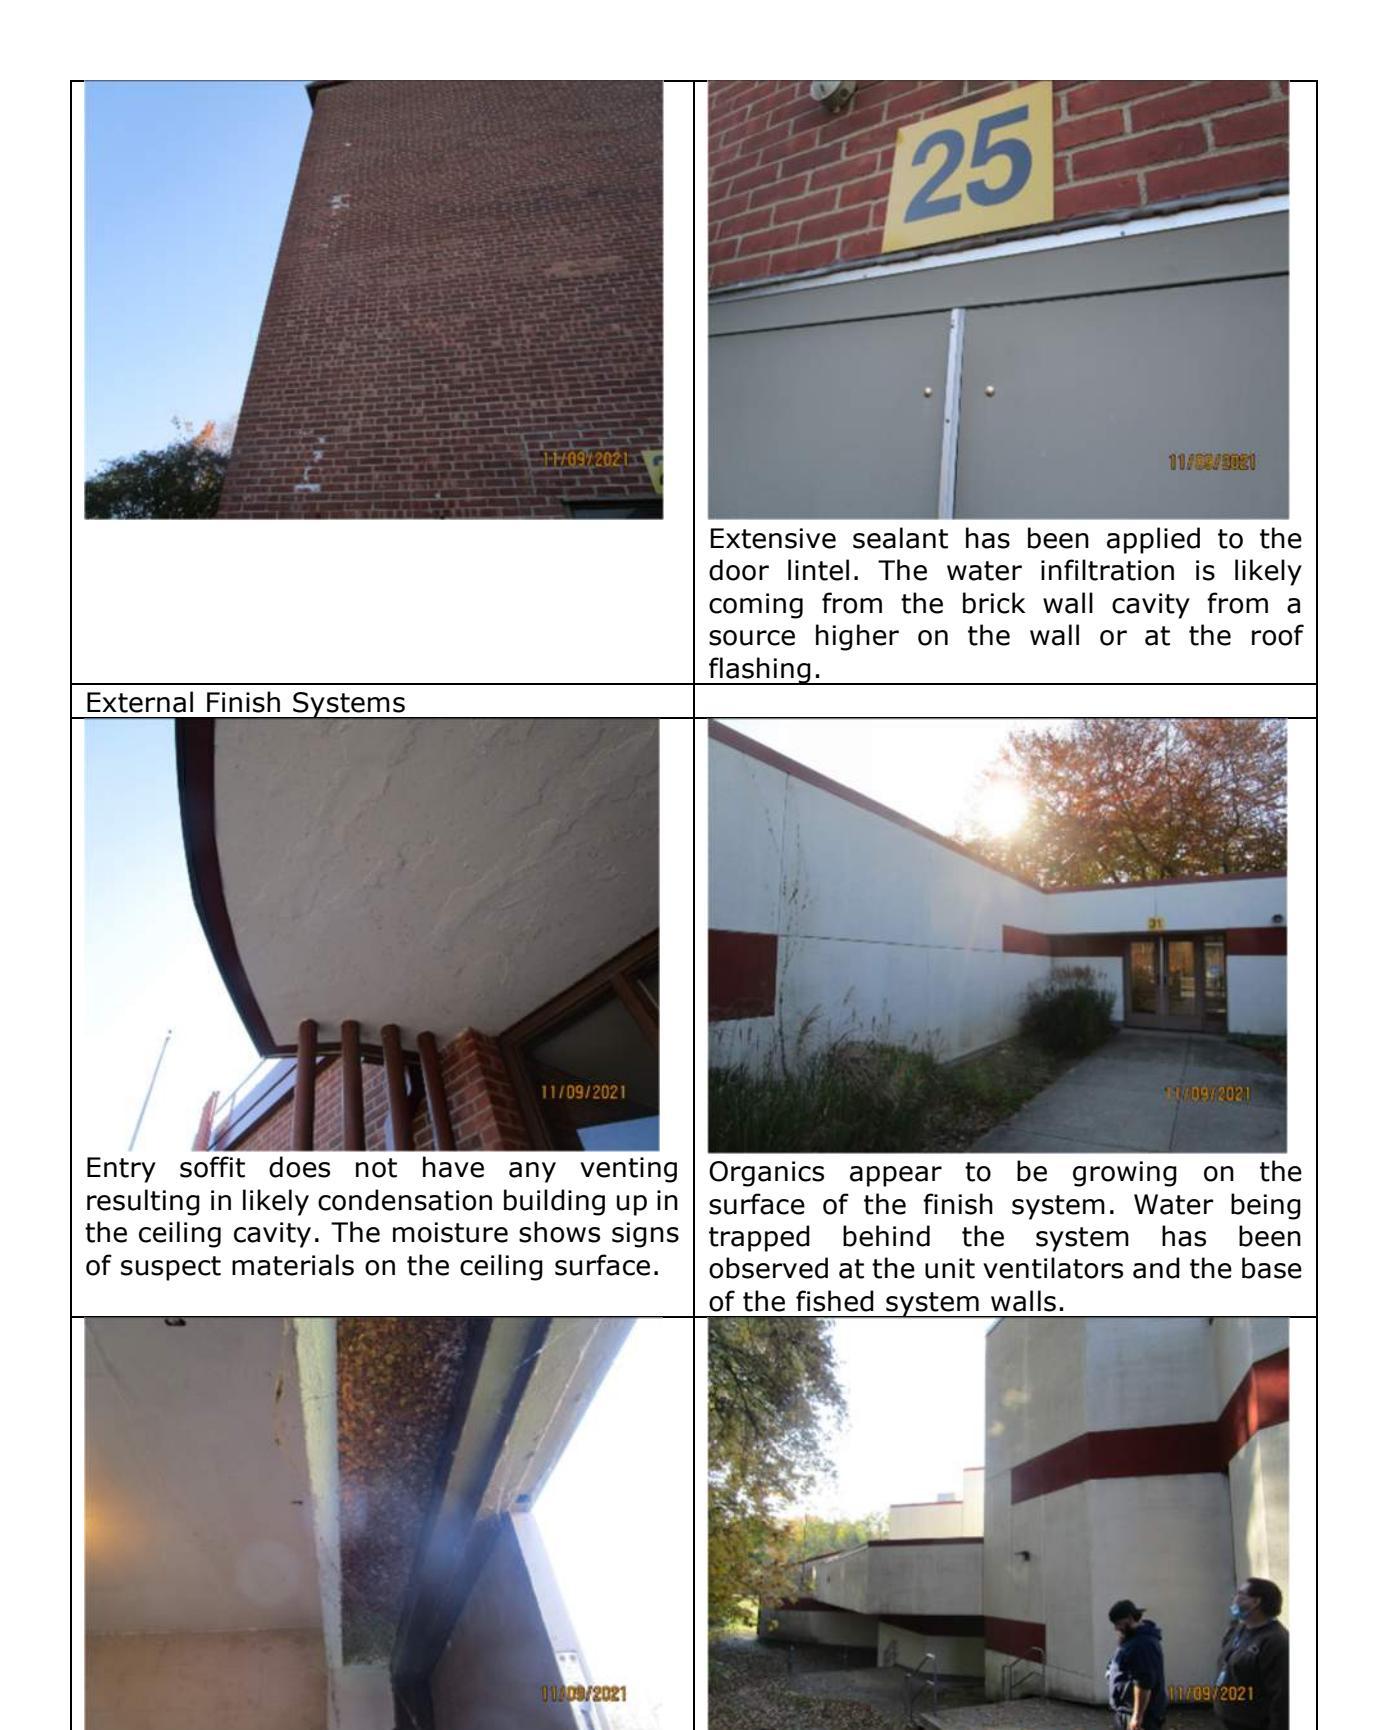
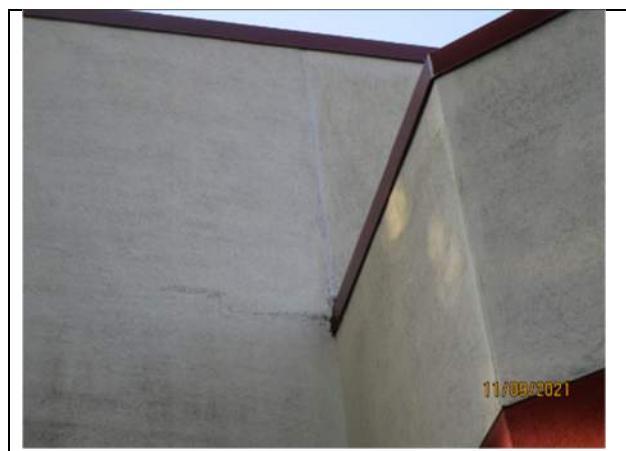
#### **Exterior Wall Systems**

14	Exterior Wall Systems	<ul> <li>Exterior wall lacks air barrier and insulation.</li> <li>EIFS Delamination</li> </ul>	<ul> <li>All the External Insulating Finish System needs to be removed and replaced. The masonry walls need to either be replaced or have a cavity wall created with an air barrier and insulation.</li> </ul>
15	Exterior doors & Store front	<ul> <li>Wind driven rainwater infiltration is reported</li> </ul>	<ul> <li>The exterior doors and store front entrances need to be replaced due to water leakage, no seals, inefficiency, and lack of insulation.</li> </ul>
16	Roof access Ladders	<ul> <li>The ladders on the roof are very loose at the anchor points</li> </ul>	• The wall needs to be opened to provide adequate blocking, patched, and properly anchor the ladders to the building.

Cracks in the finish system have been sealed to try to prevent water infiltration.
