## PROPERTY CONDITION ASSESSMENT Long Lots Elementary School

Colliers Project Leaders USA NE, LLC ("CPL") is pleased to present the Property Condition Assessment (PCA) for Westport Public Schools. The purpose of this PCA is to determine the current condition of Long Lots Elementary School and provide recommendations for repairs and upgrades.

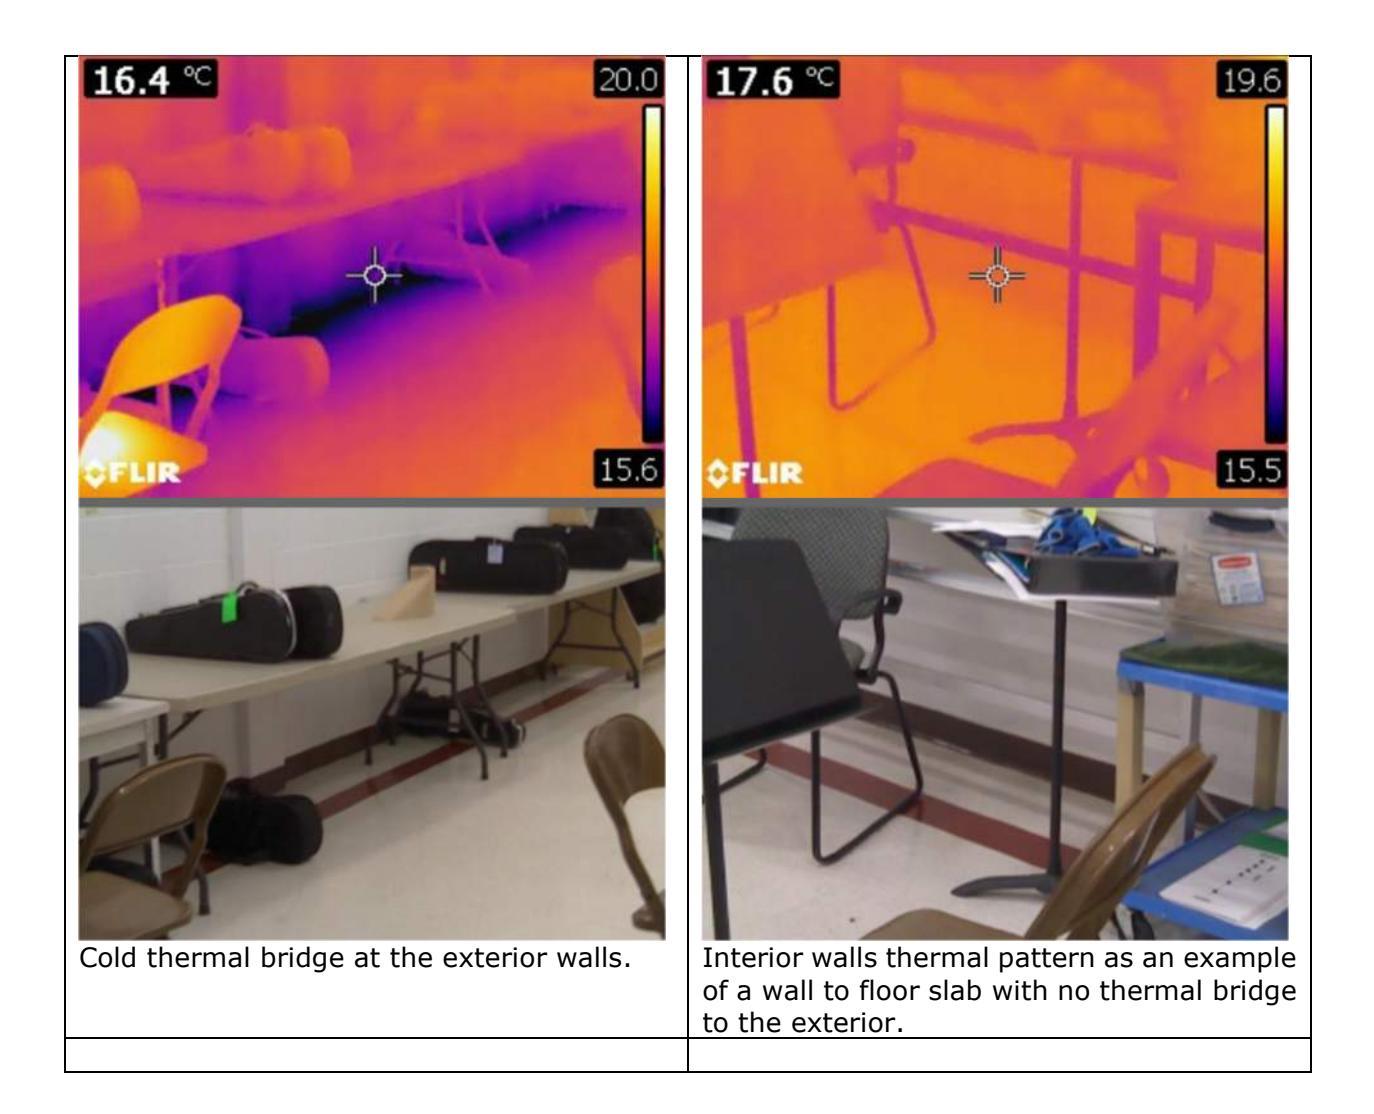
floor slab inside of the building causing a cold spot on the walls and floor that can lead to condensation.

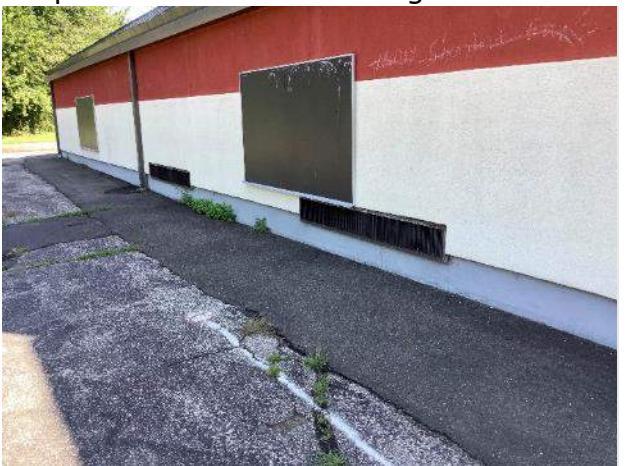
8. The fan coil unit's outdoor air (OA) dampers are located outside the classrooms a couple of inches above the ground level.

OA grills on the outside wall for fan coil unit ventilation.
