**Building Information - Yellow Springs Exempted Village (45674) - Yellow Springs High School/McKinney Middle School**

**Building Pictures - Yellow Springs Exempted Village(45674) - Yellow Springs High School/McKinney Middle School(42416)**

**GENERAL DESCRIPTION**

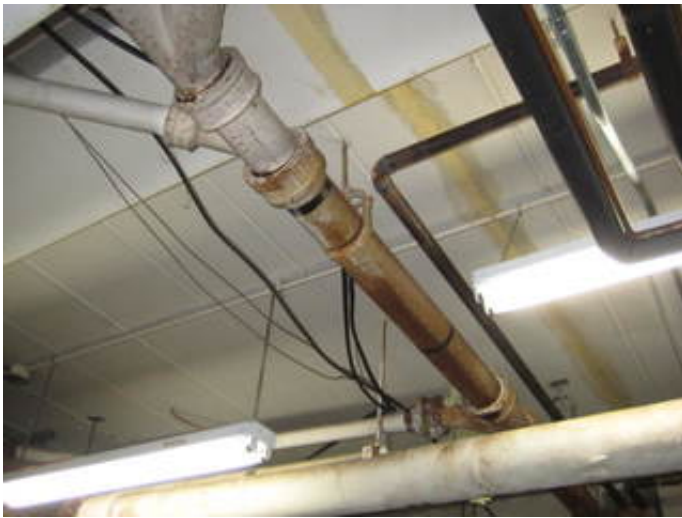
Sanitary Waste Piping

**Recommendations:** Existing conditions require no renovation or replacement at the present time.
