2021

Stamford HS Stadium Facility Assessment & Analysis Report

Stamford High Stadium
55 Strawberry Hill Avenue
Stamford, Connecticut 06902

StudioJAED
42 Weybosset Street, Suite 403
Providence, RI 02903
401.648.0884

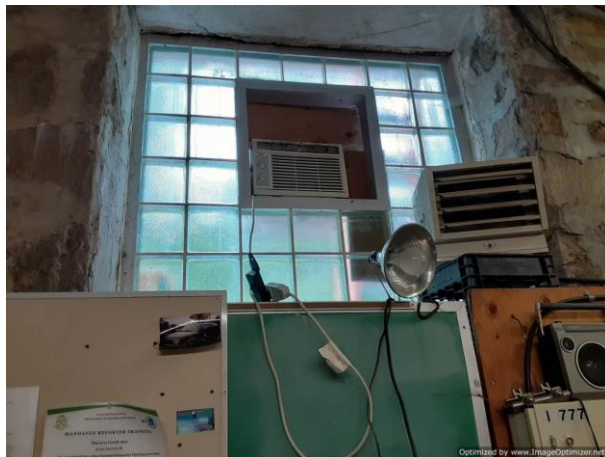
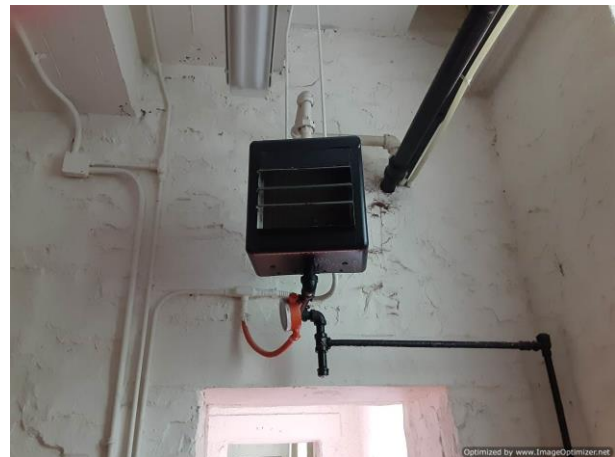
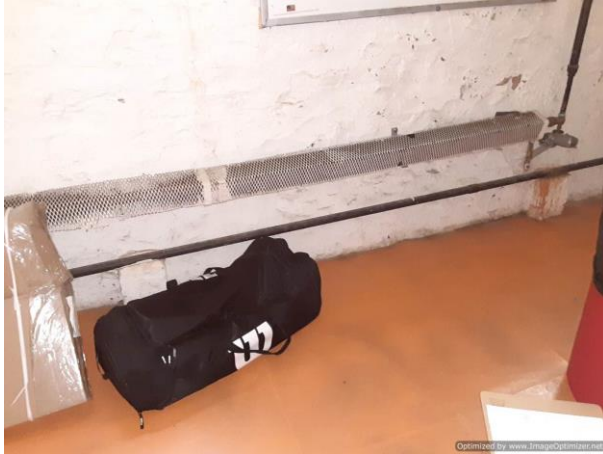
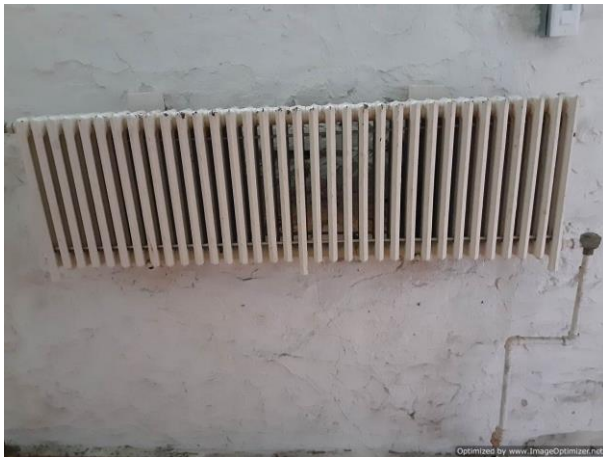
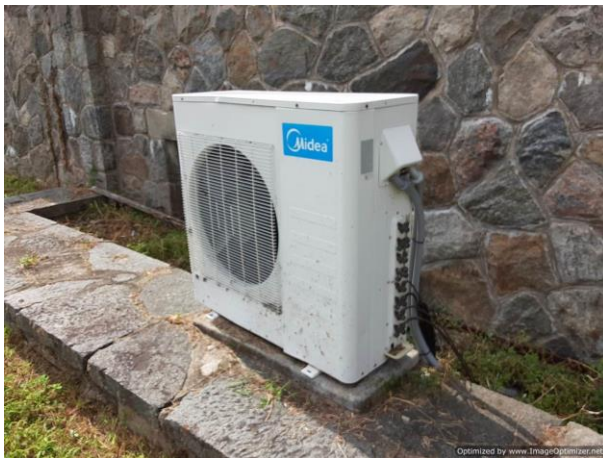
The visitor (west) grandstand offices, locker room and storage areas are heated by steam radiators, fin tube radiation and unit heaters which look largely original to the building. The steam boiler was replaced in 2010. Two window air conditioning units provide cooling to the office areas. Exhaust fans to each area are installed through the exterior wall. The home (east) grandstand restrooms and storage areas are heated by electric space heaters. Air conditioning is provided to some areas by ductless split systems. Exhaust fans are ceiling hung and ducted to the exterior. The concession stand and press box are heated by electric baseboard heaters. There is no air conditioning provided. All of the steam piping, radiators, fin tube radiation, unit heaters, exhaust fans, air conditioning systems and electric heaters should be replaced within the assessment period.

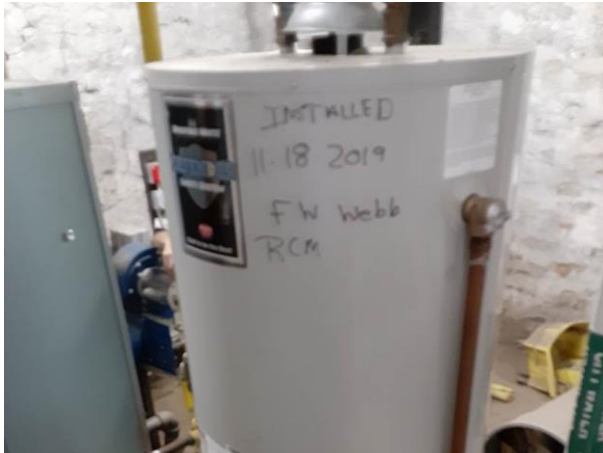
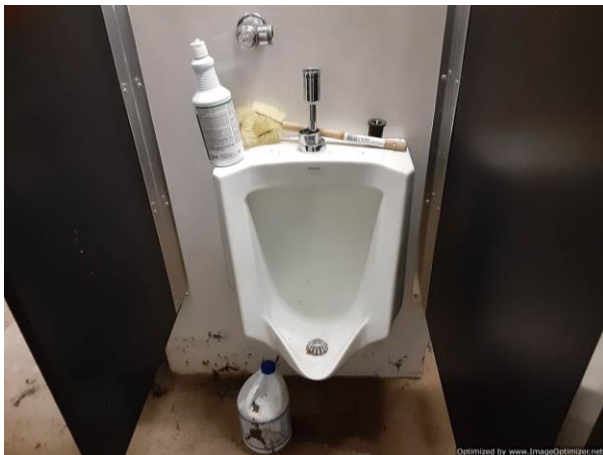
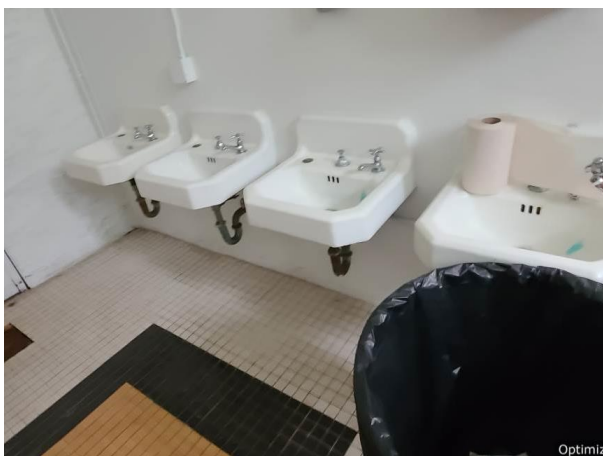
The plumbing systems and fixtures in both grandstands appears to be largely original. Hot water is provided to the locker rooms in the visitor grandstands by a gas fired hot water heater that was replaced in 2019. Hot water is provided to the restrooms in the home grandstands and concession stand by individual electric hot water heaters. The electric hot water heaters, fixtures, domestic water and sanitary waste piping should be replaced within the assessment period.

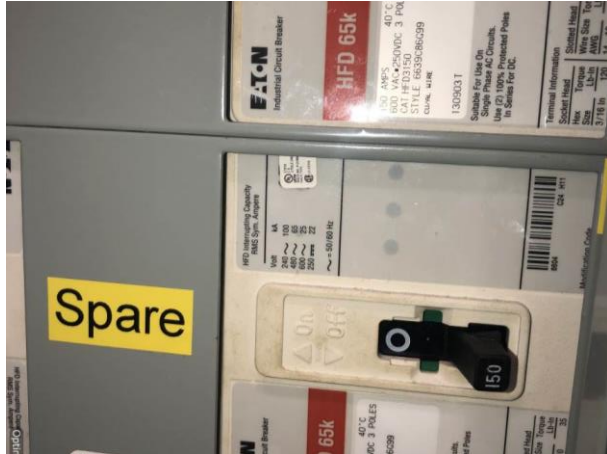
The Stadium has a “Home” side and a “Visitor” side. The Home side has a newer Press Box installed in 2013 with all newer panel boards and wiring. In the basement (under the stairs) is a 150 amp main and 150 amp spare which feeds other panels in the basement and upstairs in the Press Box. The visitor’s side contains a 200 amp Main breaker which resides in the Home basement. The visitor’s side appears original from time of construction. This assessment covers replacement of all wiring, panel boards and lighting on the visitor’s side.

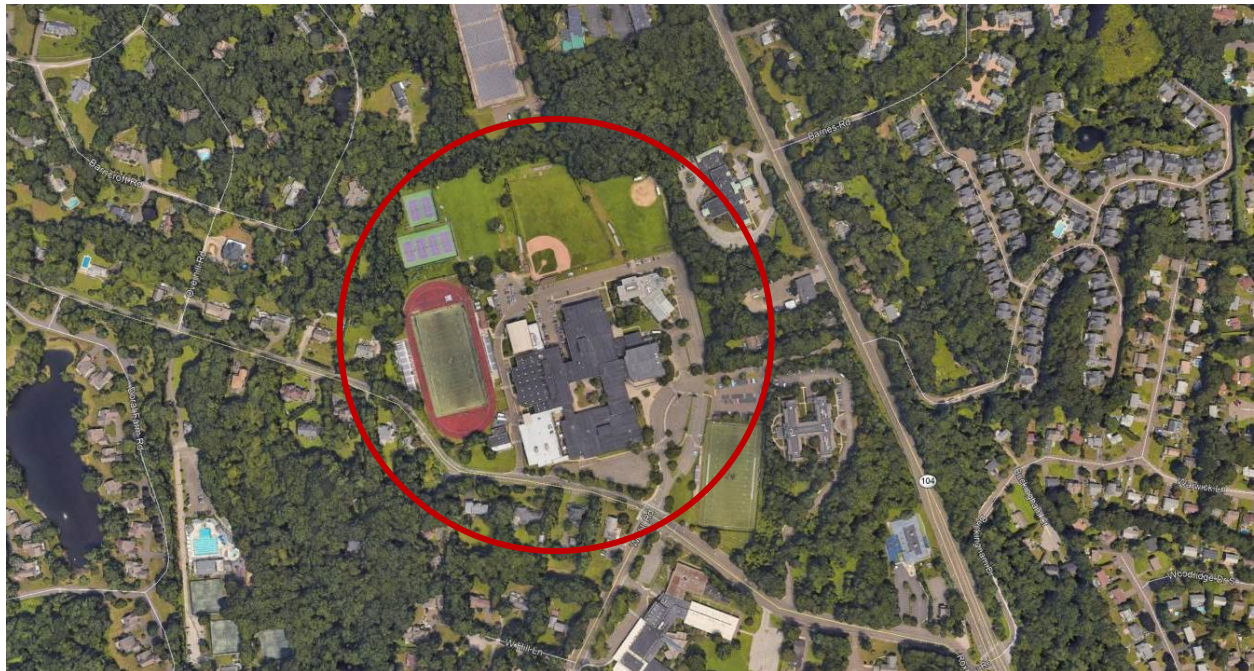
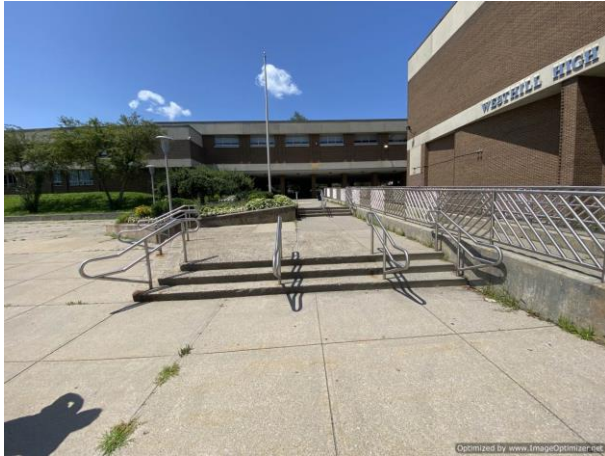
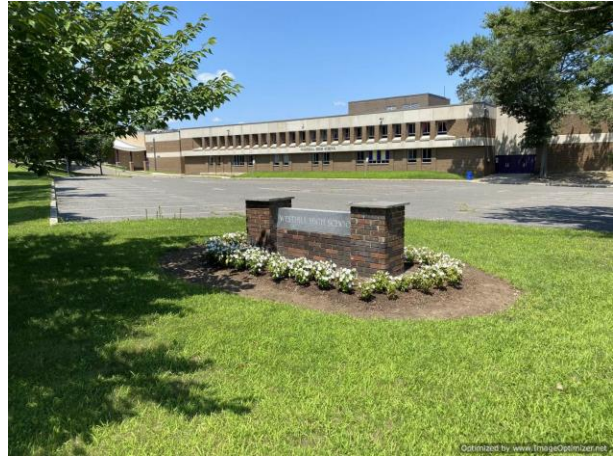
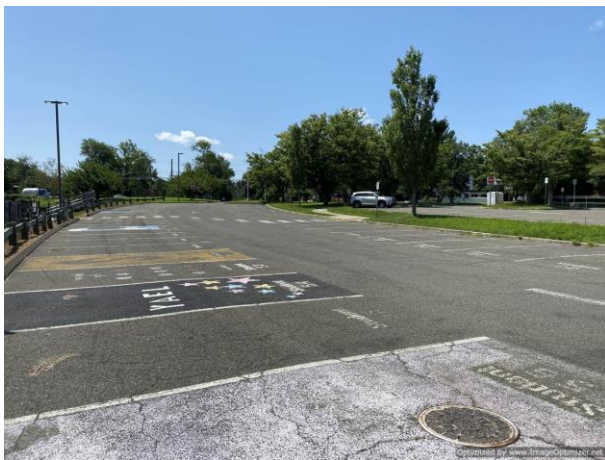
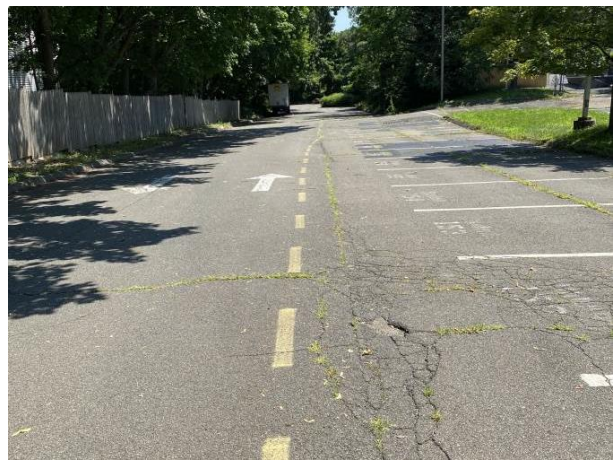
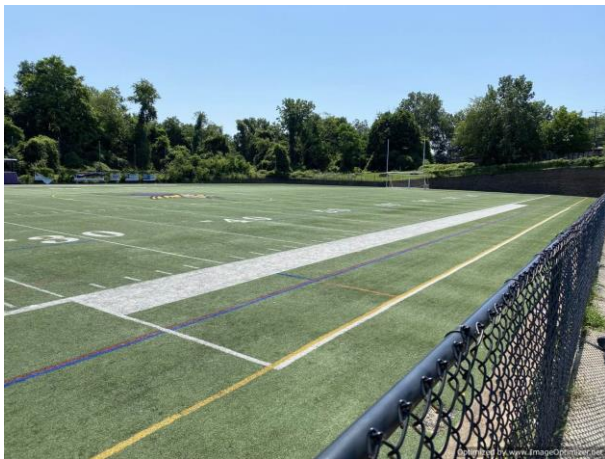
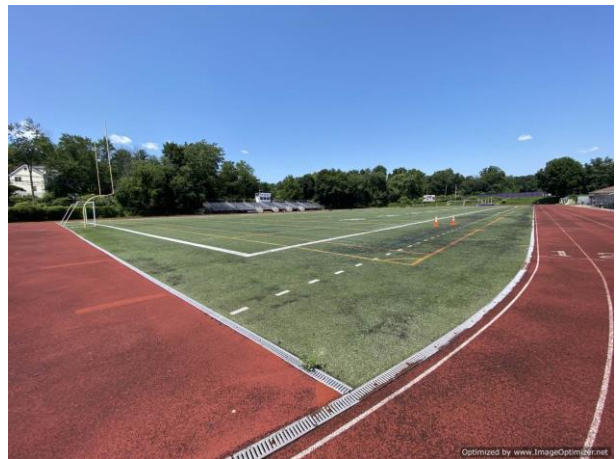
There are approximately 449 spaces in open lots. The paved parking areas are in fair to good condition with evidence of cracking and pavement section deterioration. The asphalt drive isles are in good condition. Sidewalk surfaces in large are in good condition with small areas being in fair condition. Fencing is provided along the north, east, and west property lines, and around the bus parking lot, tennis courts, gas metering, baseball fields, soccer field, football field, and softball field. The perimeter fencing is in good condition with isolated sections of damage. Grass play areas/field appear to be in good condition. The artificial turf football fields are in fair condition. The tennis courts appear to be new. Storm water from the roofs, landscaped areas, and paved areas flows into on site inlets and catch basins with underground piping connected to the municipal storm water management system.

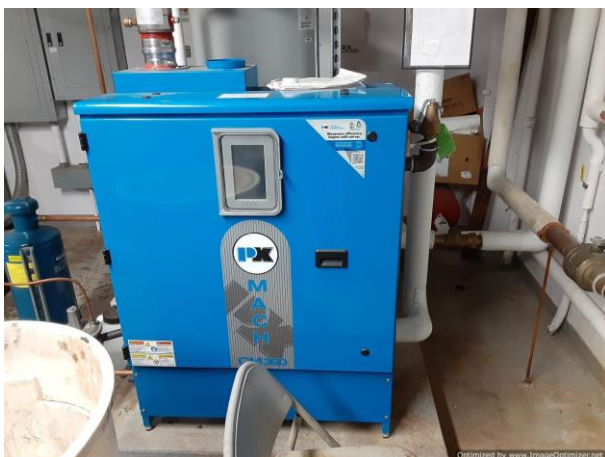
The main building plumbing systems appear to largely be original. Hot water is provided by a gas fired hot water boiler and storage tank with circulators that were replaced in 2019. Fixtures appear to be original with sporadic maintenance throughout the years on an as needed basis. Fixtures should be replaced within the assessment period.

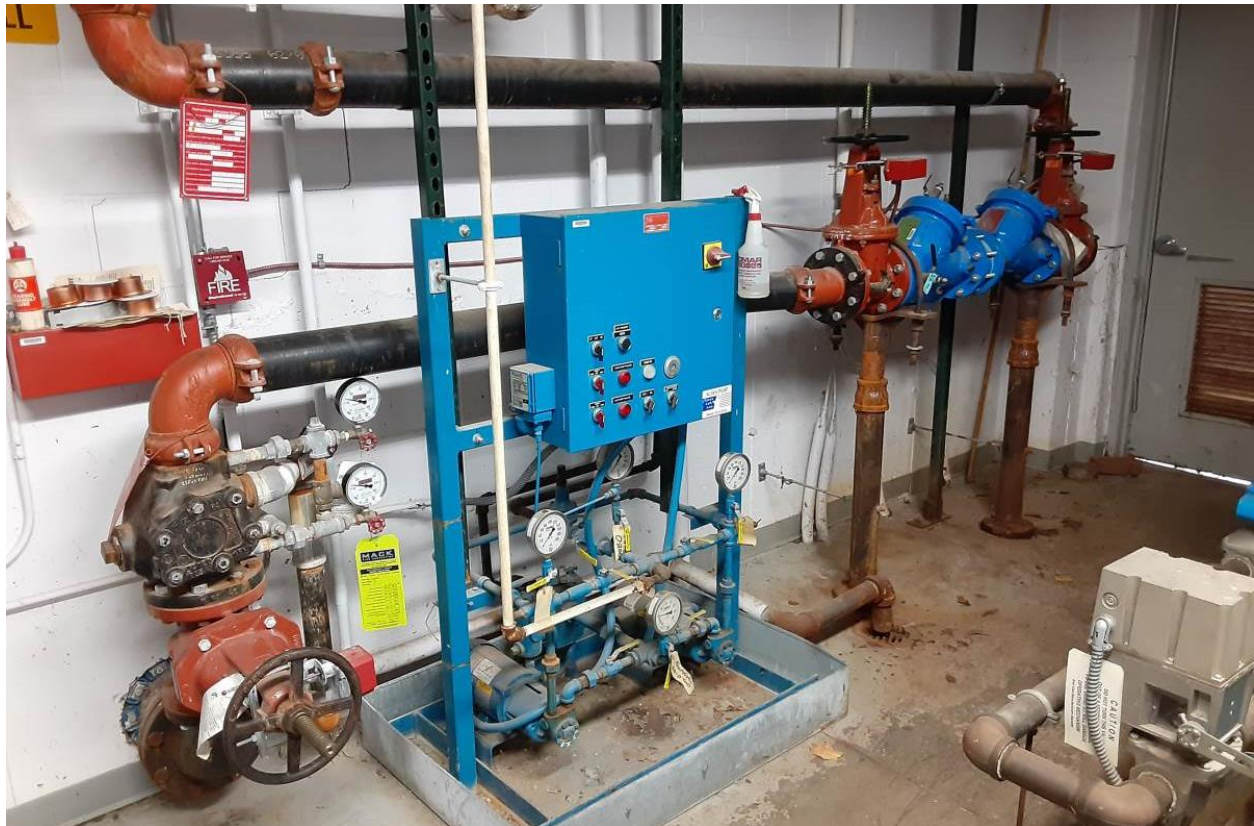
The building sprinkler system was installed when the building was completed in 2002 and is in good condition not requiring replacement within the assessment period

The fire alarm system has audio/visual devices in each classroom and bathroom. Classrooms also have sprinklers present.

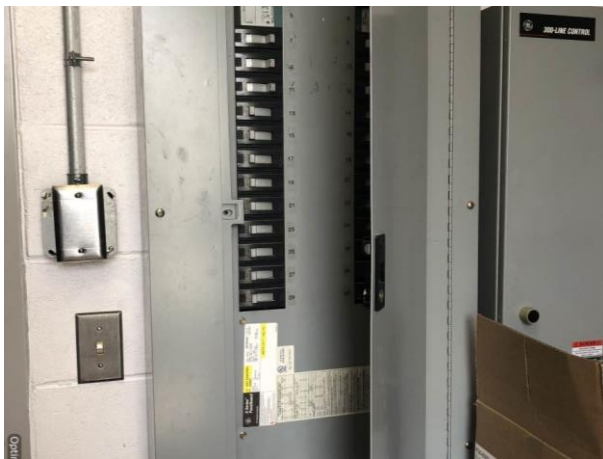
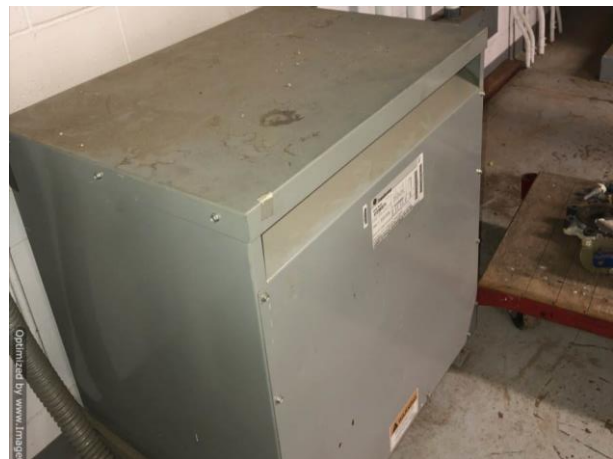
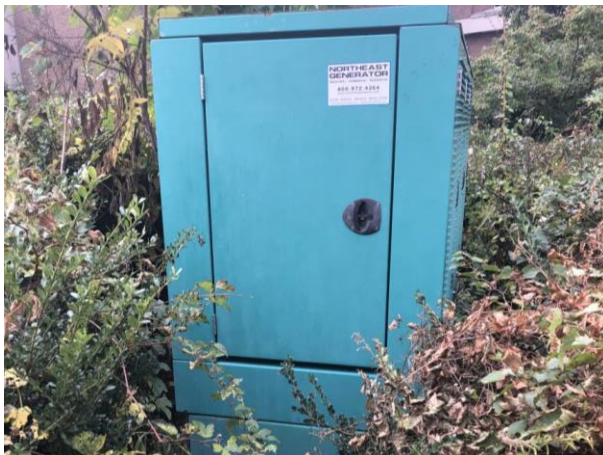
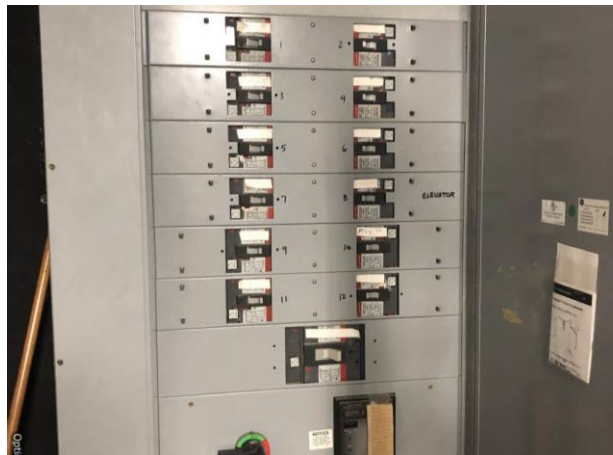
Three phase 480V power enters into an 800 amp rated main breaker/disconnect switch with distribution sections. This switchgear is located in the Mechanical and Electrical room on the ground floor. Secondary transformers convert power to 208v three phase and 120v. Panels located in the building are powered from the transformers. Branch circuits for outlets, lighting and equipment originate from these panels. Most of the wiring in the building is original since the time of construction, 2001. Building's Emergency and Exit lights are powered by an 80kW diesel generator set. Lighting throughout the school is LED. Light fixtures are either recessed or surface mounted. Classroom lights are controlled by wall switches and motion sensors.

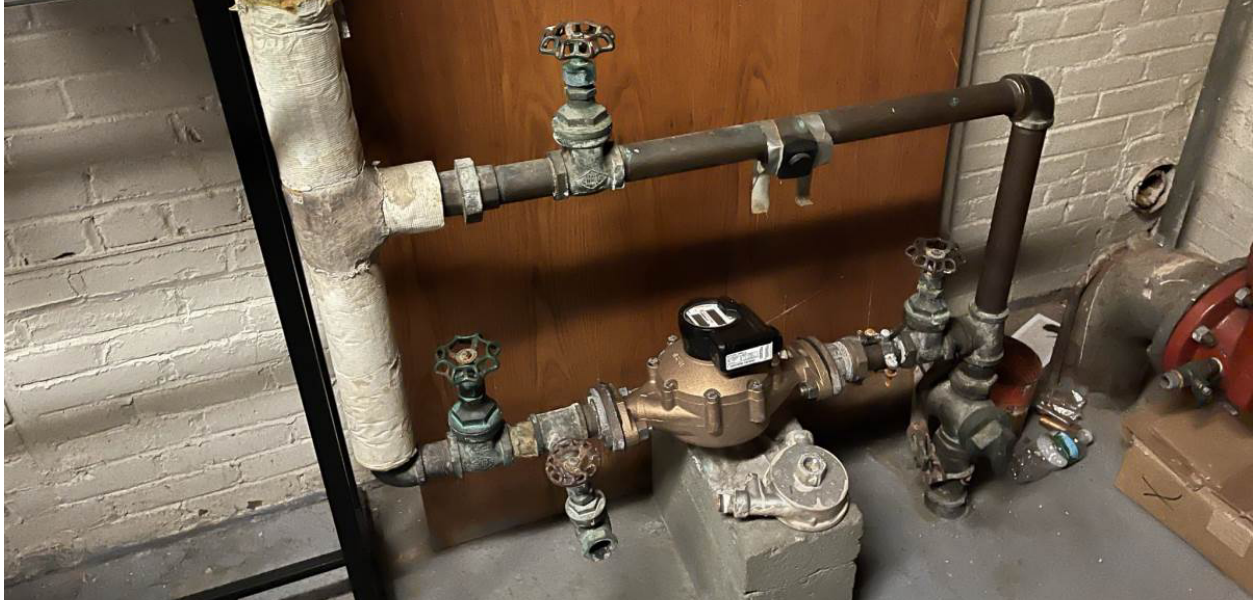
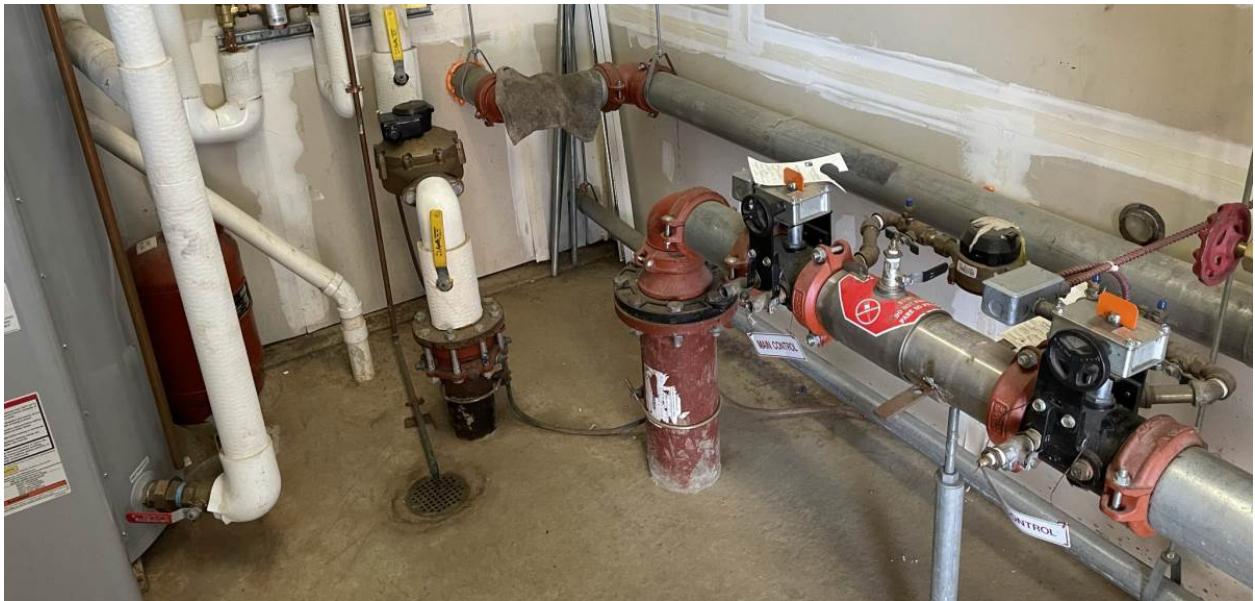
The plumbing supply and sanitary piping are approaching the end of their expected useful lives. The above mentioned domestic hot water heaters are failing according to maintenance staff as well. Most of the plumbing fixtures appear to be in good condition. Refer to the corrections report for specific plumbing replacement or repair recommendations.

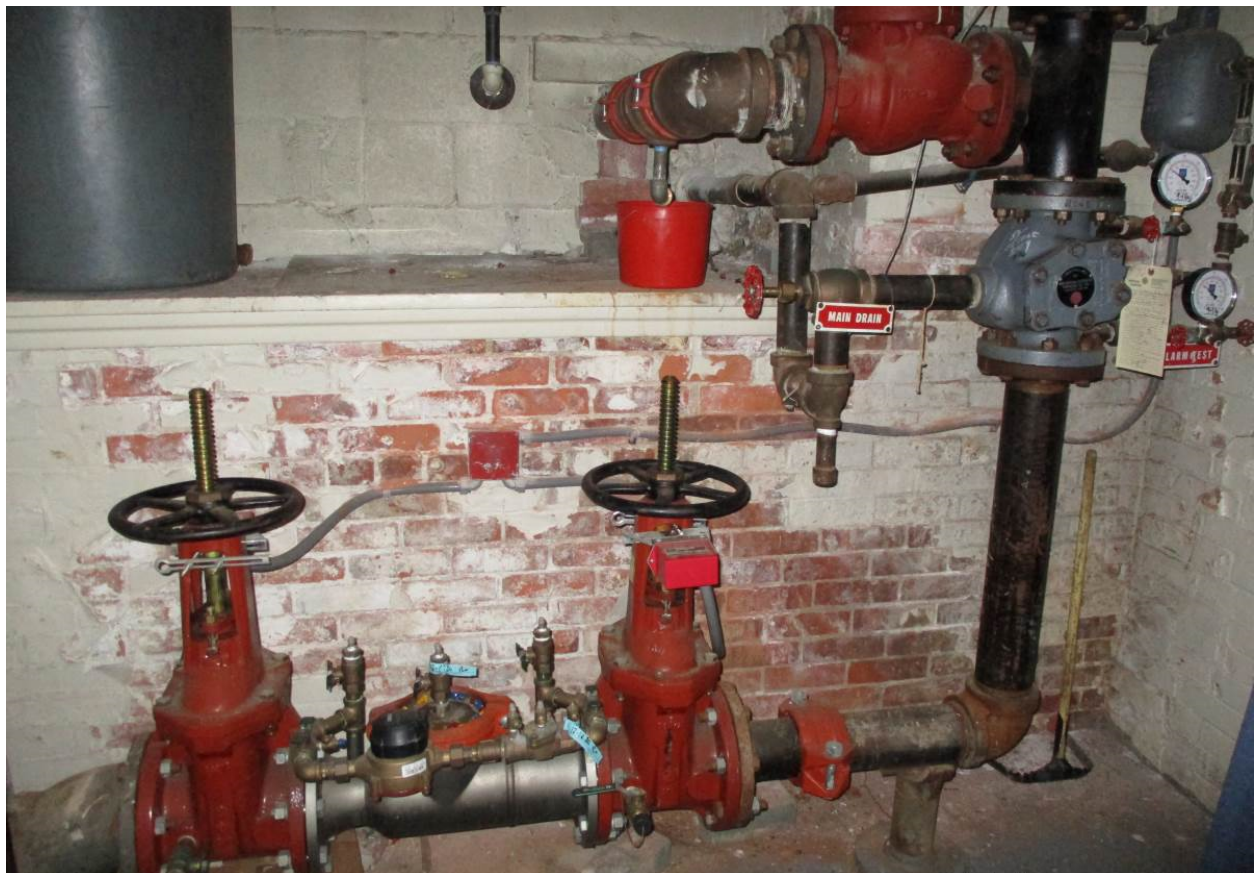
The Main building is protected by a wet pipe sprinkler system with the exception of the gymnasium. The kitchen hood is protected by a wet chemical hood fire protection system that appears to be in good condition. Refer to the corrections report for specific fire protection system replacement or repair recommendations.

The existing fire alarm system protects the entire building and includes a new EST main control panel and old fire alarm devices. The system, however, is non-addressable. In order to meet current code requirements, all fire alarm devices and wiring will need to be replaced to provide an addressable system.

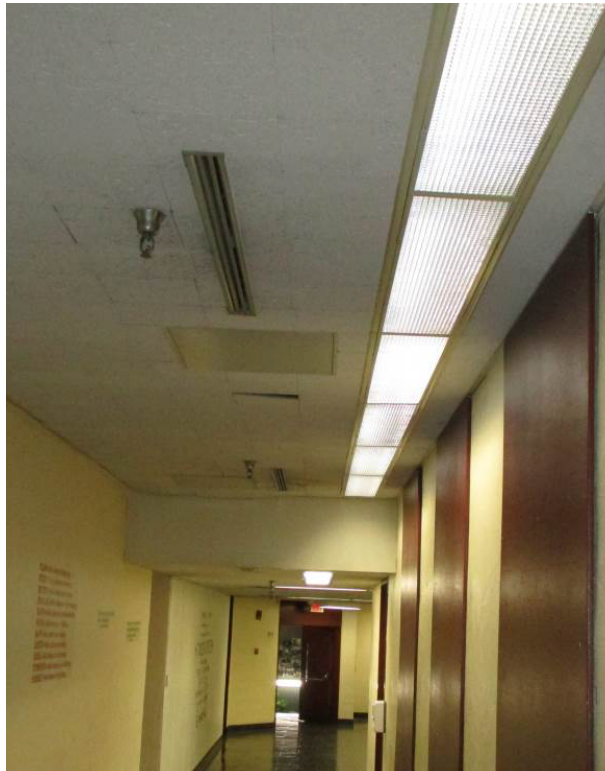
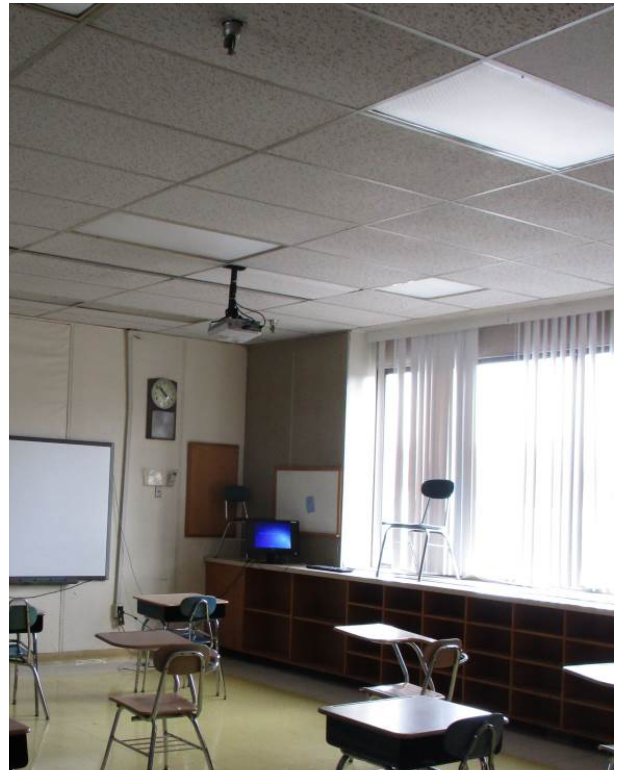
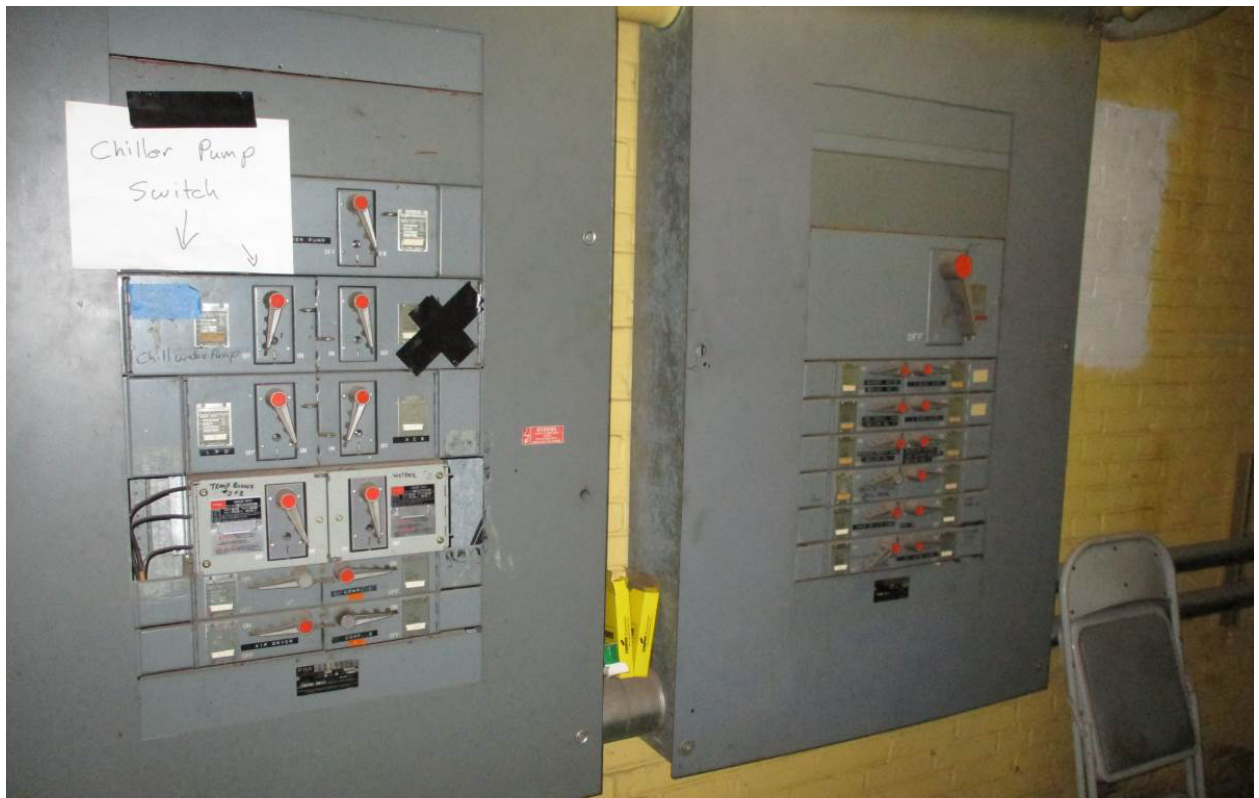
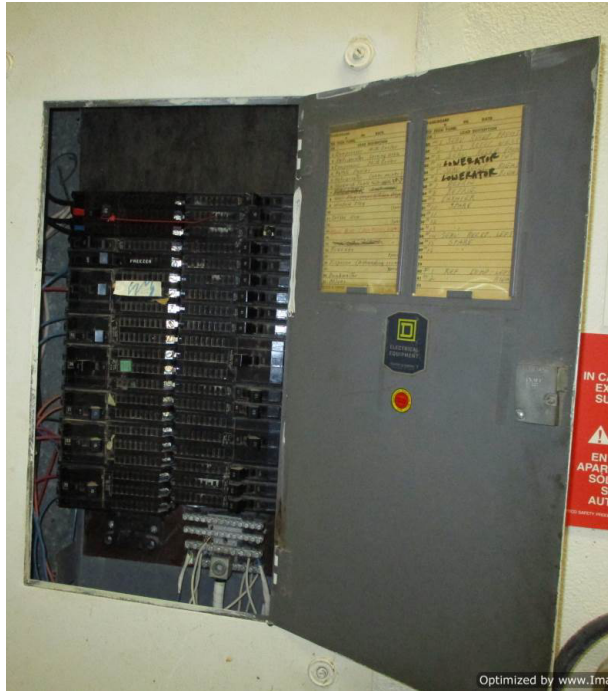
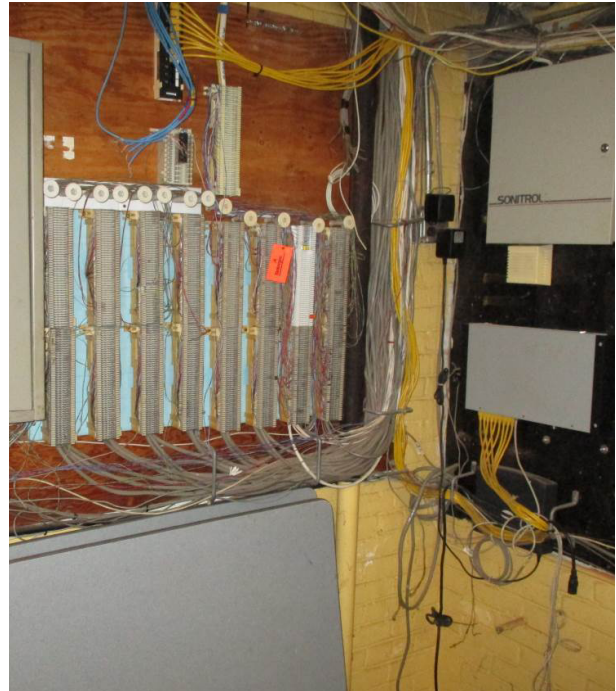
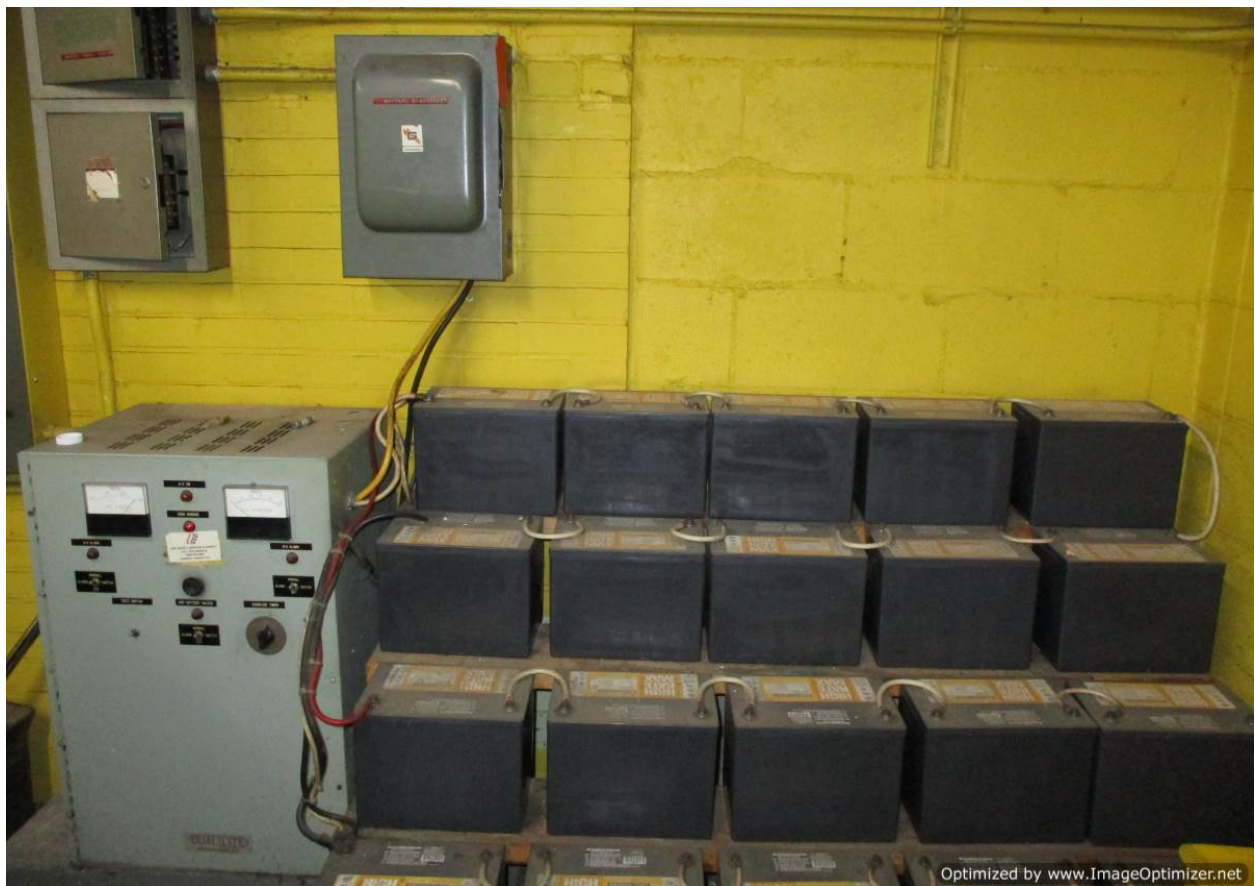
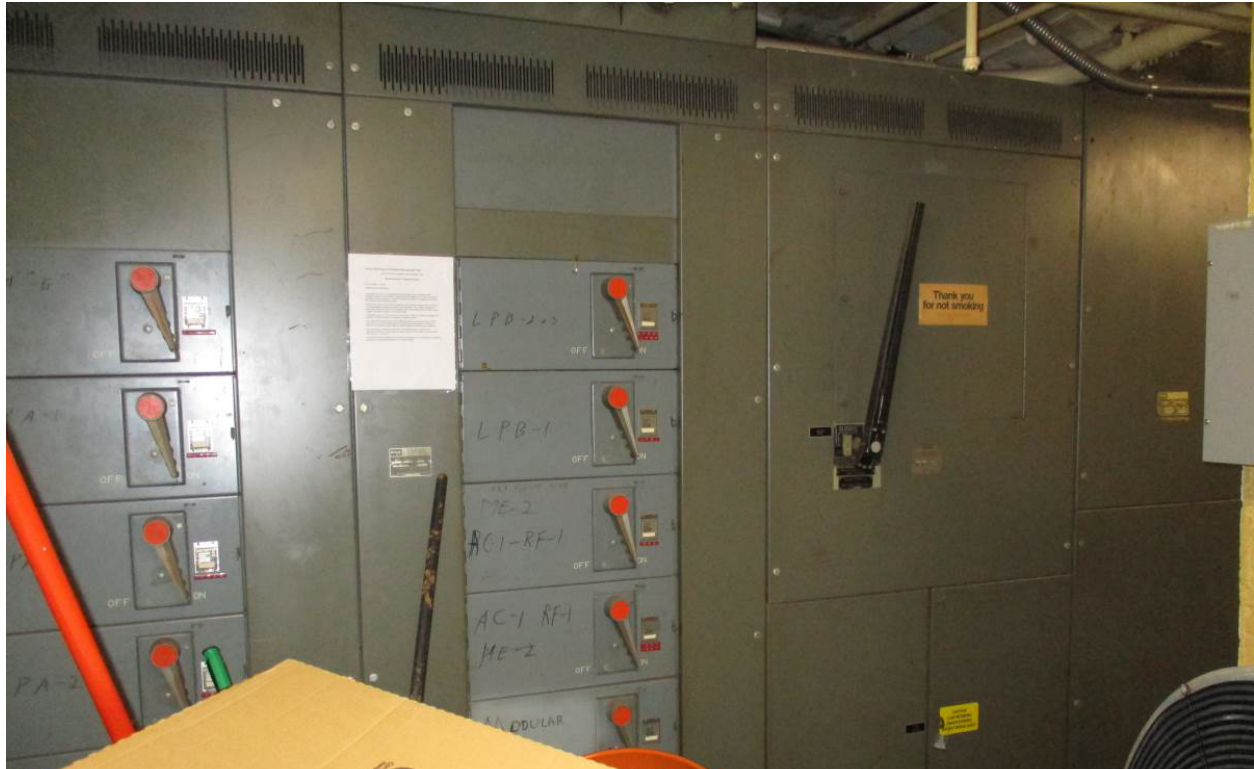
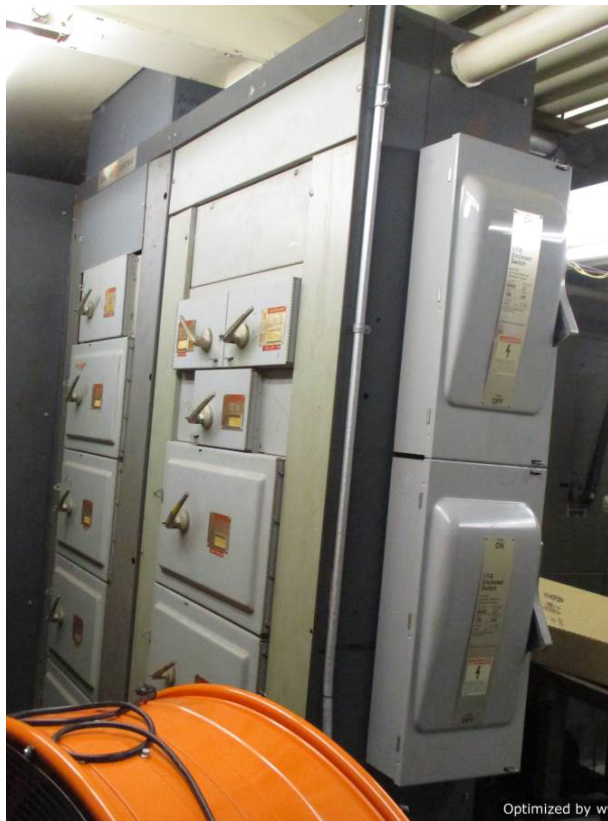
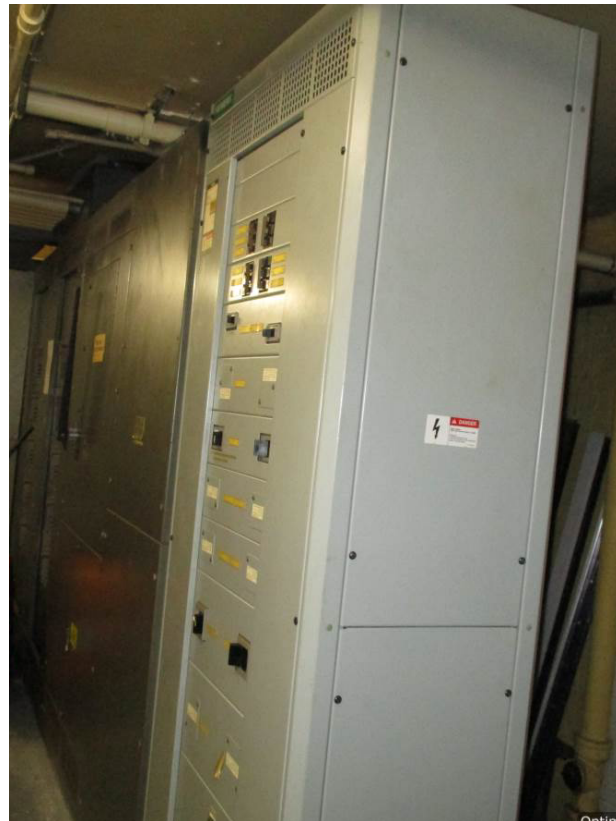
Interior lighting in the Main Building is mixture of recessed and surface mounted fluorescent light fixtures controlled by wall switches. We recommend that all lighting be upgraded with new LED lights. Exit and emergency lights are powered by an array of car batteries. Existing exterior wall mounted perimeter lights are LEDs and appeared adequate as it is supplemented by street lights. The original Auditorium lighting, stage lighting, and dimming console systems are functional but recommended for replacement as they are inadequate and dated.

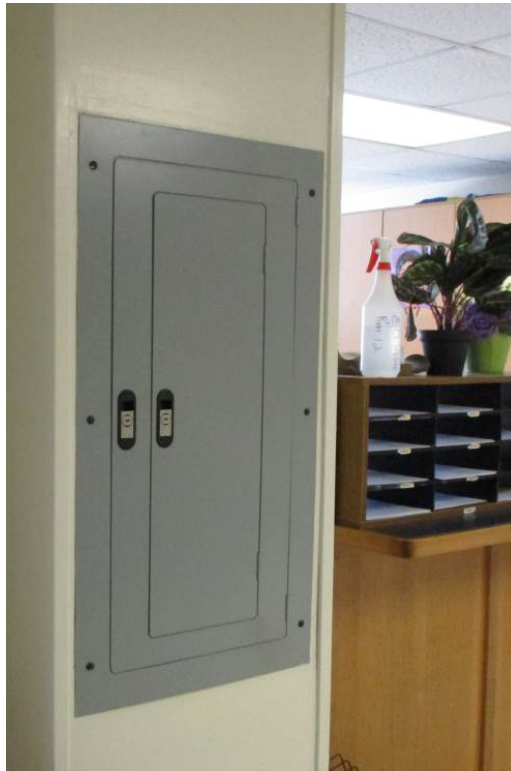
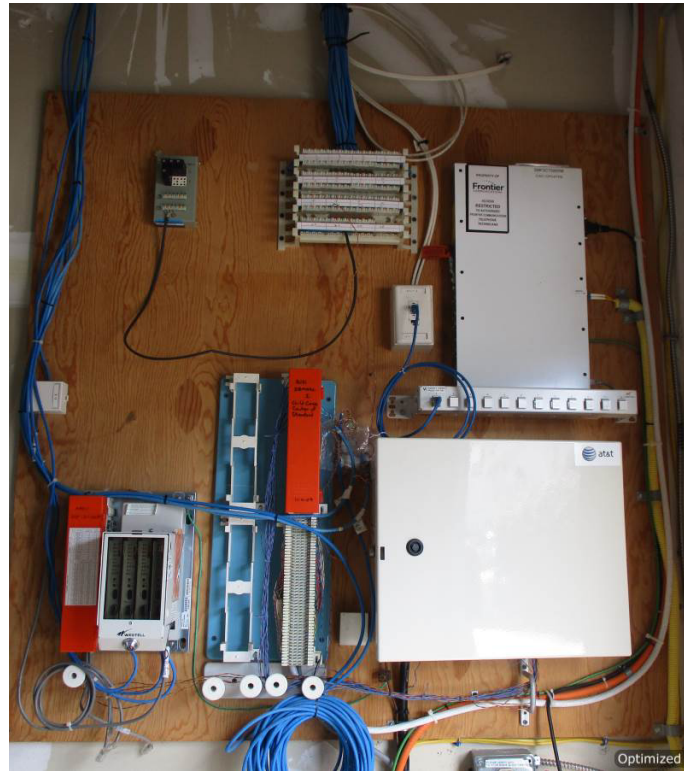
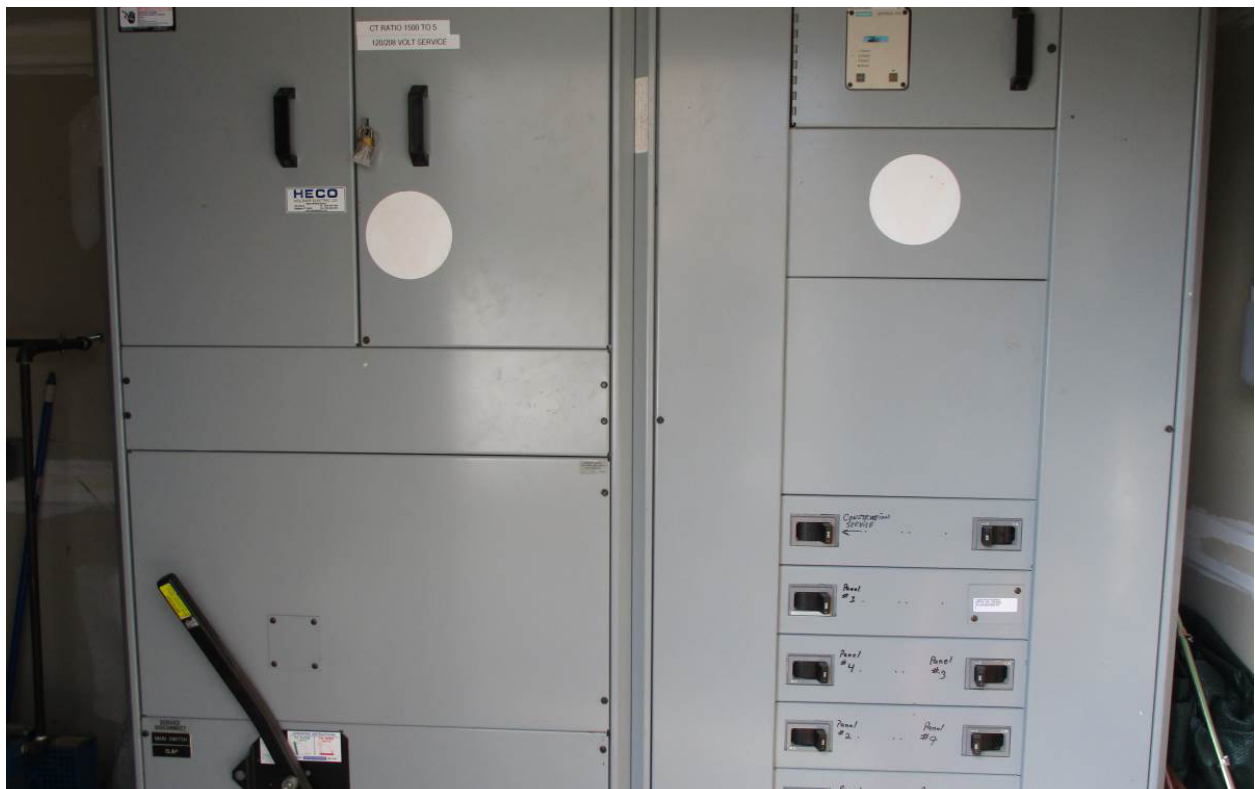
Modular Classrooms

The modular classrooms have excellent switchgear, panels, and wiring. The electric service is separate from main building with a dedicated pad mounted transformer which is owned by the electric utility company. Lighting provided is predominantly recessed 2x4 fluorescent lights which are in good condition.

The existing IT infrastructure is adequate and is in good condition.
