REGIONAL SCHOOL DISTRICT 18

Facility Study – Consolidated School

August 15, 2021

Regional School District 18 Lyme & Old Lyme Facilities Study & Educational Specifications

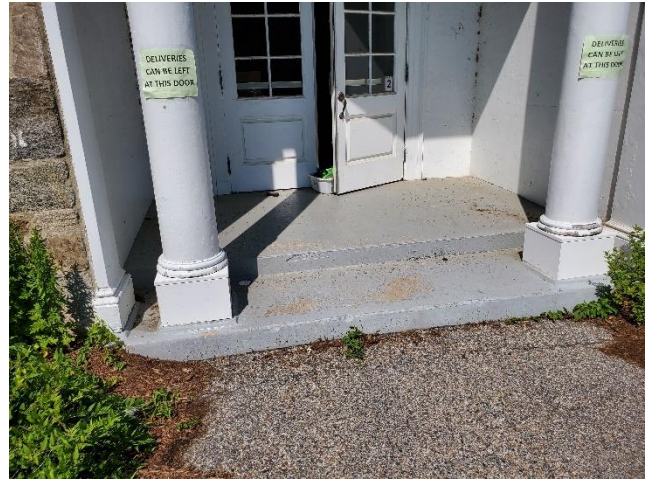
Masonry: The original exterior wall assembly is a masonry backup with stone exterior veneer. Subsequent additions were designed and constructed with a CMU backup and CMU veneer. The CMU and stone has been maintained over the years and appears to be in good condition. There are some small areas of staining on the CMU façade and one exterior stair wall that is failing. At the original building where there is wood trim and wood exterior siding there is noticeable wear, chipping and peeling paint and overall aging of some of the wood features.

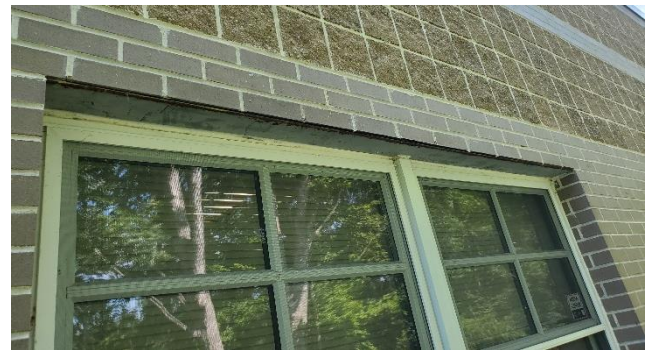
Windows: The windows were replaced in a 2000 renovation project. They are double hung aluminum windows that are a more traditional design. The windows appear to be in good shape and have been maintained well. No cracked glazing was noticed or broken seals. The exterior aluminum flashing appears in good shape as well.

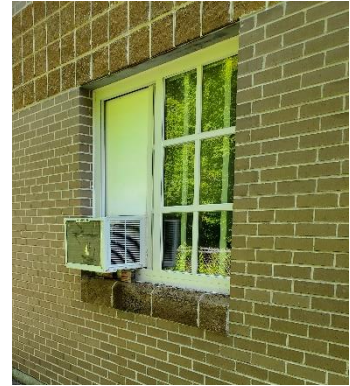
Windows: As noted previously in the 1.1 Exterior Wall section the windows were replaced in 2000 and are generally in good condition and have been maintained well both from the inside and outside of the building. The building does not have central air conditioning however and window units have been installed in the windows for every exterior room. Since the windows weren't designed to house a window unit the sashes remain open providing a break in both the thermal envelope and acoustical separation from outside noise. Transom windows above the exterior doors and within the hollow metal frames are starting to fail as the hollow metal frames start to rust and deform.

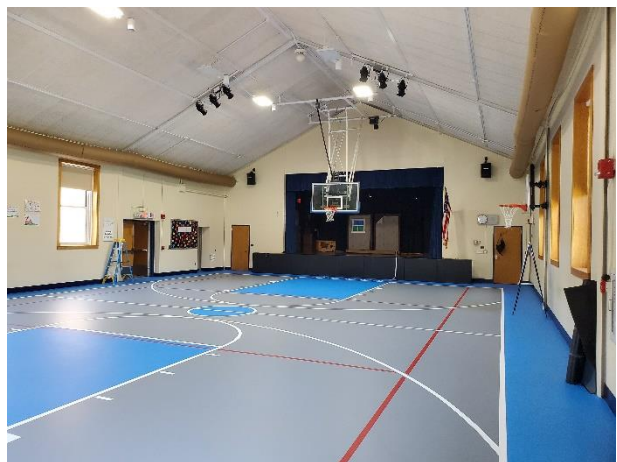
- *Vinyl Tile:* Much of the school is vinyl tile that appears to be in good condition. Many of the tiles have been maintained with minimal cracking or damage noted.
- *Ceramic Tile:* In lavatories, the ceramic tile floors also appear to be in good condition with no noticeable cracked or broken areas. Grout damage or discoloration was minimal and consistent with the age of the tile.
- *Rubber Floors:* The small stage area that is part of the gymnasium has a wood floor system. The wood floor generally looks to be in good shape and condition for the use that it receives.
- *Rubber Floor:* The gymnasium space just recently received a new rubber floor system. The flooring is in great condition with no visible issues or concerns.

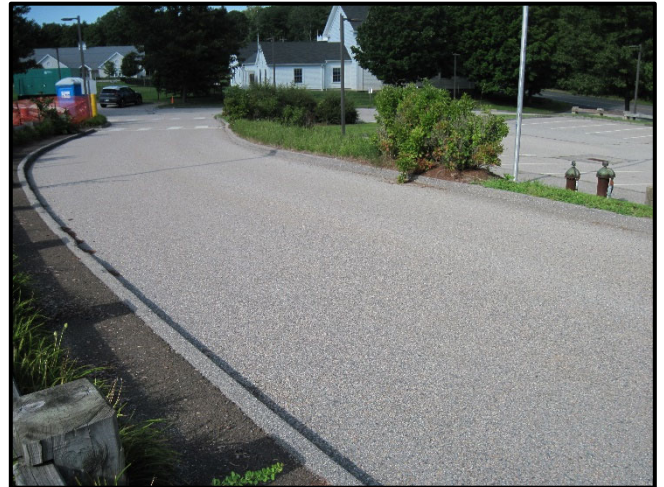
Drive 2 looking northeast.

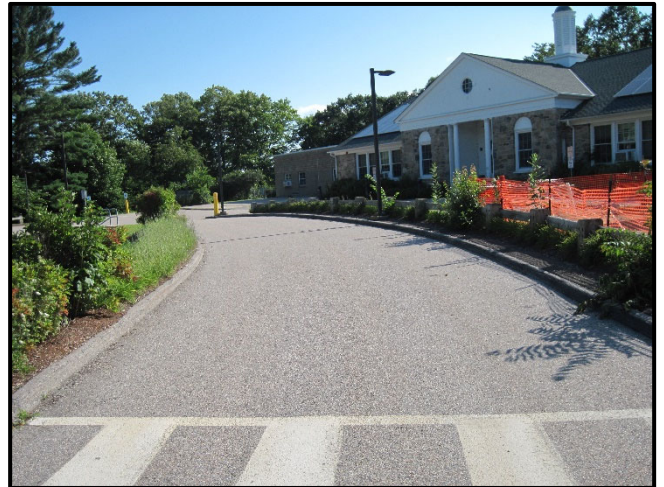
Some of the cracks observed have been treated with asphaltic crack sealer while other areas of cracking have not been treated. It was also noted that some of the previously treated/sealed cracks exhibit signs of additional crack expansion/sealing failure, including the presence of grassy vegetation. An example of this is a large crack at the southern end of Drive 2.

Drive 2 looking south at pedestrian crossing.

Area	Classification	Commentary
Drive 1	Fair	Crack repairs recommended.
Drive 2	Fair	Crack repairs recommended; Cut/repair large crack at south end.
Lot 1	Fair	Crack repairs recommended
Lot 2	Fair	Crack repairs recommended

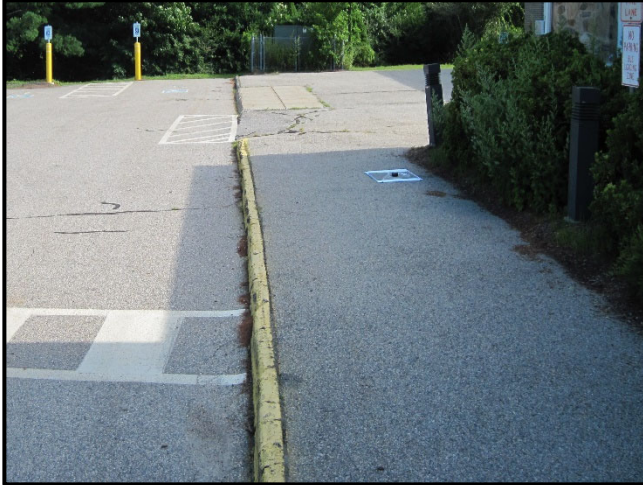
Bituminous sidewalk along the school's front (looking south). Accessible parking and PL1 visible beyond.

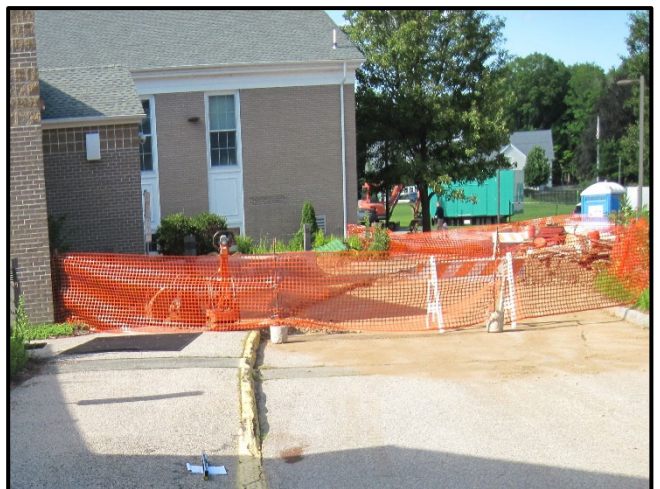
Stair 1 and Ramp 1 at front of school, under construction at time of visit.

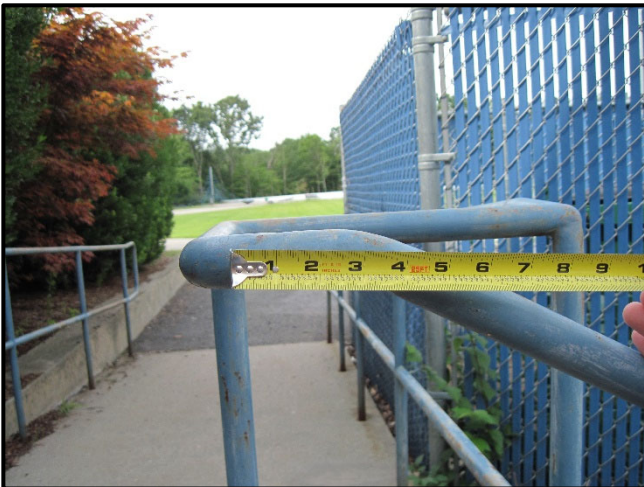
Stair 3, top handrail extension (north rail).

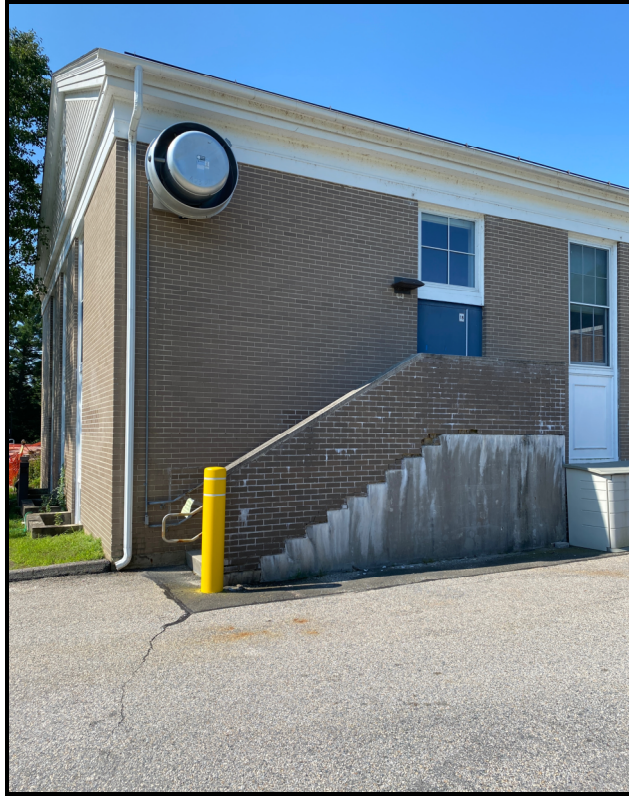
PHOTO 1: 7/23/2021 - Exterior stairs at gymnasium

stairs adjacent to the gymnasium were severally deteriorated and require replacement. See Photo 1. Moisture infiltration has caused multiple brick spalls and efflorescence staining which also can be seen in Photo 1. Several control joints caulking appeared to be starting to crack and dry rotted. Also, several locations along the exterior walls required repointing of the CMU. The original structure's exterior walls were comprised of stone and mortar. The exterior walls appeared to be in satisfactory condition with no signs of distress. Note that we were unable to access the roofs to review the condition of the roofing systems.

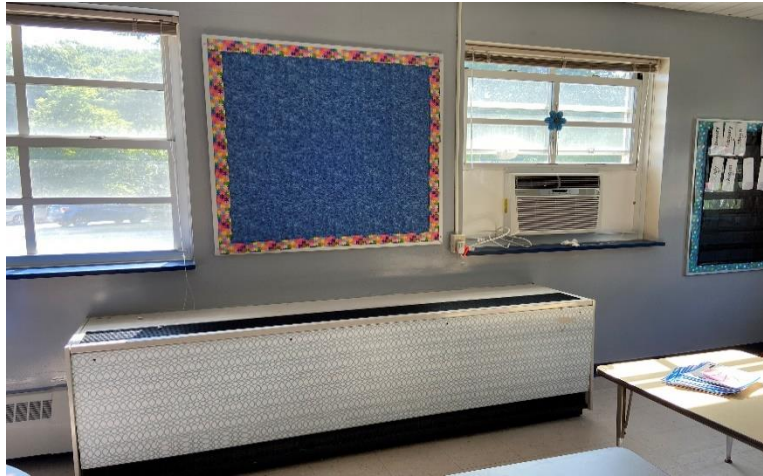
Unit Ventilator Serving a Classroom

1. Heating throughout the occupied portions of the building is provided by a combination of unit ventilators, perimeter radiation, cabinet unit heaters and rooftop heating and ventilating units. The majority of the indoor heating devices are in fair condition, but will need to be replaced in the near future. The outdoor rooftop units will be addressed in a later section.

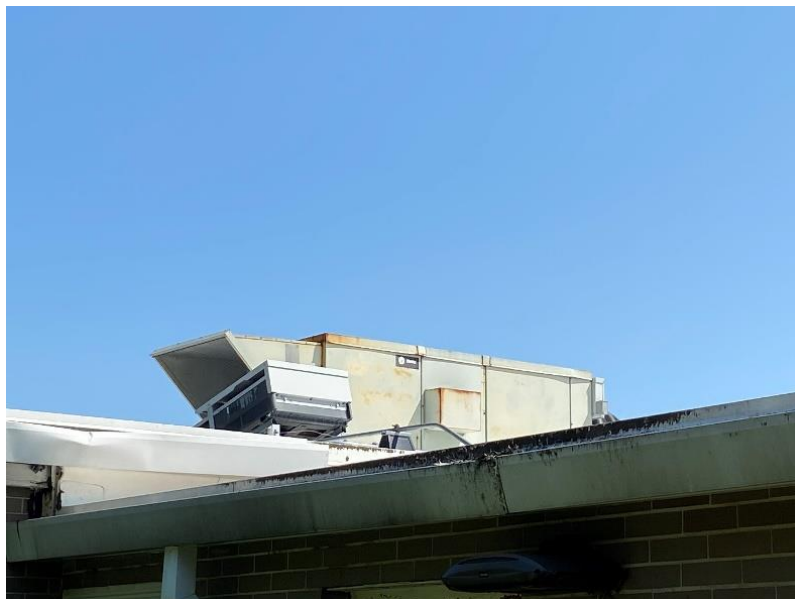
1. Five rooftop units, unit ventilators and multiple exhaust fans provide ventilation to the building. RTU-5 serves the gym and is new. The other four rooftop units serve administration offices, special education spaces and the media center and include cooling. These units are over 20 years old and appear to be in poor condition. Casings for each unit are rusted and showing signs of wear. A typical rooftop unit has an approximately 20 year useful life which these are beyond. In addition, the motor efficiency, filter quality, and other features are not meeting today's standard for schools. Lastly, cooling or dehumidification systems are strongly recommended for modern schools.

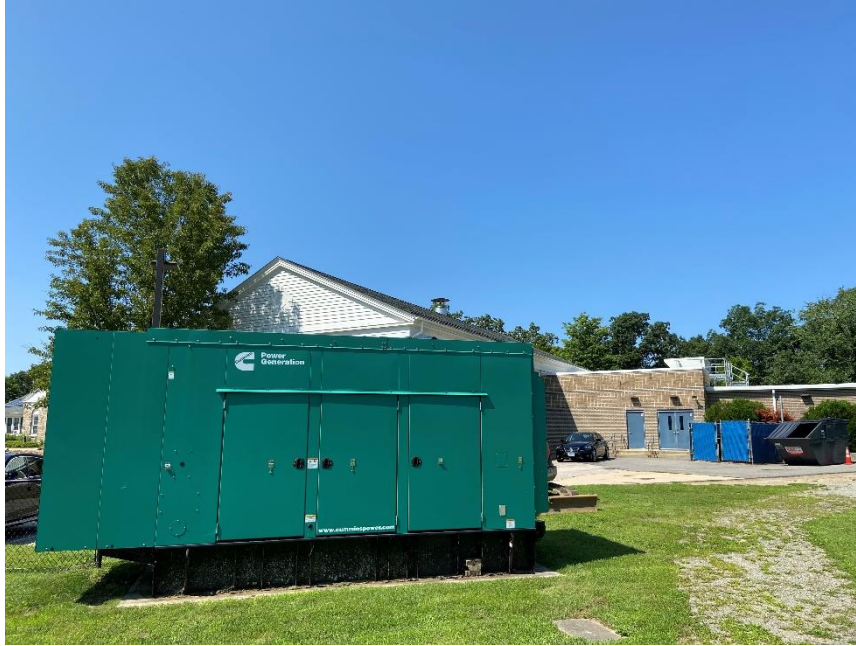
Emergency Generator

It was noted that the emergency generator, located on the east side of the building adjacent to Lot 2, is not protected by bollards and is not surrounded by any type of protective enclosure. The pad-mounted electrical transformer is located on the south side of the school and is surrounded by a chain link fence. It was also noted that tires have been placed around the two water supply wells. It is recommended that these tires be replaced with tamperproof steel protective enclosures that protect the wellhead, but do not provide opportunities for animal nesting.

4. There is an emergency generator on property between the school and Town Hall which serves both buildings. Power from the generator enters the school and is controlled by a Cummins automatic transfer switch. The output of the transfer switch is an emergency distribution panel. The transfer switch and panelboards are in good condition.

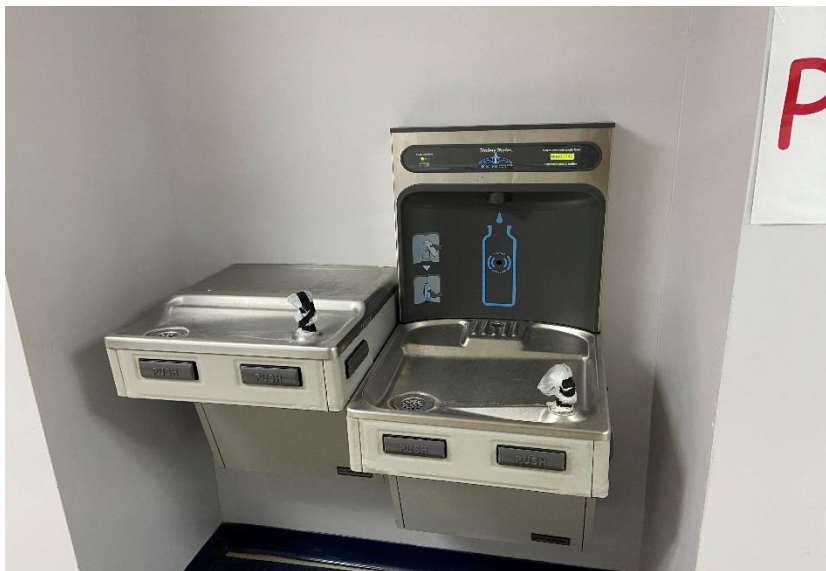
Water Cooler with Bottle Filler

1. Plumbing fixtures within the building are generally of the 20 year age from the previous renovation. Fixtures appeared to be clean, well maintained, and in fair condition with a 30 year useful life.
2. In general plumbing fixtures are as follows:
 - Water Closets in gang bathrooms are wall mounted, vitreous china with manual flush valves.
 - Urinals are wall mounted, vitreous china with manual flush valves.
 - Lavatories serving single use bathrooms and in gang bathrooms are wall mounted vitreous china with manual faucets. Tailpiece and trap are missing ADA compliant insulation and guard in some locations.
 - Electric drinking fountains are surface mounted and appear to be in good condition.
 - Classroom sinks are top mount stainless steel, with manual faucets. These fixtures appear to be in good condition.
