# CAPITAL ASSESSMENT PLAN

Cologne Academy  
1221 South Village Pkwy  
Cologne, MN 55320

JB Vang Management, LLC  
1335 Pierce Butler Route  
St. Paul, MN 55104

January 11, 2021

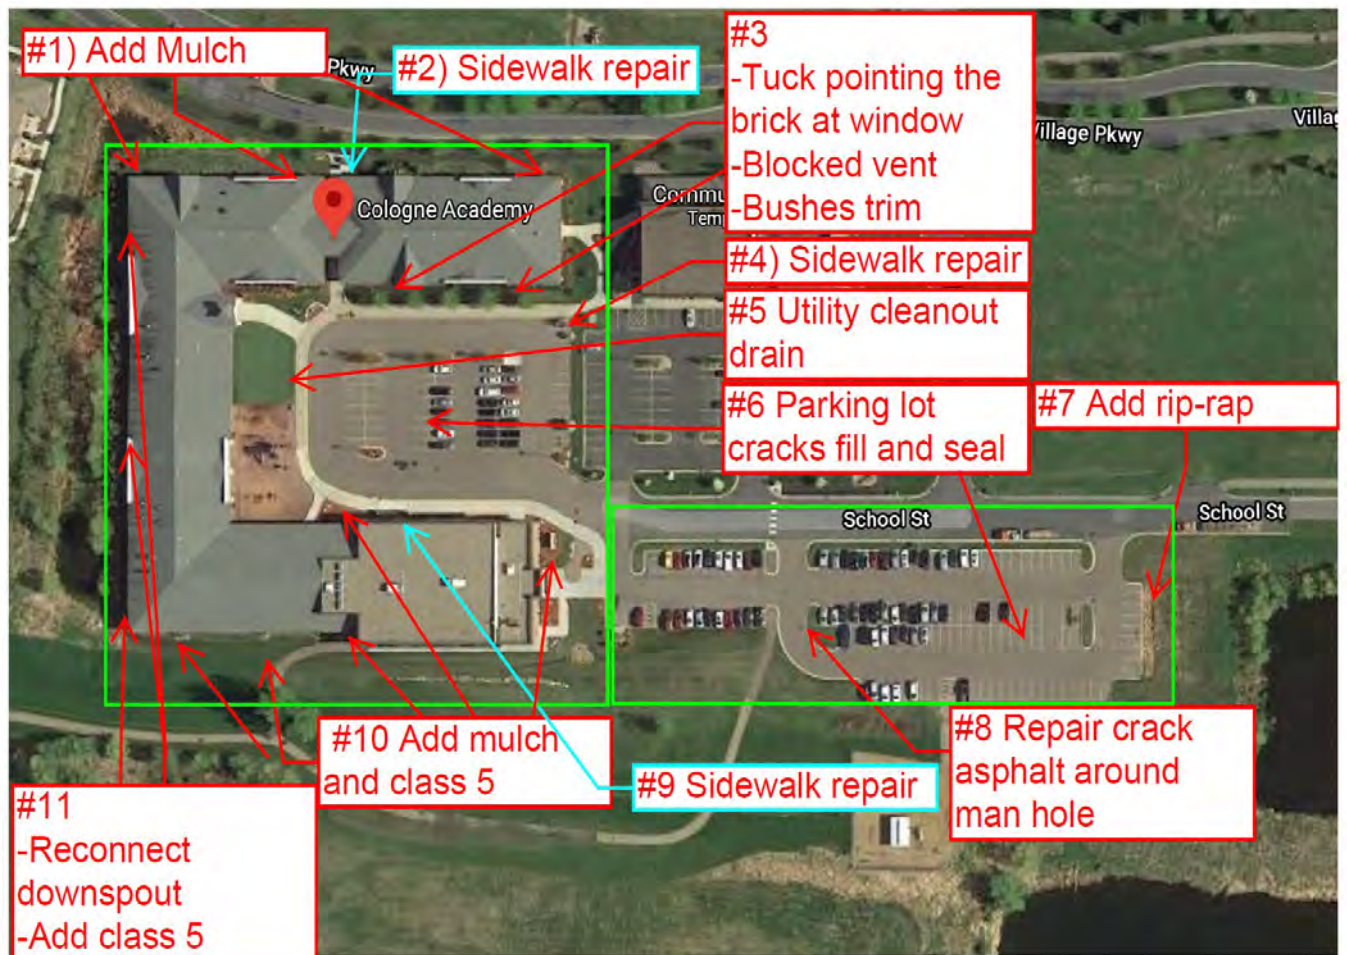
Location 1: This includes the flower bed and landscaping along the whole north side of the building. The mulch and poly have deteriorated and left a 2" – 5" depression between the plastic poly bedding and the top of the grade. The lack of mulch causes water to get into the foundation and door landings. If this condition continues, the egress landing and the building foundation will be undermined. Adding new poly and mulch will remedy this condition.

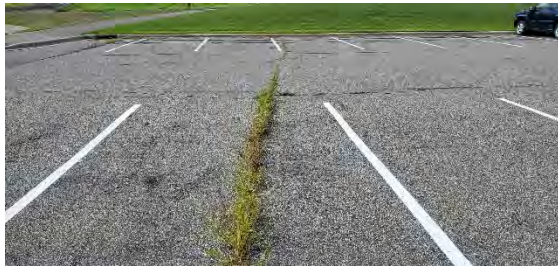
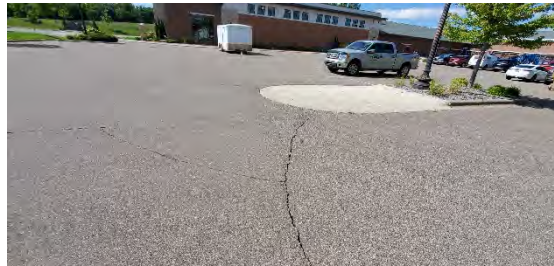
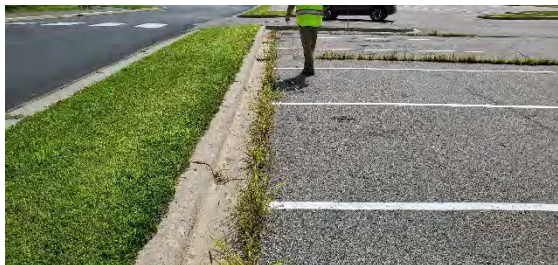
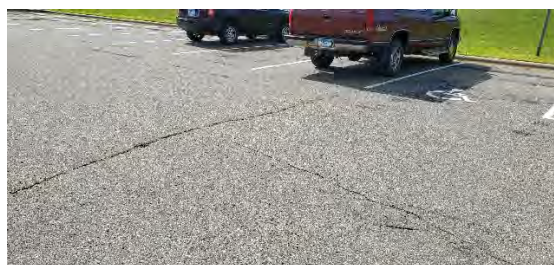
Location 6: This area encompasses the parking lot in the courtyard and the lot to the east of the gym. There are a number of asphalt cracks throughout the two parking lots and drive lane. The freeze and thaw cycle will worsen and expand the cracks. Weed control should be applied to the weeds that grow in the cracks and between the curbs and asphalt line. Asphalt cracks should be cleaned and filled. The asphalt should be seal coated and re-striped to prevent more cracks and to extend the life of the asphalt.

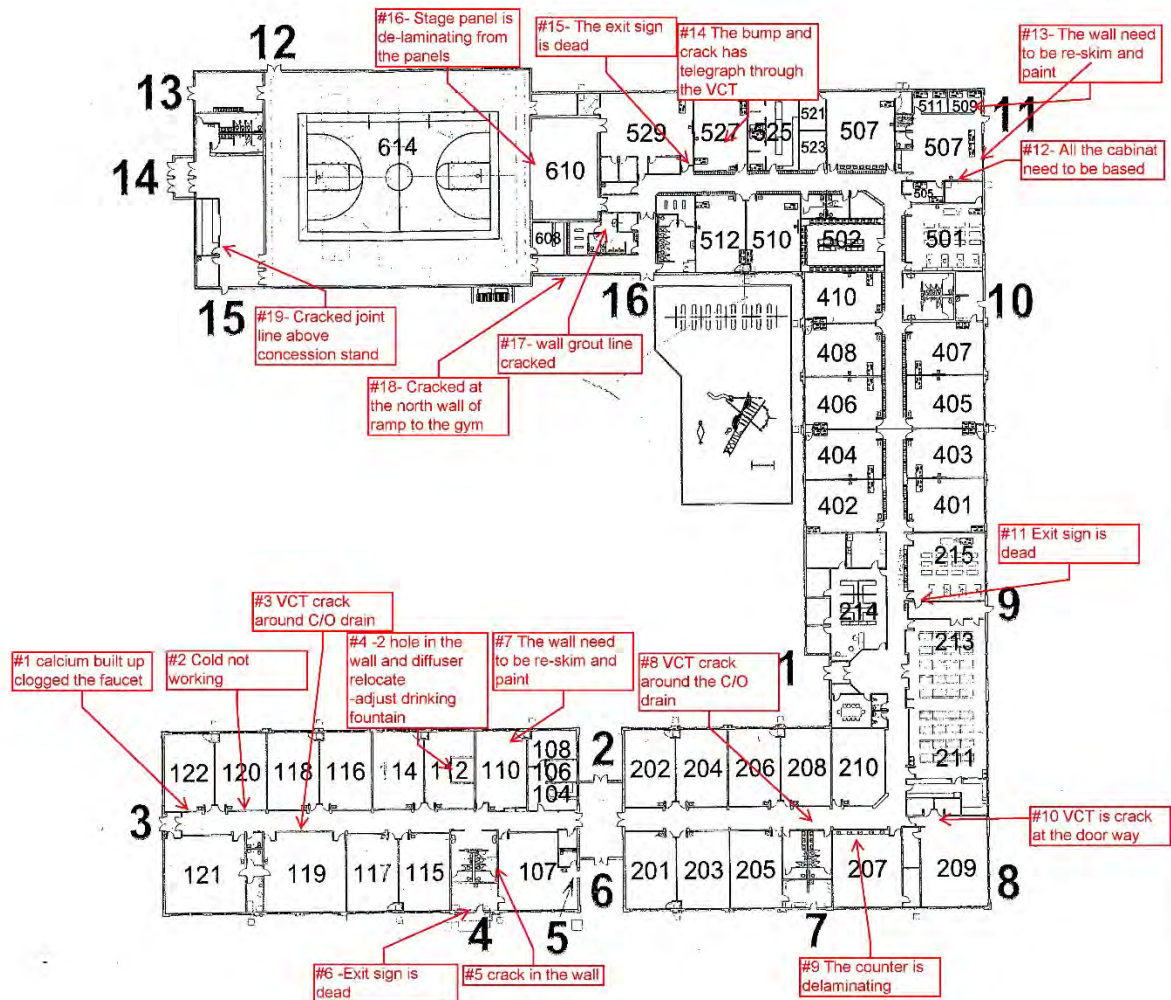
Location #1: The faucet in room 122 is clogged from calcium build-up. The faucet head filter needs to be cleaned out or replaced.

Location#2: The cold-water handle in room 120 is not working. It looks like the handle needs to be replaced due to the gear in the handle being worn out.

Location#3: The VCT outside room 119's clean out drain is cracked and may be a trip hazard.

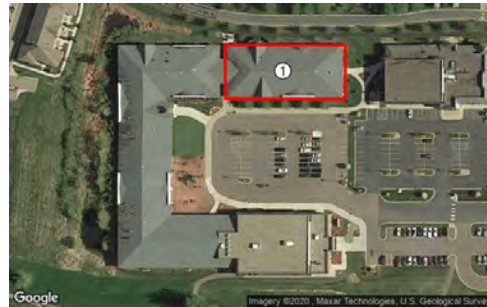
**Section:** Shingle Area Phase 1  
**Size:** 19005  
**Overall Grade:** A

Membrane: A  
 Flashings: A  
 Sheet Metal: A

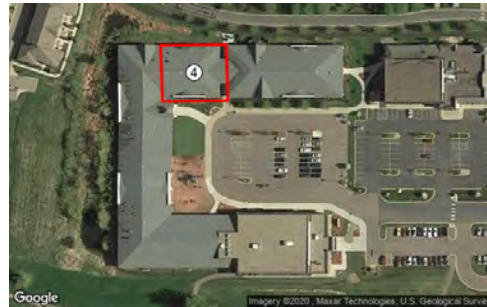
**Section:** Shingle Area Phase 2  
**Size:** 10858  
**Overall Grade:** A

Membrane: A  
 Flashings: A  
 Sheet Metal: A

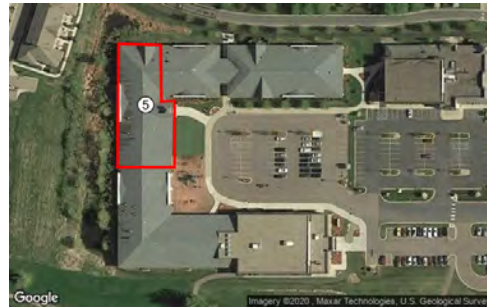
**Section:** Shingle Area Phase 3  
**Size:** 18322  
**Overall Grade:** A

Membrane: A  
 Flashings: A  
 Sheet Metal: A

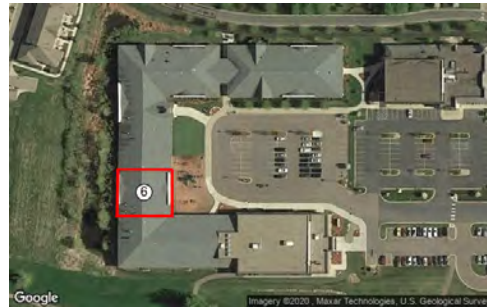
**Section:** Shingle Area Phase 4  
**Size:** 7528  
**Overall Grade:** A

Membrane: A  
 Flashings: A  
 Sheet Metal: A

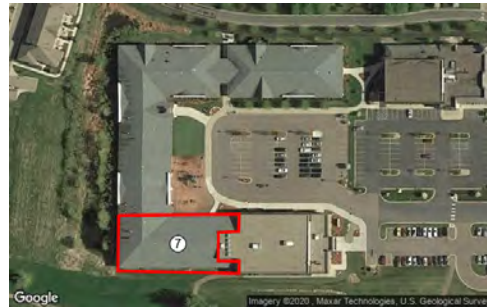
**Section:** Shingle Area Phase 5  
**Size:** 18794  
**Overall Grade:** A

Membrane: A  
 Flashings: A  
 Sheet Metal: A

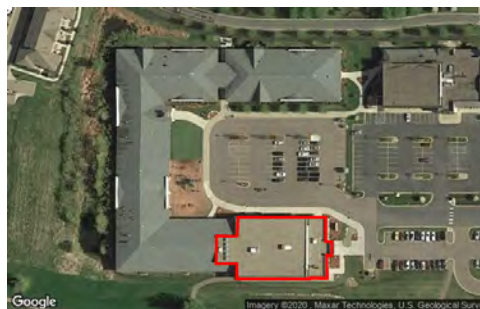
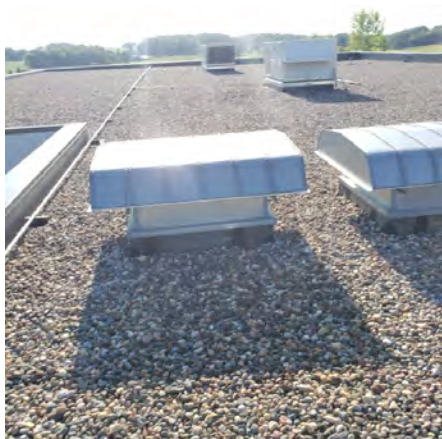
Inspection revealed these roofs are in good shape

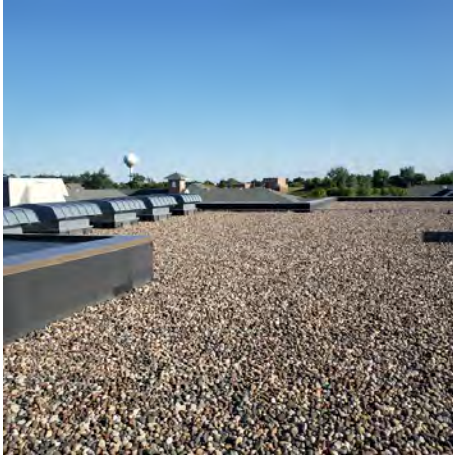
1

We noted a membrane puncture on the lower roof section. This would be repaired during our priority repair visit

### **General - Yearly Roof Maintenance Program (ALL SECTIONS) (Remedial)**

Perform a general inspection of all roof sections paying close attention to roof flashings, field seams, and drainage. Remove any ponding water and check for crushed insulation. Repair any minor membrane damage (small cuts/tears). Check and clear all drains & scuppers. Clean roof surface of all nature's debris. Remove and dispose of any foreign debris. Check and caulk all vent stacks & storm collars as necessary. If any major issues are found, we will provide a proposal for repair.

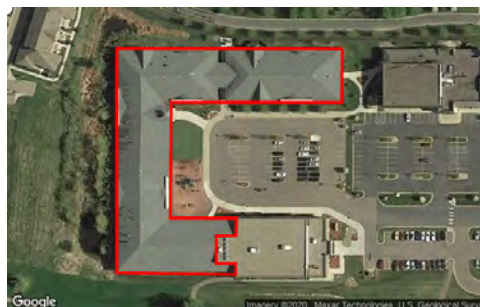
These roofs are in good shape with some maintenance repairs recommended

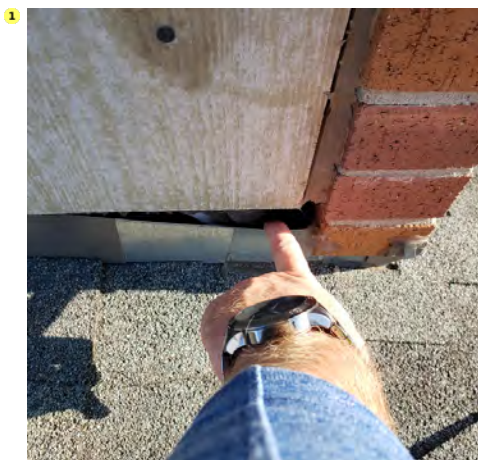
During our roof walk, we noted some areas open to water infiltration that are in need of immediate repair.

### **General - Priority Roof Repair Visit (Shingle and Flat Roof Areas) (Emergency)**

- Load all materials and equipment
- Set-up safety equipment as necessary
- Inspect all roof sections
- Perform repairs to open flashing area
- Check all coping caps and seal joint covers and open areas as required
- Perform repair to membrane puncture on flat roof area
- Check pipe flashings and roof penetrations and seal as time allows.
- Provide photo documentation of work performed
