WALKER RESERVOIR DAM

VERNON, CONNECTICUT

#14616

INSPECTION REPORT

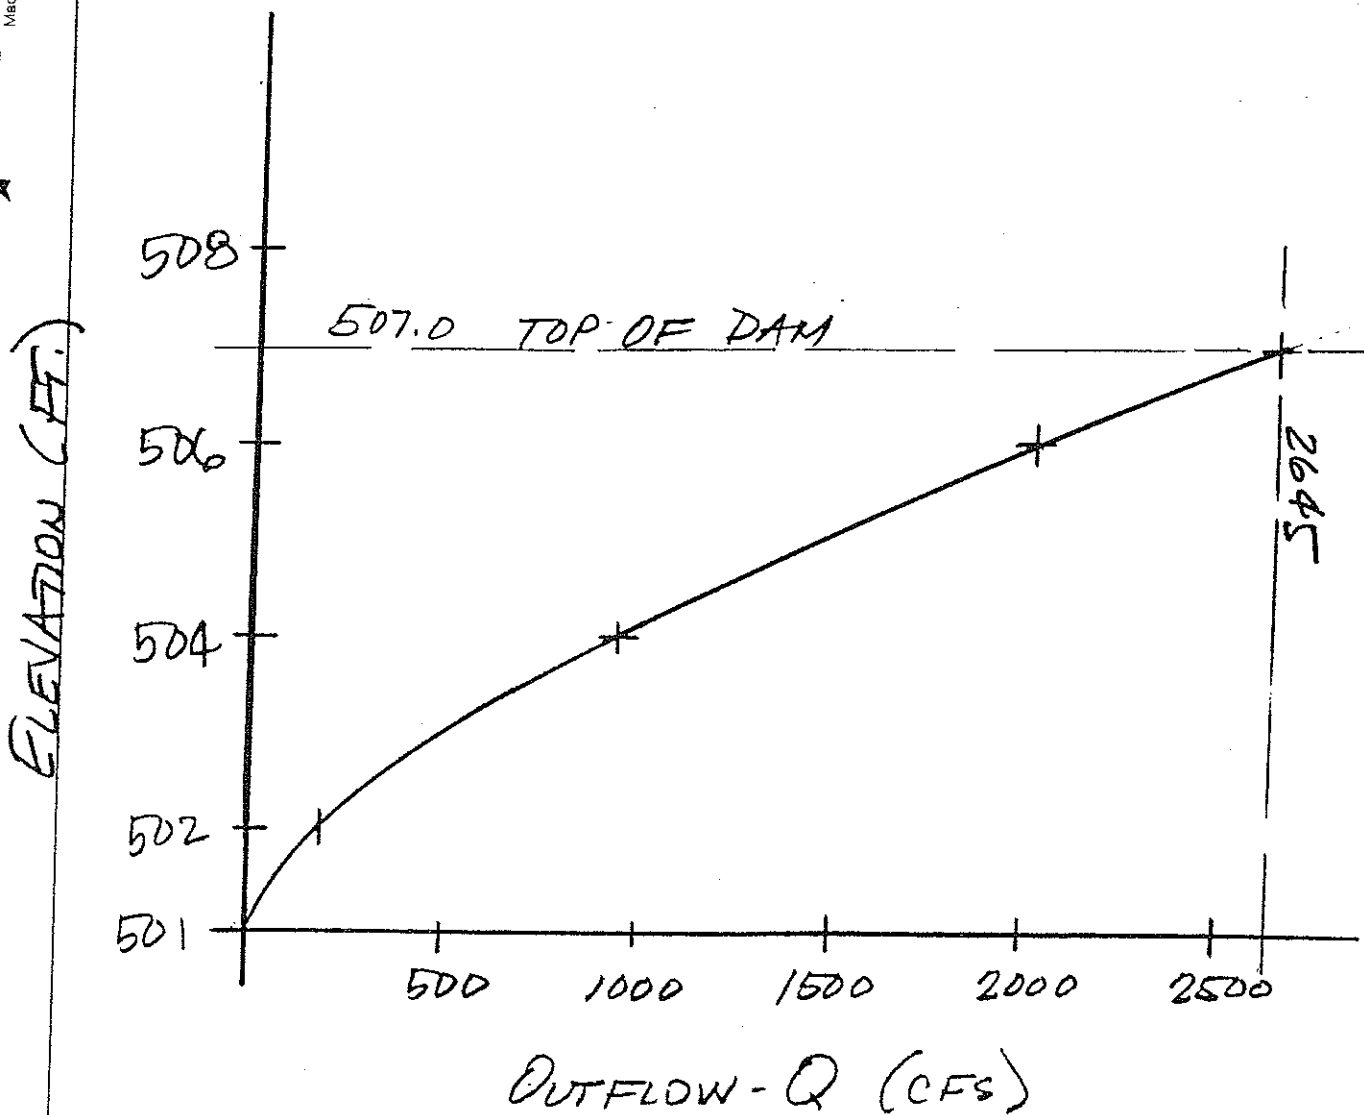
ELEVATION VS. OUTFLOW

(BASED ON $Q = CLH^{1.5}$, WHERE $C = 3.0$
AND $L = 60'$)
