Facilities Assessment

Bayberry Elementary School

113 Bayberry Lane
Watchung, NJ 07069

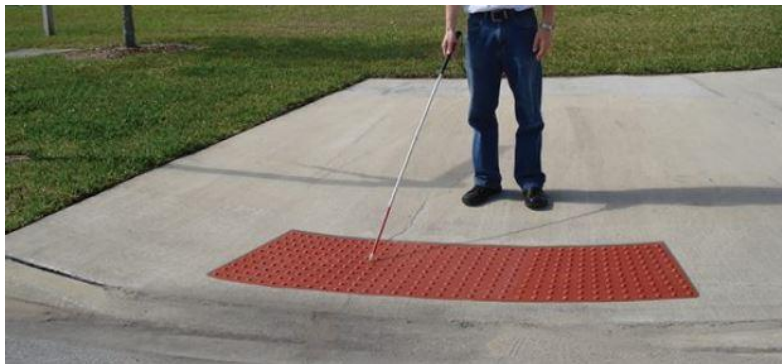
ADA REQUIREMENTS: All of the curb cuts are missing detectable/tactile warning surfaces:

This is an example of a detectable/tactile warning surface:
