Facilities Assessment

Valley View Middle School

50 Valley View Road
Watchung, NJ 07069

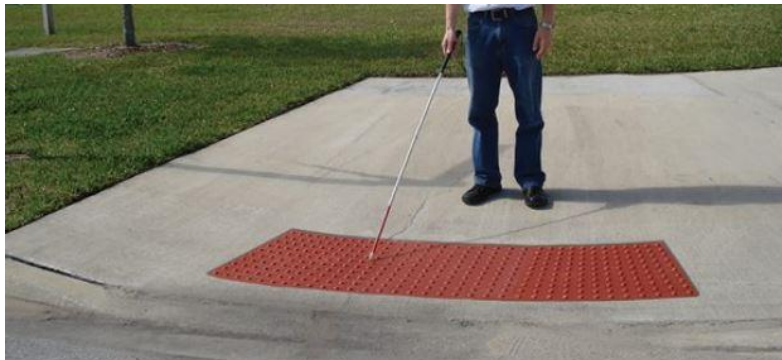
This is an example of a detectable/tactile warning surface:

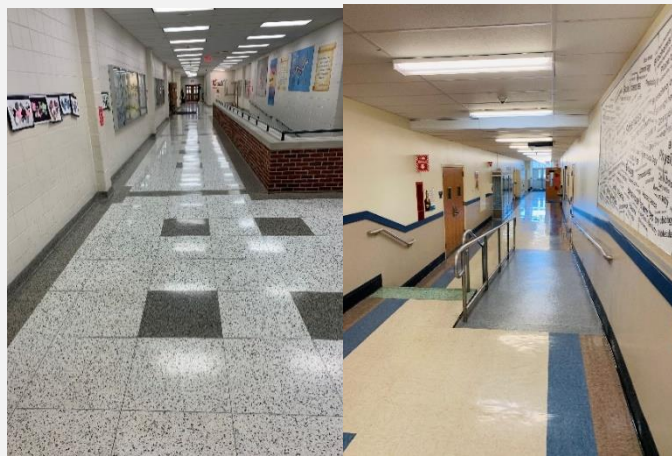
INTERIOR FINISHES FLOORS, VINYL COMPOSITION TILE (VCT) / CEILINGS: Most of the main corridor floors are terrazzo – and are in excellent condition. The other corridor floors are Vinyl Composition Tile (VCT) and are in excellent condition.

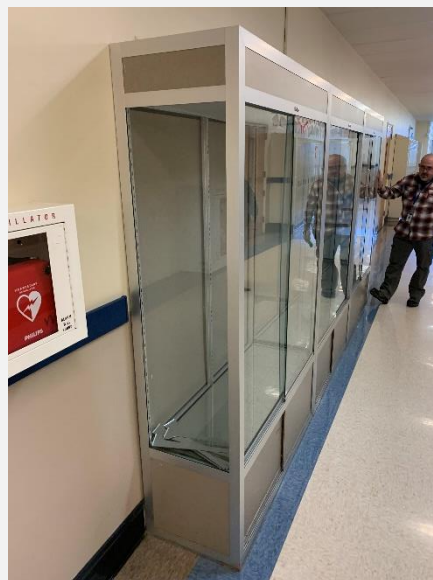
There is a large trophy case (mostly empty) in a corridor of the original wing of the school. It would make more sense to locate it in the main corridor outside of the Gymnasium where there is more than enough room.

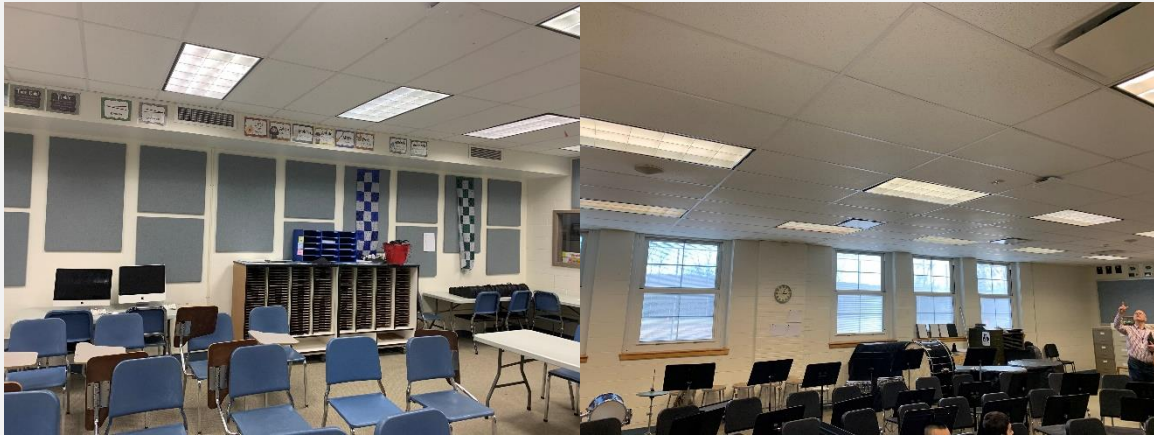
The Choral Music Room has acoustic wall treatments while the Instrumental Music Room has none.

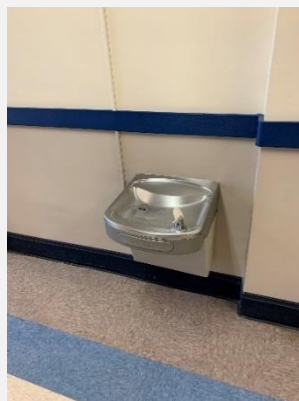
The existing drinking fountains could be replaced with combination drinking fountain/bottle fillers.

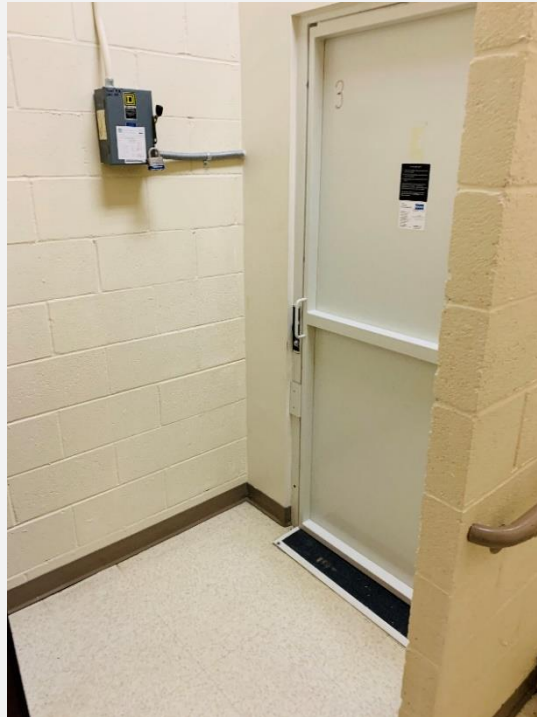
STAIR LIFT: Is in good condition.

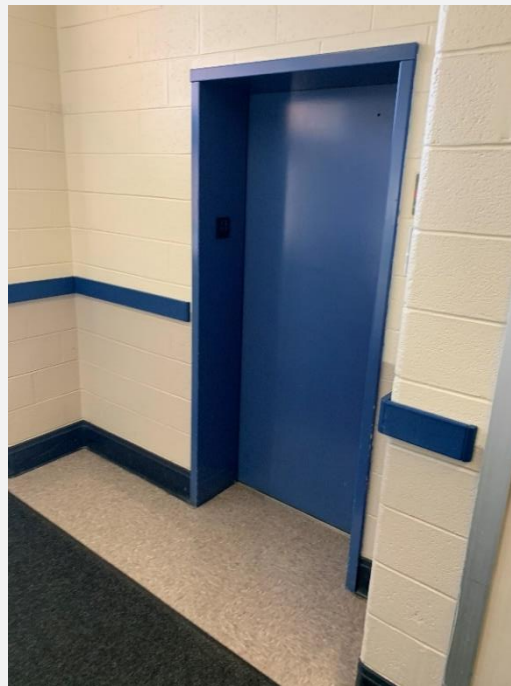
ELEVATOR: Adequate

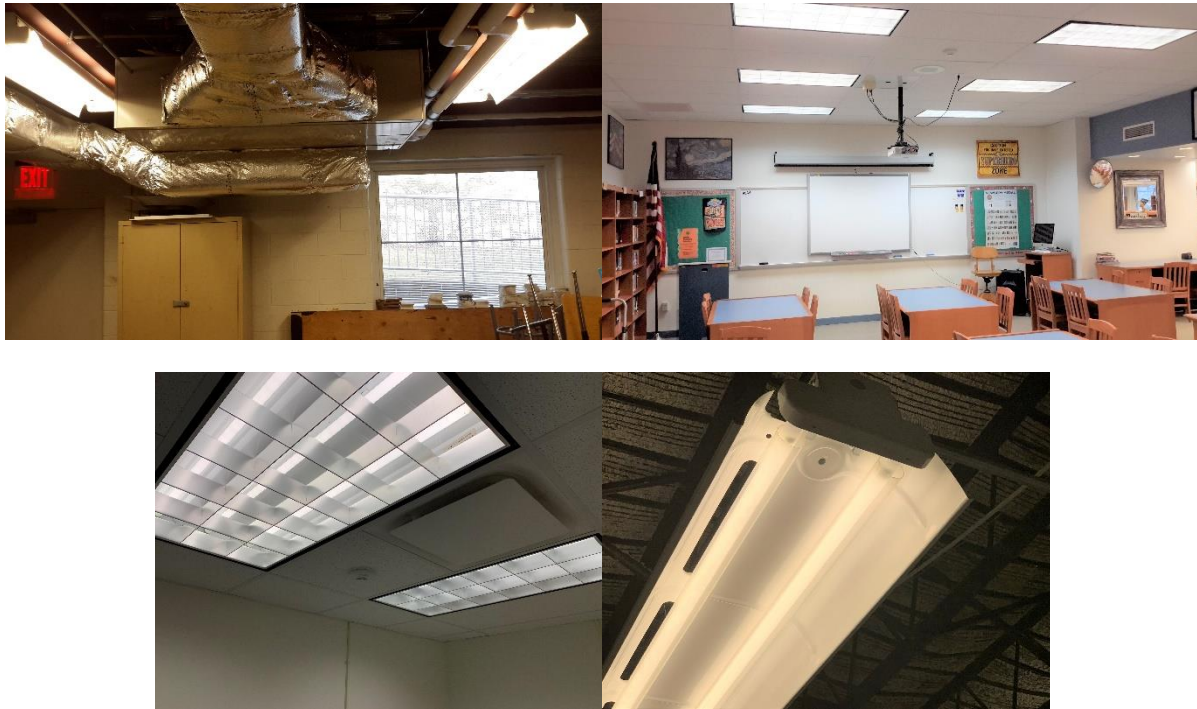
INTERIOR LIGHTING: All existing fluorescent fixtures should be replaced with LED fixtures for increased energy efficiency and light quality. Pricing of LED fixtures is now very competitive and the maintenance (bulb, ballast replacement) is greatly reduced. For any existing 2' x 4' lay in fixtures, LED retro fit kits are available. **THIS WORK WAS DONE OVER THE SUMMER OF 2020.**

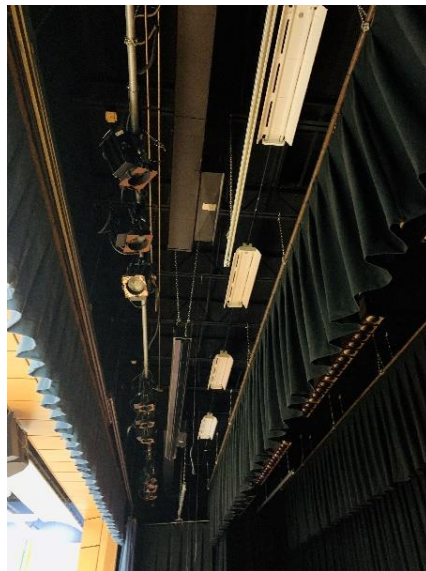
The stage lighting should also be replaced with LED fixtures:

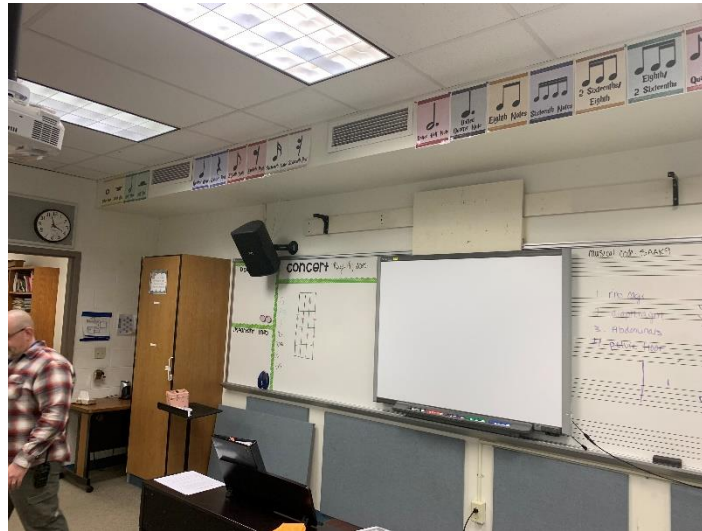
TECHNOLOGY: The school is looking into the possibility of replacing any Smart Boards with Promethean Boards, or a more cost effective alternative.

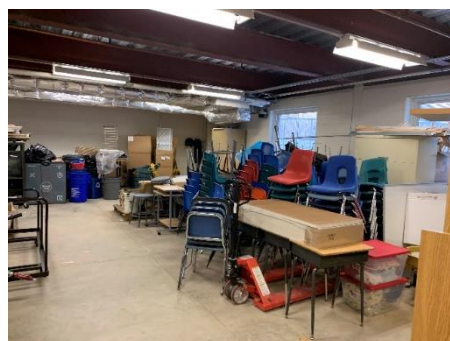
The adjacent storage space could have been configured into additional art room space while also providing more natural light into the classroom.

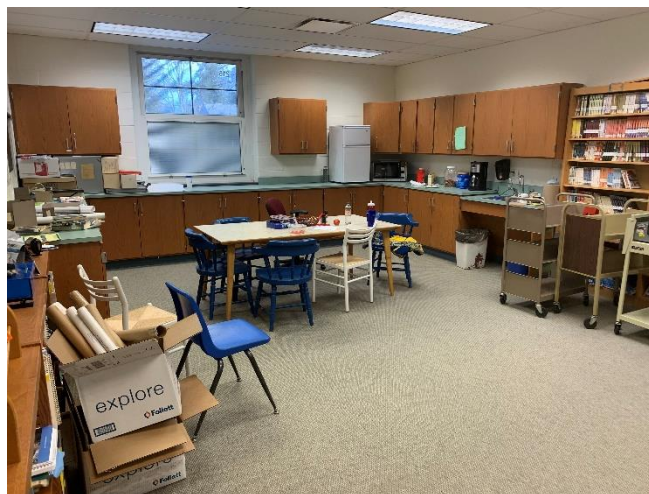
There is also a large “Workroom” adjacent to the main space that is also under-utilized.

Ideally, the tall shelving units around the perimeter of the space would remain, the remaining shelving would be replaced with mobile shelving units – and the furniture would be replaced with modular furniture.

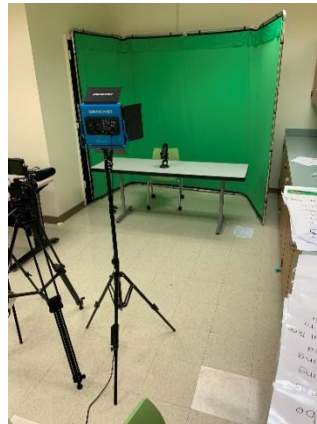
A “Teacher’s Workroom” (adjacent to the Technology Suite” is being used as a studio for morning announcements. Perhaps this studio could be incorporated into the current Media Center “Workspace”.

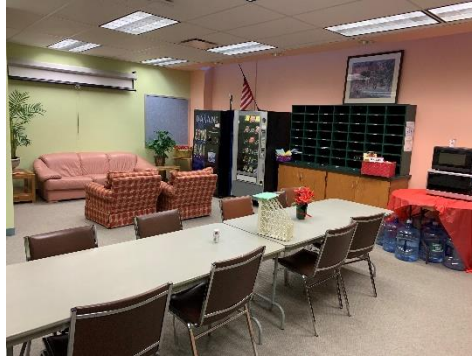
FACULTY LOUNGE: Removing the projection screen and painting this room a more neutral color would do wonders for this space.

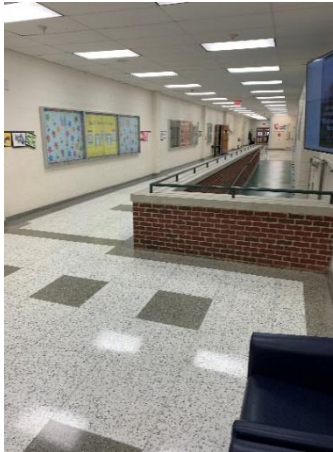
MAIN ENTRY HALL/CORRIDOR: The space in front of the ramp is wasted; it could possibly be used as an informal meeting area or be used for some other use.
