MERCER ISLAND SCHOOL DISTRICT
LONG-RANGE FACILITY PLAN

Issue Paper 3: Existing Facility Condition

16 DECEMBER 2019

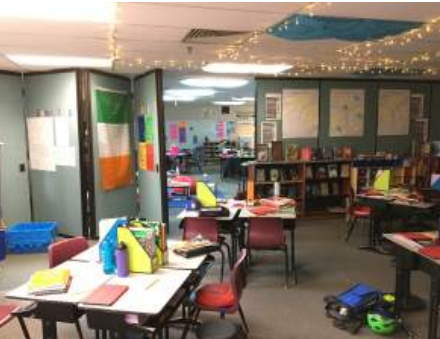
Island Park Elementary School Classroom

Building interiors are in good to fair condition. Observed issues include water damage to Classroom Building ceilings in

several locations, and there are missing acoustical ceiling tiles in the multi-purpose room.

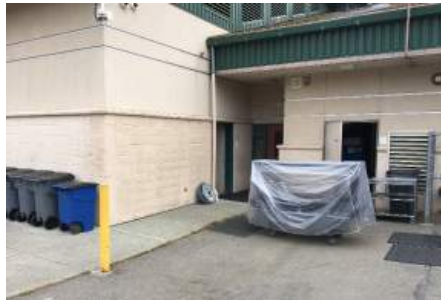
Lakeridge Elementary School: Lunch carts stored outside during the day

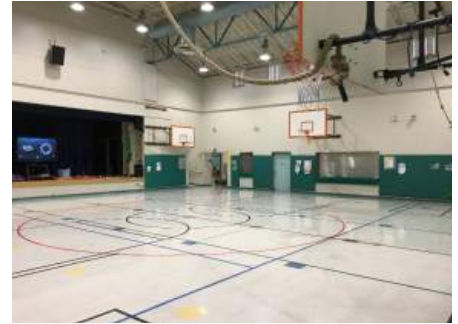
The building interior is in fair to good condition. The wooden stage in the multipurpose room has a lot of wear, and there is damage to wall corners in corridors.

West Mercer Elementary School: Multipurpose

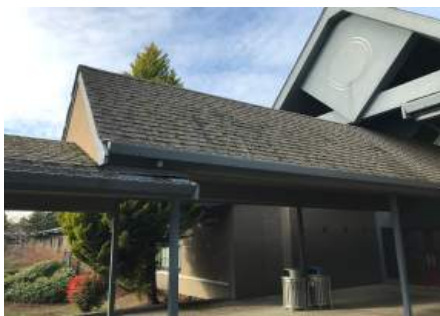
Islander Middle School: Classic Building

The 100/200, and 300 building exteriors are in fair condition with the exception of the roof on the 100/200 Building. It is past the end of its life and in need of replacement.

Windows in 100/200 Building have compromised perimeter seals and defective hardware. The wood fascia has been damaged in different locations.

- > Roof replacement (*critical* at the 100/200 Building and also needed at the 300 building)
- > Toilet partition replacement and restroom configuration throughout
- > Fencing to create a secure campus
- > Bus loop asphalt replacement / grid-overlay
- > Bus loop lighting replacement
- > Stucco repairs
- > Interior and exterior paint
- > Flooring replacement
- > HVAC equipment replacement
- > HVAC controls upgrade
- > Track and field replacement (currently in partnership with the City of Mercer Island)

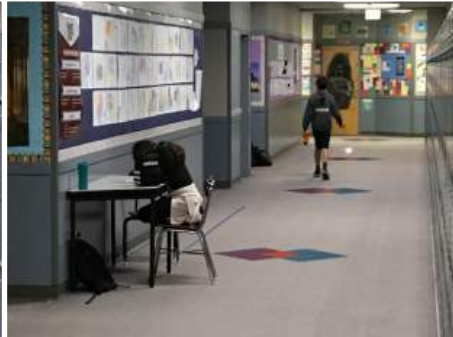
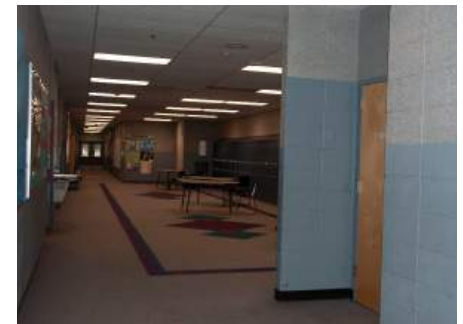
IMS Classic Building: Lack of natural light

IMS Classic Building: Small group learning / pull-out areas in hallways
