Re: Oak Park and River Forest High School
2021 Visual Observation
East & West Pool
Oak Park, IL 60302
LEI Project No: 21210579.000

VISUAL OBSERVATION OF THE
OAK PARK AND RIVER FOREST HIGH SCHOOL
EAST AND WEST POOL
OAK PARK, IL 60302

LEI PROJECT NO. 21210579:000

JULY 19, 2021

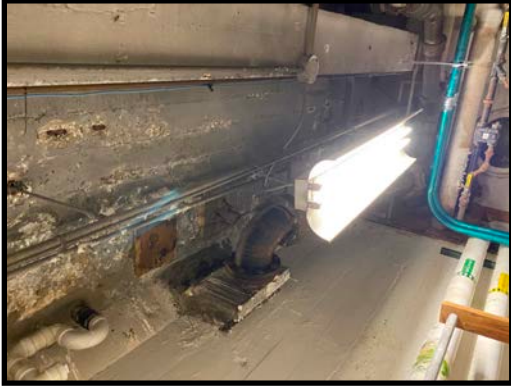
03

The pool deck framing consists of concrete beams and pan joists on the south, east and north sides. The deck on the west side of the pool is a one-way slab. On three sides of the pool, south, north and west, the floor deck concrete framing had undergone significant repair work after the time of our observation in 2013. The previous repair work appears to be in good condition, but as stated in our last report, there are still a few areas of spalled concrete and exposed rebar [Photos 1&2]. At a few locations, such as the northwest corner of the pool, exposed and corroded reinforcement is visible in areas previously patched, indicating that some of the patch material has spalled. This was noted in our previous report and the condition appears nearly the same. [Photo 3].

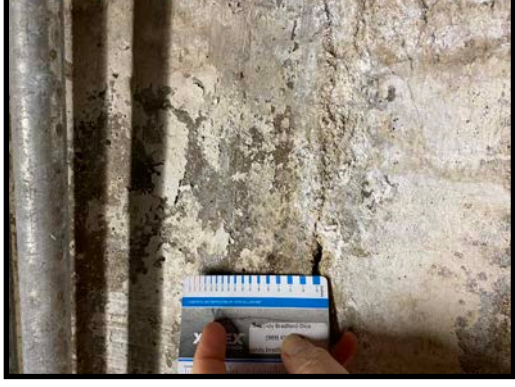
10

The walls of the east pool were primarily dry with a few areas of water seepage, although there were numerous stains indicating previous water leakage [Photos 4,5,6,7,8, & 9] Many of these stains were present at the time of our last observation, but it is likely that some have developed in the last seven years. As noted in our last report, some cracks in the walls of the pool have been filled with an injected epoxy. Also noted in our last report, some cracks have not been repaired and the concrete is delaminating and deteriorating. [Photos 10-15] Some seepage stains appear that they may be at concrete joints between separate concrete pours when the pool was first constructed. [Photos 16-19].

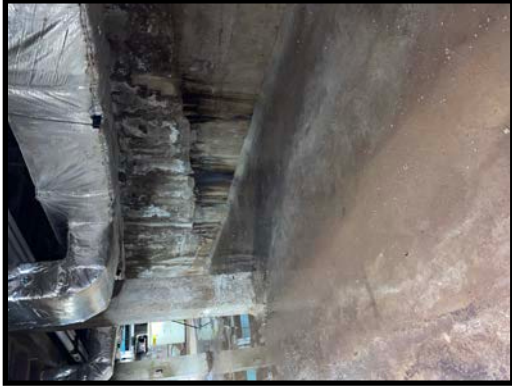
39

The walls of the west pool each had several areas of water seeping through cracks in the walls or at joints of pipes penetrating the wall at the time of our observation [Photos 33-38]. The east wall had the most significant seepage as well as stains from seepage, some of which were very dark rust stains. Most of the areas with dark rust stains continued to seep water during our visit [Photos 39-42] There were large areas of standing water on the floor at the time of our observation [Photos 43-44] At numerous locations along the walls, there is notable efflorescence. [Photo 45]. As previously noted, the south end of the east wall has an outward bow (with outward being away from the water side); however, it could not be determined if the degree of bow has increased since this characteristic was first observed in 2013.
