#720 12/1/9
RFP Fox Hill Tower
FILE
EXISTING CONDITION SURVEY
&
SCOPE OF PROPOSED RESTORATION WORK

FOR
MEMORIAL TOWER AT FOX HILL
VERNON, CT

October 9, 2003

HUBBARD & ASSOCIATES ARCHITECTS LLC
159 Hubbard Street, Middlefield, Ct 06455

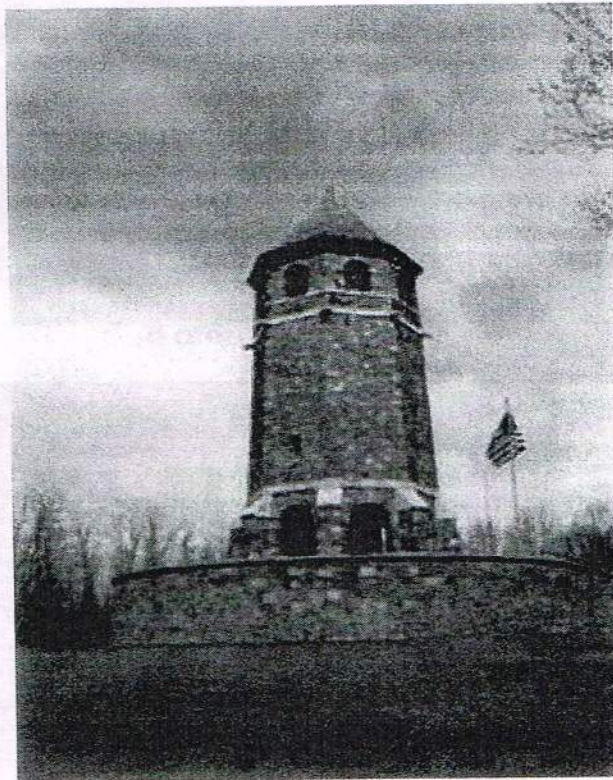
Photo A

The walls of the Tower and the walls around the Promenade and Walk are made of the "jewel building stones" as described in the Introduction. The Tower has four floors in the interior and is approximately 60 feet tall measured from the first floor to the apex of the roof. At the

fourth, and highest, level is an Observation Room. The first level is comprised of inner octagonal stone walls set in from outer octagonal stone walls with arched openings that support the second to fourth floors of the Tower walls (See Photos B, D, E, and F below). As such, a portion of the floor extends past the inner walls and connects to the outer walls and is exposed to the exterior (See section below on Floor/Ceiling Construction). There are stone buttresses at the eight intersections of the walls at the first level. The buttresses have granite capstones and end in height at the second floor, which is ringed with a band of granite trim (See Photos A above and B below). There is extensive efflorescence at the buttresses and arches, which have led to heavy salt deposits at the underside of the arches (See Photos B, C and D below).

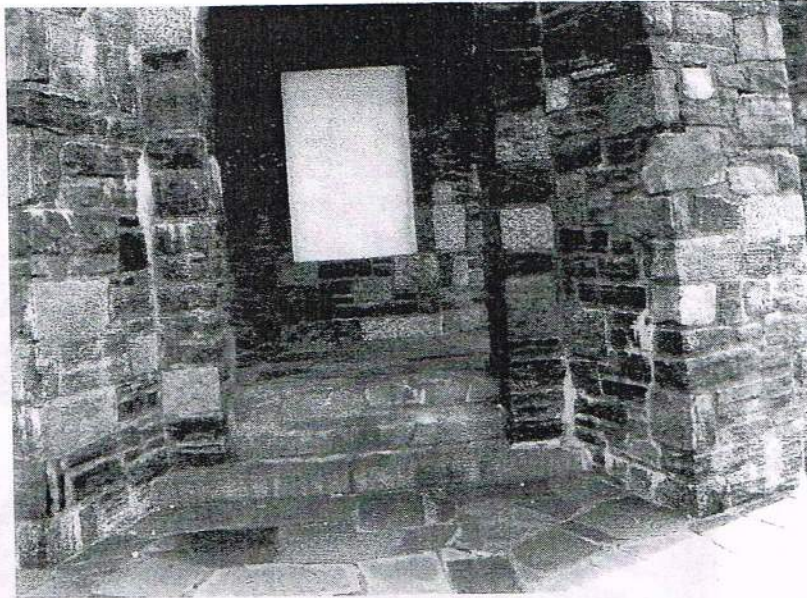
Photo D

There are granite steps below each arched opening that lead from the Promenade around the Tower to an octagonal flagstone walk between the inner and outer Tower walls. The steps are 5 foot wide at the arch and are comprised of three risers at approximately 6 inches and three treads at 12 inches. There are cracks in the steps and little mounds of salt deposits here and there due to water dripping from the arches above (See Photos D and E below). The salt deposits should be removed from the arches and steps. The mortar joints at the arches should be raked and re-pointed with mortar to match the original mortar. The cracks in the steps should be repaired with an epoxy injection or replaced. There are no railings at these steps as required by Code.

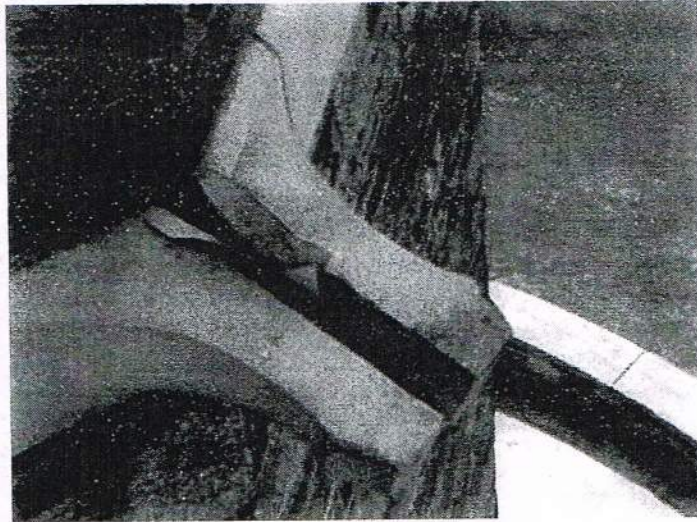
There are granite bands circling the Tower in three locations: one at the window sill level of the arched windows at the top of the Tower, one at the fourth floor incorporating granite gutters leading from through-wall drains at the interior side of the floor (See Photo I below), and one at the top of the buttresses (as previously described). The gutters don't appear to provide any purpose, since the fourth floor of the Tower is enclosed from the weather. The gutters are lined with lead-coated copper flashing which should be replaced.

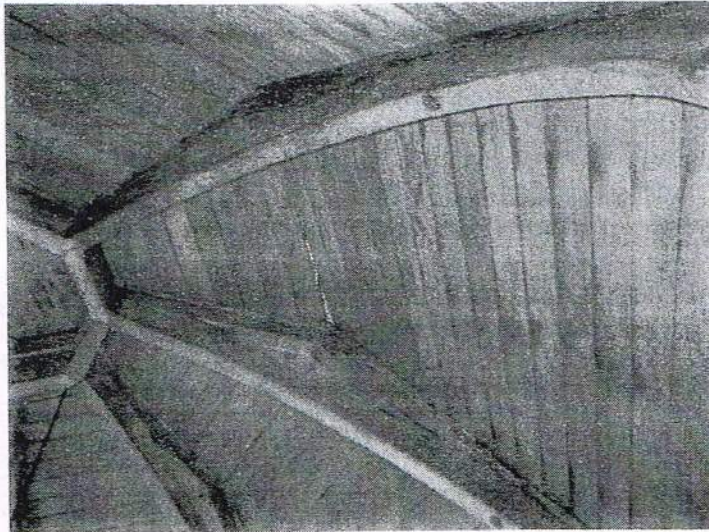
The ceiling of the roof is open to the Observation Room at the fourth floor of the Tower, and does not appear to be stained due to any obvious recent leaks. The roof structure is comprised of exposed oak decking supported by an exposed oak truss at each wall intersection that connects to an octagonal oak compression ring in the center of the Tower (See Photo P below). There is a flat panel hatch in the ring that leads to a low attic area in the peak of the roof. We were unable to access this attic area. The height of the underside of the compression ring is approximately 16 feet from the floor of the Observation Room. The ceiling is in good condition. There is one truss that has separated slightly from the decking, but doesn't appear to be creating any unsound conditions (See Photo Q below and the section on Existing Structural Conditions).

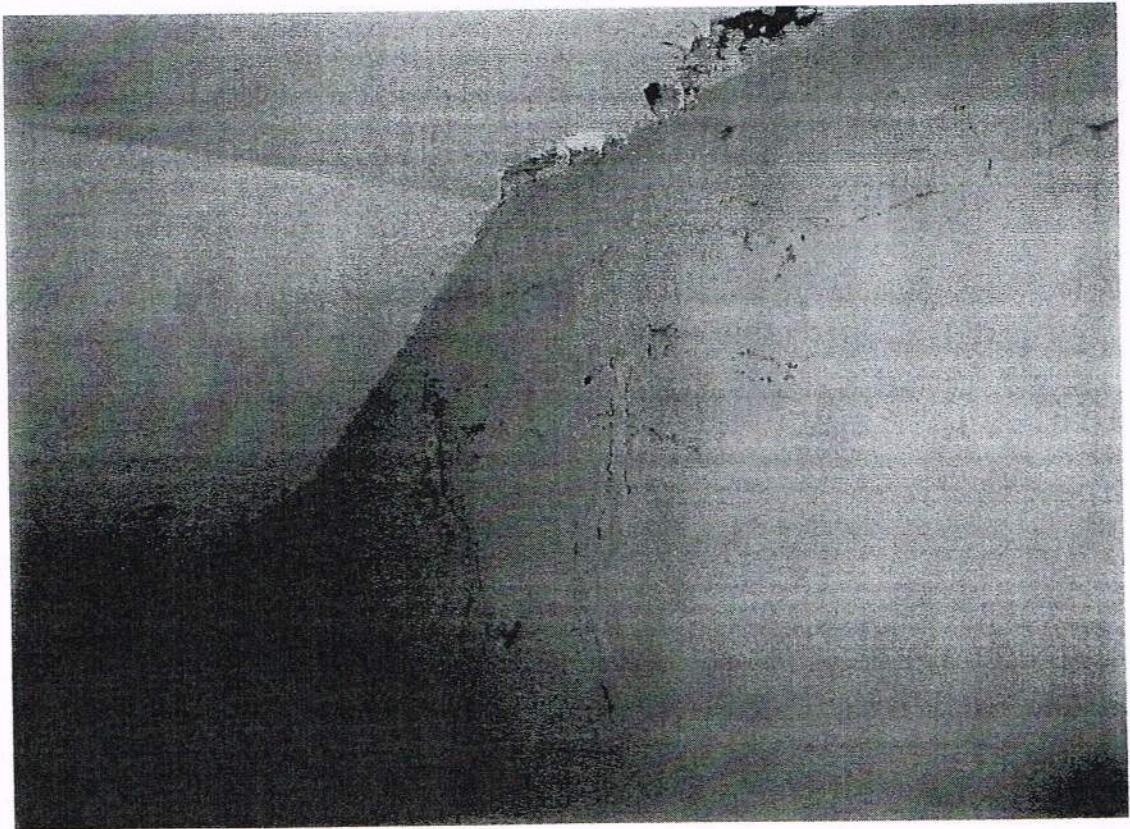
Photo Z

The other floor/ceiling assemblies are contained within the Tower walls. They are in fairly good condition, except for a few areas that need repair work at cracks and areas of spalling. There are rust stains in the ceiling in some areas, indicating that the steel reinforcing in the structure has been exposed to moisture. The floors are painted on the walking surfaces and there is a coating of what appears to be paint on the ceilings. These coatings on the floors/ceilings should be removed in order to better assess the condition of the concrete slabs for needed repair work. See Photos S – Z below for examples of the condition of the floors/ceilings.

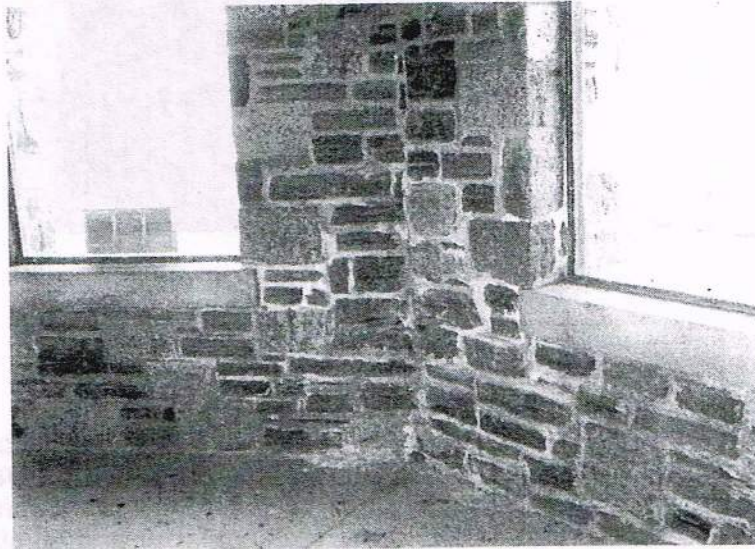
Photo BB

The interior side of the walls on the fourth floor consists of exposed stone, which is the same stone used on the exterior walls of the Tower walls, and is in good condition. The walls are approximately 18 – 20 inches thick at this floor from interior to exterior faces and 9'-6" high at the roof intersection. Each octagonal side measures approximately 7'-8" wide, with 18'-6" between opposite walls. The joints in these walls have been raked and re-pointed in the past with inappropriate mortar. Approximately 60% of the joints should be raked and re-pointed again with mortar to match the original mortar as described above for the exterior side of the Tower walls. There is a fair amount of efflorescence on these walls that should be removed. See Photos U above and BB below for examples of the fourth floor walls.

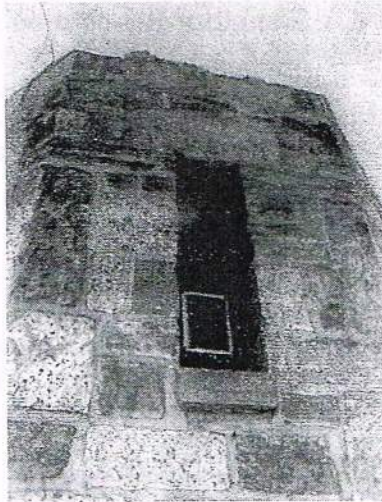
Photo DD

floors. See Photos X and Y above for the second and third floor windows and DD below for the first floor windows.

In general, the plexiglas is foggy and scratched with graffiti, the vents are coming loose or are missing, and water running off of the frames is staining the building. All windows should be removed and replaced with new with painted metal frames (which could match the aged patina of the existing bronze if desired). The glazing should be changed to safety glass to provide a safe view out of the windows. New metal vents can be installed instead of windows in the narrow windows in the lower levels for air intake and also at the bottom of the Observation Room windows for air discharge. This ventilation system may be sufficient to remove moisture from inside the Tower as described in the section regarding Mechanical systems below.

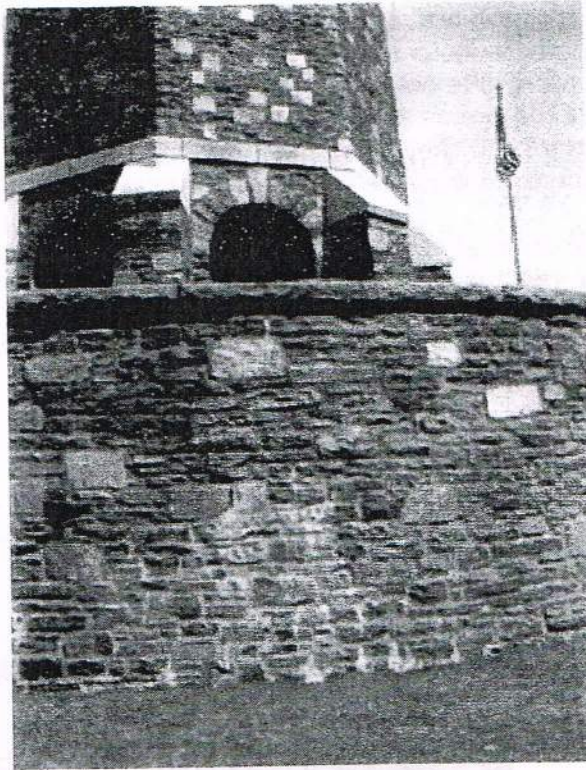
Photo HH

Surrounding the Tower is a semi-circular Promenade with a stone wall constructed of the same stones as the Tower. The wall is in good shape, but has the same problems as the exterior walls of the Tower: efflorescence, stains, loose or missing mortar in joints, moss growing in the mortar joints, poorly installed re-pointing work, etc. This wall should be cleaned and repaired/re-pointed as recommended for the Tower walls (See Photos FF and HH).

The top of the wall surrounding the Promenade is 37 inches high off the flagstone walking surface at the interior side and about 8'-9" above grade on the exterior side. This wall doesn't conform to code as a guardrail. The wall is approximately 24 inches thick at the top, and angles out slightly down to grade on the exterior side (See Photos FF, HH and II).

Rough cut granite stones were used to cap the walls surrounding the Tower at the Promenade. These stones are in excellent condition and are approximately 29 inches wide by 6'-6" long by 6 inches thick. The joints between the capstones are in poor condition and have had sealant installed in them in the past. The joints should be cleaned, with the existing sealant, which appears to be a polyurethane sealant, removed. New backer rods and polyurethane sealant to match the color of the stone should be installed.

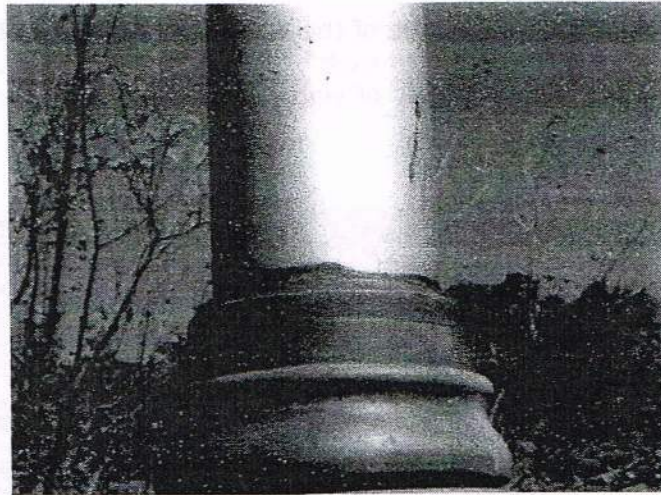
There is a flagpole on the granite plinth where the walls surrounding the Promenade and Walk intersect (See Photos II and NN below and Appendix G). The base of the flagpole has lead in the alloy of the bronze finish. The flagpoles are painted metal and rusting in some locations, especially at the bases (See Photo JJ below). The rust should be removed and the flagpoles should be painted.

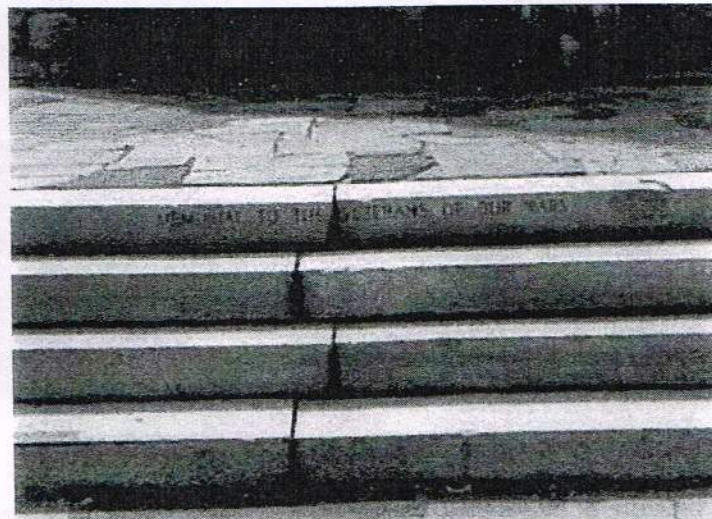
There are granite stairs leading down from the Walk to the Promenade. They consist of four risers at approximately 6 inches each with 12 inch treads. The width of the stairs is approximately 27 feet. There are no railings at these stairs, which should be installed. These stairs are in relatively good shape, with some cleaning, re-setting of stones, joint re-pointing and cleaning work required. See Photo II above and Photo KK below. Chiseled into the top riser is "Memorial to the Veterans of our Wars".

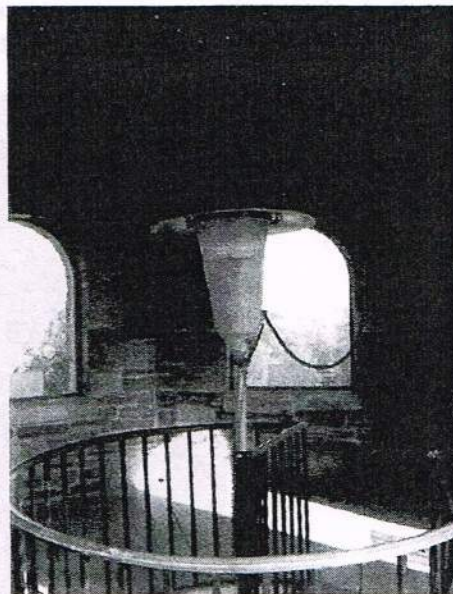
There is a conduit dangling down from the attic hatch to the beacon light. The purpose of this light is to light the Tower up at night. This light should be removed, and new lights located on the site around the Tower should be installed for this purpose (See Photo VV below for the light inside the Observation Room and Appendix C for Proposed Site Improvements). There is also a beacon light at the apex of the Tower roof that is used to light the Tower for air traffic (See Photo N above).

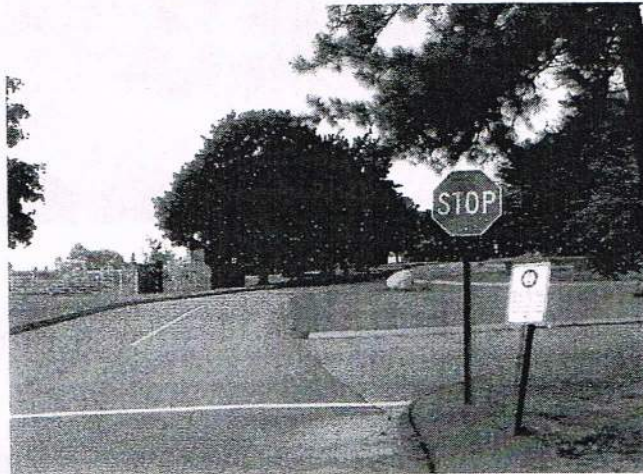
The Tower is reached by entering Henry Park. Once in the Park, there is a lack of signage to direct visitors to the Tower, and this should be remedied with the installation of new signs. For instance, when stopping at the intersection shown in Photo WW below, there is a small sign indicating the hours that the Tower is open, but not giving any directions as to how to find the Tower.

There should be signs directing visitors to the Tower at each intersection within Henry Park and better signage at the entrances to the Park.

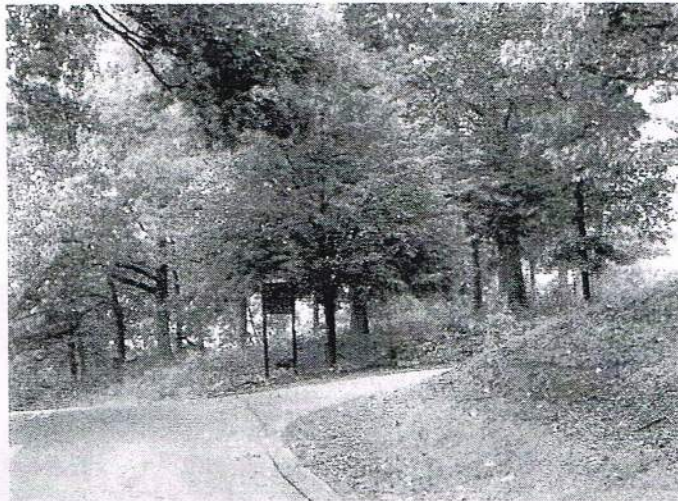
At the intersection shown in Photo XX above, there is a street sign for Tower Road, but no other signage to direct visitors to the Tower. Although the Tower is at the top of the hill behind this intersection, it is blocked from view by trees. At the intersection shown in Photo YY below, there is a sign for the Tower, but no information to tell you which way to go at this intersection to find the Tower.

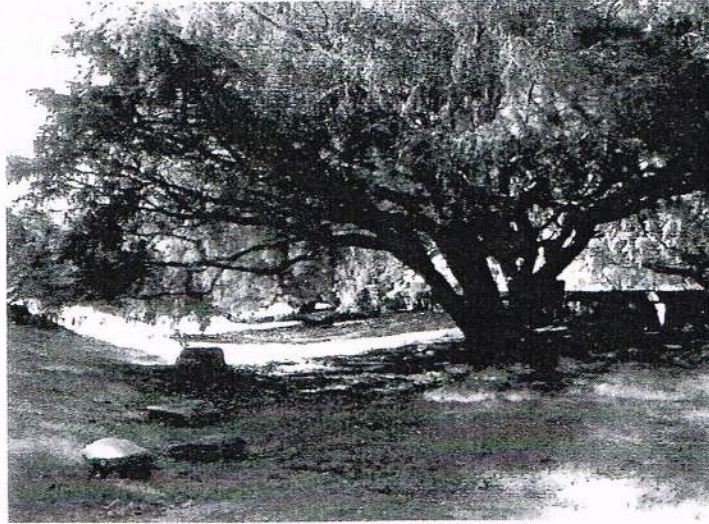
Photo AAA

There is a large expanse of lawn surrounding the Tower that contains several large oak, maple and hickory trees. There are weeping hemlock, apple and crabapple trees lining the Walk. The hemlocks are original plantings but have become too big and are subject to blight at any time. Only four hemlocks remain: one at the north side of the Walk and three to the south side. As such, there is a patchwork of trees lining the Walk, which should be removed and replaced with new weeping hemlocks or blight-resistant flowering trees (See Photos LL above and AAA below for the trees at the Walk).
