### FACILITY ASSESSMENT

# Central Intermediate School

## MAY 15, 2017

#### 1.1 CENTRAL INTERMEDIATE SCHOOL

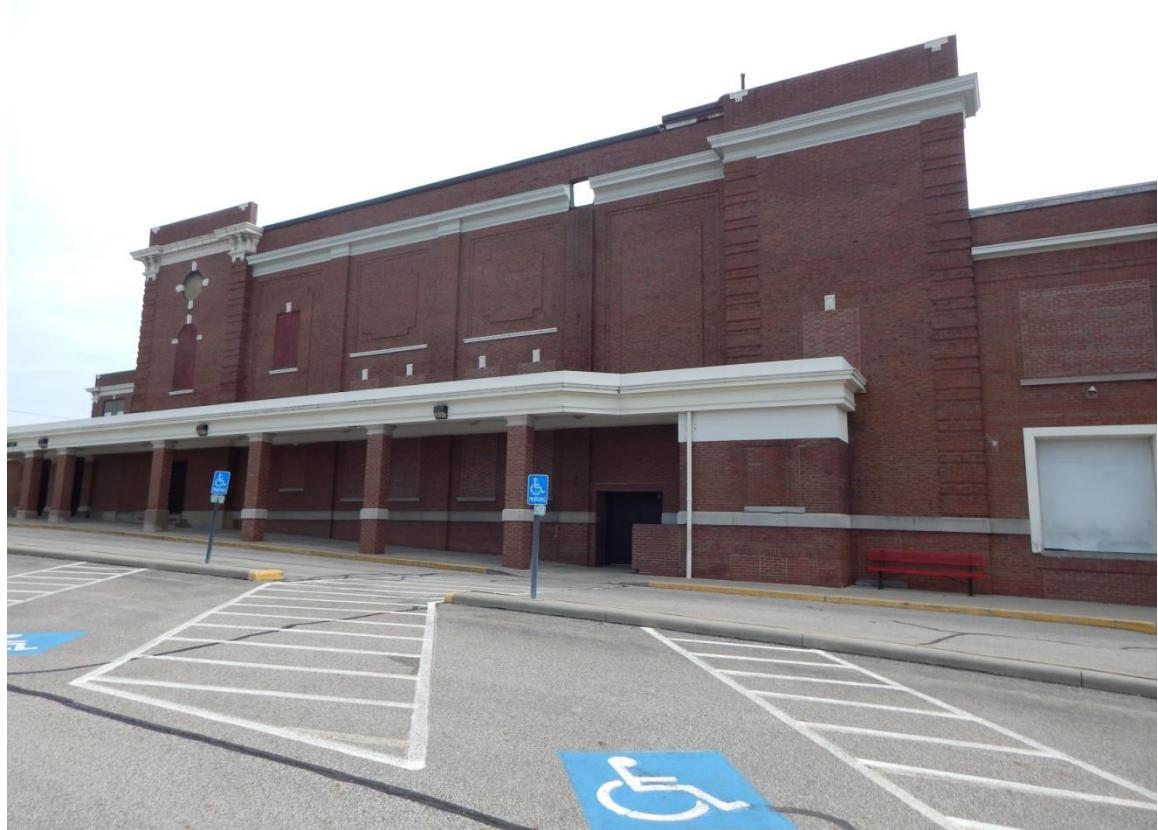
Figure 2-1

*Description:* The facility is equipped with two primary parking areas with designated accessible parking spaces which are provided with a pathway to the main entries from the East and West lots. The total quantity of reserved parking spaces is adequate. A portion of the spaces are lacking appropriate signage. There are no accessible loading and unloading zones. Walkways and island crossings are not equipped with detectable warnings at all required areas. (Fig. 2-1)

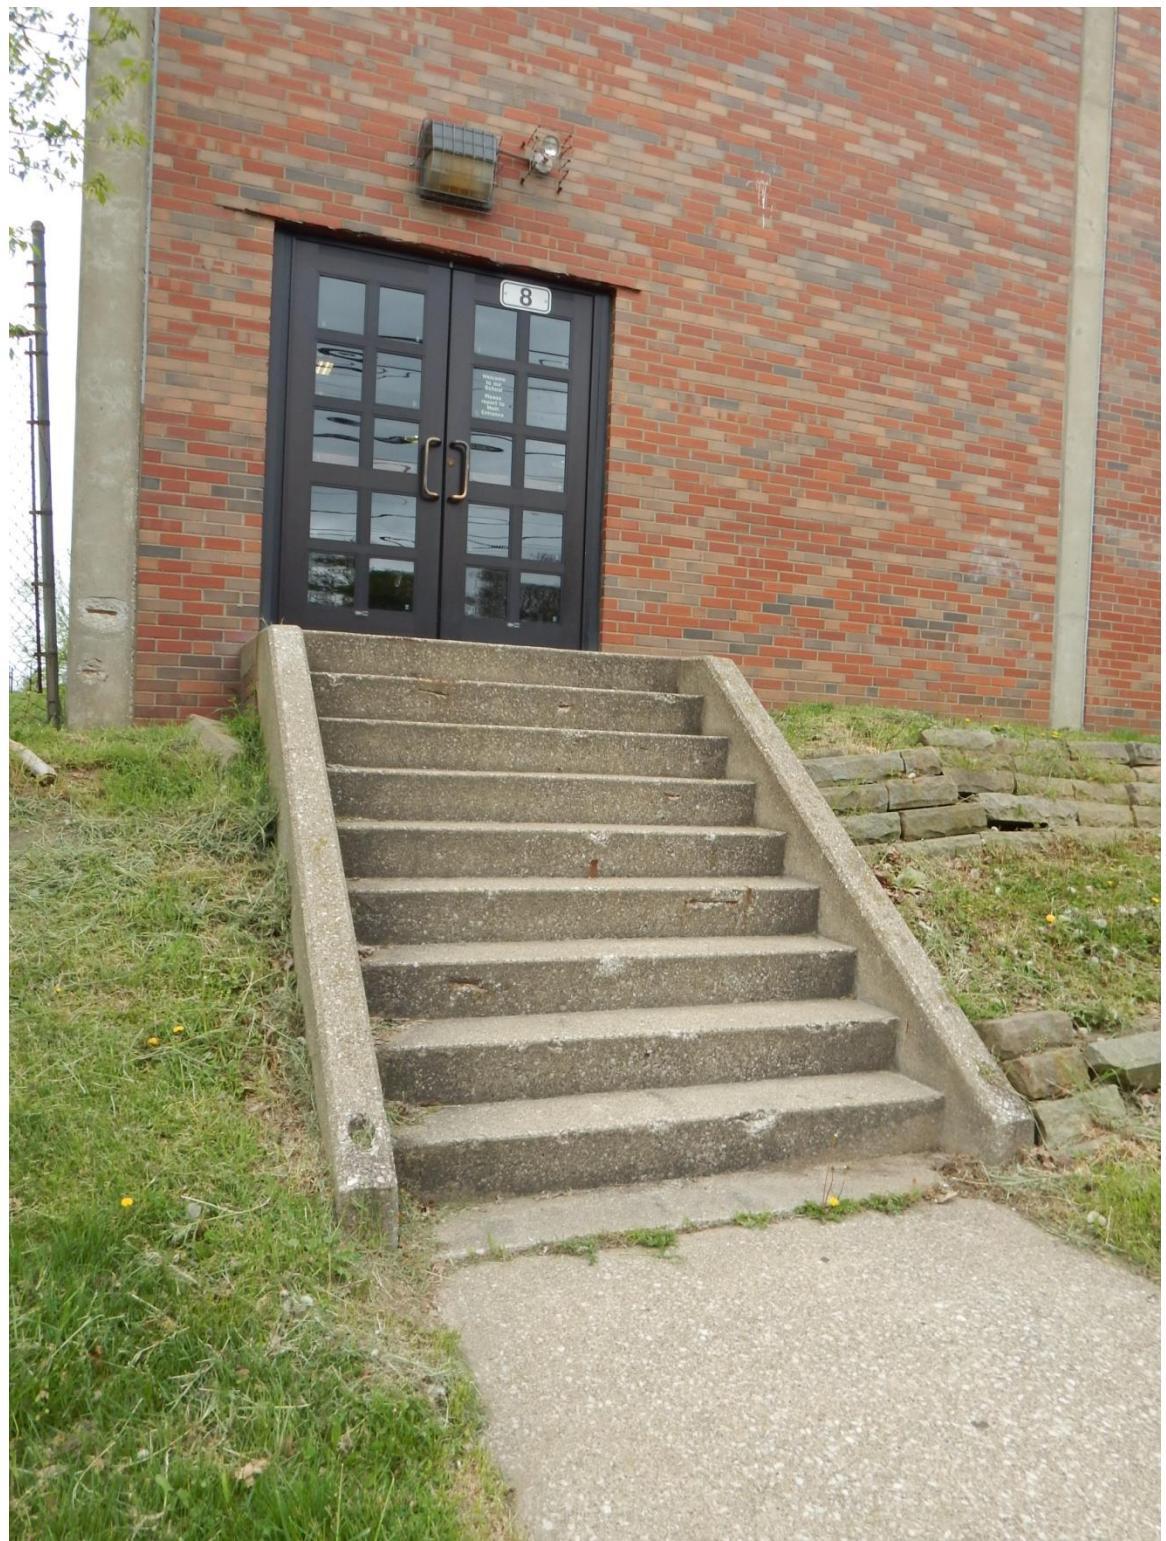
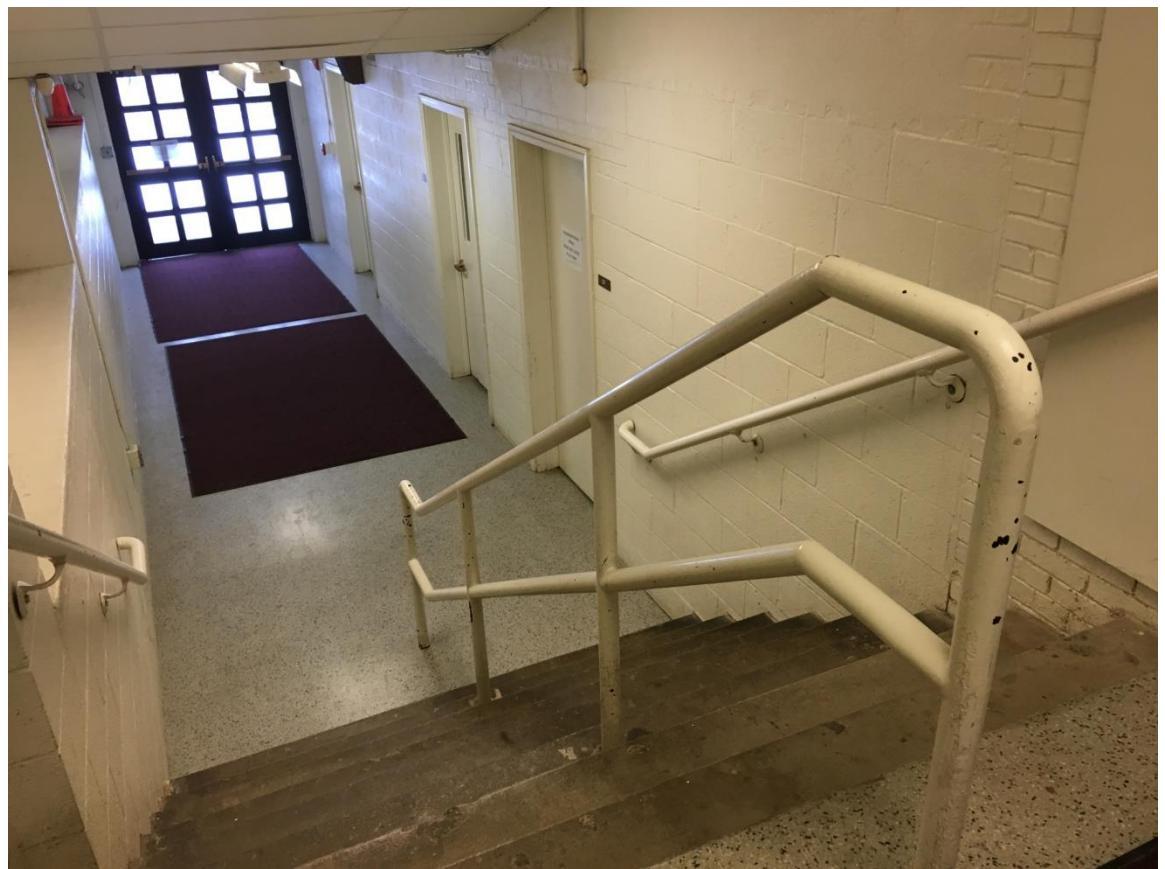
Figure 2-7

The facility is equipped with three elevators which provide access to the varying floor levels within the complex. Elev 1 off the Auditorium lobby provides access to the Auditorium balcony and 1907 and 1927 2<sup>nd</sup> and 3<sup>rd</sup> floor levels. Elev 2, adjacent to the Auditorium stage, provides access for the stage level and the lower level of the 1927 Auditorium addition. Elev 3, located along the main corridor of the 1999 Addition provides access to the lower level and main floor of the 1999 Addition. Corridors are interconnected and an accessible path of travel is provided through the majority of the complex. The Main entry lobby of the 1907 Addition is only accessible to the main level of the building by stairs. (Fig. 2-2) Access to the intermediate level of the Administrative Office is provided by ramp but, the door accessing the secretarial area from the ramp is not equipped with adequate maneuvering clearances. (Fig. 2-3, 2-4) An accessible path of travel is provided to the Gymnasium of the 1973 Addition through a retro-fitted corridor through the original locker rooms. This access point appears to be locked, hindering free access to the area. (Fig. 2-5, 2-6) The main access to the lower level Gymnasium is provided by stair from the first floor. Several entry/exits are not accessible due to level change and are not equipped with directional signage. (Fig. 2-7, 2-8)

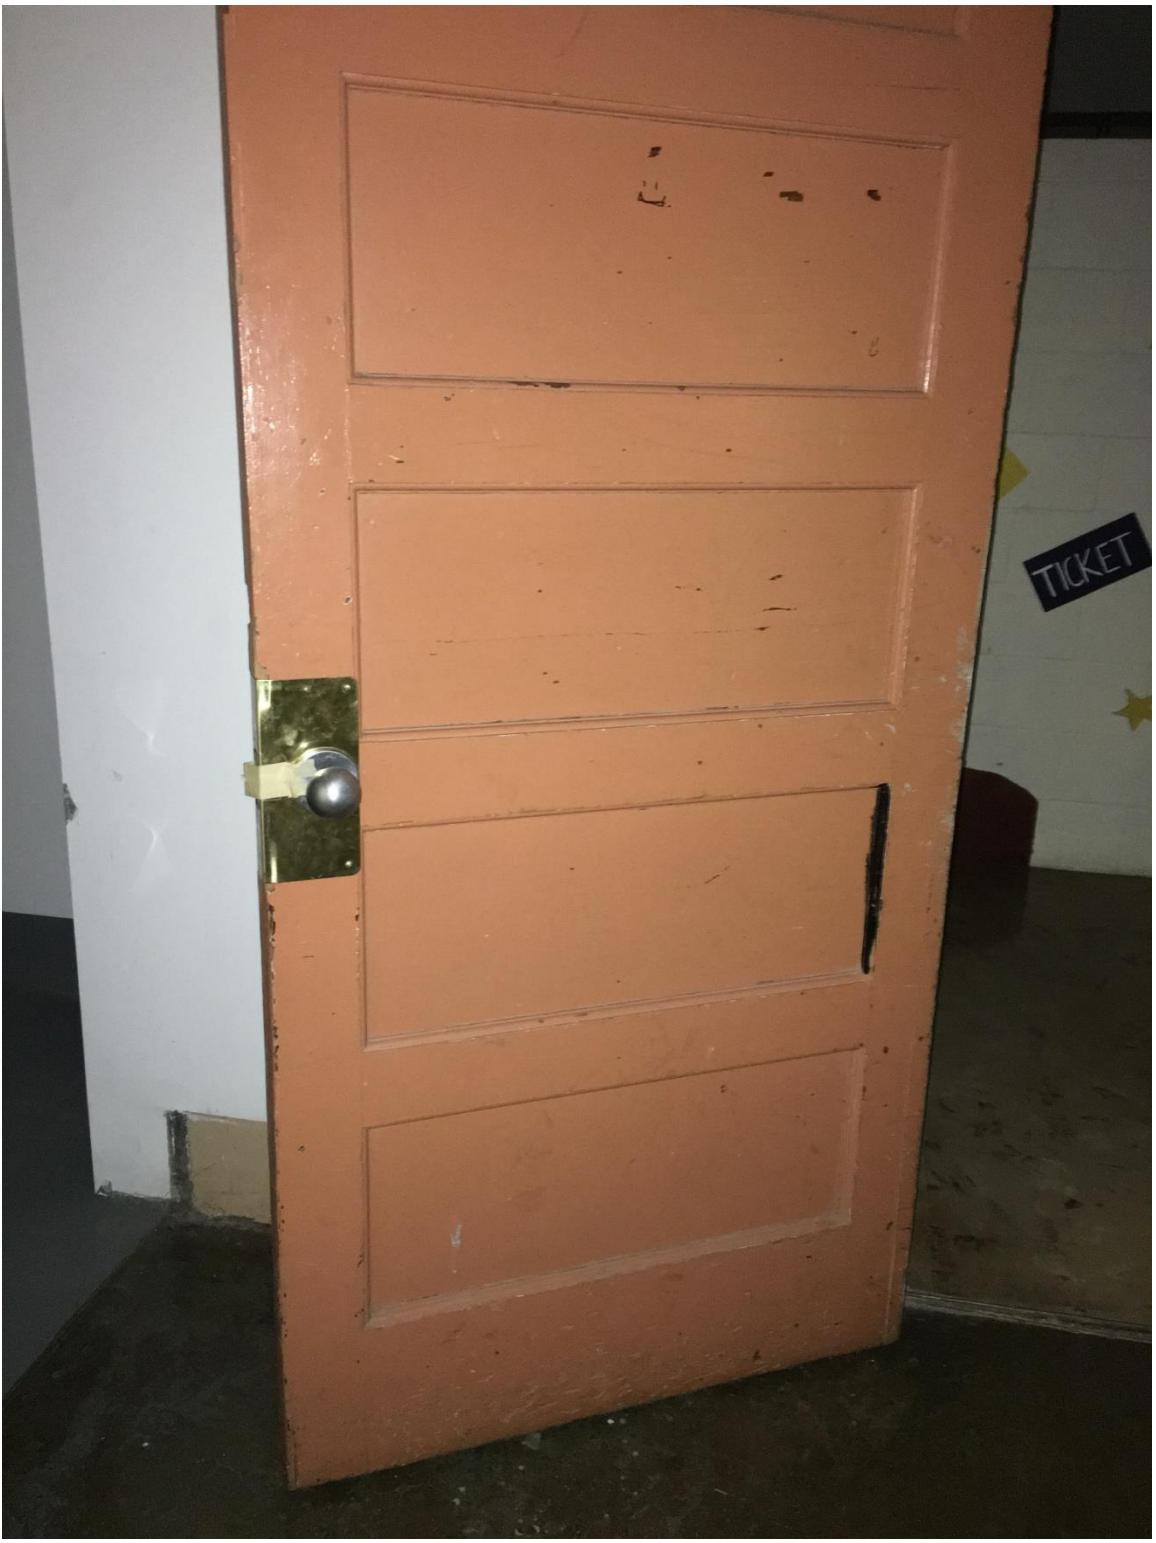
Figure 2-9

The majority of interior doors throughout the complex are equipped with lever type hardware. Accessible hardware is not provided at a few door locations. These typically include all doors at the lower level spaces below the Auditorium stage, miscellaneous closets or storage rooms and some faculty areas. (Fig. 2-9, 2-10) Entrances to most of the educational spaces and office areas are provided with the required minimum maneuvering clearances. A limited quantity of doors are not provided with adequate maneuvering floor clearance and some maneuvering clearance areas have been obstructed by furnishings or moveable equipment. (Fig. 2-11)

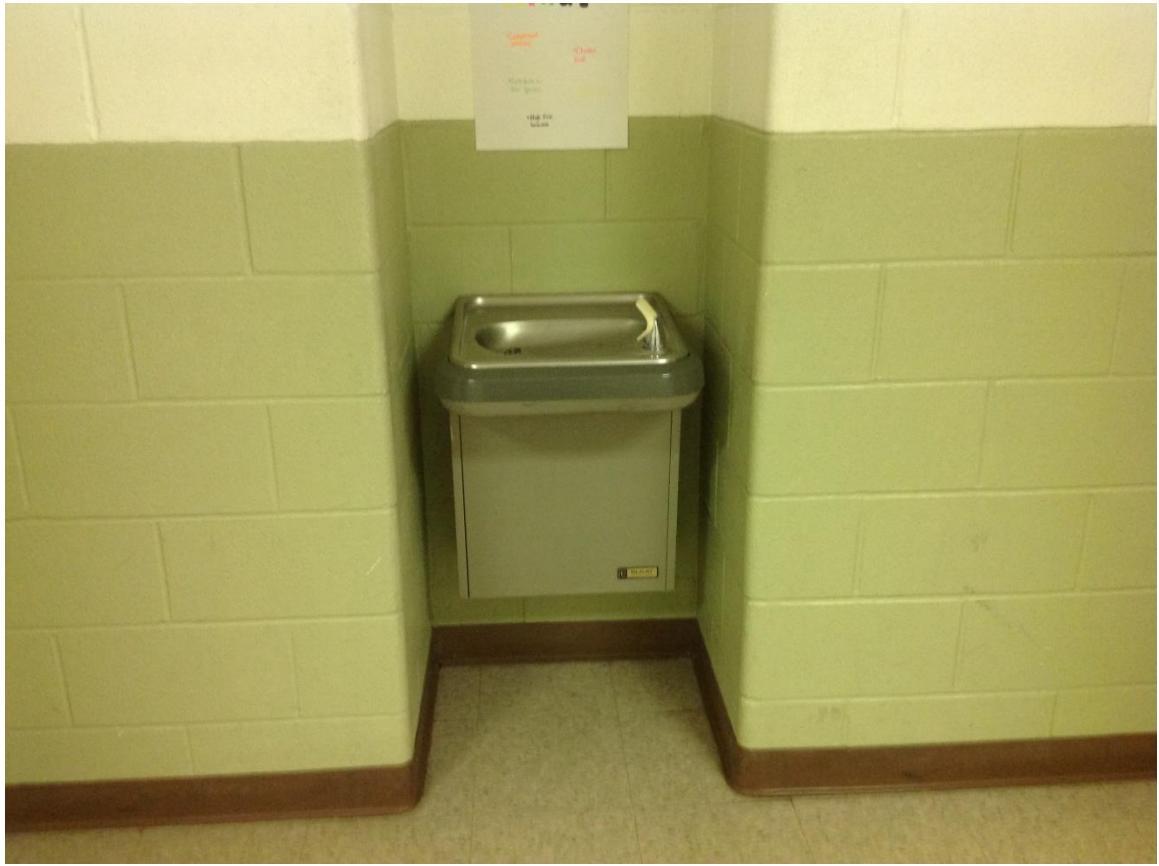
Figure 2-18

The large group toilet facilities and clinic toilet in the 1907 Building were renovated to provide accessible accommodations. However, the clinic toilet is lacking grab bars and a portion of accessories are located outside reach ranges. The paper towel dispensers protrude more than 4'' into the path of travel. (Fig. 2-12, 2-13, 2-14) The majority of the remaining toilet facilities and showers throughout the complex are not accessible. There are several attempts to provide accessible facilities however, modifications are incomplete or are an inappropriate application of the ADA/ANSI Guidelines. Most of the restrooms do not have required clearances at toilet fixtures. A portion of the faculty toilets have a raised threshold at the door assembly with an outwardly door swing across the riser. (Fig. 2-15, 2-16, 2-17) The complex is provided with dual height accessible drinking fountains in some areas. There are several accessible drinking fountains mounted for wheel chair access without dual accommodation for required standing access and a portion of drinking fountains are not accessible due to installation in undersized recesses. (Fig. 2-18)

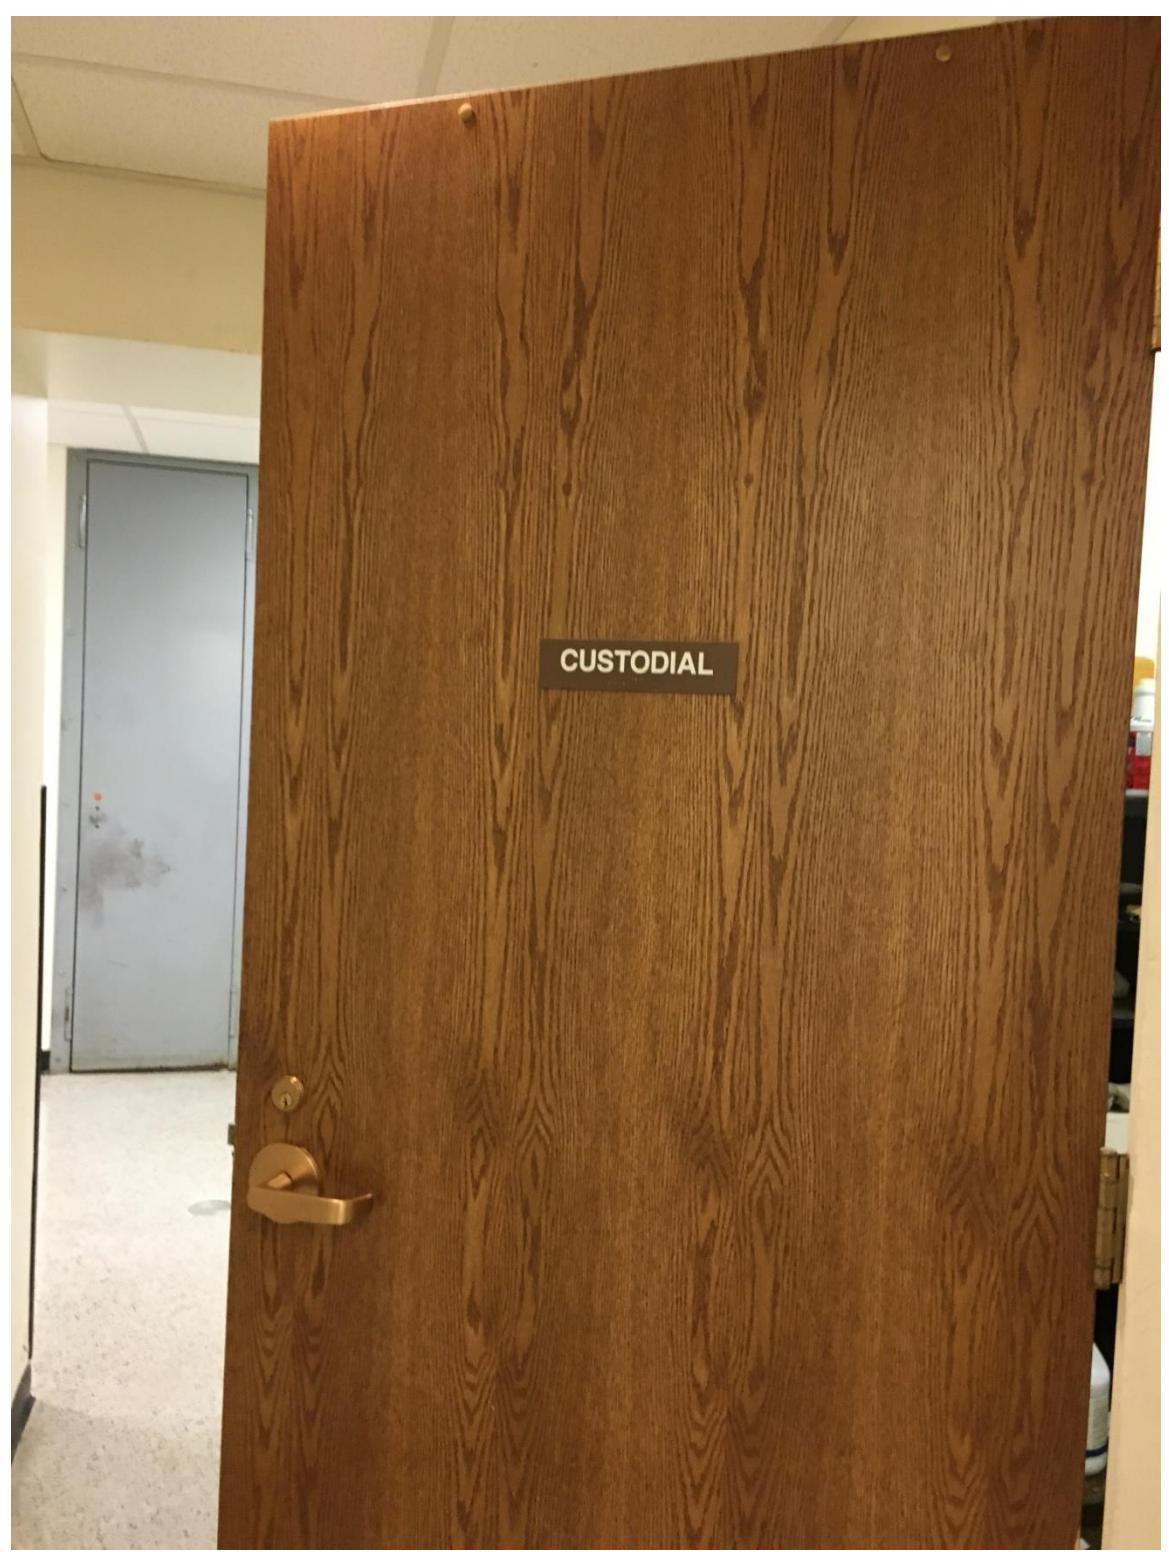
Figure 2-19

Accessible signage is provided throughout the complex but a few intermittent locations are mounted outside specified height limits or installed on active door leafs. (Fig. 2-19)

Replace non-conforming signage and upgrade accessible signage throughout the complex in conjunction with extensive renovation of the structure.

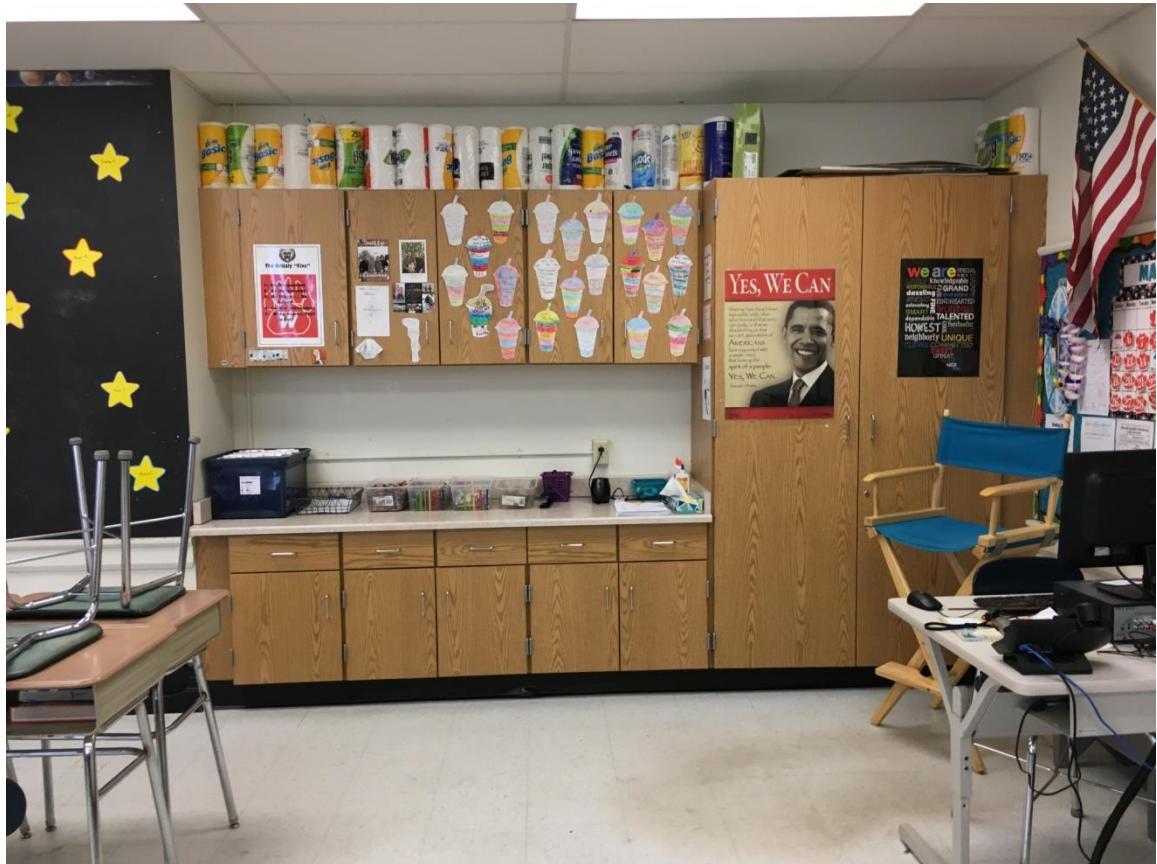
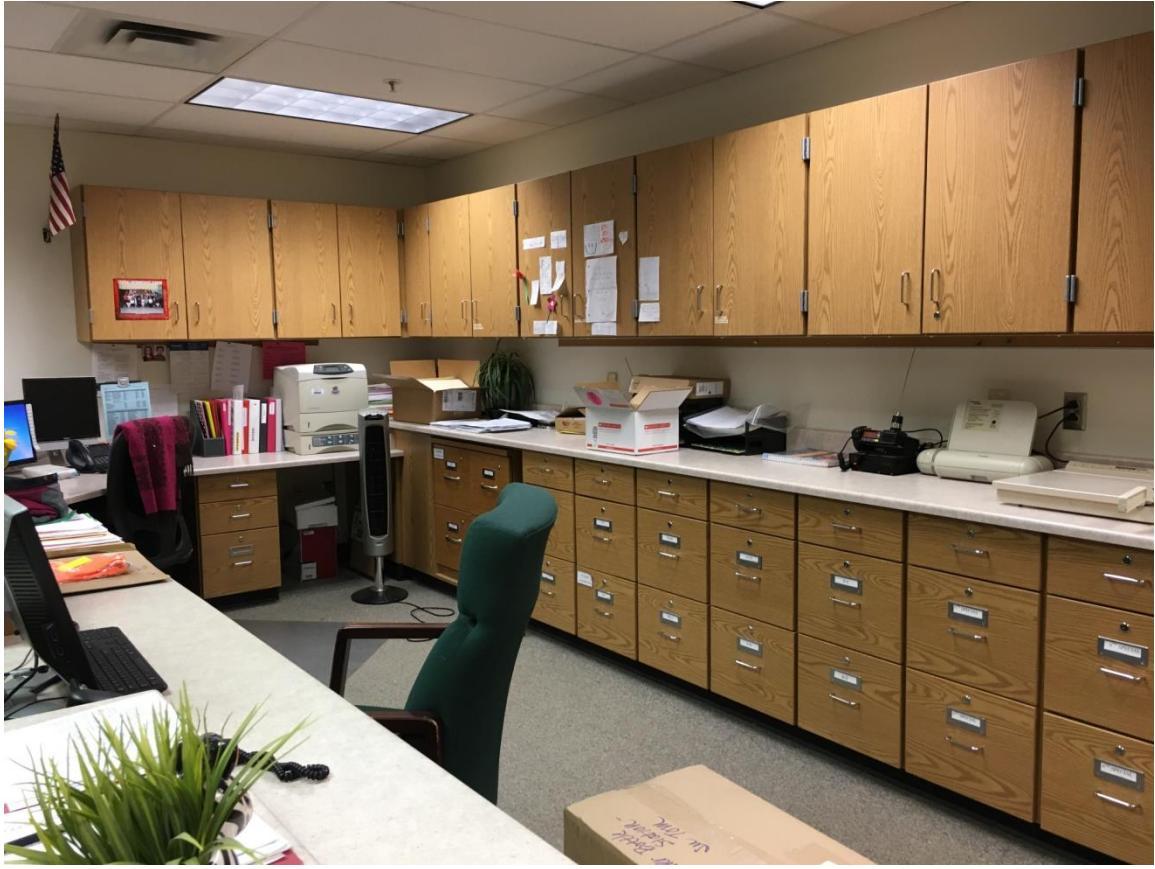
Figure 2-20

The casework at classrooms does not provide knee clearance for front approach access at sinks. Base casework, counters and sinks are typically installed at an elevation of 30" above finish floor in the classroom spaces. This elevation is an acceptable range for children age 6-12 but is below the standard accessible height limitation of 34" for sink access for adults. The casework at staff and administrative spaces do not provide handicapped accessibility or accessible work stations. Base casework, counters and sinks in these areas are installed at an elevation of 36" above finish floor and exceed the accessible height limitation of 34" for sink access and obstructed reach. (Fig. 2-20, 2-21)

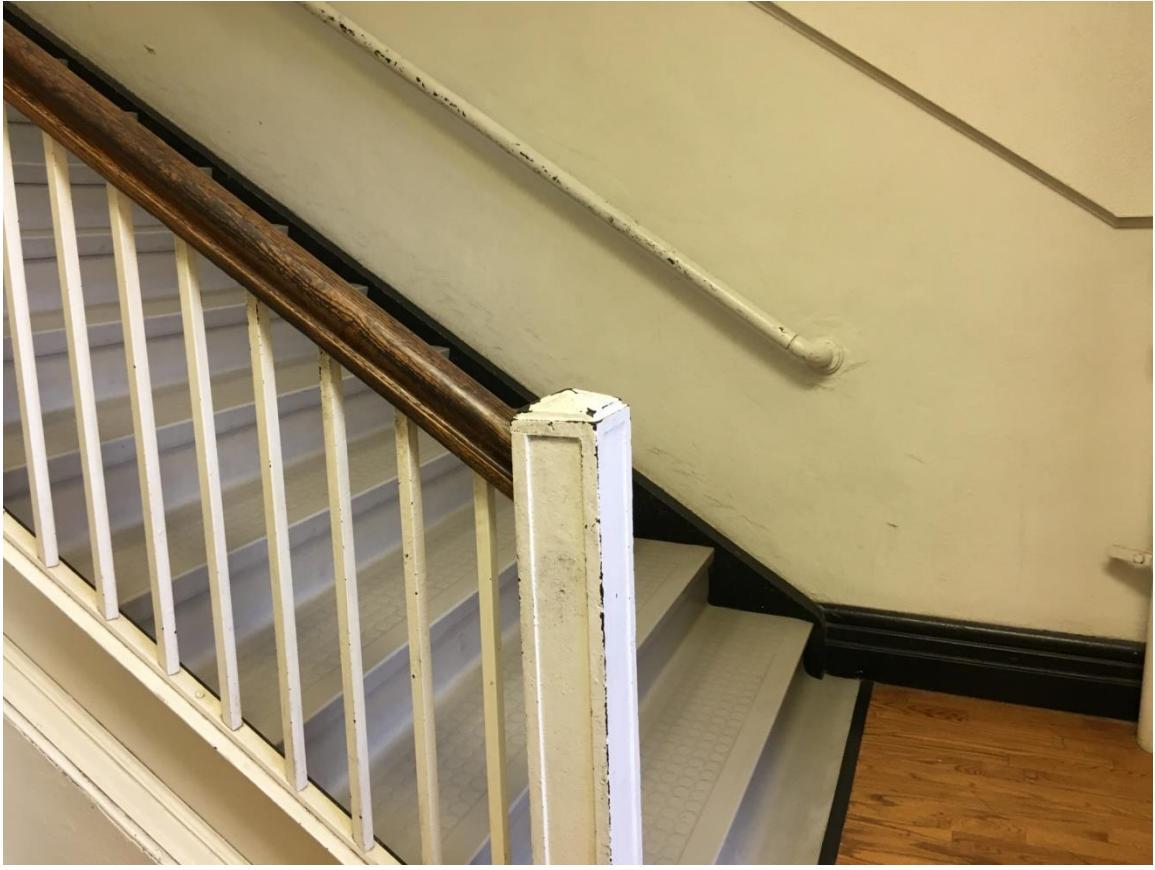
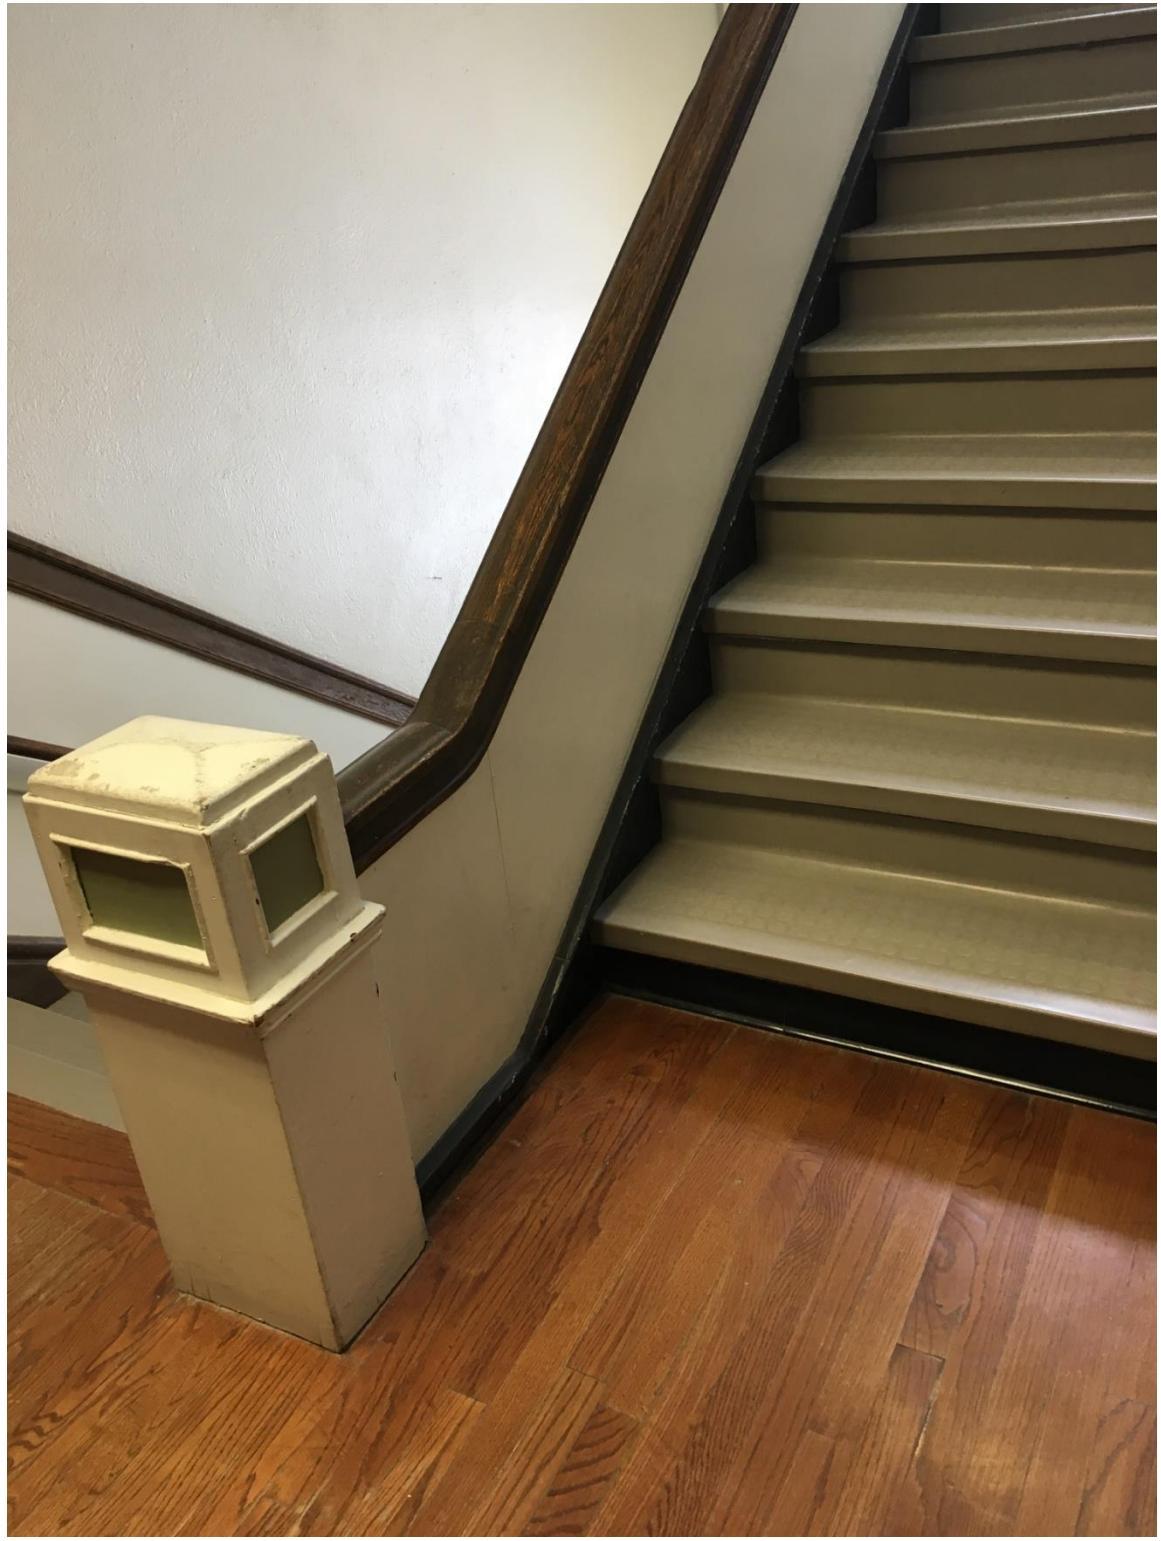
Figure 2-22

The existing handrails at the majority of the stair assemblies do not conform to profile requirements and are not equipped with handrail extensions. The handrail/guardrail assemblies at the 1907 Building are dangerously low and violate current code provisions. (Fig. 2-22, 2-23)

Provide accessible handrails at non-conforming stair assemblies.

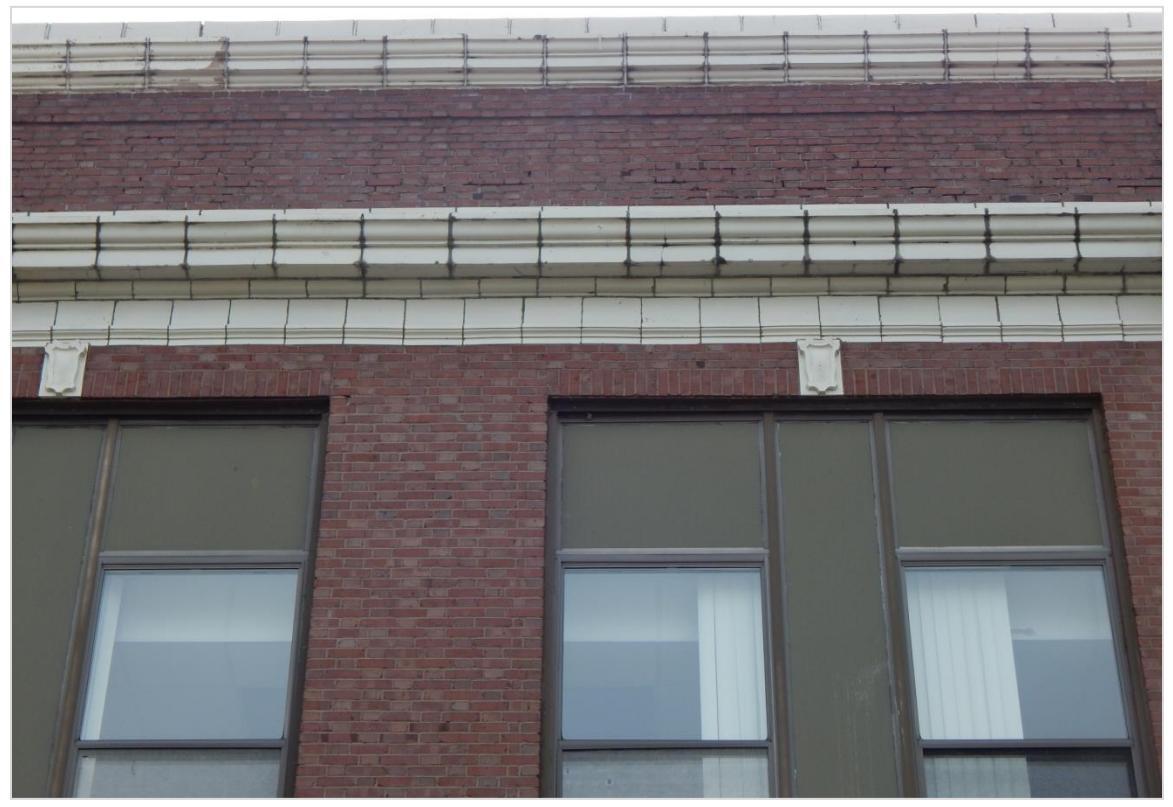
Figure 3-2

There are moderate amount of mortar joints that are missing or cracked. (Figs. 3-1, 3-2, 3-3)

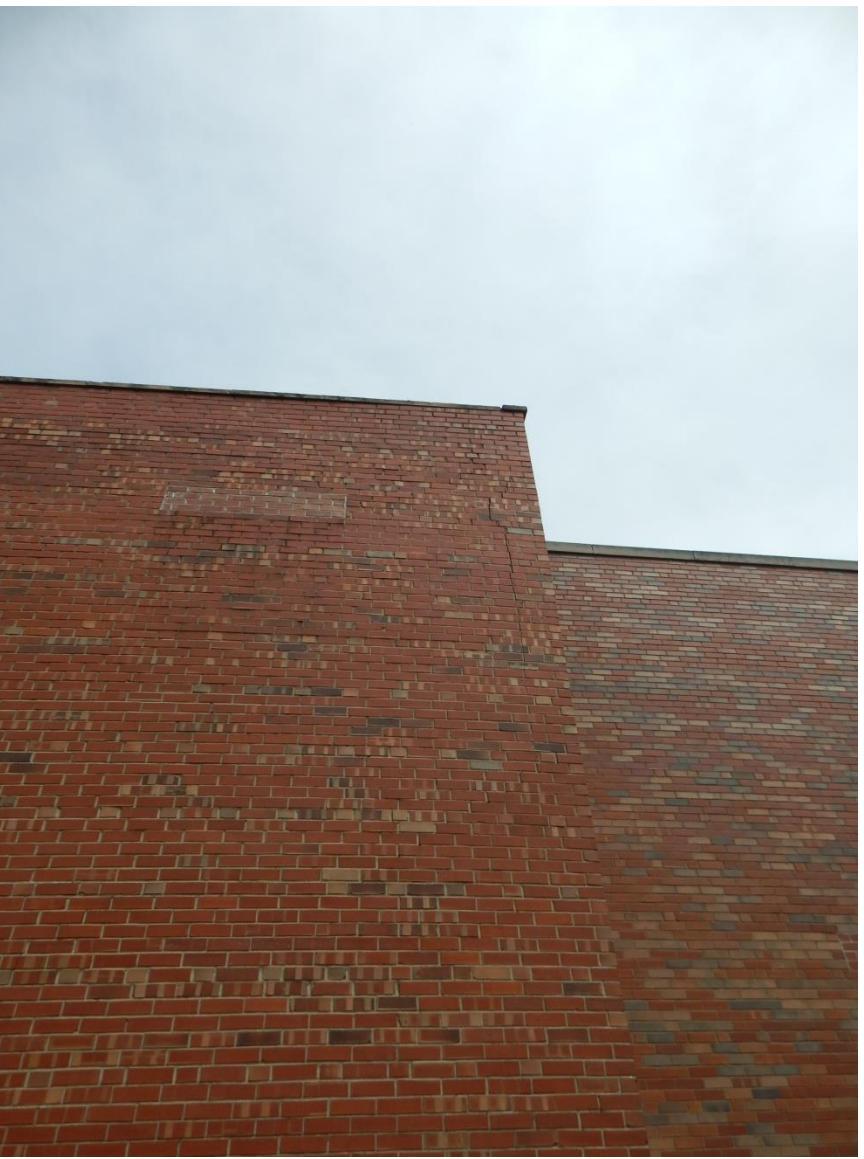
Figure 3-4

There are a few areas where there is movement in the brick. (Figs. 3-4, 3-5, 3-6)

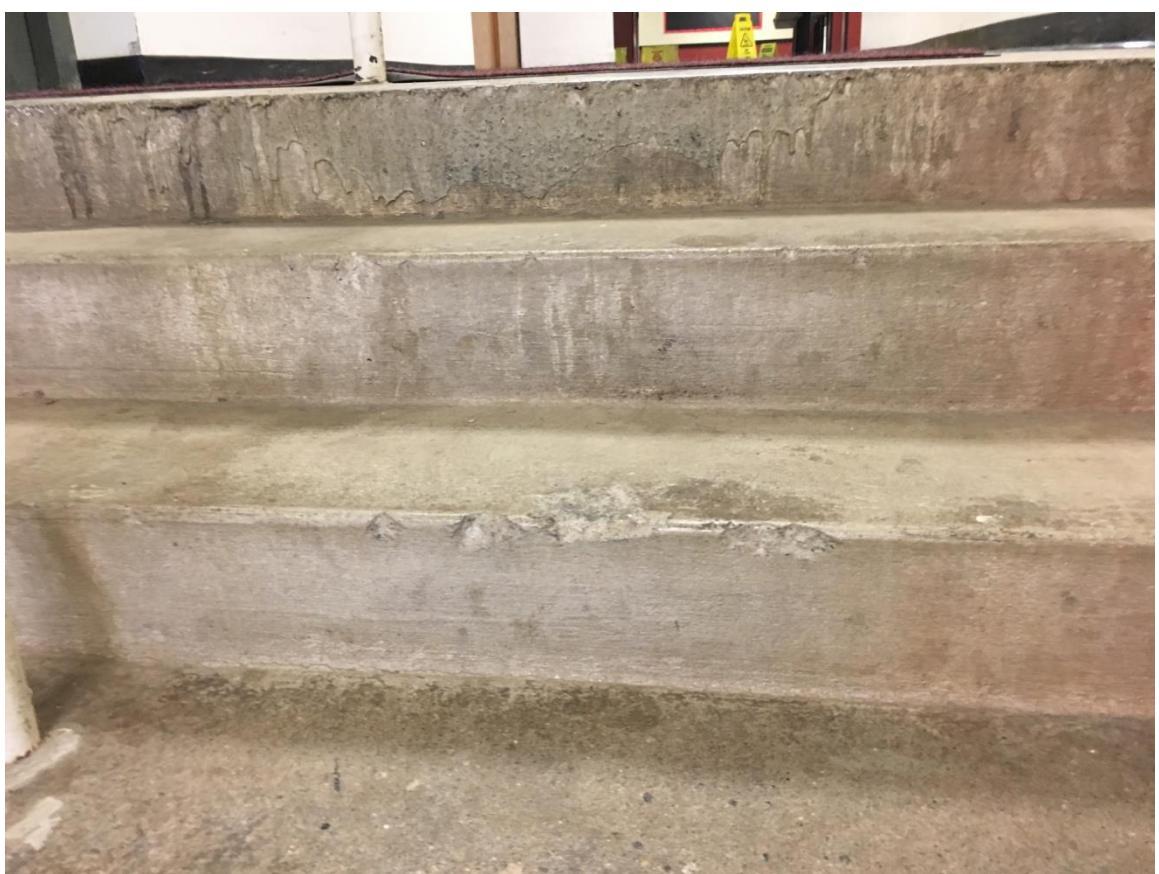
Figure 5-14

Resilient base was updated with flooring renovations throughout the complex and is generally in satisfactory condition with limited damaged at intermittent locations. (Fig. 5-13) The majority of stair assemblies have rubber treads in satisfactory condition. The stairs accessing the lower level of the Auditorium Addition are bare concrete with intermittent damage. The concrete stairs accessing the mechanical area are in poor condition. (Fig. 5-14, 5-15) The mechanical area is unusually finished with vinyl flooring which is in very poor condition. (Fig. 5-16) The Gymnasium has wood athletic flooring which displays signs of wear. (Fig. 5-17)

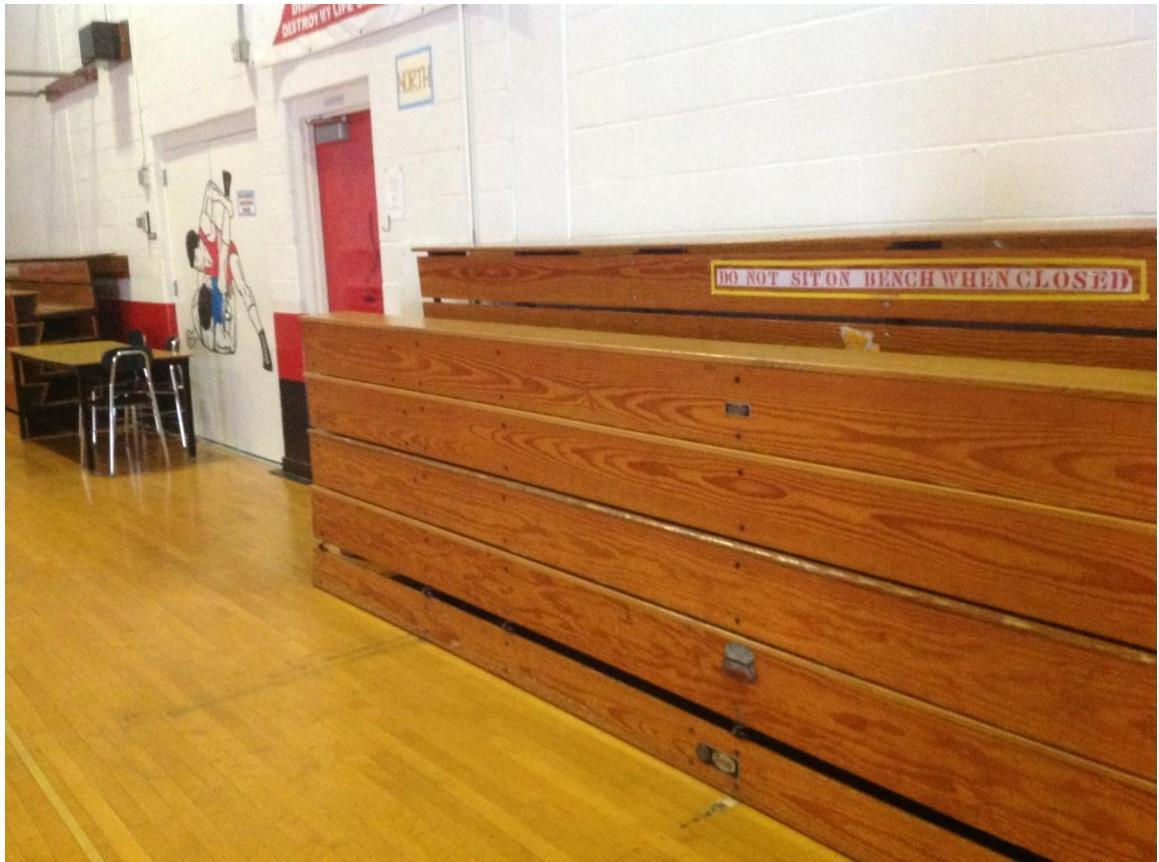
Figure 5-17

The bleachers at the 1973 Gymnasium are wood and are in poor condition. (Fig. 5-17)

*Recommendation:* Determine which pieces of kitchen equipment have exceeded or are approaching their life expectancy or not working properly or energy efficiently and replace. Over twenty years all will need replacement. Replace wood bleacher seating at the Gymnasium and include handicapped accessible seating provisions.

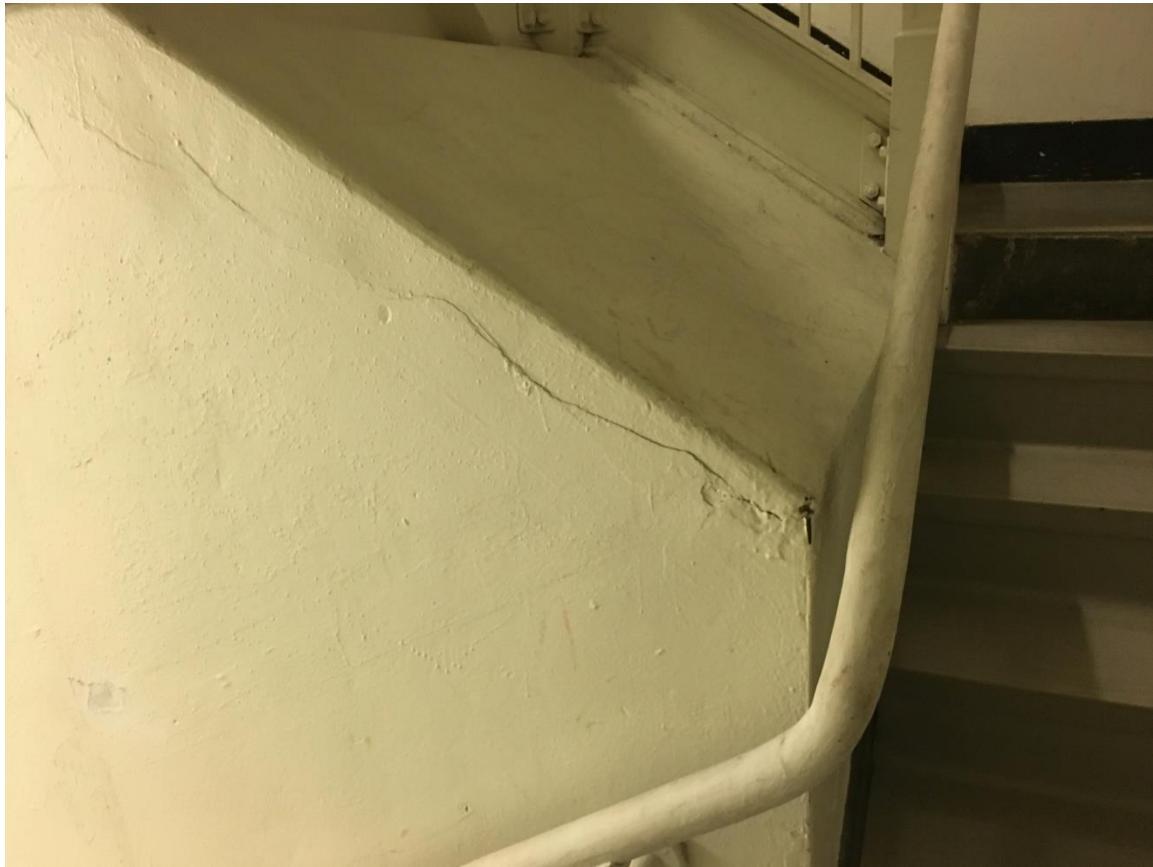
Figure 6-2

*Description:* The majority of interior wall surfaces consist of plaster, painted brick and concrete masonry units, glazed concrete masonry or gypsum board assemblies. The plaster wall finish at the 1907 and 1927 buildings are damaged in some areas. (Fig. 6-1, 6-2) The plaster surfaces at the lower level of the 1927 Auditorium addition are damaged in many areas and are in poor condition. The exterior masonry walls at this area also display evidence of moisture infiltration in some areas. (Fig. 6-3, 6-4) The concrete masonry walls of the gymnasium display evidence of movement and "stair stepped" cracking in multiple locations. (Fig. 6-5) There are a few cracks in the masonry and mortar joints in other areas of the complex, but the remaining walls are generally in good condition. (Fig. 6-6) The wall surfaces of the double volume corridor adjacent to Student Dining display evidence of water damage extending from the translucent panel skylight system within this space. (Fig. 6-7) The gypsum wall surfaces in high traffic areas display evidence of repeated repair. (Fig. 6-8) Unprotected wall corners and column enclosures have edge damage. (Fig. 6-9) There are intermittent locations of minor damage throughout all areas of the complex requiring repair. (Fig. 6-10)

The plaster surfaces throughout the 1907 and 1927 are reported to contain asbestos and will require complete replacement with abatement work.

*Recommendation:* Repair all cracks in concrete, concrete block, and brick masonry, repair mortar joints and clean brick surfaces of efflorescence. Repair/replace all damaged surfaces at the lower level of the Auditorium addition. Repair damaged plaster and intermittent damaged surfaces throughout the complex. Provide complete replacement of plaster surfaces at the 1907 and 1927 Additions in conjunction with abatement activities. Provide new rigid sheet protection panels, corner guards and chair rail at gypsum wall surfaces receiving continual abuse. Provide corner guards at unprotected edge locations.

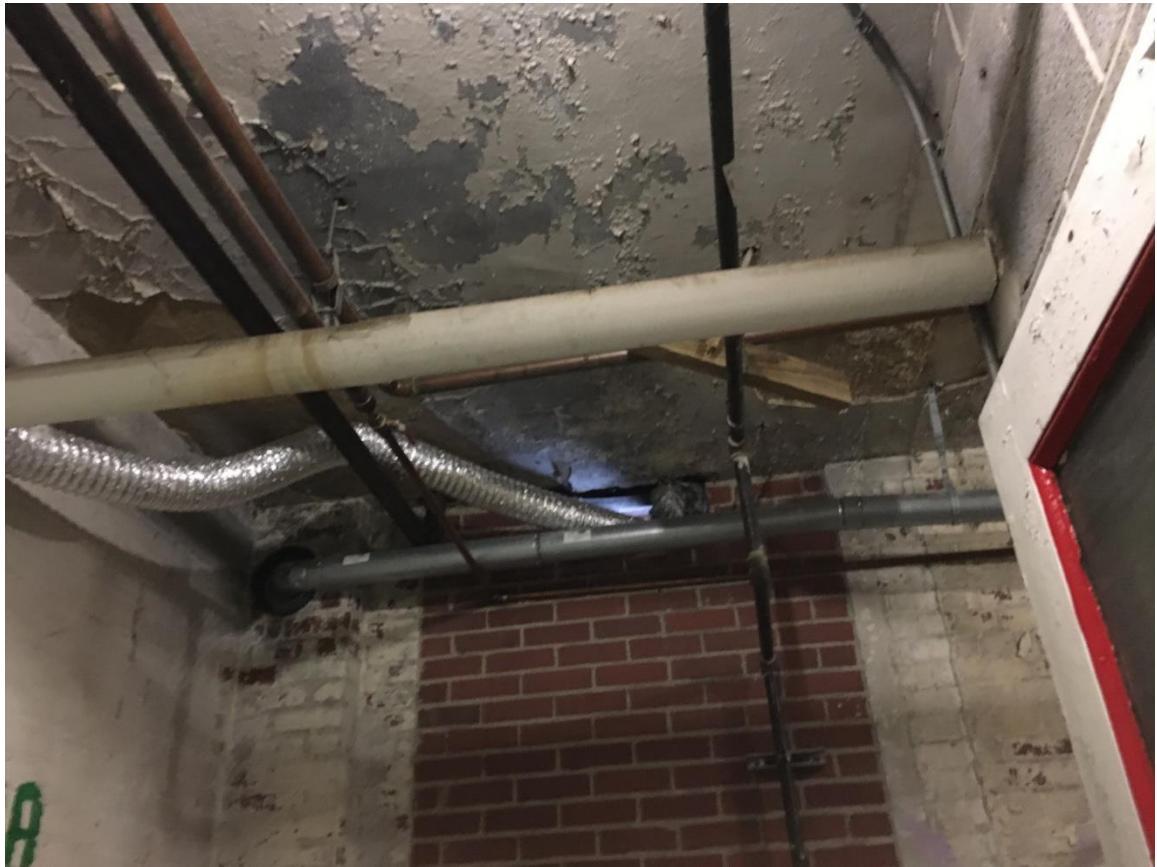
Figure 7-5

*Description:* The majority of rooms and spaces throughout the complex have a suspended  $2' \times 4'$ acoustical ceiling system. The ceiling system through-out the 1907-1973 additions is generally in good condition. The ceiling tiles are stained or display evidence of water damage in a few areas. (Fig. 7-1) The ceiling tiles at the 1990 Addition are often mismatched within room spaces throughout this addition and tiles are beginning to sag. A portion of the tiles are stained or damaged. (Fig. 7-2, 7-3) A limited area of the ceilings in the complex are painted concrete decking and exposed decks. The ceiling at the 1927 Auditorium House is acoustical plaster which has been well maintained. The ceilings at the lower level of the Auditorium Addition are plaster in fair to poor condition with damage in multiple locations. (Fig.-7-4, 7-5, 7-6, 7-7)

*Recommendation:* Provide gypsum/plaster ceiling repairs as required and paint throughout the lower level of the 1927 Auditorium Addition or replace in their entirety with new suspended acoustic. The addition of a new suspended acoustic ceiling system within this area will also require modification of the existing fire suppression system. Replace plaster ceiling surfaces at the 1907 and 1927 additions in conjunction with abatement activities. Clean exposed ceilings and paint as part of general maintenance. Replace interment damaged ceiling tile throughout the complex. Replace and upgrade ceilings at the 1990 Addition. Replace ceilings at the 1907-1973 additions, excluding the Auditorium, Student Dinning and Gymnasium in conjunction with HVAC improvements.
