### FACILITY ASSESSMENT

# Central Intermediate School

## MAY 15, 2017

#### 1.1 CENTRAL INTERMEDIATE SCHOOL

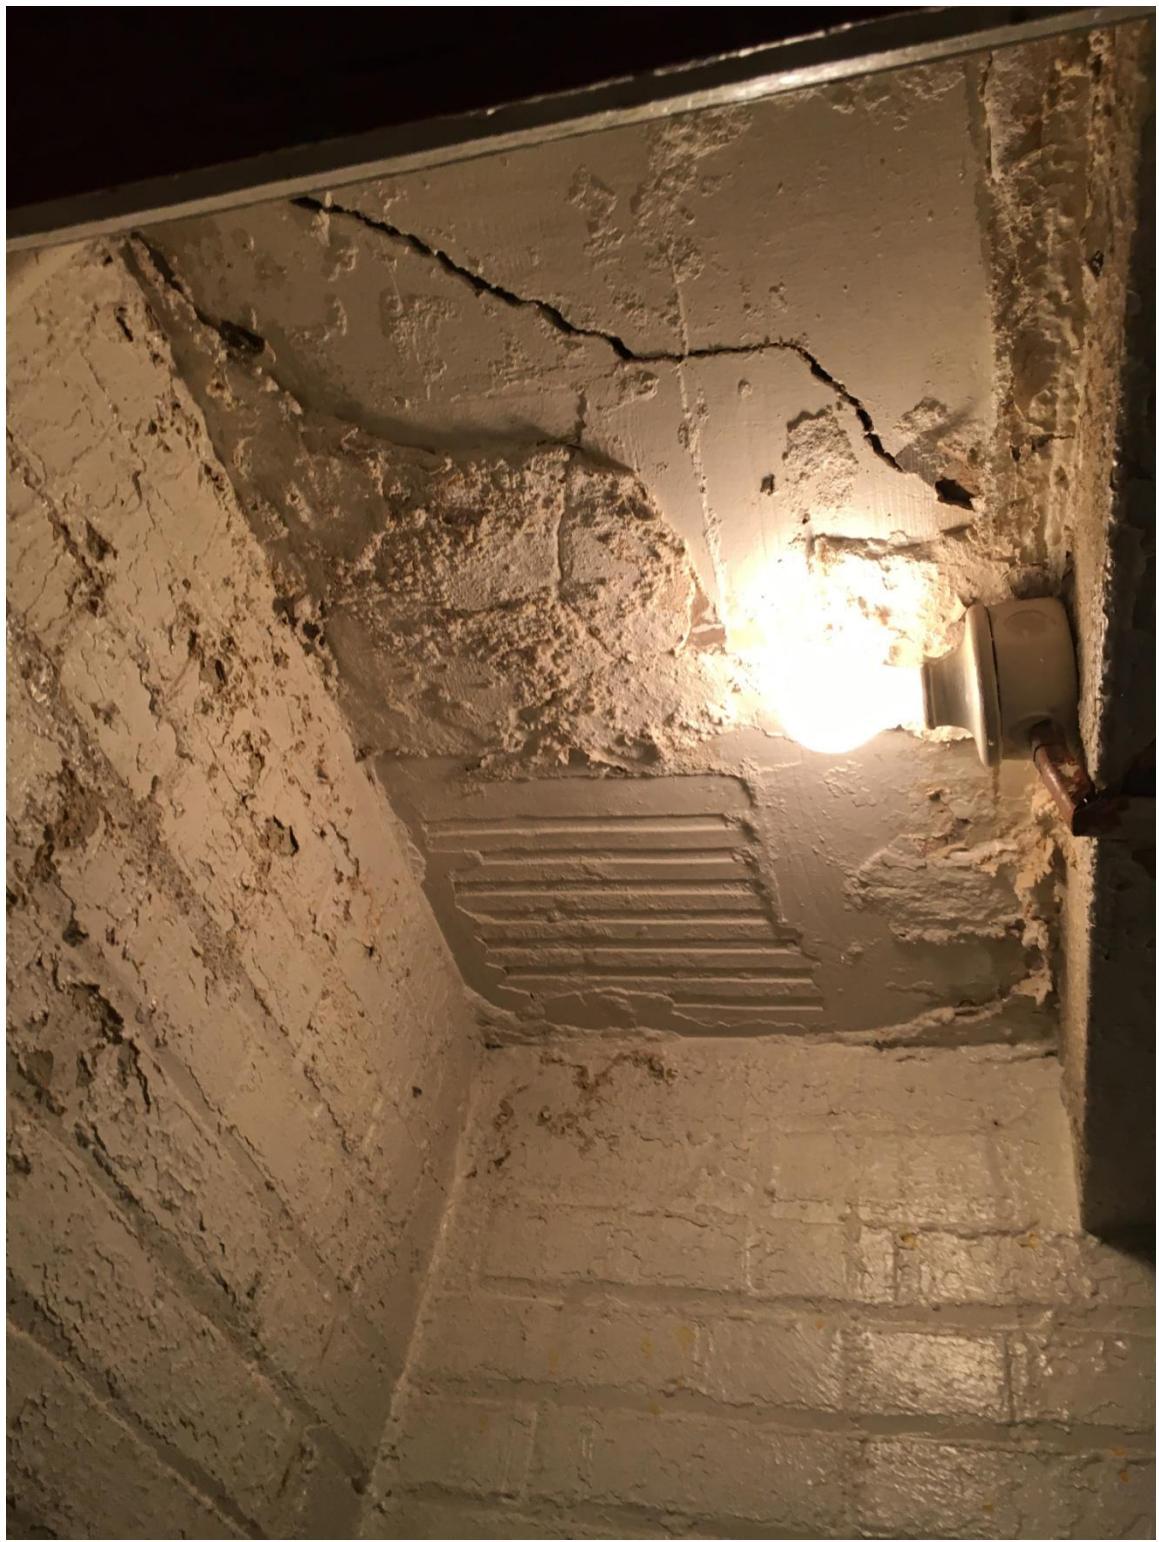
Figure 7-6

*Description:* The majority of rooms and spaces throughout the complex have a suspended  $2' \times 4'$ acoustical ceiling system. The ceiling system through-out the 1907-1973 additions is generally in good condition. The ceiling tiles are stained or display evidence of water damage in a few areas. (Fig. 7-1) The ceiling tiles at the 1990 Addition are often mismatched within room spaces throughout this addition and tiles are beginning to sag. A portion of the tiles are stained or damaged. (Fig. 7-2, 7-3) A limited area of the ceilings in the complex are painted concrete decking and exposed decks. The ceiling at the 1927 Auditorium House is acoustical plaster which has been well maintained. The ceilings at the lower level of the Auditorium Addition are plaster in fair to poor condition with damage in multiple locations. (Fig.-7-4, 7-5, 7-6, 7-7)

*Recommendation:* Provide gypsum/plaster ceiling repairs as required and paint throughout the lower level of the 1927 Auditorium Addition or replace in their entirety with new suspended acoustic. The addition of a new suspended acoustic ceiling system within this area will also require modification of the existing fire suppression system. Replace plaster ceiling surfaces at the 1907 and 1927 additions in conjunction with abatement activities. Clean exposed ceilings and paint as part of general maintenance. Replace interment damaged ceiling tile throughout the complex. Replace and upgrade ceilings at the 1990 Addition. Replace ceilings at the 1907-1973 additions, excluding the Auditorium, Student Dinning and Gymnasium in conjunction with HVAC improvements.

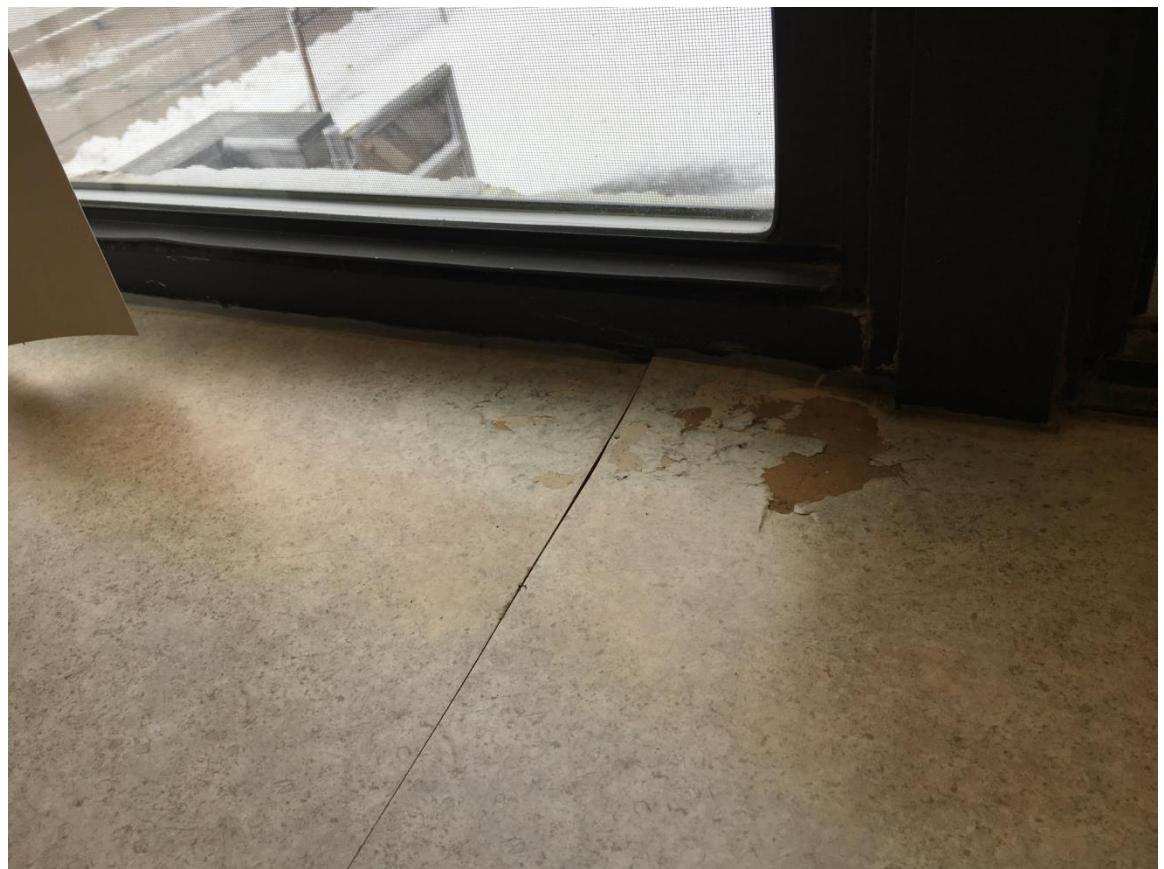
Figure 8-2

*Description:* Casework throughout the Complex is plastic laminate with plastic laminate counters and overall is in good condition. Occasional pieces of casework display minor intermittent damage. A portion of the plastic laminate counters are damaged typically at counter ends and missing edge veneer. (Fig. 8-1) Continuous plastic laminate window sills are provided above the built-in book shelving/casework along the exterior walls and are heavily damaged from water infiltration or condensation in many of the classrooms at the 1907/1927 Additions. (Fig. 8-1, 8-2)

*Recommendation:* Repair and/or replace damage counter assemblies. Replace the plastic laminate window sill with solid surface materials throughout the 1907 Original Building. Replace casework exceeding accessible height limitations or where lacking accessible work stations. All casework throughout the complex should be budgeted for replacement in the next five years as these materials are approaching there useful life expectancy.

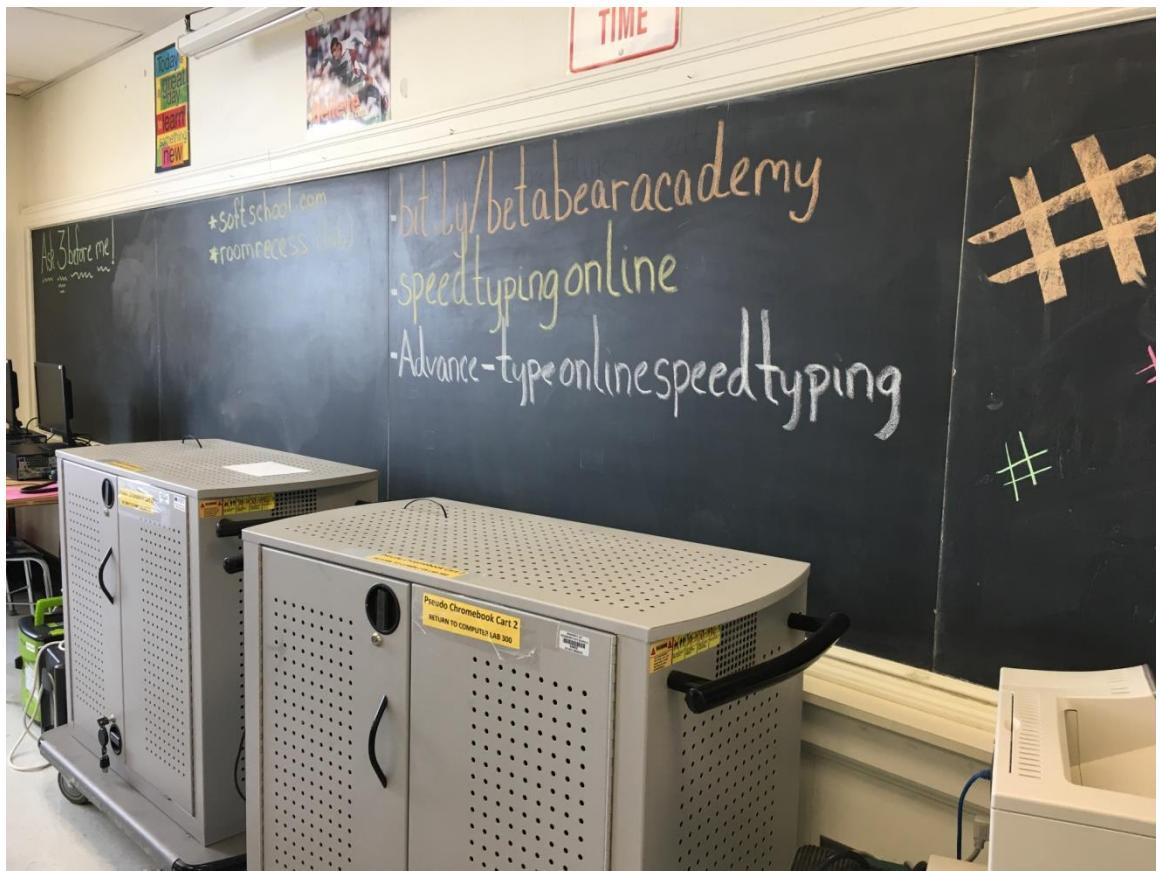
Figure 9-2

*Description:* The majority of visual display surfaces throughout the complex are marker boards. Most of the assemblies are in satisfactory condition. Occasional units are damaged. (Fig. 9-1) The original chalk boards at the later building areas have been typically covered with Marker/Tackboard units or teacher display, but a few of the chalk board assemblies remain in service. (Fig. 9-2) There are interactive boards in many Classrooms.

*Recommendations:* Replace chalk boards with marker/bulletin boards and replace fatigued marker board assemblies. Replace visual display surfaces at the 1907 and 1927 Additions in conjunction with abatement activities.

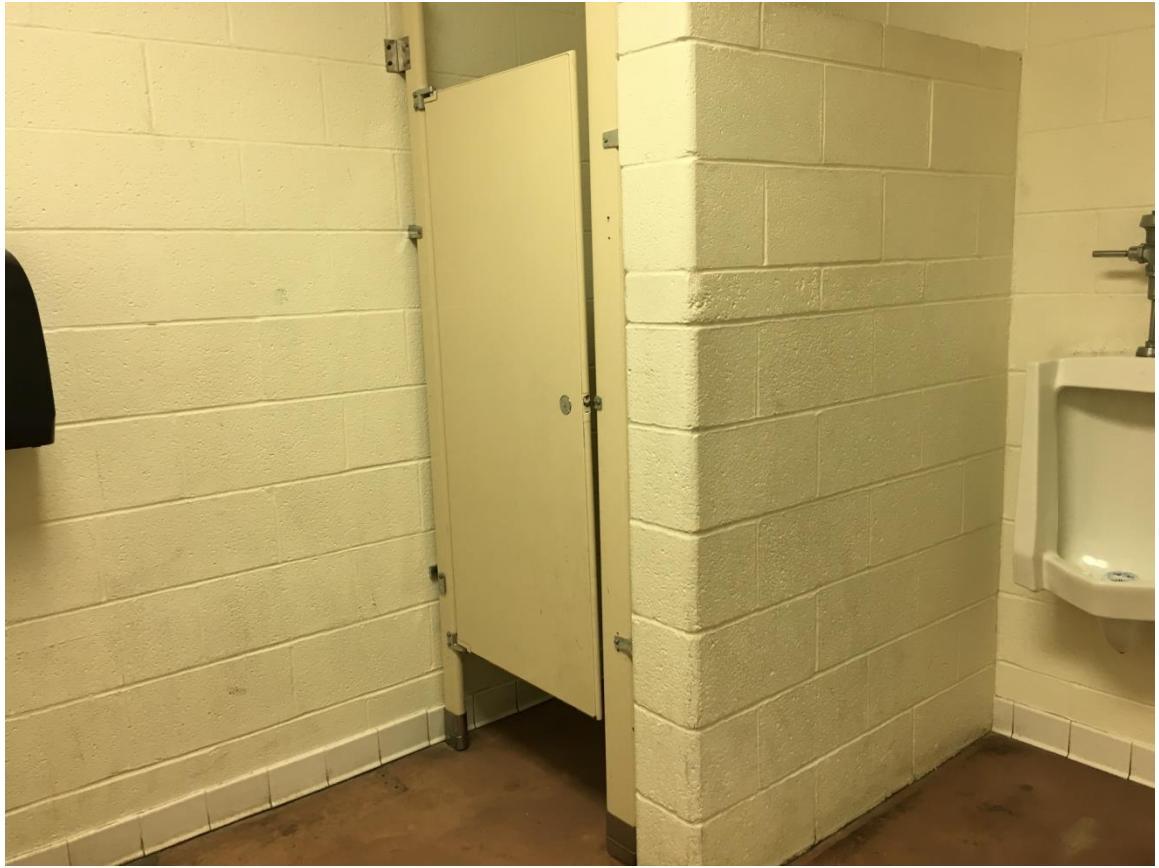
Figure 10-2

*Description:* Toilet partitions at the renovated large group restrooms at the Original 1907 have solid HDPE partitions in satisfactory condition. The toilet partitions at the reaming toilet facilities and locker rooms are metal or CMU partitions in fair to poor condition. Toilet accessories at a portion of the restrooms have been mounted outside accessible reach ranges or project more than 4 inches into the path of travel. (Fig. 10-1, 10-2)

*Recommendation:* Replace all toilet partitions and accessories in conjunction with accessibility renovations these include all dated metal and CMU assemblies. Remount accessories outside reach ranges and relocate accessory protrusion hazards at the 1907 Toilet Rooms, the partitions are satisfactory. Budget for replacement of all toilet partitions as these finishes are approaching there useful life expectancy.

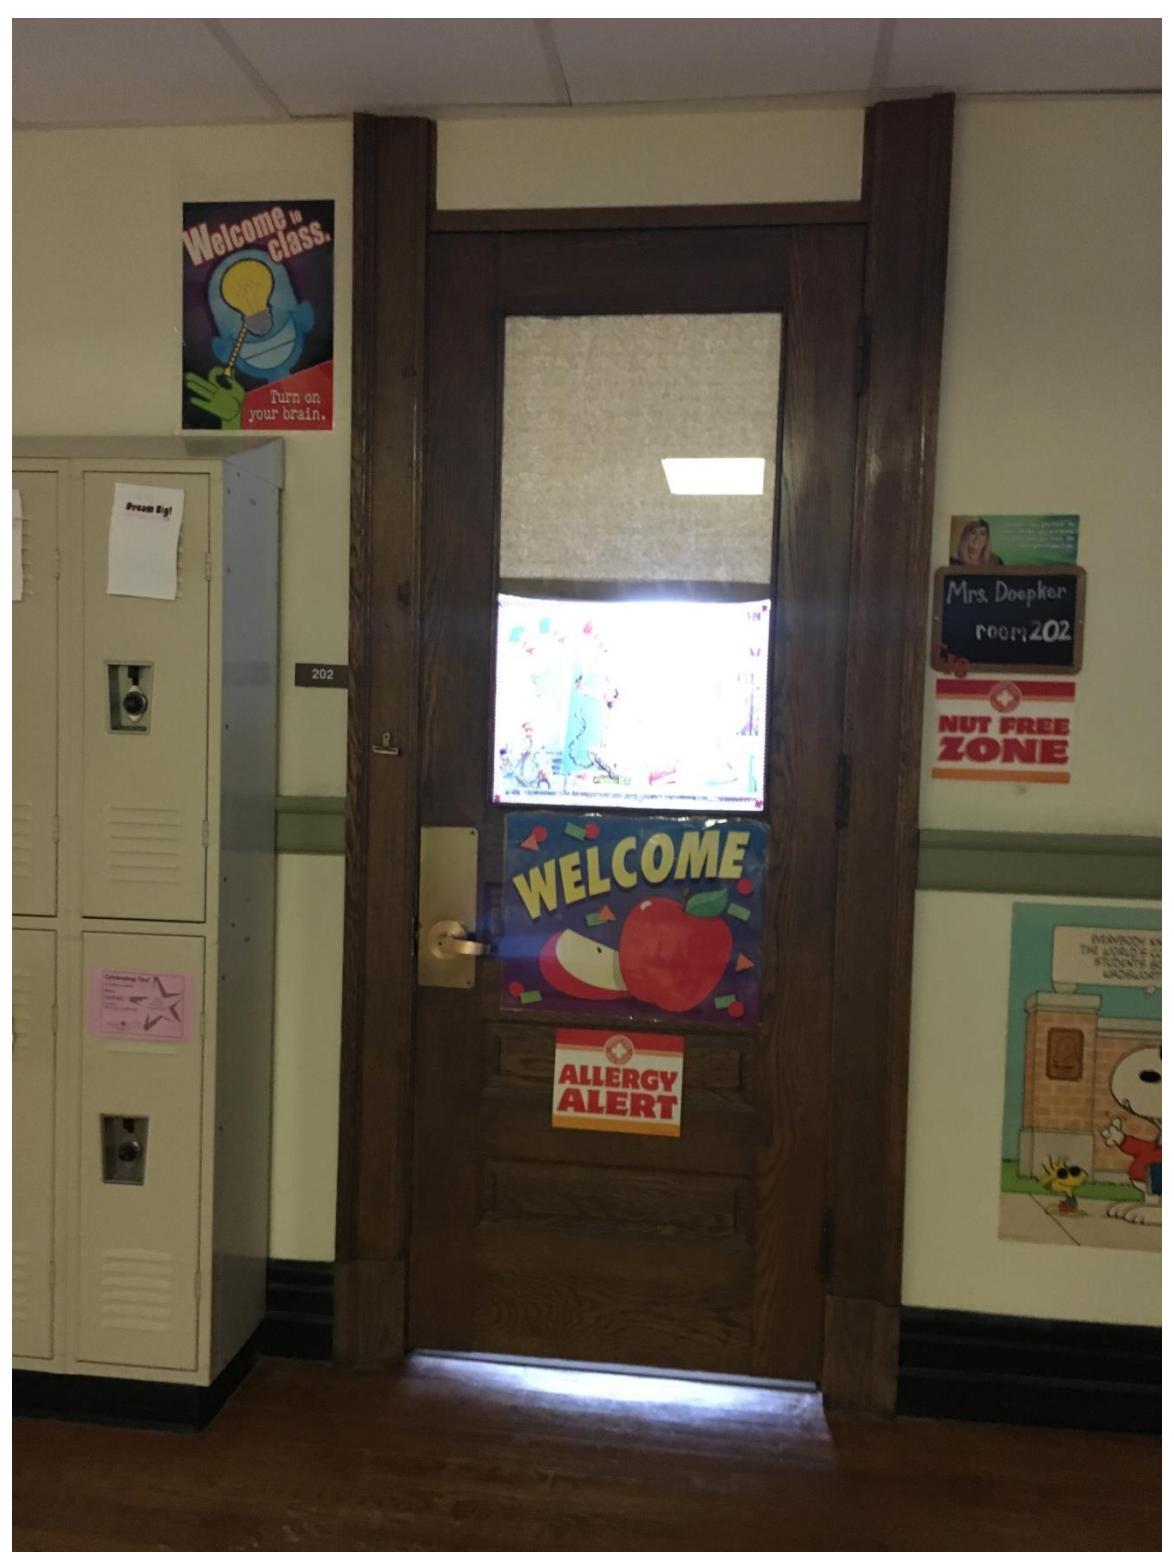
Figure 11-1

Description: The majority of doors at the 1907 Original Building are the original solid wood panel door assemblies. The door surfaces have been refinished and are generally being satisfactorily maintained. The vision panels at most units did not indicate the glazing was tempered. (Fig. 11-1) The vestibule doors at the main entry are not properly undercut and rub against the floor finish. The frames are corroded from salt and water accumulations. (Fig. 11-2) The majority of the doors throughout the 1927-1960/1966 Additions were updated in 2001 with solid core wood doors in satisfactory. A portion of the doors have intermittent veneer damage or are damaged from traffic abuse. (Fig. 11-3) Vision panels were tempered. The door assemblies at the lower level of the 1927 auditorium Addition were not updated and many of the units are in poor condition. The majority of the doors at the 1973 Gymnasium Addition were hollow metal doors of various ages. The hollow metal panels are dented in some areas or are dated installations. (Fig. 11-4) The door installations at the 1990 Addition are painted solid core wood doors generally in satisfactory condition. (Fig. 11-5) Vision panels have wire glass glazing at portion of the door assemblies. (Fig. 11-6)

Recommendation: Assure the glazing at the original 1907 wood door assemblies are equipped safety glazing or consider replacing the entire door assemblies with updated units. Replace the door and frame assemblies at the 1907 vestibule storage closets. Replace and update the door assemblies including hardware at the lower level of the 1927 Auditorium Addition. Replace damaged hollow metal door assemblies at the 1973 Gymnasium Addition. Replace wire glass with tempered safety glazing and replace intermittent damaged door assemblies and hardware throughout the remaining areas of the complex. Provide solid vinyl protection panels and edge trim at high abuse locations. Budget for replacement of all door assemblies throughout the complex as these materials are approaching there useful life expectancy and to provided a unified appearance through all additions.

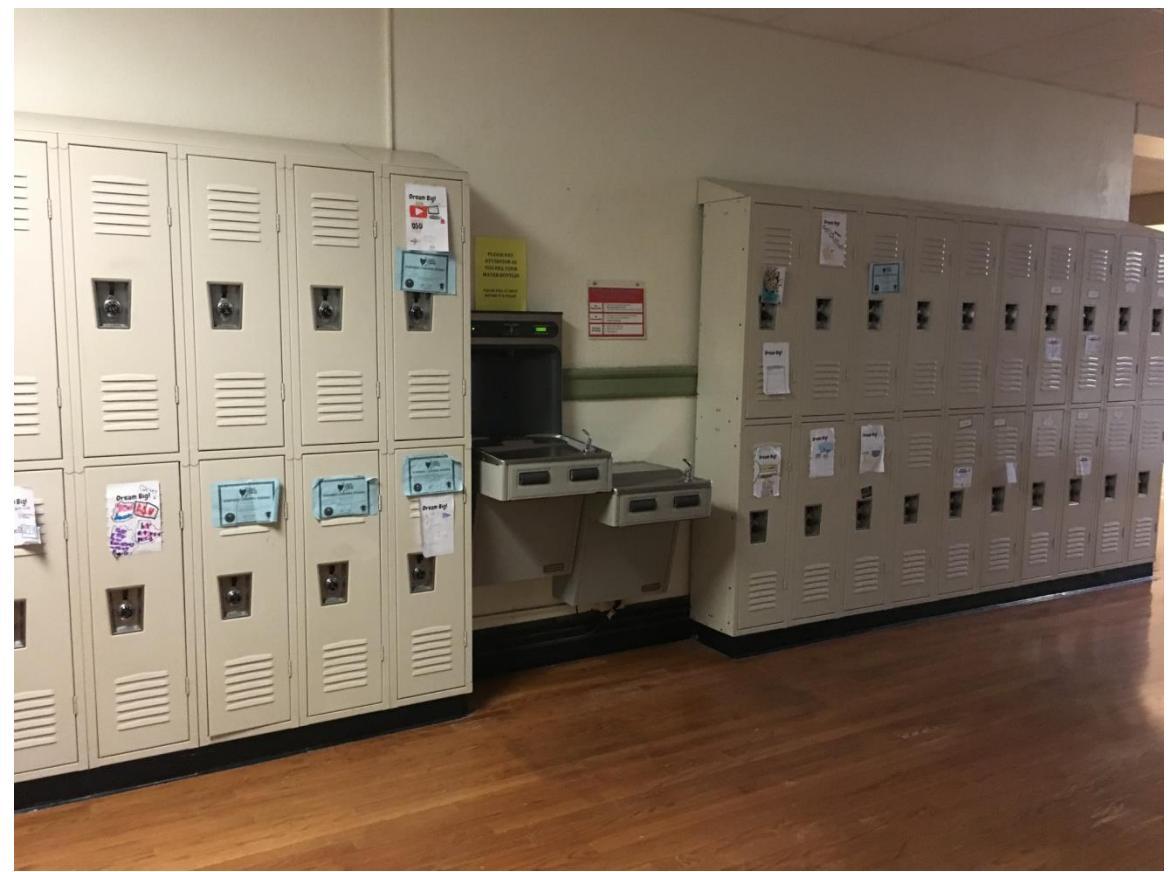
Figure 12-1

*Description:* Lockers throughout the complex have been updated with dual tiered assemblies. The units overall are in good condition. (Fig. 12-1)

*Recommendation:* Continue maintenance and hardware repairs as needed to maintain condition. Remove/ reinstall/replace all lockers at the 1907 and 1927 additions in conjunction with abatement activities.

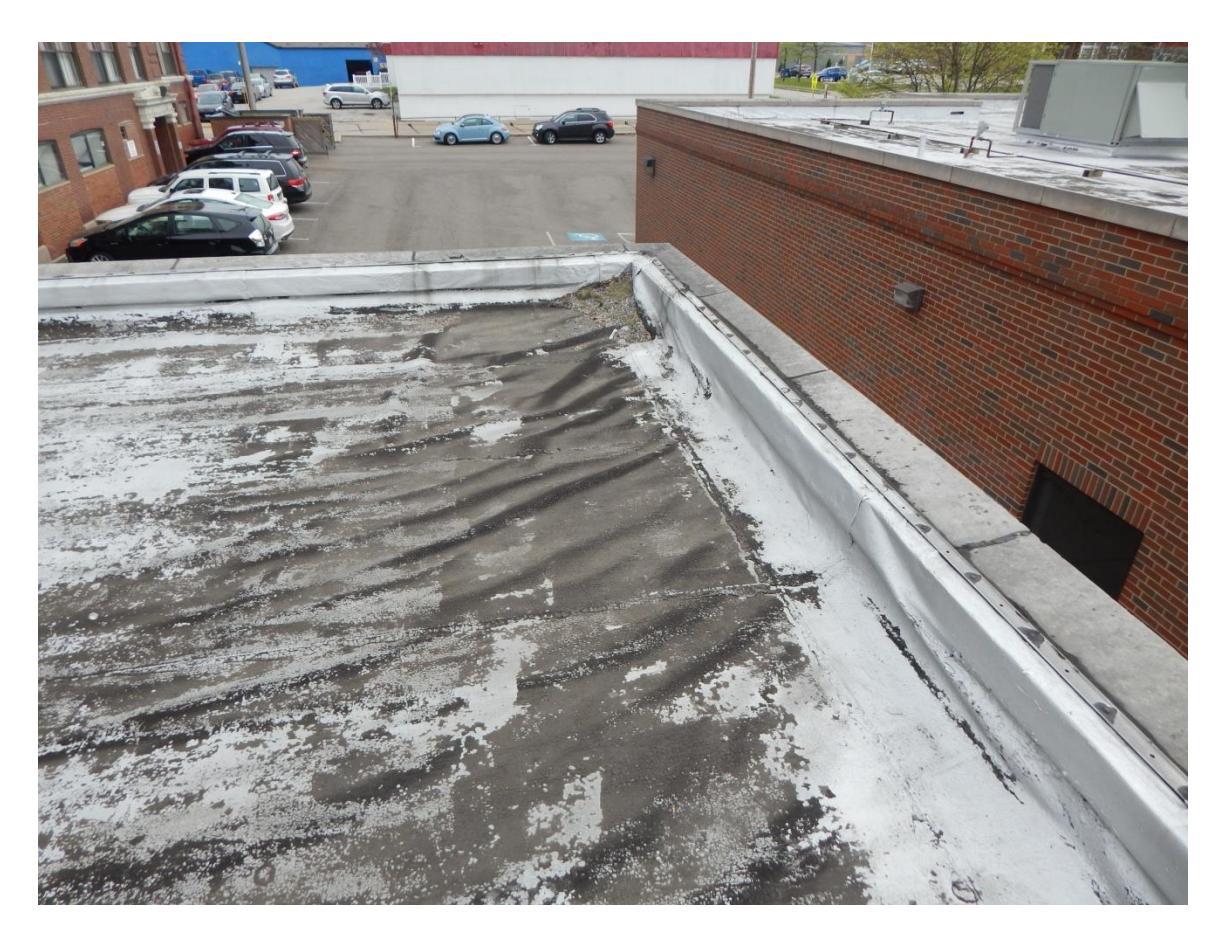
Figure 13-5

Some of the cap sheet is detached. (Fig. 13-5)

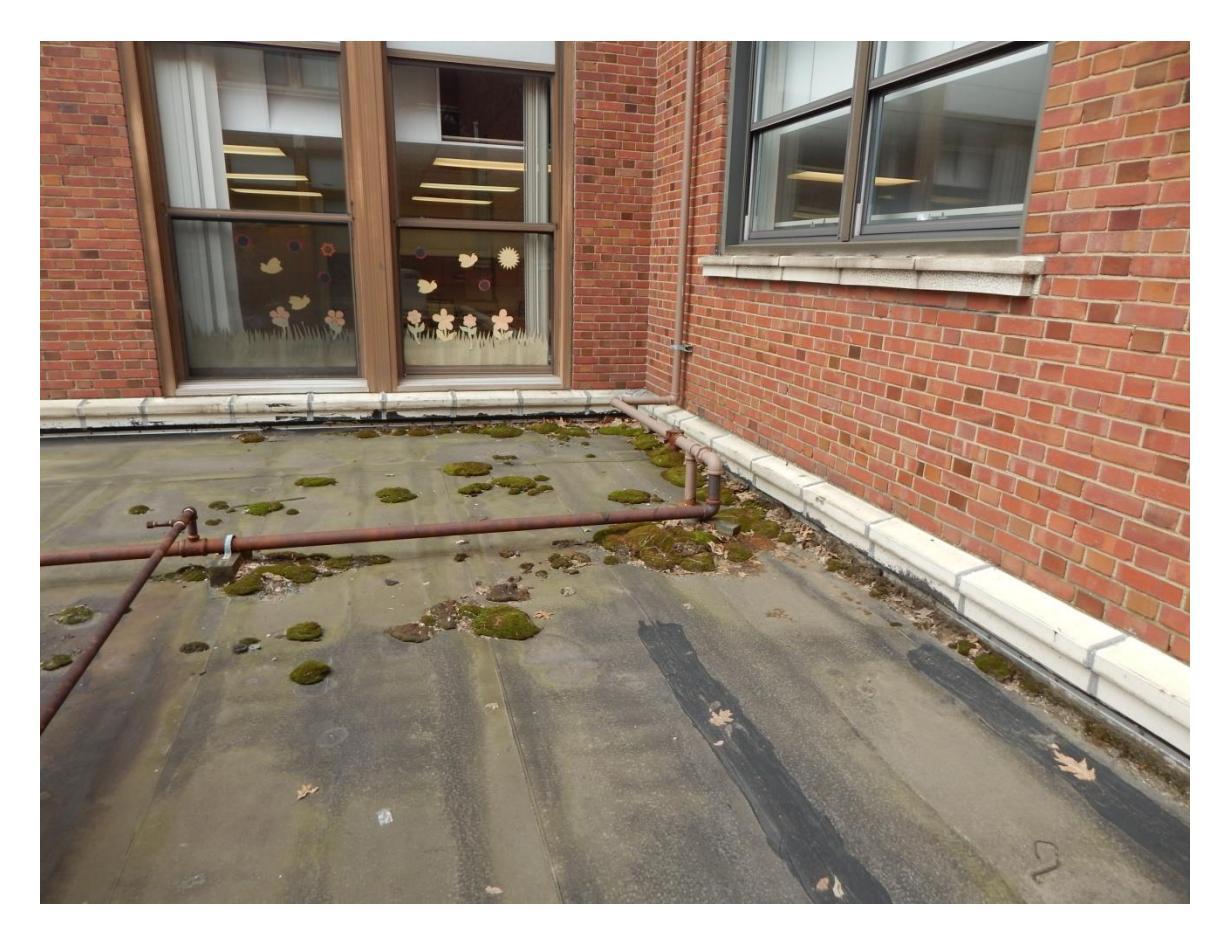
Figure 13-6

There have been areas patched. (Fig. 13-6)

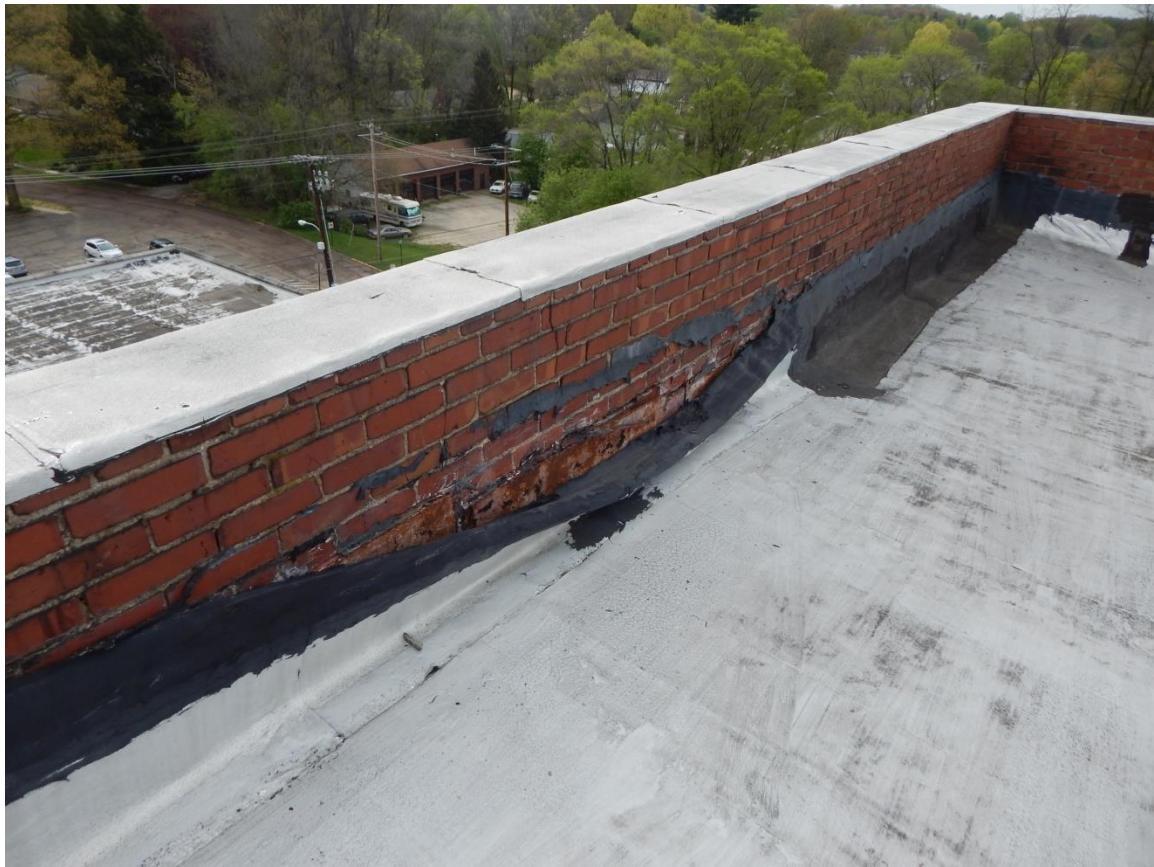
Figure 13-7

Some terminations are open. (Fig. 13-7, 13-8)

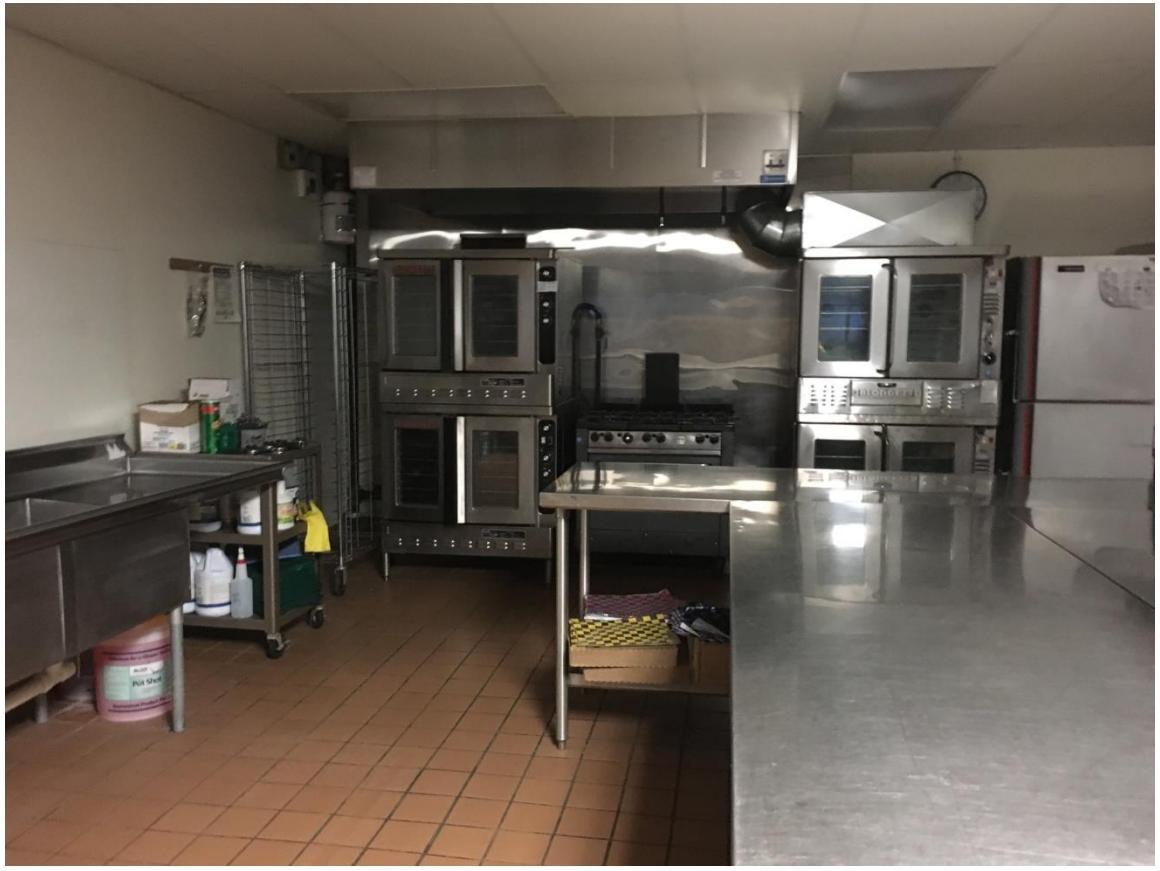
Figure 14-1

*Description:* This building has a Kitchen. The kitchen and serving equipment was noted to have been updated in 2001 but the age and condition of all equipment was not identified. (Fig. 14-1)

*Recommendation:* Determine which pieces of kitchen equipment have exceeded or are approaching their life expectancy or not working properly or energy efficiently and replace. Over twenty years all will need replacement. Replace wood bleacher seating at the Gymnasium and include handicapped accessible seating provisions.

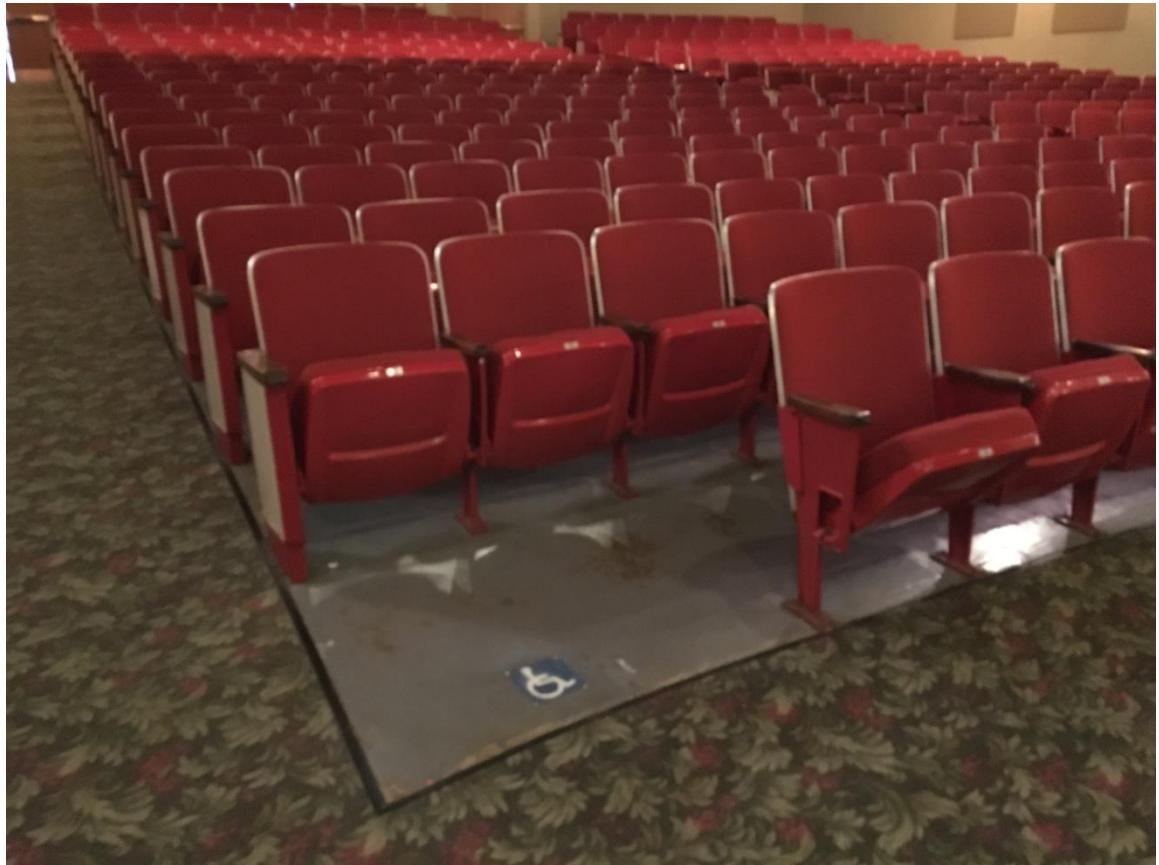
Figure 14-2

The Auditorium seating has been well maintained and fabric covering is generally in good condition. (Fig. 14-2)

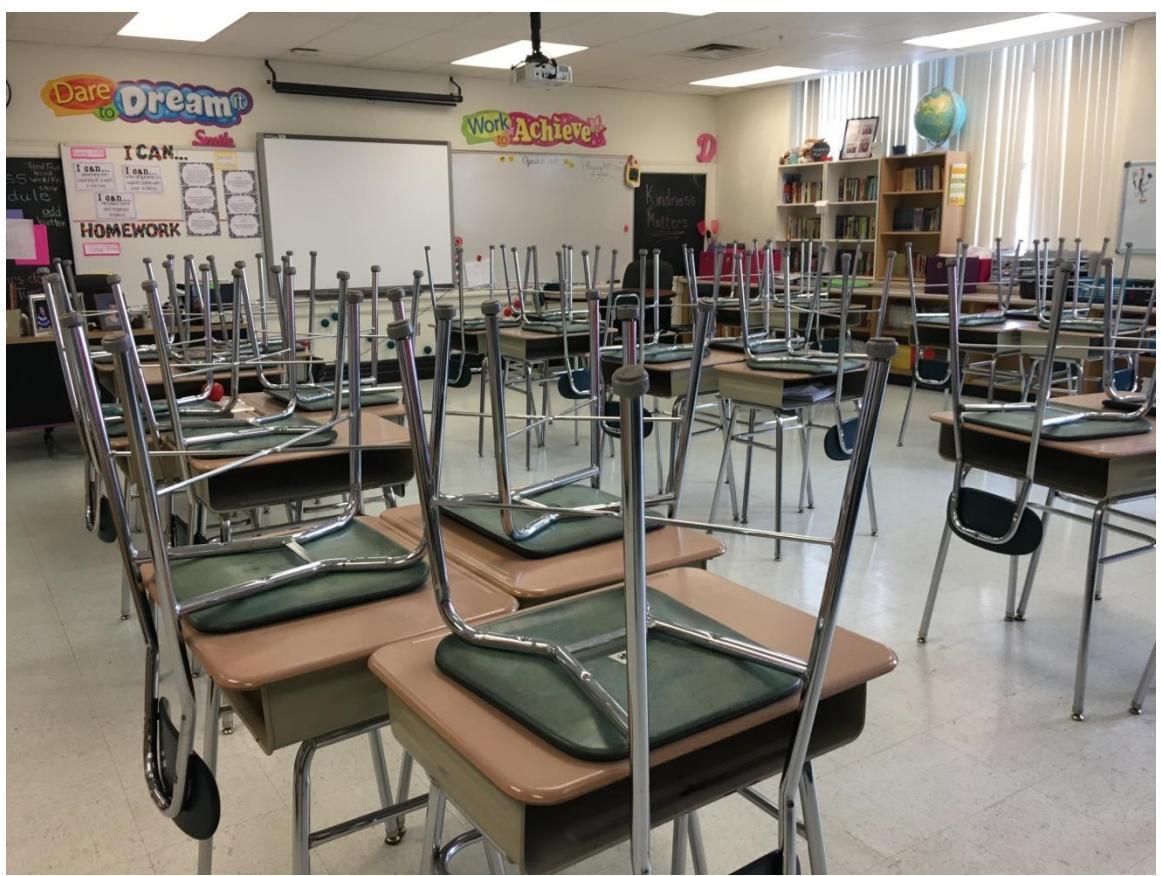
Figure 15-1

*Description: Description:* Furniture throughout the complex has been updated in the past and appears to be of consistent age and generally is in satisfactory condition. (Fig. 15-1)

*Recommendation:* Continue maintenance and replace damaged furniture as needed. Over twenty years all will need replaced.

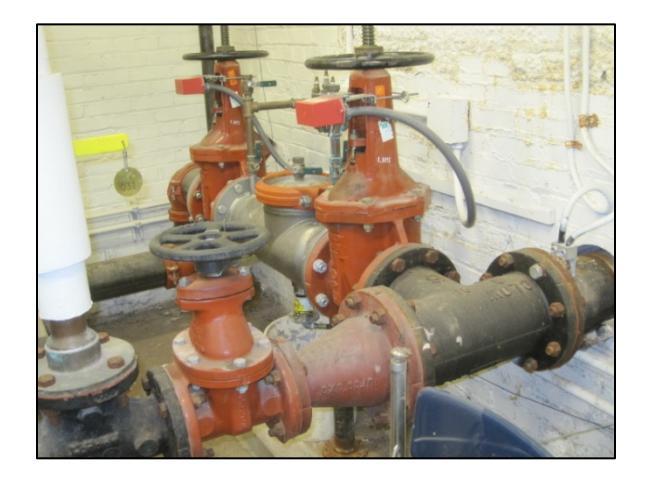
- 1. Water Service / Sprinkler Coverage
  - A. Description:
    - 1.) A 6-inch combination domestic-water / fire-suppression water service serves the building. A 6-inch fire suppression service line feeds a fire pump, downstream of a reduced-pressure-zone (RPZ) backflow preventer.

- B. Recommendation:
  - 1.) Since the fire suppression water service is located in the 1907 portion of the building, major re-work will be necessary with any renovation.

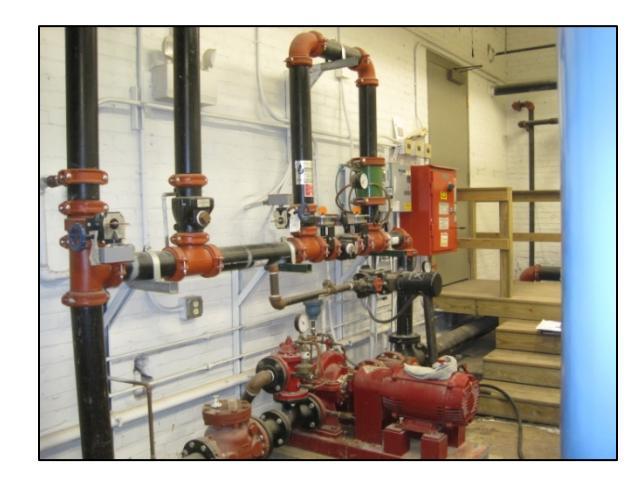
The fire pump is a Patterson Pump Model 5x3 Mac, 500 gallons per minute (GPM) at 40 pounds per square inch gauge (PSIG), 20 horsepower (HP). There is a Grundfos jockey pump to maintain system pressure.

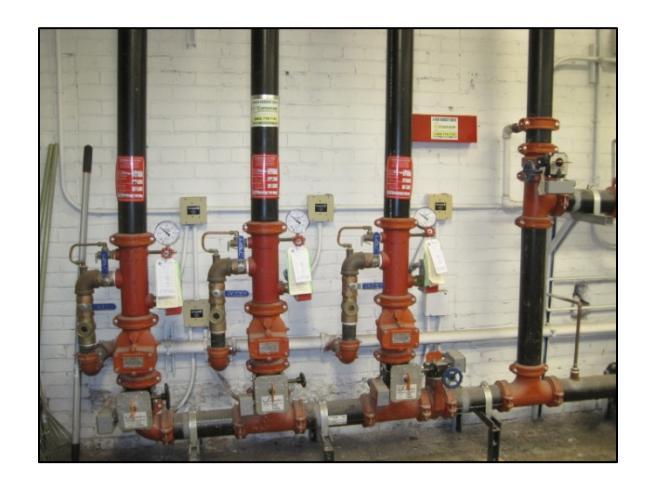
3.) The fire suppression is a wet-pipe system, consisting of (3) risers. System pressure is 100 PSIG and the entire building is fully suppressed

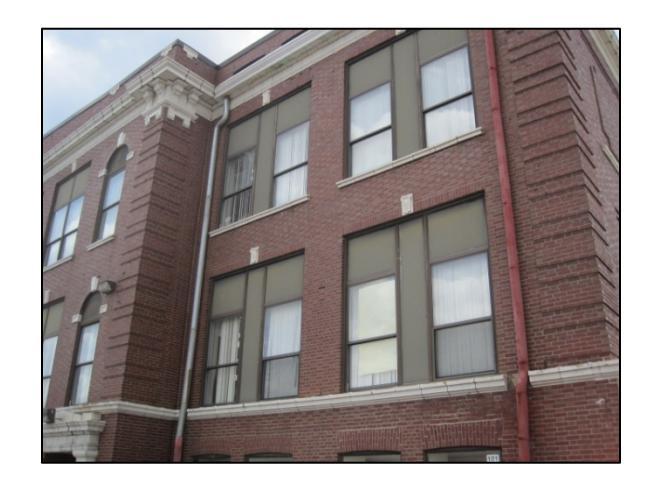
- 4. Interior Storm Piping
  - A. Description:
    - 1.) The condition of the interior storm piping is unknown.
    - 2.) The roofs of the original 1907 (3-story) building, the 1927 auditorium, and the 1962/1966 classroom additions are all drained by gutters and downspouts.

- 3.) The roofs of the student dining area, the 1973 gymnasium addition, and the 1990 classroom addition have roof drains and interior storm water piping.
- B. Recommendation:
  - 1.) Perform an interscopic inspection of the underground storm piping to determine its condition.

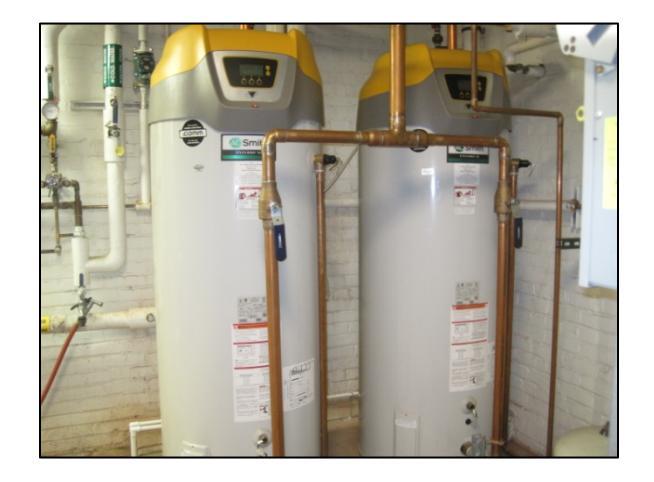
- 5. Domestic Water Supply Piping
  - A. Description:
    - 1.) The domestic water piping is a combination of copper and galvanized piping; the overall condition was reported as good. Galvanized piping was observed in the 1927 addition, in the Lower Level locker room below the stage. We suspect that there is galvanized piping in portions of the 1907 original building.
    - 2.) Domestic hot water for the entire building, with the exception of the 1990 addition and the gymnasium locker rooms, is provided from (2) 100-gallon, A.O. Smith Model BTH 199-100, high-efficiency, condensing, gas-fired water heaters that are located in the north mechanical room. These water heaters were manufactured in January 2012 and are in very good condition. The hot water is stored at 120 degrees F. There is a domestic hot water return system, which maintains the hot water temperature throughout the building.

- B. Recommendations:
  - 1.) Replace all galvanized domestic water piping.
  - 2.) Replace the water heating boiler and storage tank in the 1990 addition. Add an ASSE-1070 TMV to this system.

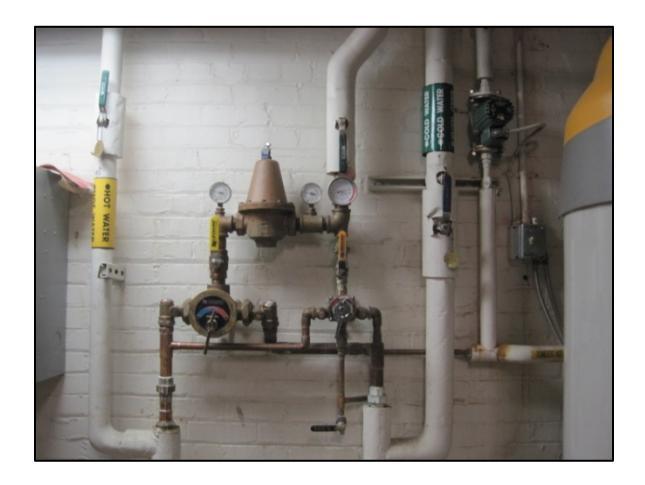
3.) There is a master thermostatic mixing valve (TMV), which meets the American Society of Sanitary Engineering (ASSE) 1070 Standard, serving the above domestic hot water system. Water is delivered to the building at 100 degrees F, except for the kitchen, which receives 120 degrees F. hot water.

- 3.) It is highly recommended that the domestic hot water be stored at 140 degrees F. and distributed throughout the building at 120 degrees F., then tempered to 109 degrees F through point-of-use ASSE-1017 TMV at hand-washing fixtures.
- 6. Plumbing Fixtures
  - A. Description:
    - The building contains (8) large group restrooms (4 girls, 4 boys), (1) clinic toilet room with a shower, and (6) staff/single-use toilet facilities.
    - 2.) Fixtures are a combination of floor-mounted water closets, wallmounted urinals, lavatories, and electric water coolers. There are no sensor-operated flush valves or faucets.

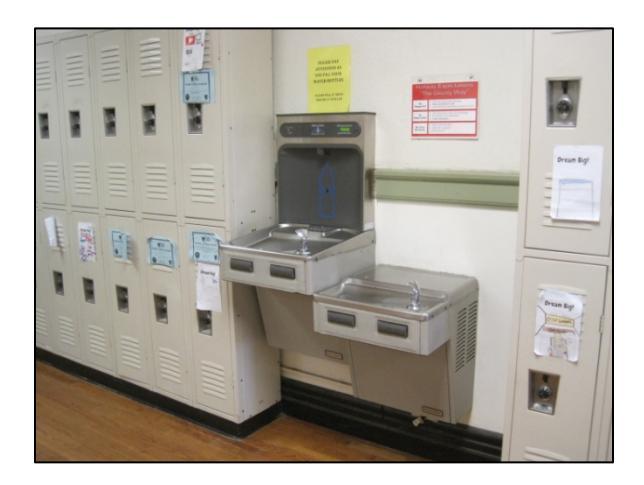
5.) The electric water coolers are wall-mounted, and several are high/low units with a bottle filler.

- 7.) The custodial closet janitor's sinks are in good condition.
- B. Recommendations:
  - 1.) Replace plumbing electric water coolers and urinals with low-water use fixtures. Utilize sensor-operated flush valves.
  - 2.) Replace lavatories, as needed, and utilize sensor-operated faucets.

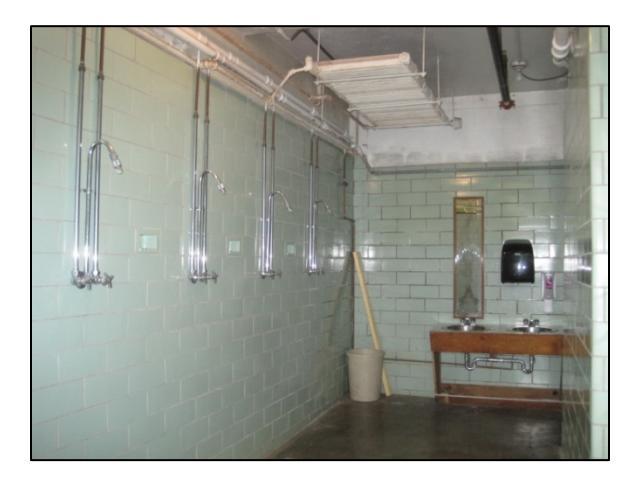
6.) The showers in the gymnasium locker rooms and the showers in the dressing rooms below the stage do not appear to be used. The stainless steel lavatories and floor-mounted water closets below the stage are in fair condition, but very old.

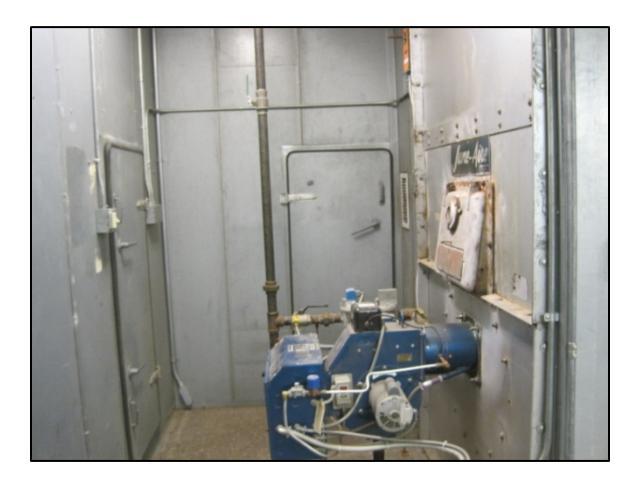
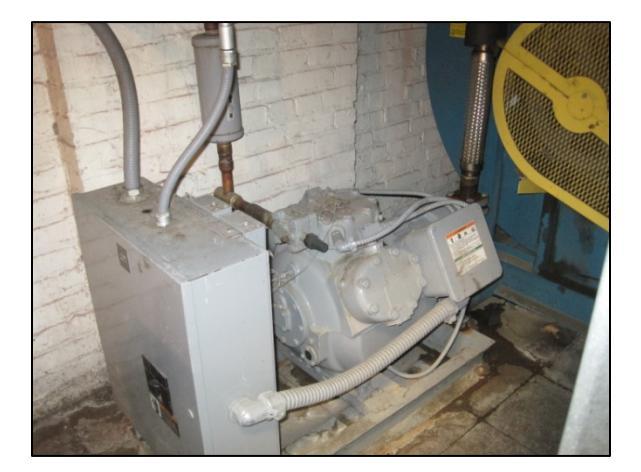
- A. Description:
    - 1.) As noted above, the June-Aire AHUs serve the main 3-story portion of the building. Both of these AHUs are in fair condition. Each unit has an indirect, gas-fired, built-up hot deck, which is in fair condition. The existing dual-duct mixing boxes reportedly do not shut off the hot or cold air streams completely, making it difficult to provide uniform temperatures within the spaces.

- a.) The unit located in the first floor mechanical room has (2) refrigerant R-22 reciprocating compressors located within the supply fan plenum. Heat dissipated by the compressors elevates the cold deck temperature. The condenser coil for this unit was not observed, but is believed to be located within the relief air plenum for the unit.

- 6.) A gas-fired RTU serves the auditorium entrance lobby. This unit was not surveyed since the roof was not readily accessible.
- B. Recommendations:
  - 1.) Replace the (2) June-Aire AHUs and the dual-duct system. We have successfully designed a similar replacement for this system at another District. A dedicated outdoor air system (DOAS) AHU with an air-cooled condensing unit was installed, utilizing the existing hot deck ductwork to distribute outdoor conditioned air to the various zones. Individual zones, e.g., classrooms, office suites, etc., were served by variable refrigerant flow (VRF) fan coils and central air-to-air heat pumps. Other energy-efficient HVAC systems could also be considered for these spaces.

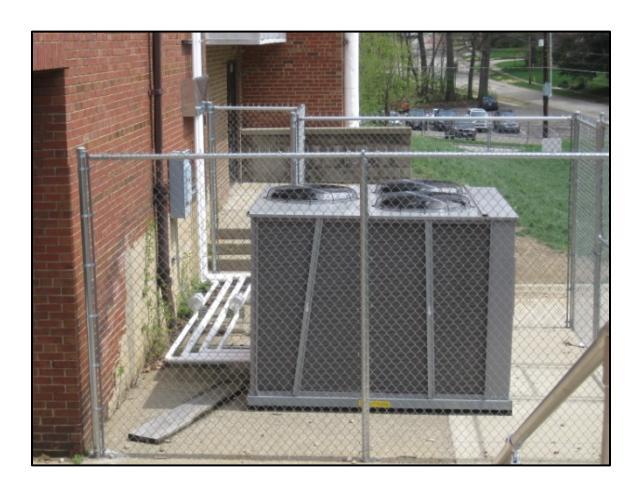
b.) The second unit, located in a built-up plenum at the second floor level adjacent to the stage, has had the DX cooling coil replaced and a new air-cooled condensing unit installed ongrade south of the stage. The condensing unit is a Carrier Model 38APD05064A, manufactured in July 2014. It is in very good condition.

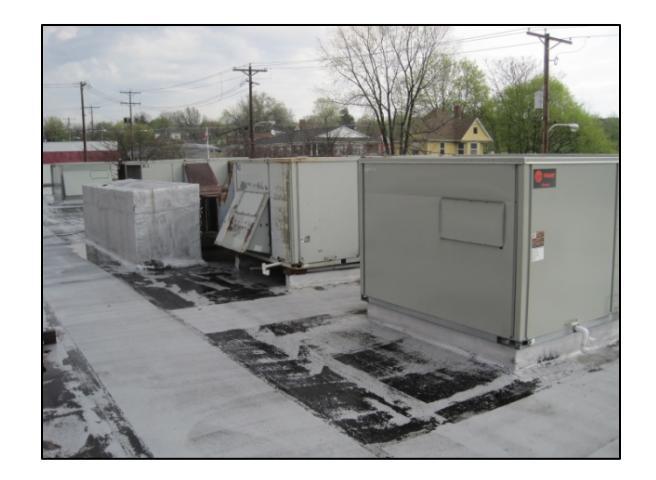
b.) Units AC-3 and AC-4, both serving the upper level, are Trane Model YSD150, nominal 12.5 tons each, and manufactured in August 2013 and February 2014, respectively. These units are in good condition.

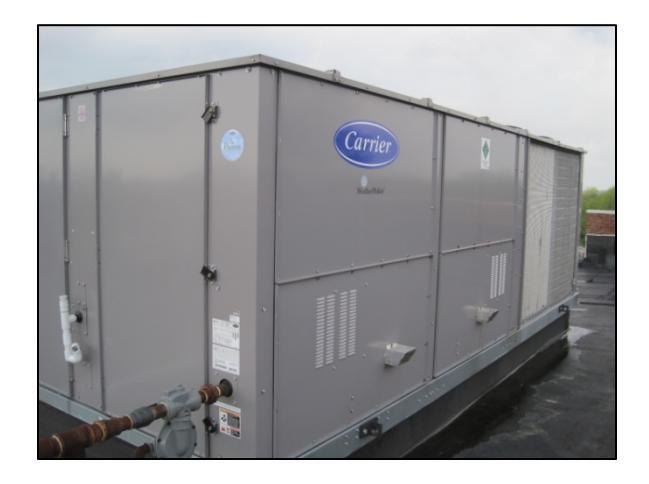
5.) The auditorium is served by a single-zone RTU, Carrier Model 48A4E040, nominal 40 tons, manufactured in August 2014. This unit is in very good condition.

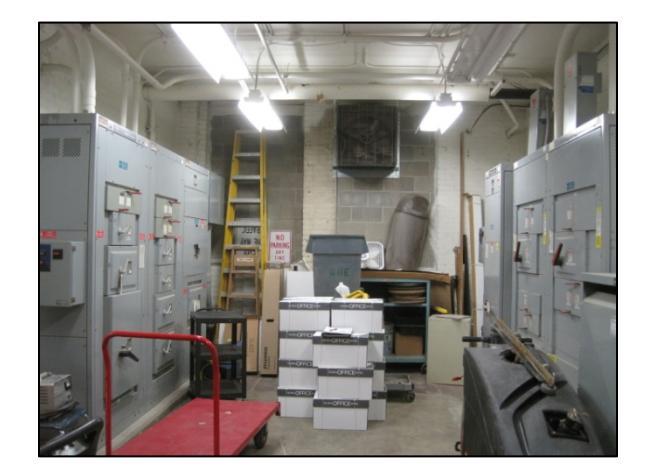
- 1. Power Distribution
  - A. Description:
    - 1.) The electrical service to the building is fed from the Power Company's pad-mounted transformer at the north side of the 1907 building. There are (2) separate secondary feeds to the two main distribution panels (MDPs) — switchboard HMDP1 and a newer switchboard HMDP2. Each switchboard is rated for 1,200 amperes at 480/277 volts, 3-phase, 4-wire. The specific age of the (2) switchboards was not determined; however, the system was updated in 2001, and appears to be in good condition.

- 3.) Service size appears to be appropriate for the current building loads; reportedly, there are no major power issues within the building.
- 4.) The building does not have a back-up emergency generator.
- B. Recommendations:
  - 1.) An emergency generator should be installed to serve the life safety systems.
  - 2.) The switchgear and newer panelboards could be retained if portions of the building are renovated. Renovation of the structure may impact conduit routing and panelboard locations through the building.
