### FACILITY ASSESSMENT

# Central Intermediate School

## MAY 15, 2017

#### 1.1 CENTRAL INTERMEDIATE SCHOOL

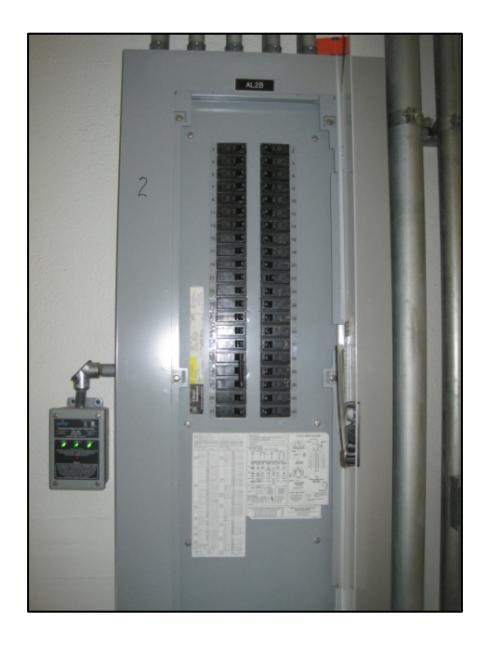
2.) Power is distributed throughout the building, from 480/277-volt and 208/120 volt branch circuit panelboards located in the main electrical room, adjacent fire pump room, kitchen, stage, and corridors. A representative number of panelboards were surveyed and all were found to be in good condition.

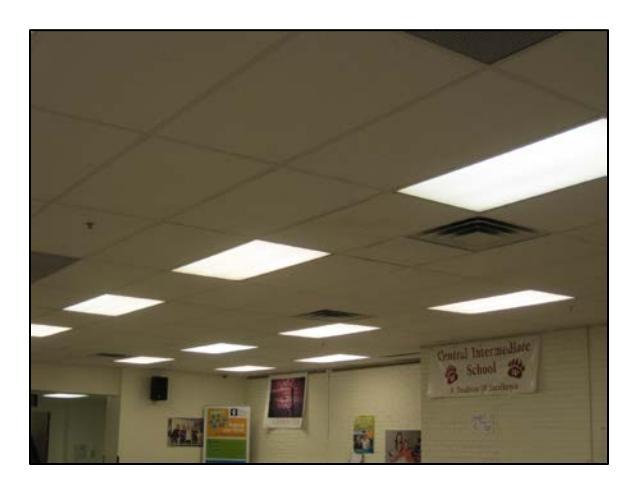
- 2. Interior Lighting
  - A. Description:
    - The school's interior lighting consists primarily of 2-foot-by-4-foot lay-in fluorescent troffers with acrylic lenses. Reportedly, there are t-8 lamps throughout, with the exception being T-12 lamps in the 2-story 1990 classroom addition. There are also some incandescent lighting fixtures interspersed in the older areas of the school.

- 2.) The gymnasium and stage are lighted with high-bay metal halide fixtures.
- 3.) The auditorium contains incandescent lighting fixtures.
- 4.) Lighting levels generally seemed adequate throughout.
- B. Recommendation:
  - 1.) Install light-emitting diode (LED) fixtures throughout. The 2-foot-by-4-foot lay-in fluorescent fixtures could be replaced on a one-for-one basis with LED fixtures.

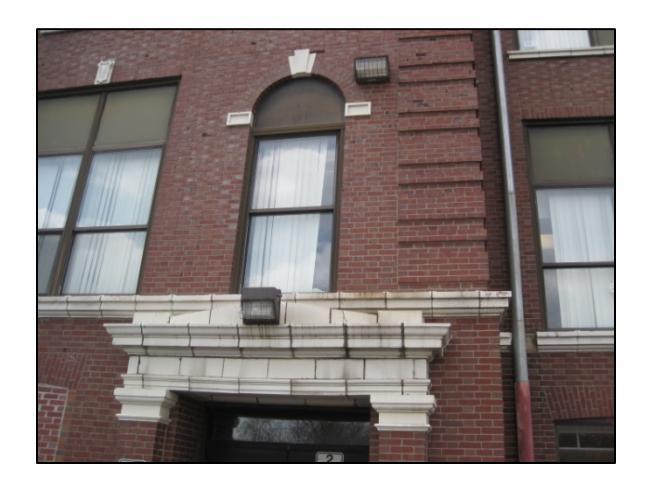
- 3. Exterior Lighting
  - A. Description:
    - 1.) All exterior lighting is attached to the building. There are no polemounted fixtures in the parking lots. The wall-mounted fixtures have high-intensity-discharge (HID) lamps. The school has been changing to LED fixtures as the existing HID fixtures fail. A few exterior doors do not have lighting fixtures. Exterior lighting is in fair condition.

- B. Recommendations:
  - 1.) The remaining exterior HID lighting fixtures should be replaced with LED fixtures.
  - 2.) Evaluate the need for any additional lighting in the parking lots.
  - 3.) Add an exterior lighting fixture at exit doors, as required.

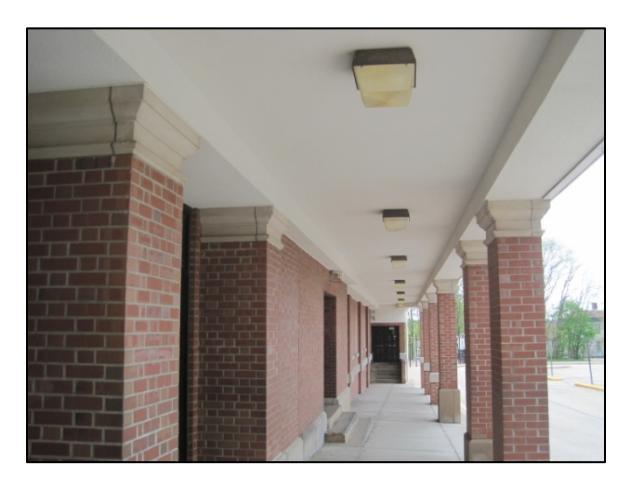
2.) The covered walkway along the west side of the auditorium has surface-mounted HID lighting fixtures.

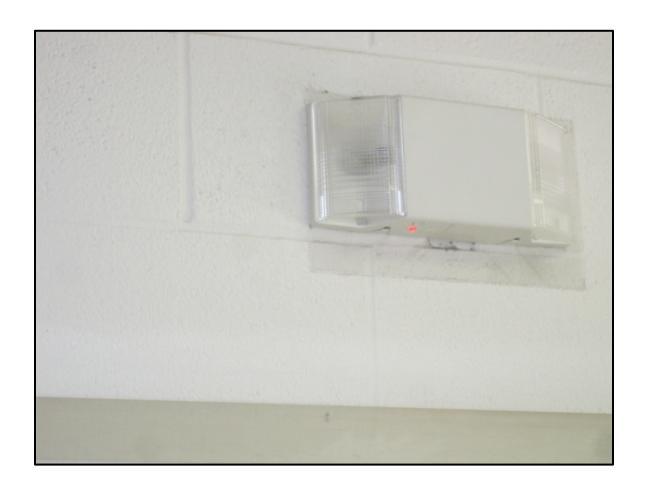
- 4. Emergency, Egress, and Exit Lighting
  - A. Description:
    - 1.) Emergency lighting consists of wall-mounted and ceiling-mounted battery-pack fixtures throughout the corridors. Emergency lighting is in fair condition.

- B. Recommendations:
  - 1.) Current Code requires that exterior lighting fixtures at exit doors be on emergency power. Circuits should be upgraded if a generator is added.
  - 2.) Provide additional exit and emergency lighting fixtures to meet current Code requirements.

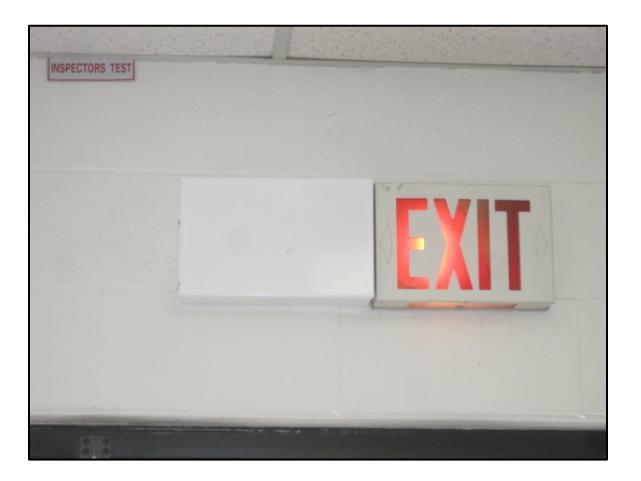
- 2.) Some exit doors do not have exterior lighting fixtures.
- 3.) Exit lighting consists of polycarbonate and steel lighting fixtures with red letters. Exit lighting is in good condition.
