Menlo Park City School District

Lower Laurel School

Tree Risk Assessment Report

April 25, 2017

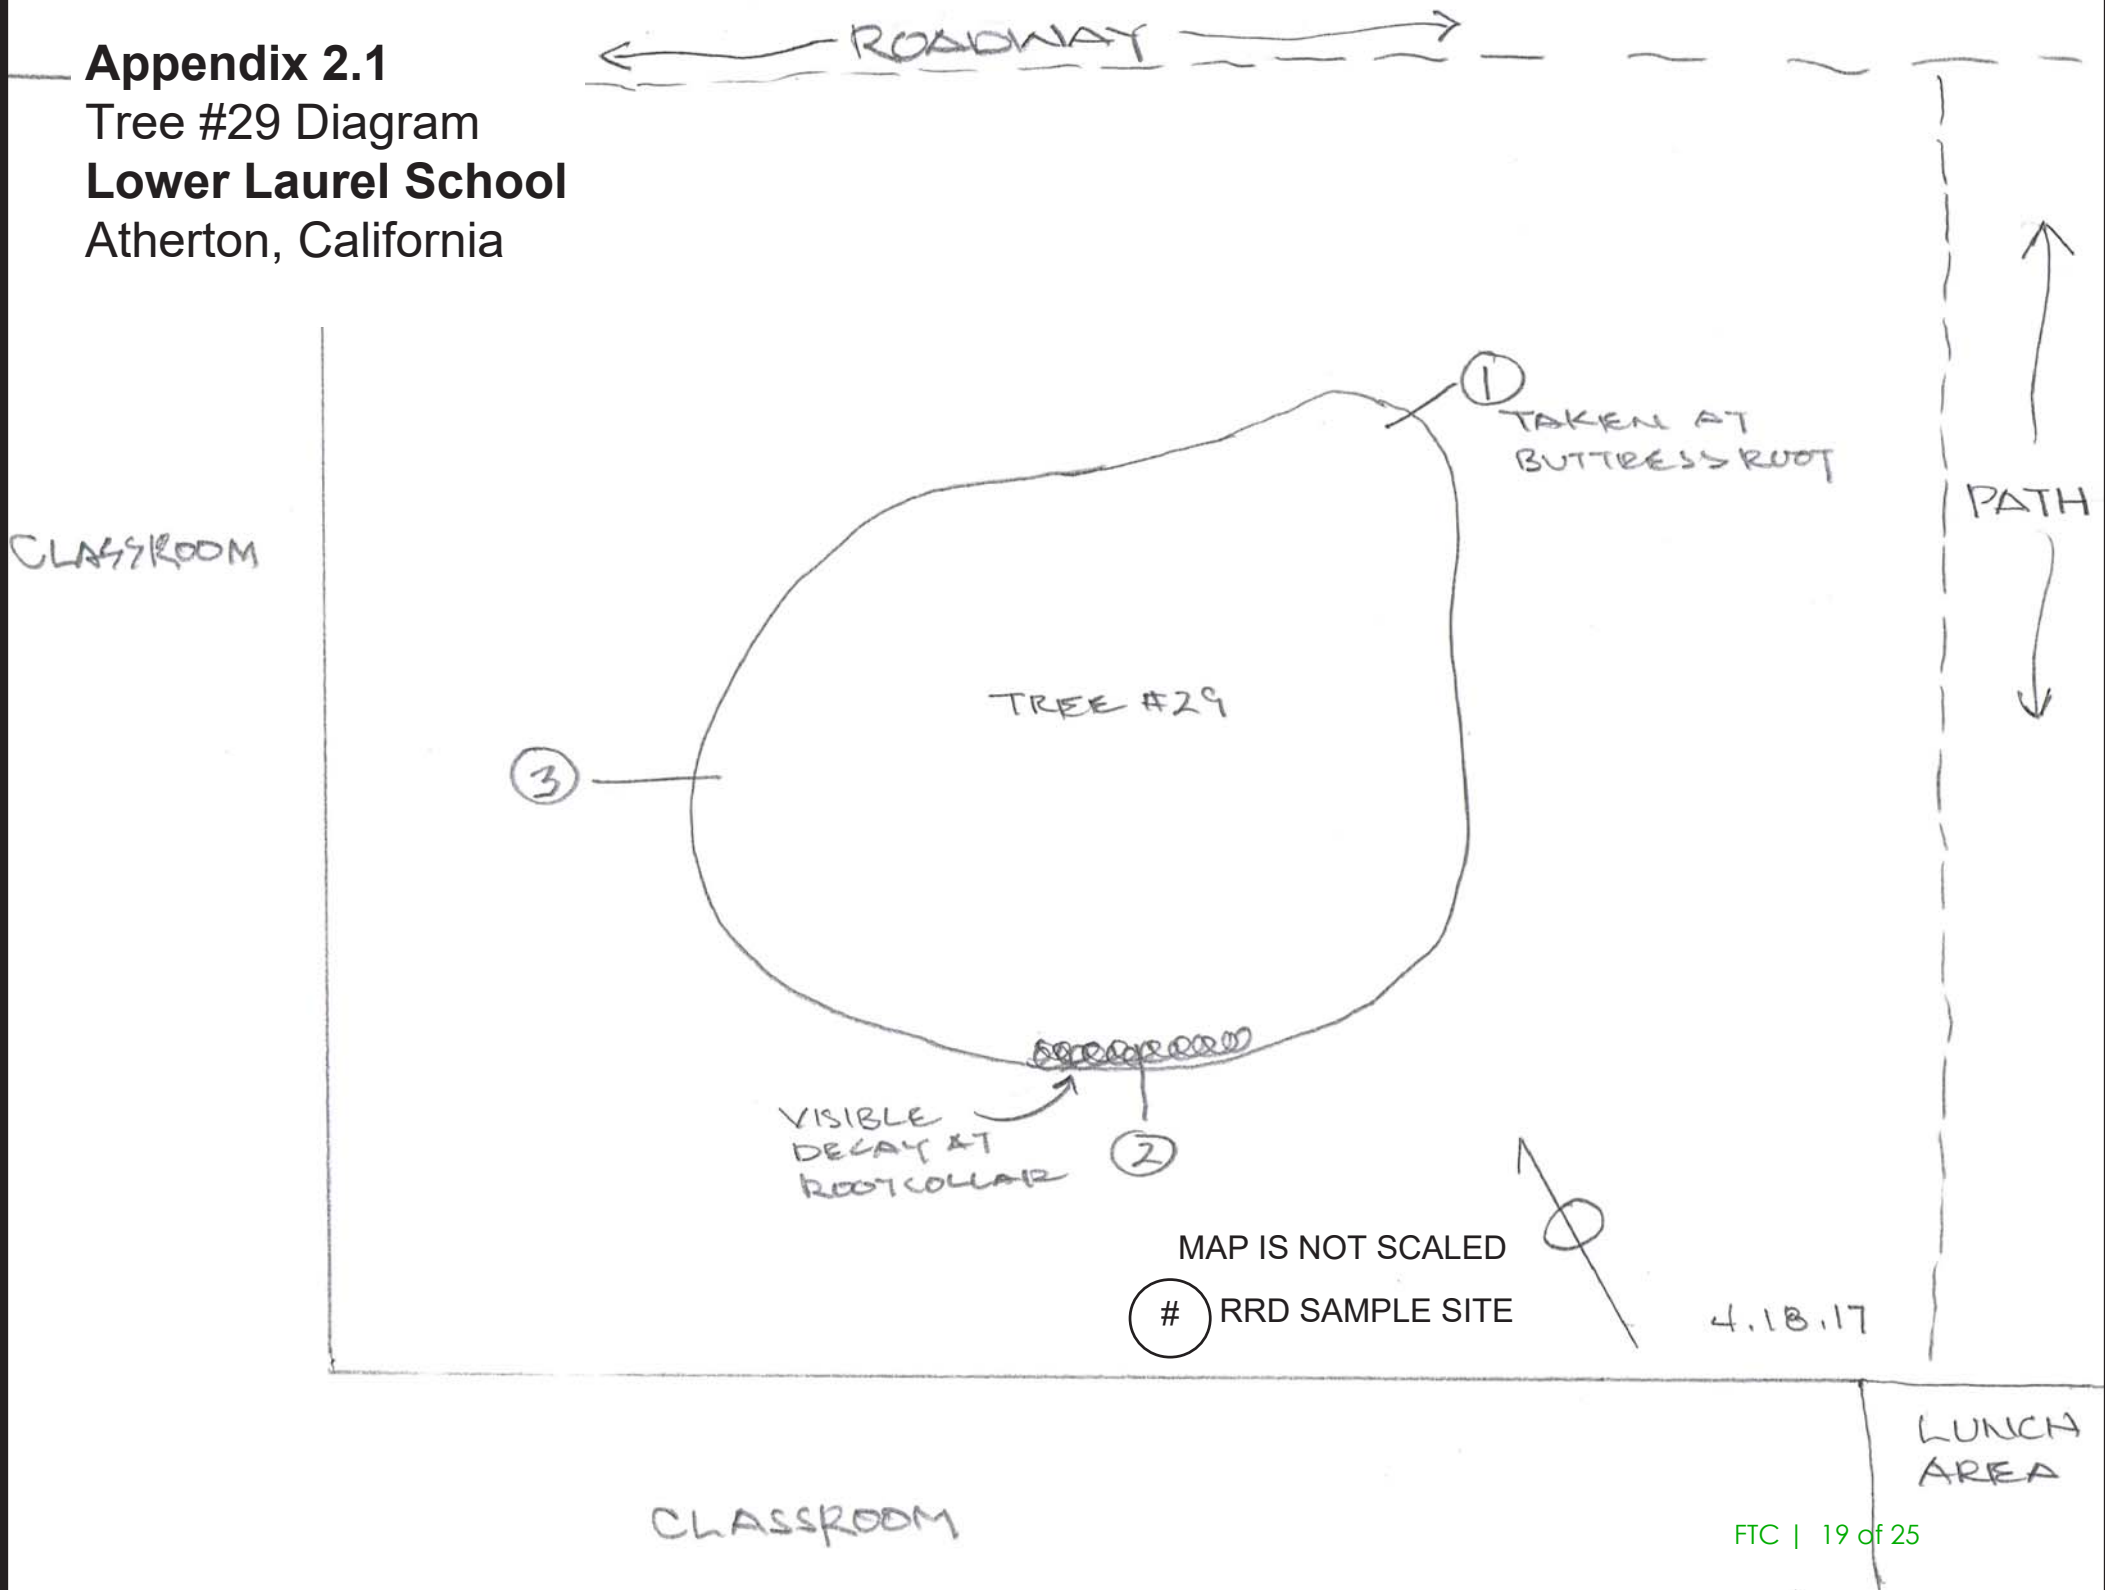
Appendix 2.1
Tree #29 Diagram
Lower Laurel School
Atherton, California

Tree 29 displayed a sparse canopy with occasional branch dieback. Two cables extended from the central leader to opposite elongated limbs. One elongated limb was over the classroom structure and appeared to be in significant decline. The other limb was over the service roadway and was in fair condition. (Photos 1 and 2) Both limbs exhibited poor diameter taper.

The trunk exhibited three active cankers. These cankers emitted an odorless dark viscous fluid that stained the bark. (Photos 2 and 7)

Tree 29 (formerly identified as Tree 13) Prior to considering Tree 29 for preservation, a root collar examination (RCX) should be completed. A cabled limb extending over the classroom building presents a moderate to high risk that requires mitigation pruning.

The RCX should be completed prior to performing any maintenance work on Tree 29. A temporary barrier should be placed around Tree 29 until a determination is made on the status of its buttress roots.

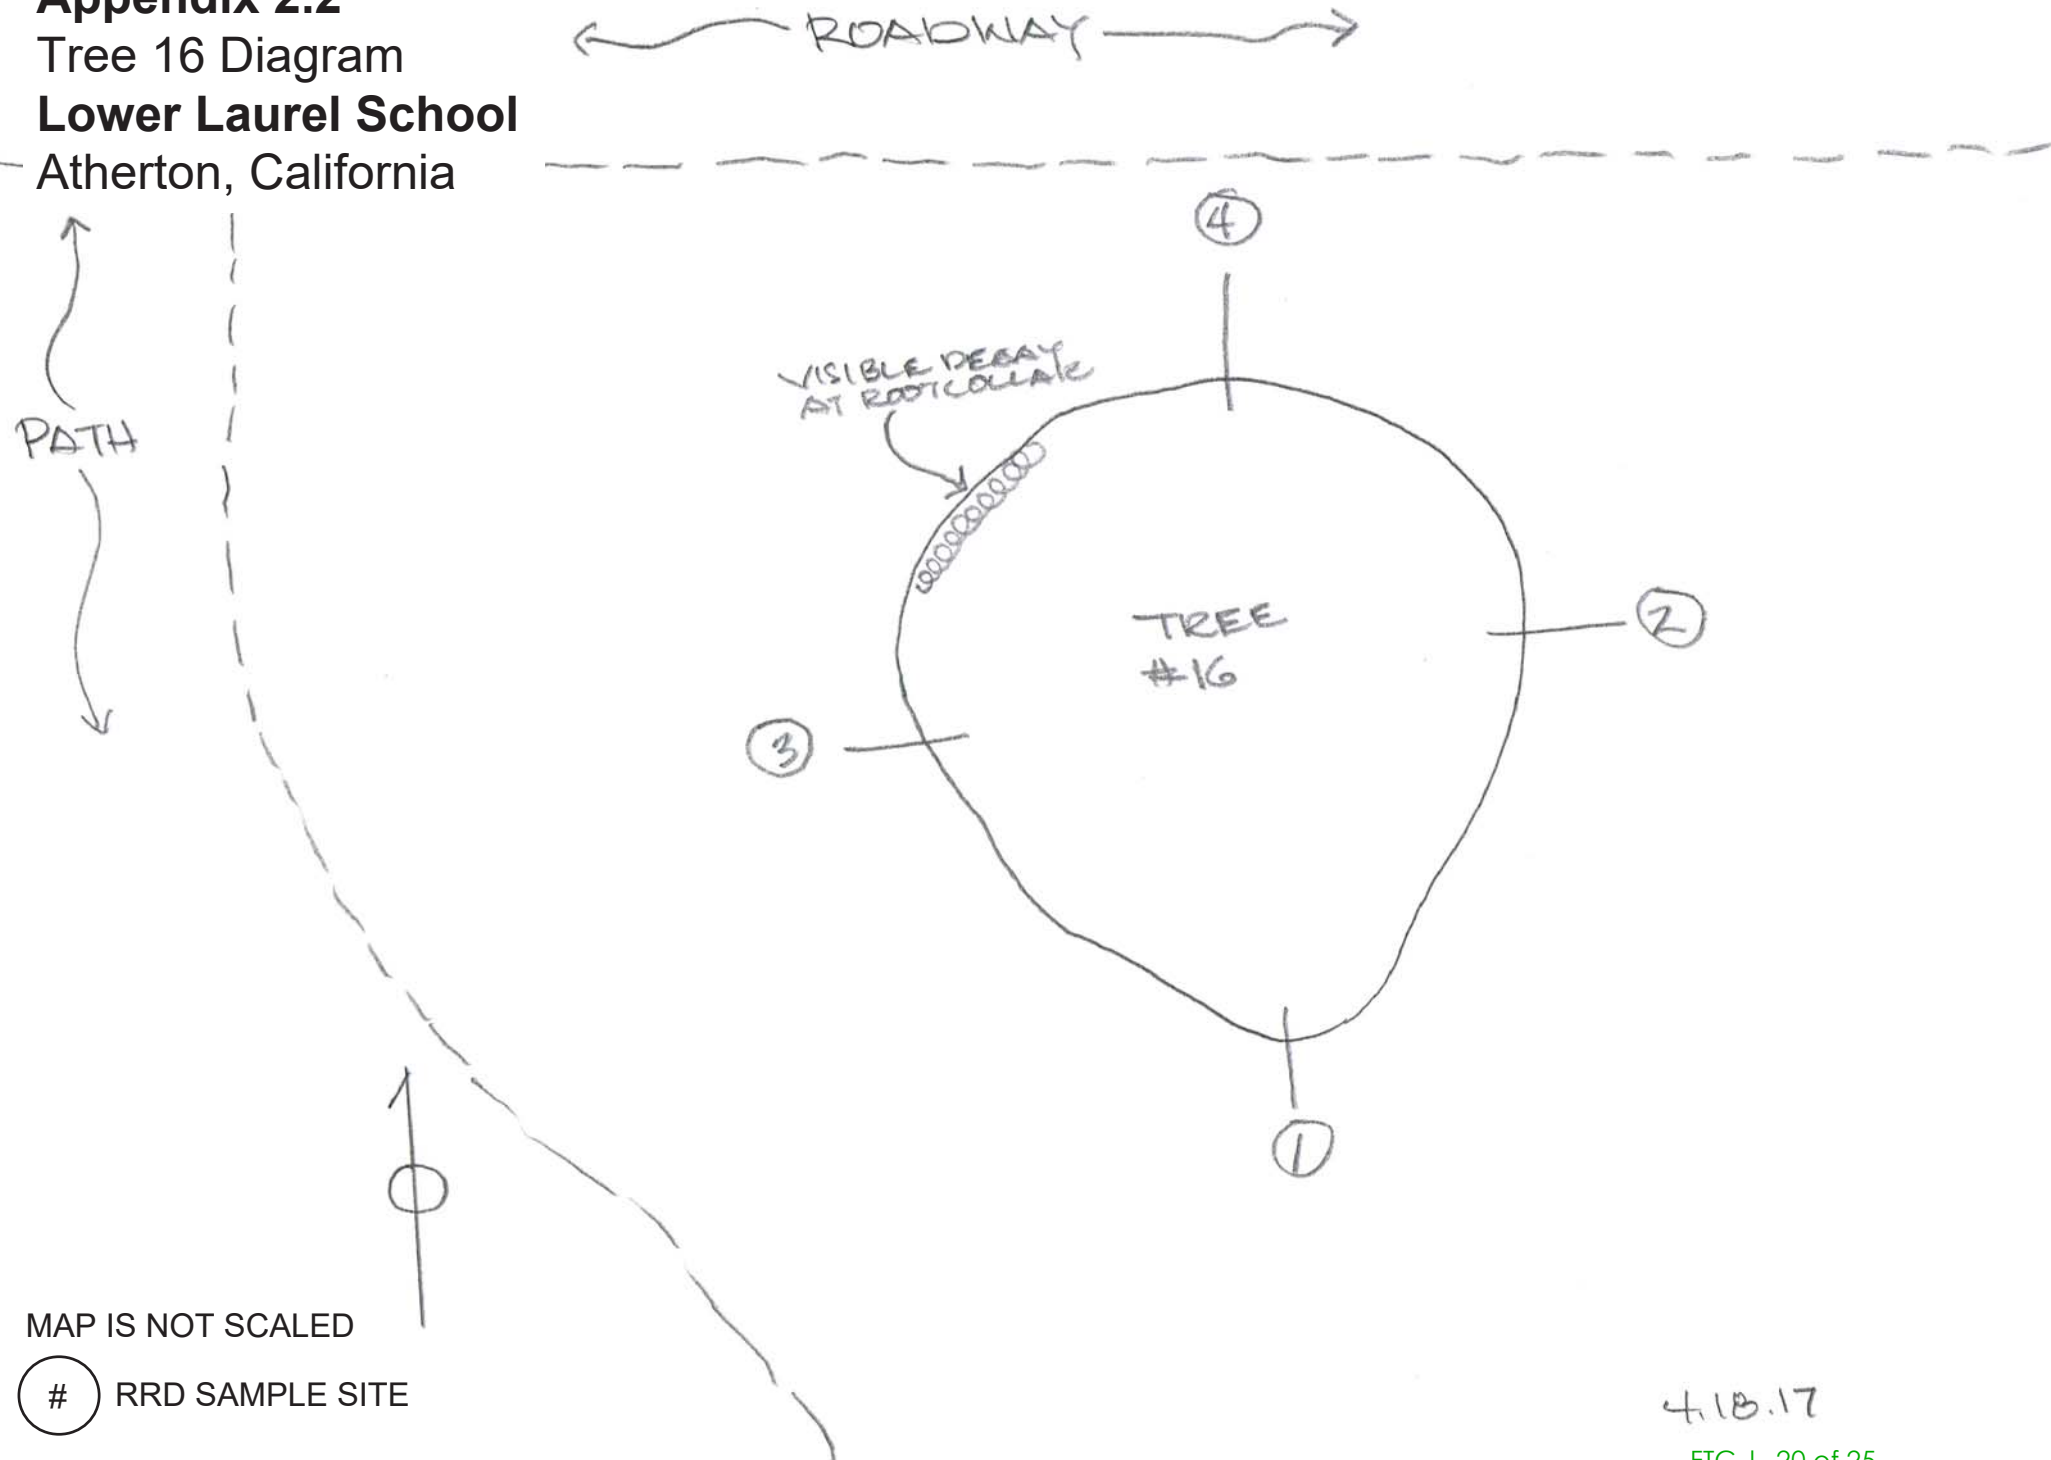
Appendix 2.2
Tree 16 Diagram
Lower Laurel School
Atherton, California

Tree 16 was determined to lack sufficient sound wood. Under current, normal weather conditions Tree 16 presents a moderate to high risk to human activity in close proximity to its dripline. Risk will increase during severe weather conditions.
