# Issue Paper 4: Existing Facility Condition

07 APRIL 2023

## EXISTING FACILITIES

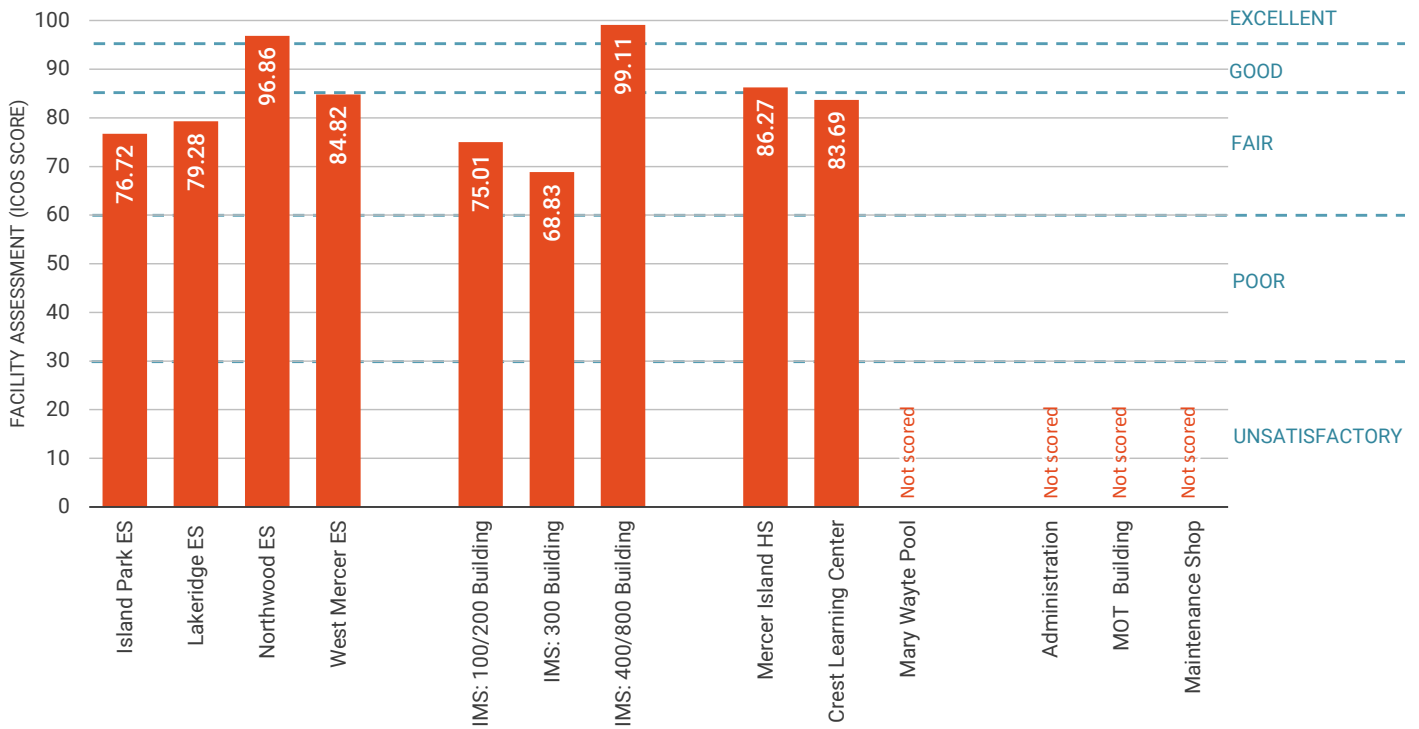
**CHART:**  
**Facility Assessment Comparison**  
 (2022 ICOS Scores)

Recently constructed facilities, including Northwood Elementary School and the new Islander Middle School building, scored over 95 percent, indicating that they are in excellent condition.

All other District facilities, which are older, still had relatively high assessment scores, all between approximately 68 and 86 percent. Mercer Island High School just barely falls into the “good” condition category and all other facilities are in the “fair” condition category. This is likely due to the substantial renovation of these facilities that was done in the mid-nineties, and because they have been well maintained by the District. None of the facility assessment scores indicate a need to replace a school facility solely based on its condition.

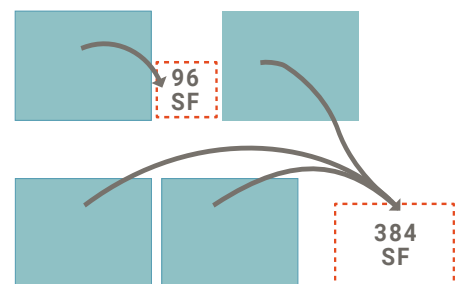
which is less than 110 GSF/student. These are well below the national median of 137 GSF/student, and the District target of 139 GSF/student, developed in the MISD Elementary School Education Specification, January 2014. It was noted by the District that although these facilities provide fairly large classrooms, they do not provide enough shared activity space.

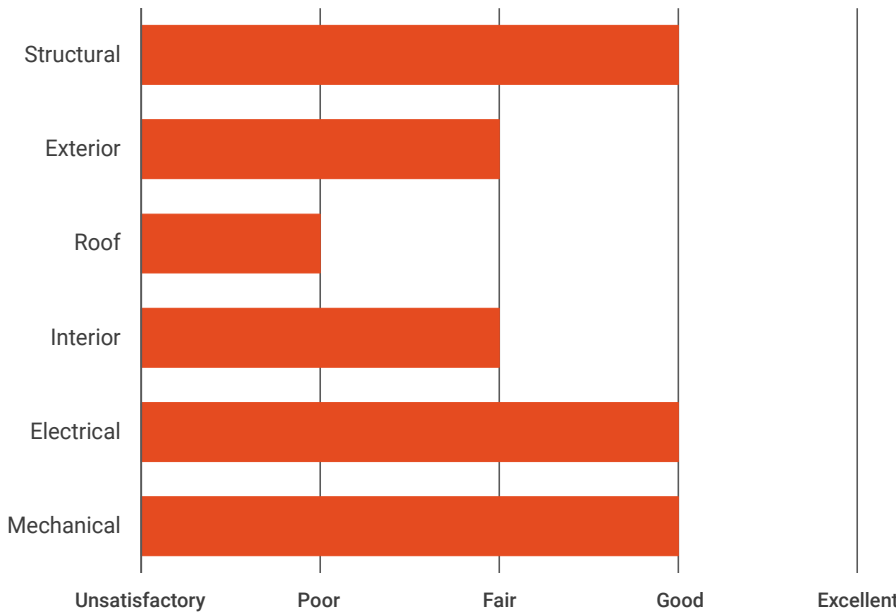
**Facility Condition by System - Island Park ES  
(Classroom Building)**

Building interiors are in fair condition.

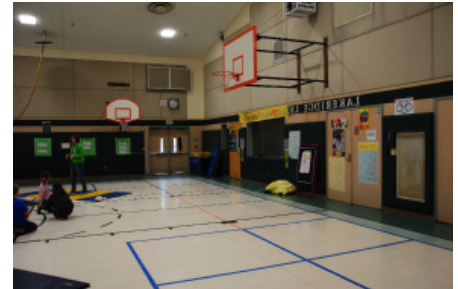
Lakeridge Elementary: Library & Multipurpose

The generator and security systems were reported by District maintenance as showing signs of age and may need to be planned for future replacement. The generator is connected to a single transfer switch with mixed emergency and standby loads, which is a deficiency relative to the NEC.

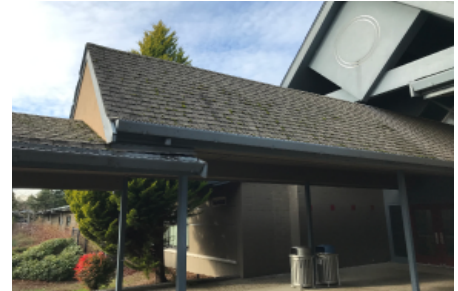
Islander Middle School: 100/200 Building

and sheet flooring in the restrooms is at the end of its serviceable life.

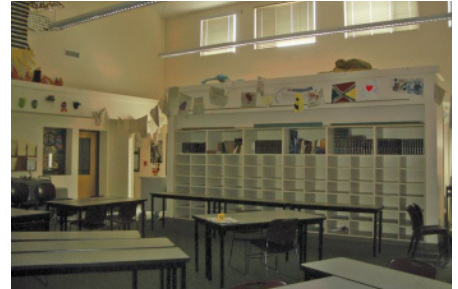
Crest Learning Center: Great Room

Telecommunications cabling to wall-mounted telecommunications devices are Category 5 cabling and do not support current transmission standards.

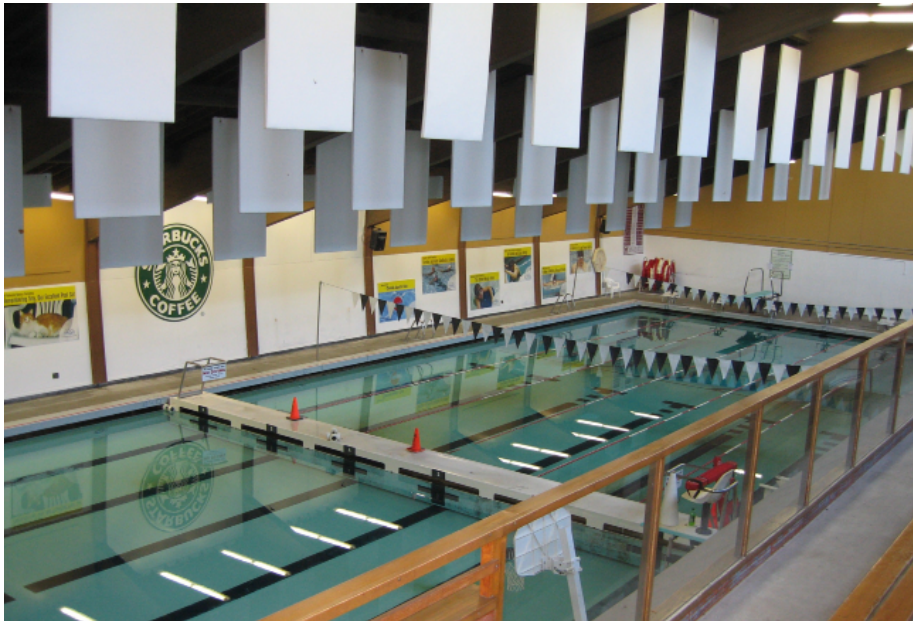
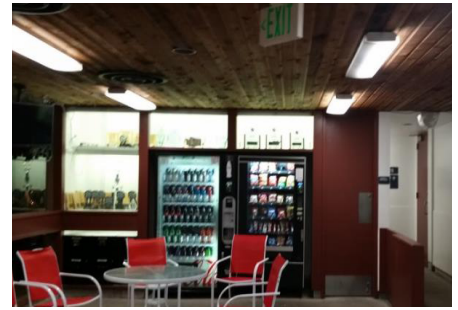
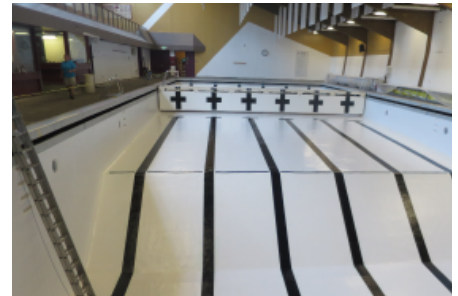
Mary Wayte Pool Interior

The building interior, including walls, floors, and ceilings, is generally in good to fair condition.

The building is in fair to poor condition. Branch wiring devices throughout appear damaged and show signs of corrosion.

Lighting fixtures in some areas show corrosion and some are missing lenses. There is not a facility-wide telecommunications system; all data access is based on a residential-style service with router and distribution within the administration area only. There is no fire alarm system in the building.

The plumbing system is generally in poor condition. There is extensive corrosion throughout, and plumbing fixtures are dated and showing signs of wear. Toilets and urinals are not low-flow style. The pool supply and drainage system was recently relined and appears to be functioning well.

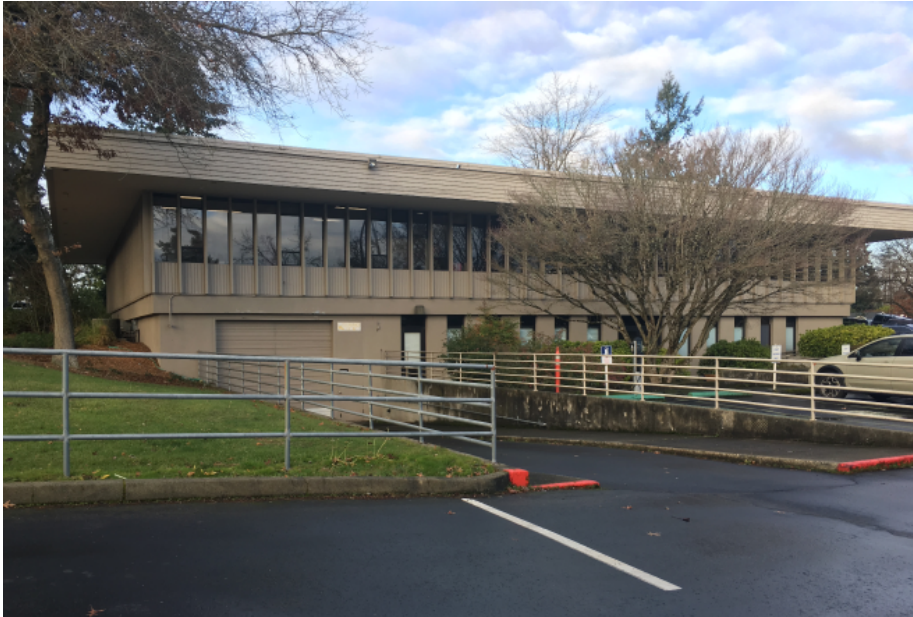
Administration Building Exterior

The building exterior is in overall good to fair condition.

Walls and floor are worn. Kitchen and upper floor restrooms are not accessible, and many of the door handles do not have levers. There is no fire separation between the warehouse and adjoining spaces, the rated one-hour corridor does not appear to meet current standards. The upper floor only has one direct access to the outside. Secondary egress out of the board room terminates into a planter.

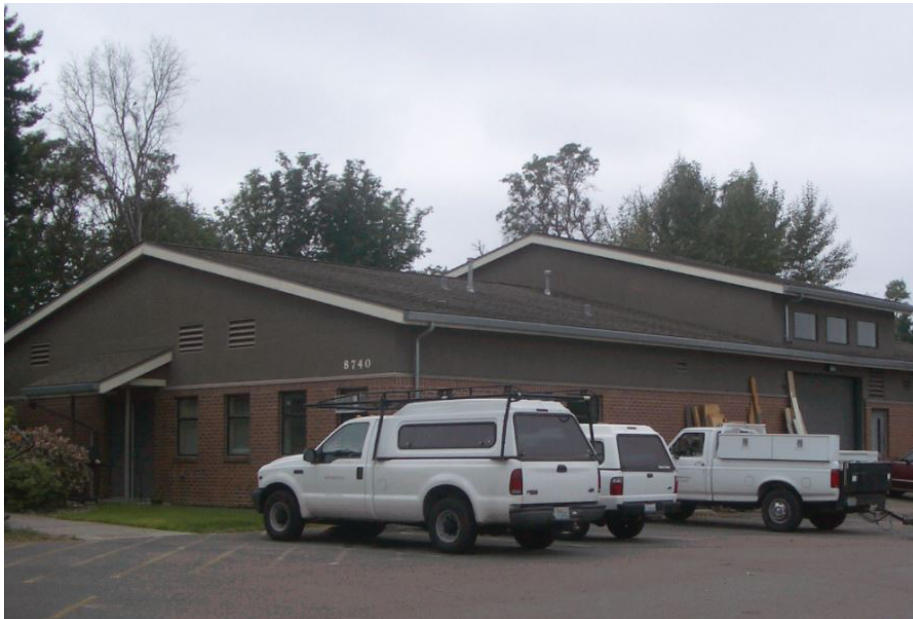
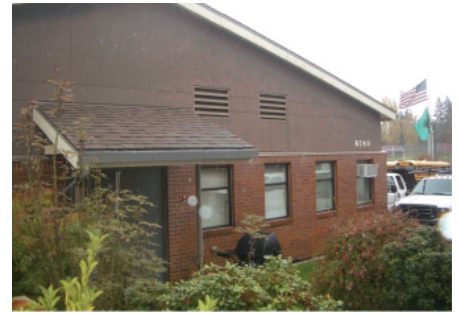
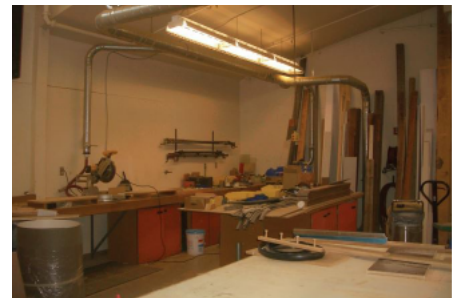
Maintenance Shop

The shop was reconstructed in 1997 and an addition was built during the construction of Northwood, due to fire lane access. There is no significant maintenance or system replacement needed for this building.
